## Inspection Report (On-Highway Truck Cab + Chassis)

Year	2014
Make	Kenworth
Model	T800
Serial Number	1XKDDP9X2EJ404499
Truck Odometer Reading	328,968
Current Inspection / State Cert / DOT	Last Inspection Performed 11/2022
Previous Application (e.g., earth moving, mining, demolition, etc)	Rental Equipment Haul Tractor

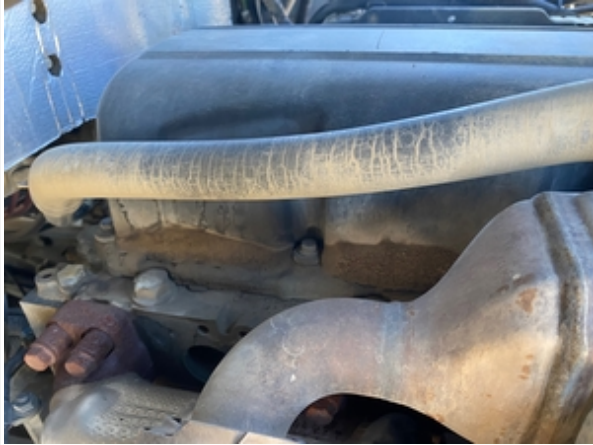
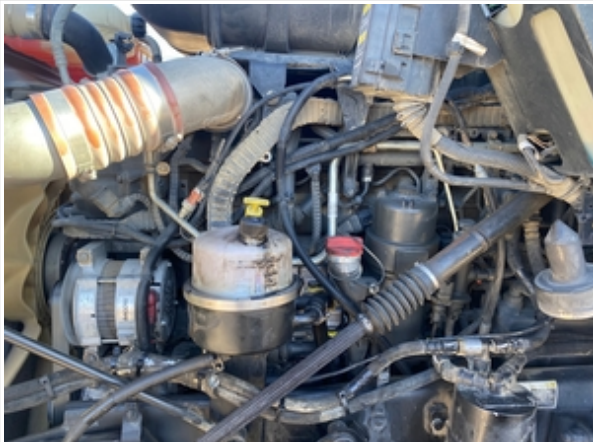
<b>Oil Leak Photos</b>

<b>Battery</b>	2 - Above Average Wear
<b>Battery Condition</b>	Other (see comments)
<b>Radiator</b>	3 - Normal Wear & Tear
<b>Radiator Condition</b>	Radiator fins & components appear to be in good working order, no signs of damage or leaks
<b>Belts</b>	3 - Normal Wear & Tear
<b>Belt Condition</b>	Belts appear in good condition & alignment with proper tension
<b>Hoses</b>	3 - Normal Wear & Tear
<b>Hose Condition</b>	Firm, pliant hoses with no signs of wear or leaks
<b>Water Pump</b>	3 - Normal Wear & Tear
<b>Water Pump Condition</b>	No unusual pump noises heard
<b>Cooling System Leaks</b>	No
<b>Coolant Color / Appearance</b>	3 - Normal Wear & Tear
<b>Coolant Color/Appearance Notes</b>	Normal Translucent appearance, no visual signs of contamination
<b>Oil Leaks</b>	Yes
<b>Oil Leak Notes</b>	Dried oil seepages seen, Other (see comments)
<b>Comments</b>	Valve cover showing signs of oil leak at valve cover gasket

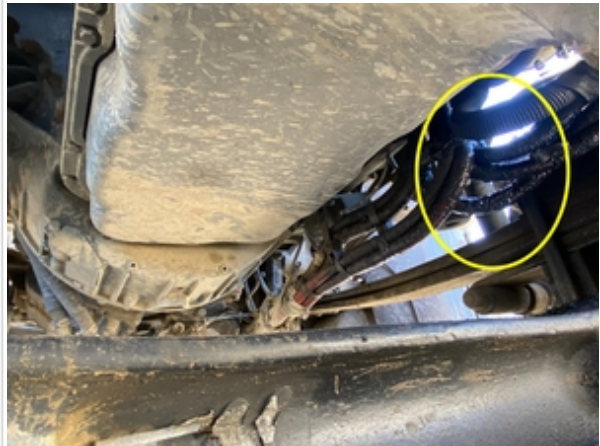
Oil buildup seen in highlighted area (possibly power steering fluid)	
Oil Color / Appearance	3 - Normal Wear & Tear	
Oil Color / Appearance Notes	Clean oil appearance, no signs of cross contamination, Appropriate oil level	
Fuel Leaks	No	
Requires DEF (Diesel Exhaust Fluid)	Yes	
DEF Tank	3 - Normal Wear & Tear	
DEF Tank Condition	Area around DEF tank cap is clean, fluid is clear & appears free of contaminants	
Overall Engine Appearance	Areas of dried seepage seen on engine hoses & components	
Overall Engine Comments	Active leak seen from left side of engine area.

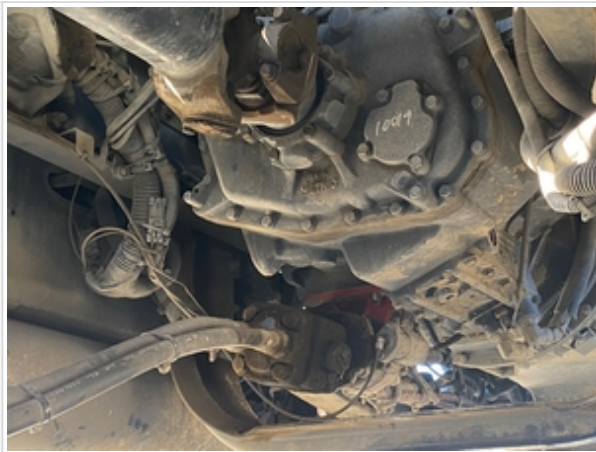
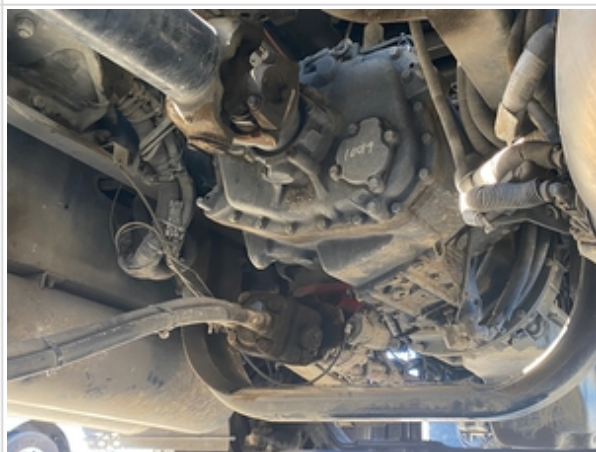
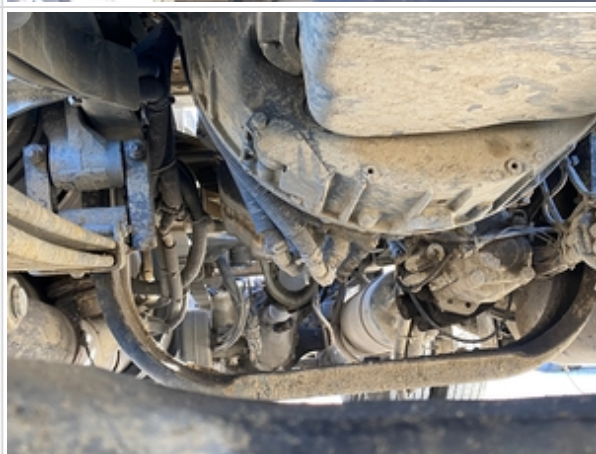
Transmission Condition Photos

<b>Transmission Info (Make/Model)</b>	Eaton Fuller 13 Speed
<b>Transmission</b>	3 - Normal Wear & Tear
<b>Transmission Condition</b>	No unusual noises or vibrations

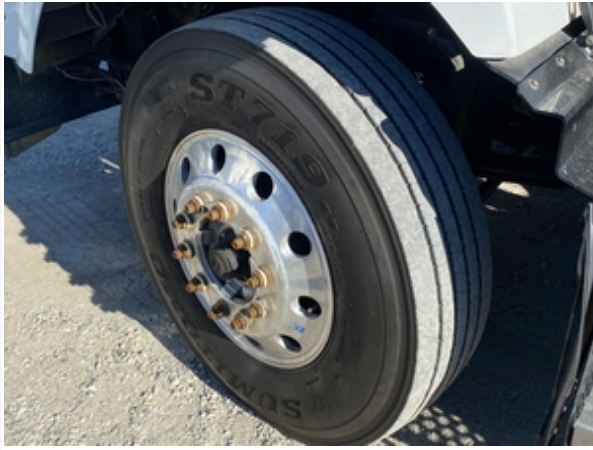
Wheels & Hub Condition	3
Wheel Seal Leaks	No
Tire Brand	Sumitomo
Tire Size	11R22.5
Front Left Tire - Ratio Remaining	50%
Front Left Tire Photos

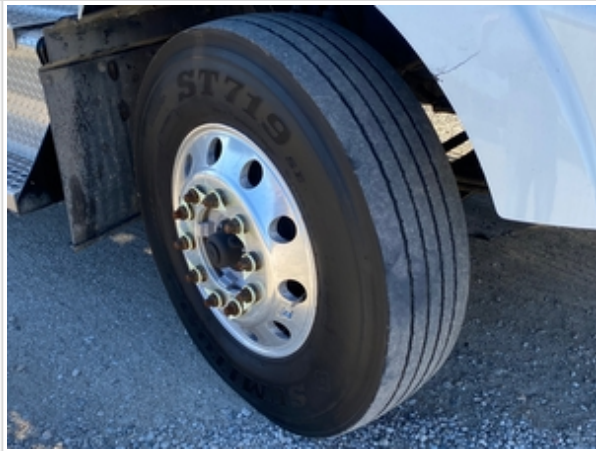
Front Right Tire Photos

Front Right Tire - Ratio Remaining	50%

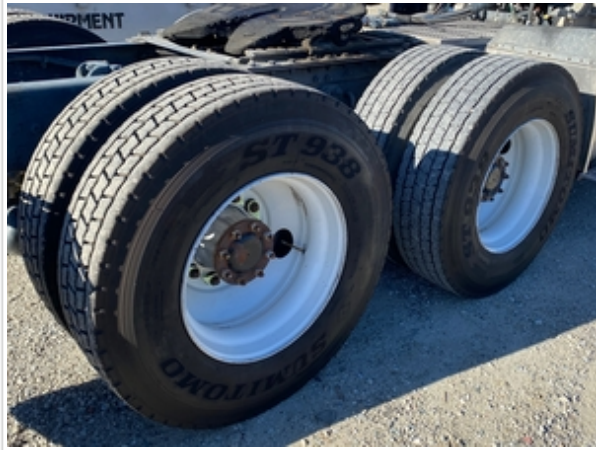
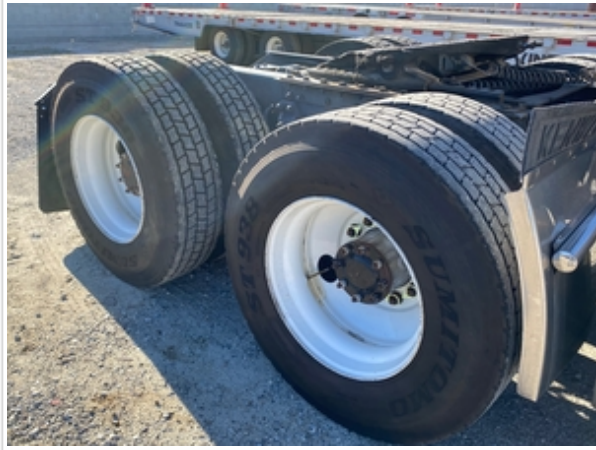
Rear Right Tire - Ratio Remaining	70%	
Rear Right Tire Photos

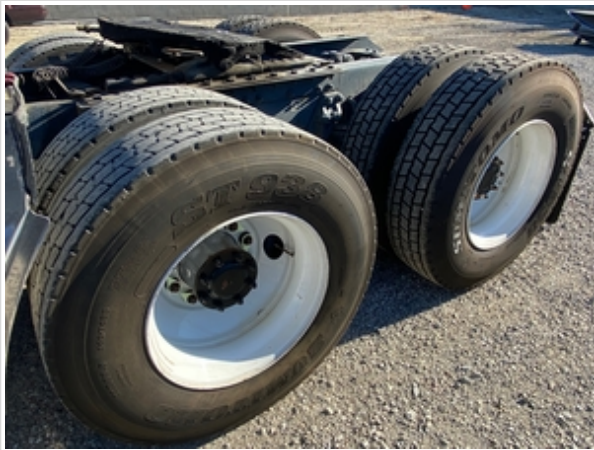
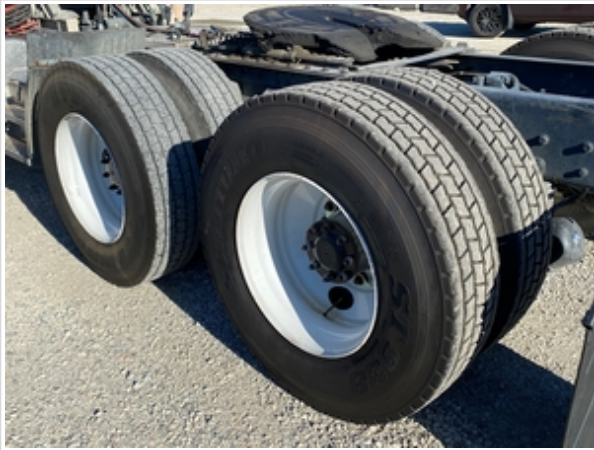
Rear Left Tire Photos

Rear Left Tire - Ratio Remaining	70%
