Inspection Report (On-Highway Service Truck)

Year	2016
Make	Freightliner
Model	M2
Serial Number	3ALACXCYOGDHF7409
Truck Odometer Reading	11,925 Miles
Current Inspection / State Cert / DOT	N/A
Previous Application (e.g., earth moving, mining, demolition, etc)	Masonry General Construction

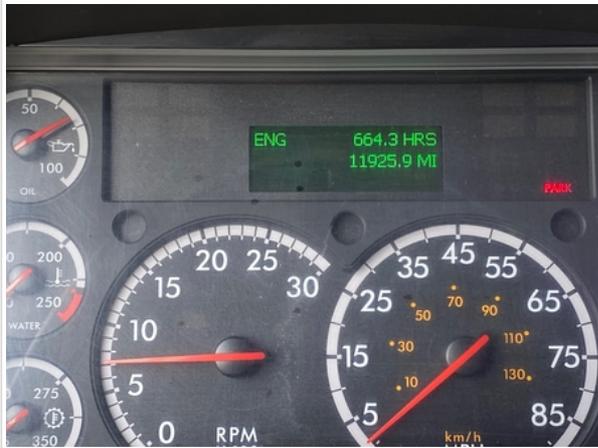
<p>Odometer Photo</p>

Odometer Activity	3 - Normal Wear & Tear
Odometer Condition	Odometer is working and in good condition
Controls/Switches/Gauges	3 - Normal Wear & Tear
Controls/Switches/Gauges Condition	All switches/gauges are in good condition and functioning
Brake System Type	Air Brakes
Air Brakes Build Correct Pressure	Yes
Clutch	0
Horn	3 - Normal Wear & Tear
Horn Condition	Horn is functioning as expected
Reverse Alarm / Backup Camera	2 - Above Average Wear
Reverse Alarm / Backup Camera Condition	Reverse alarm is configured but inoperable
Heater & A/C	3 - Normal Wear & Tear
Heat & A/C Condition	Heater and A/C work as expected
Interior Lights	3 - Normal Wear & Tear
Interior Lights Condition	All interior lights are installed and functioning

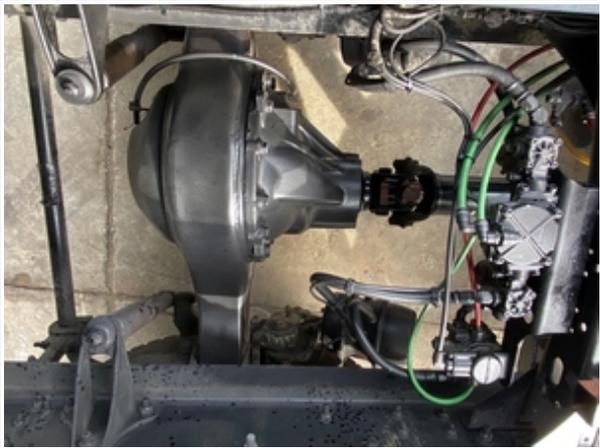
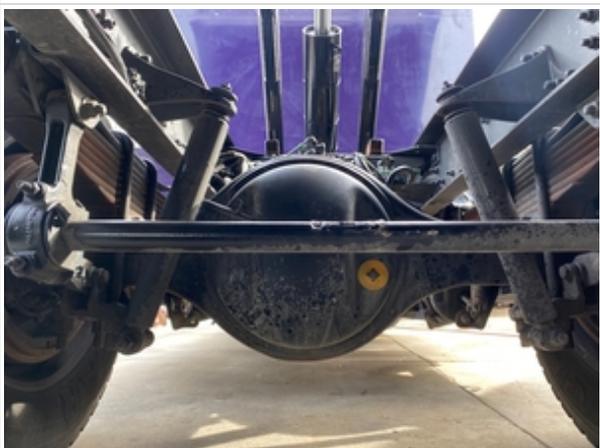
PTO	3 - Normal Wear & Tear	
Differential	Check condition of the differential(s). Take photos and notes as relevant.	
Rear Differential	3 - Normal Wear & Tear	
Rear Differential Condition	Dry housing appearance, no unusual noises heard during operation	
Rear Differential Photos

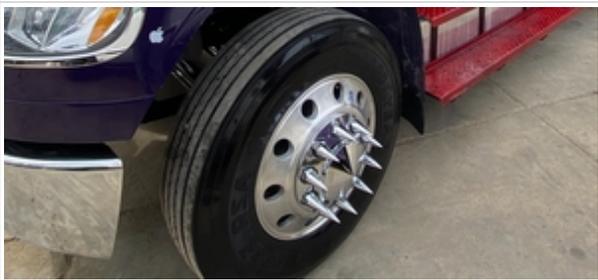
Wheel Seal Leaks	No	
Tire Brand	Goodyear	
Tire Size	295/75R/22.5	
Front Left Tire - Ratio Remaining	70%	
Front Left Tire Photos

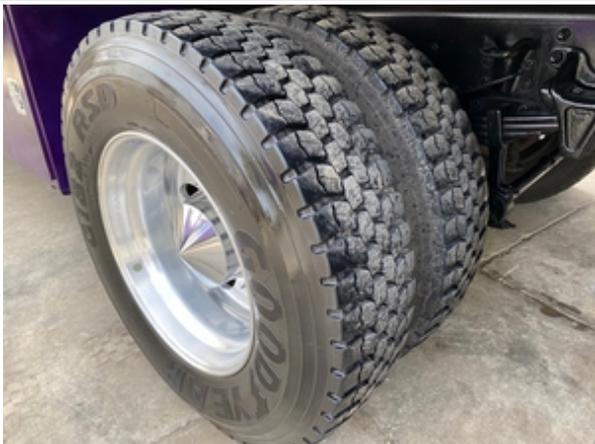
Rear Left Tire - Ratio Remaining	90%
Rear Left Tire Photos
