Inspection Report (Skid Steer)

Year	2003
Make	Bobcat
Model	763
Serial Number	512266975
Hour Meter Reading	2,563 Hours
Previous Application (e.g., earth moving, mining, demolition, etc)	Masonry General Construction

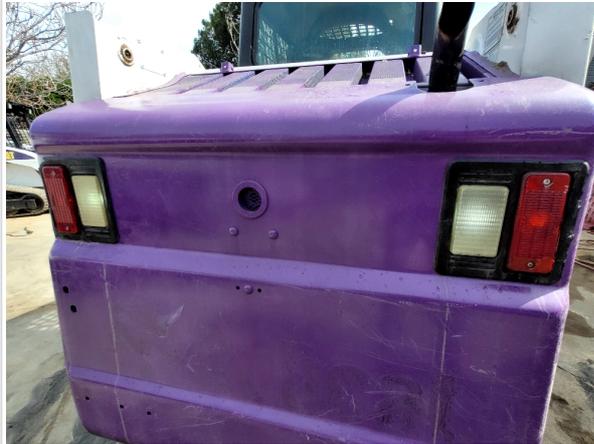
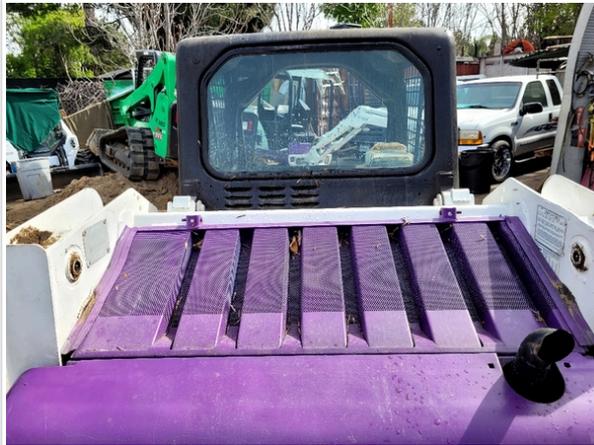
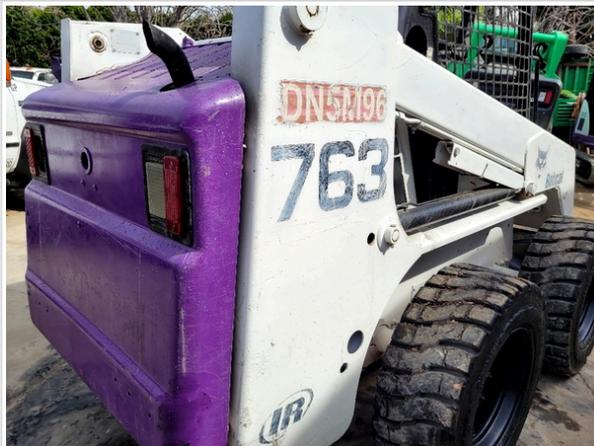
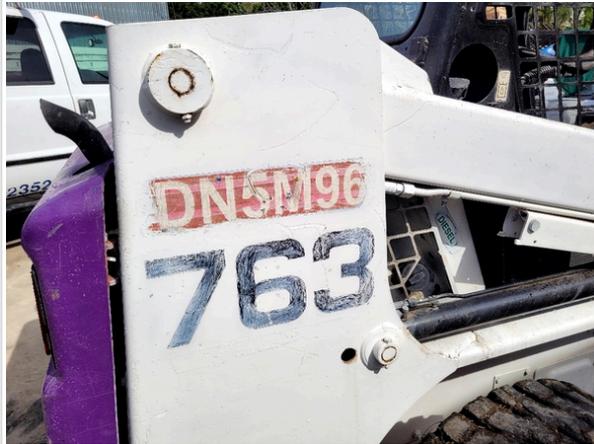
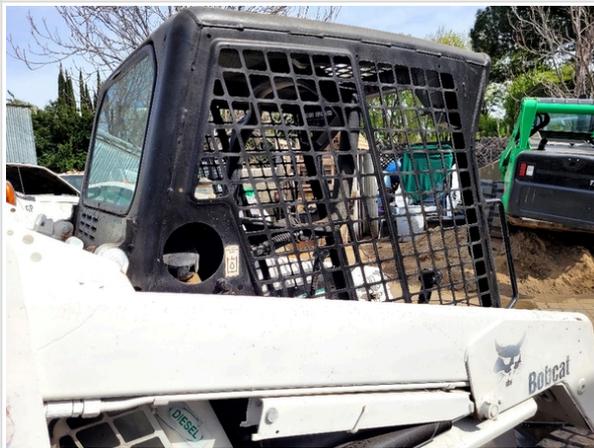
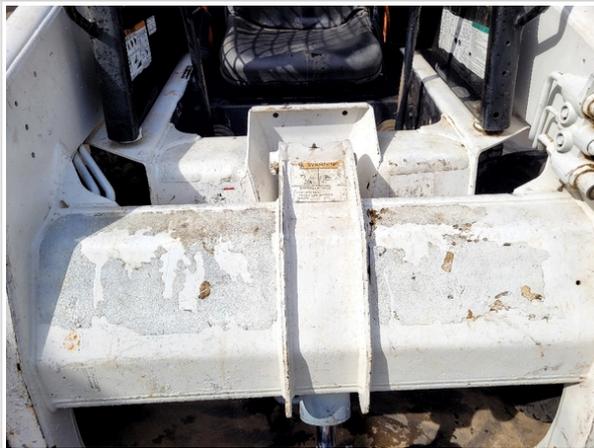
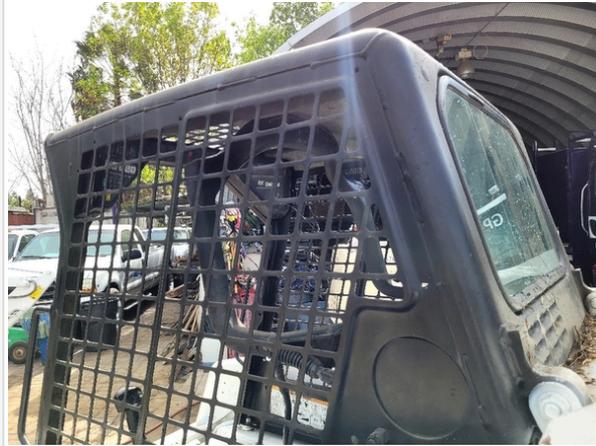
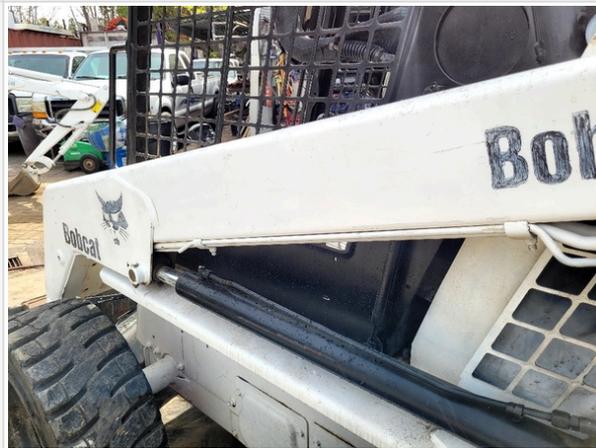
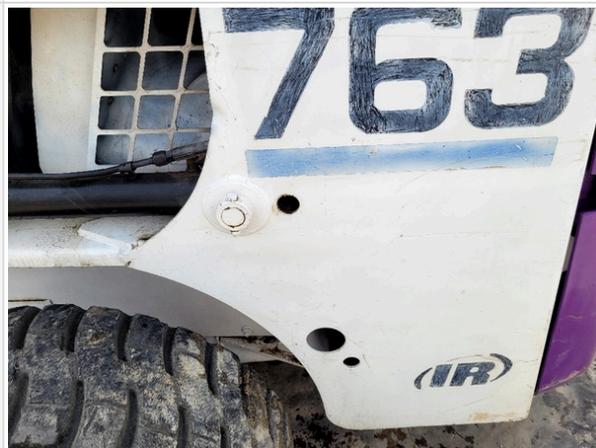
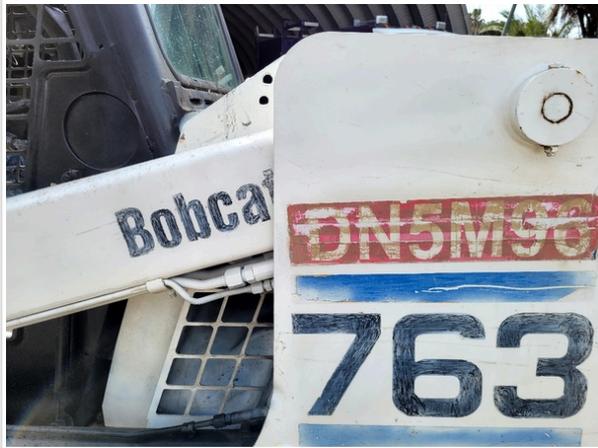
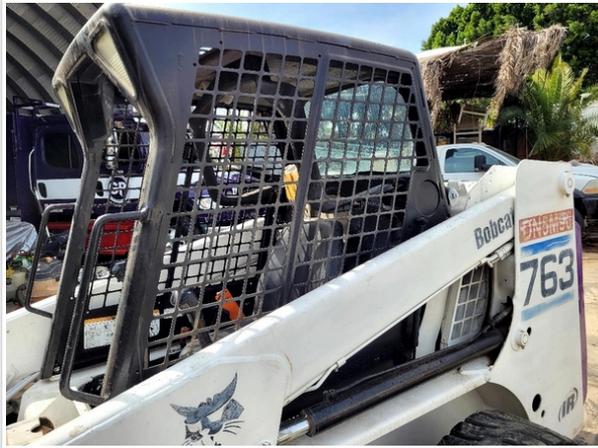
Close-up Exterior Photos

Body Panels	3 - Normal Wear & Tear
Body Panel Condition	No visible damage, good paint condition and panel fitment
Doors / Canopy Latches	3 - Normal Wear & Tear
Doors / Canopy Latches Condition	No visible damage
Steps / Ladders	3 - Normal Wear & Tear
Steps / Ladders Condition	Steps/ladders are fully intact and appear structurally sound
Handrails	3 - Normal Wear & Tear
Handrails Condition	Handrails are fully intact and appear structurally sound
Glass	3 - Normal Wear & Tear
Glass Condition	Glass intact, no visible damage
Mirrors	0
Exterior Lights	3 - Normal Wear & Tear
Exterior Lights Condition	No visible damage, lighting system is operational

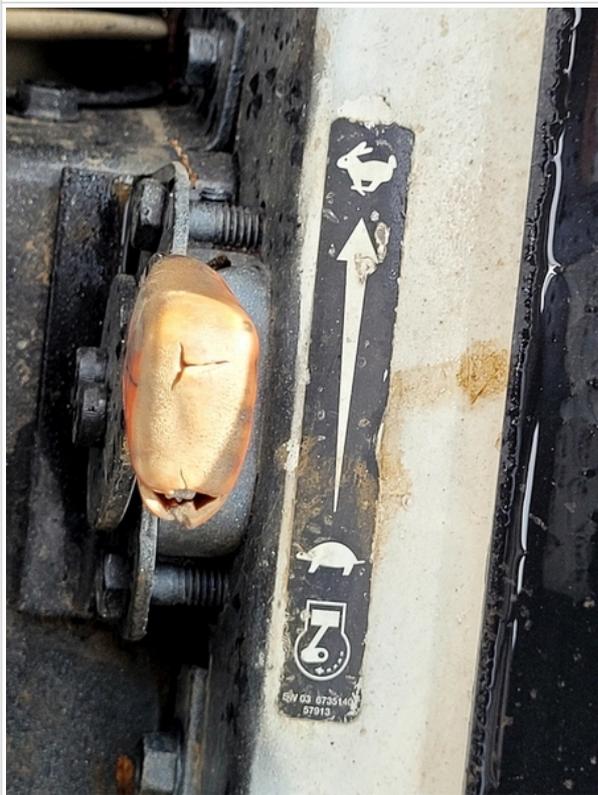
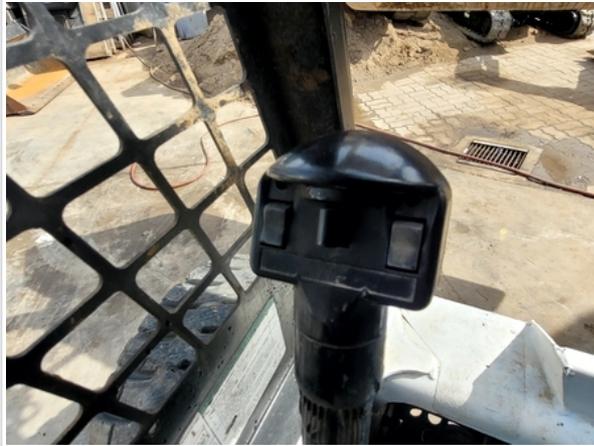
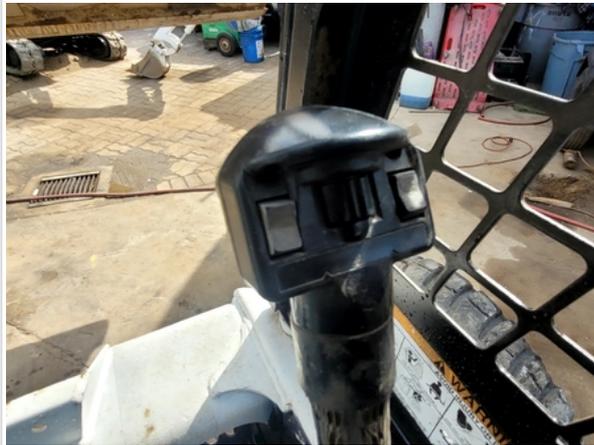
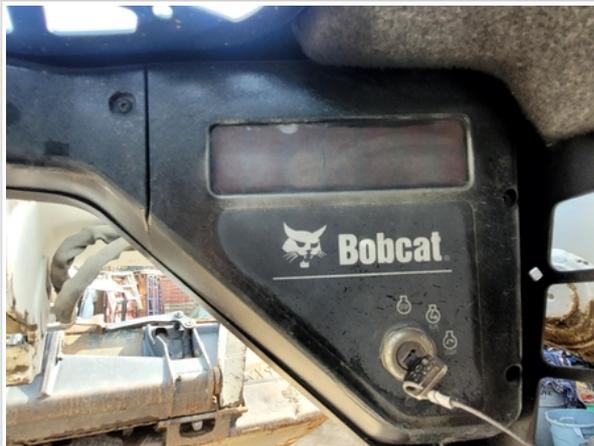
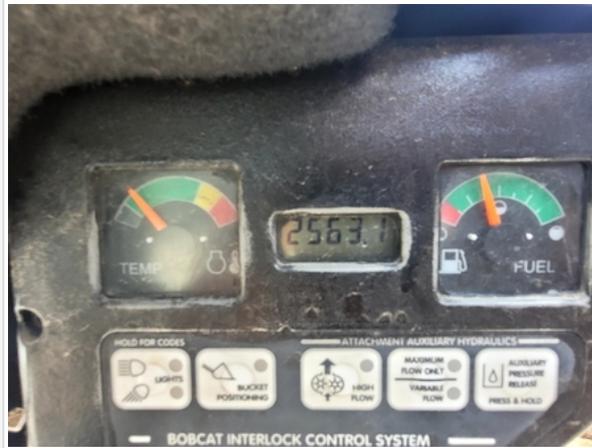
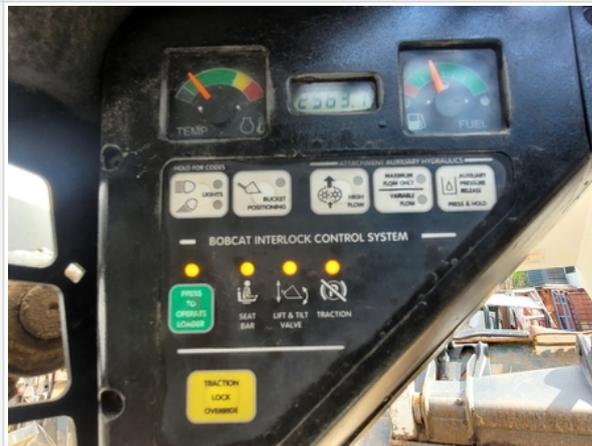
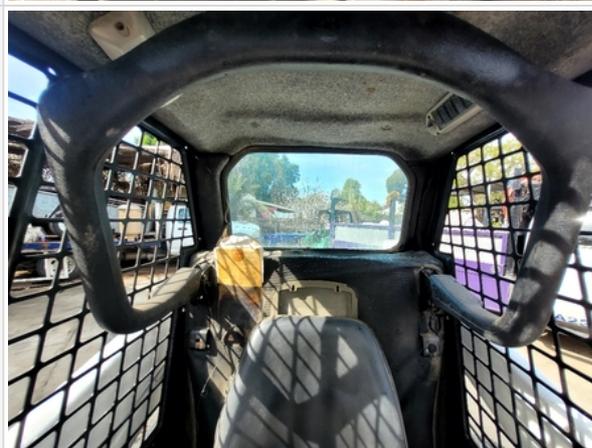
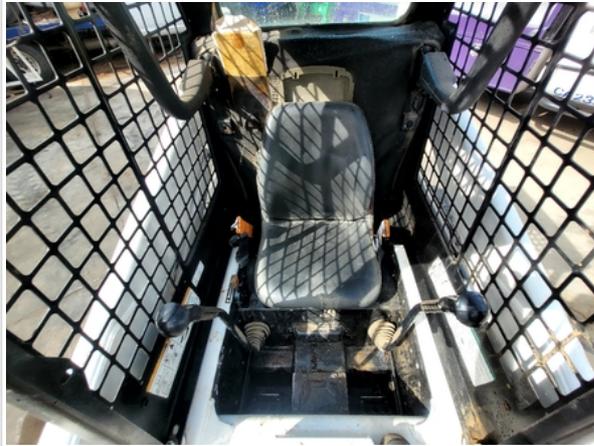
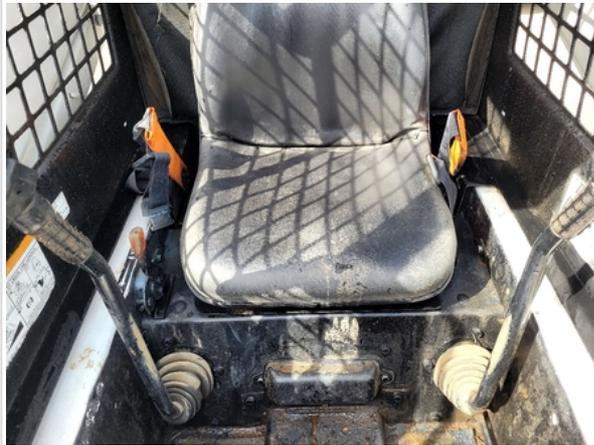
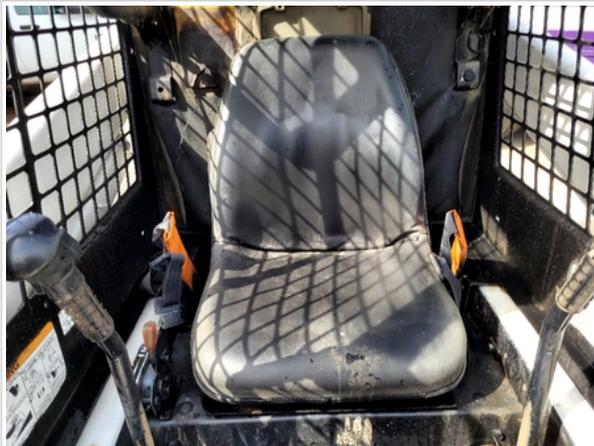
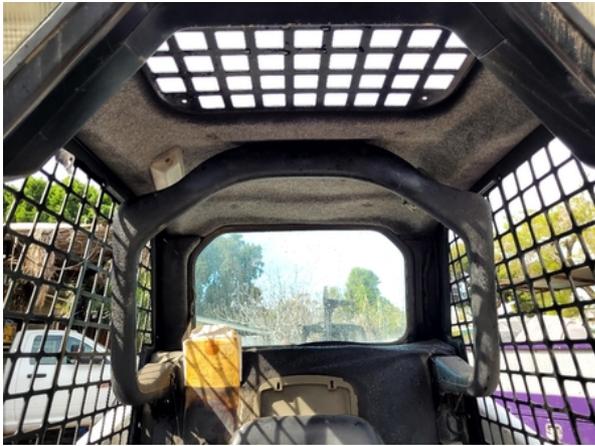
<p>Operator Cabin Photos</p>

Operator Cabin Overall	3 - Normal Wear & Tear
Operator Cabin Overall Condition	Good cabin appearance, solid floors, panels, and ceiling
Operator Seat	3 - Normal Wear & Tear
Operator Seat Condition	Seat(s) in good condition, no stains or tears in upholstery
Cabin Lights	3 - Normal Wear & Tear
Cabin Lights Condition	Cabin lights are installed with all light covers in place, bulbs are installed and working properly
Safety Lock Out / Stop	3 - Normal Wear & Tear
Safety Lock Out / Stop Condition	Safety lock out device is present, in good condition, and functional
Controls & Switches	3 - Normal Wear & Tear
Controls & Switches Condition	All switches are installed and functional
Hour Meter Activity	3 - Normal Wear & Tear
Hour Meter Condition	Hour meter is functional and in good condition
Hour Meter Activity Photos

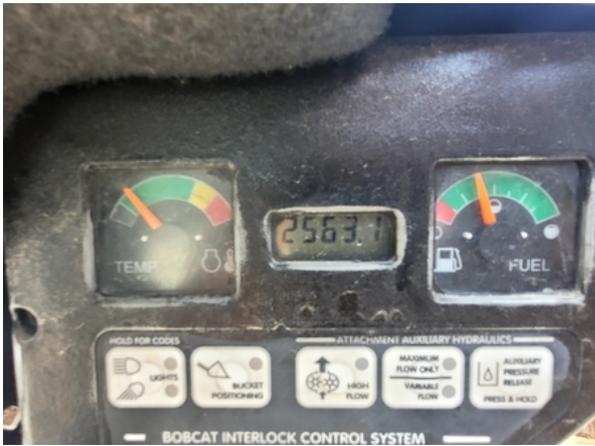
Other Gauge Activity	3 - Normal Wear & Tear
Other Gauge Condition	All cockpit gauges are functional and in good condition

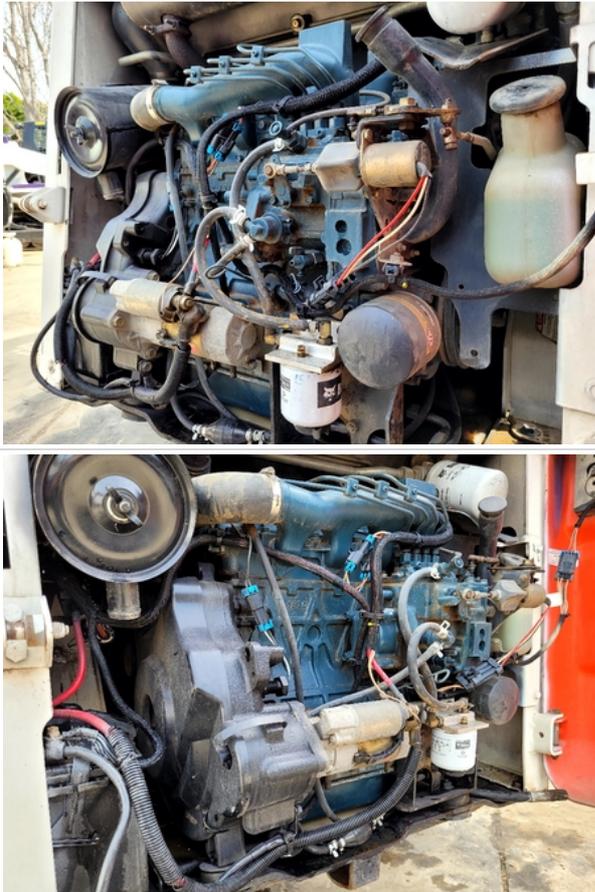
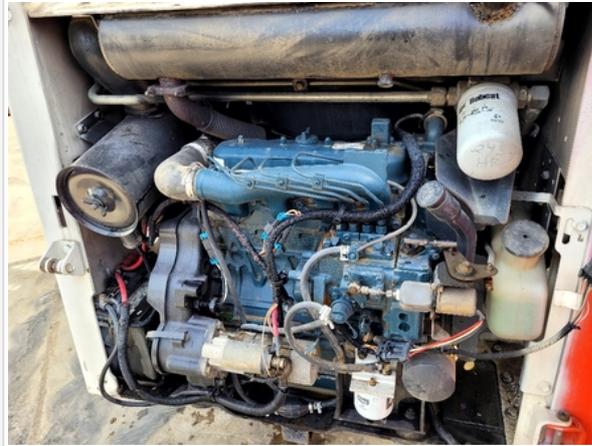
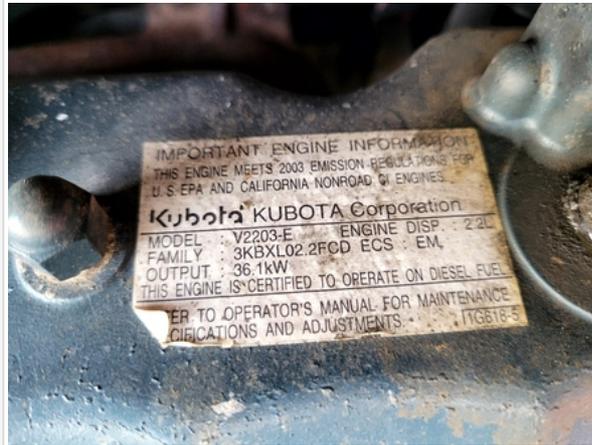
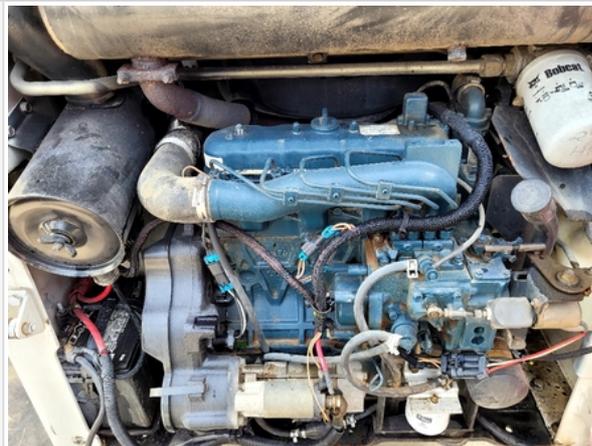
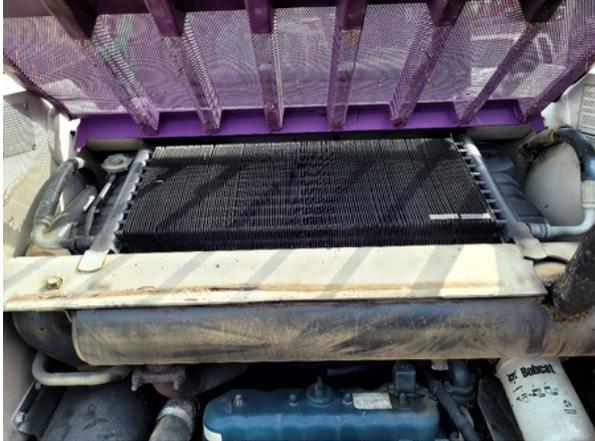
Blow-by (Visual Observation Check)	No
Unusual Noises (Upon Start-up, Idle, Shutdown)	No
Unusual Noise Notes	No unusual noises heard
Engine Smoke (Upon Start-up, Idle, Shutdown)	No
Engine Smoke Notes	No engine smoke issues observed
Engine Exhaust Color	Clear
Battery	3 - Normal Wear & Tear
Battery Condition	Clean & dry appearance, tight connections
Radiator	3 - Normal Wear & Tear
Radiator Condition	Radiator fins & components appear to be in good working order, no signs of damage or leaks
Belts	3 - Normal Wear & Tear
Belt Condition	Belts appear in good condition & alignment with proper tension
Hoses	3 - Normal Wear & Tear
Hose Condition	Firm, pliant hoses with no signs of wear or leaks
Water Pump	3 - Normal Wear & Tear
Water Pump Condition	No unusual pump noises heard
Cooling System Leaks	No
Coolant Color / Appearance	3 - Normal Wear & Tear
Coolant Color/Appearance Notes	Normal Translucent appearance, no visual signs of contamination

Requires DEF (Diesel Exhaust Fluid)	No
Overall Engine Appearance	Clean & dry
Overall Engine Comments	Overall engine appearance in good shape with no active leaks observed and sounds healthy running under load.

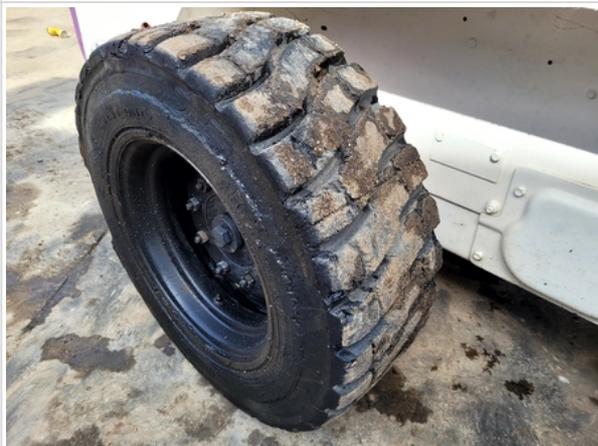
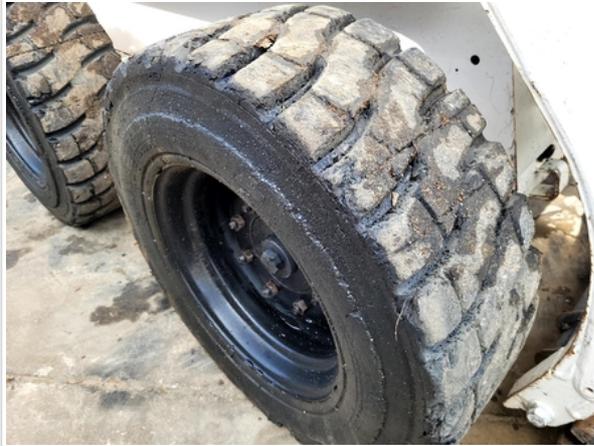
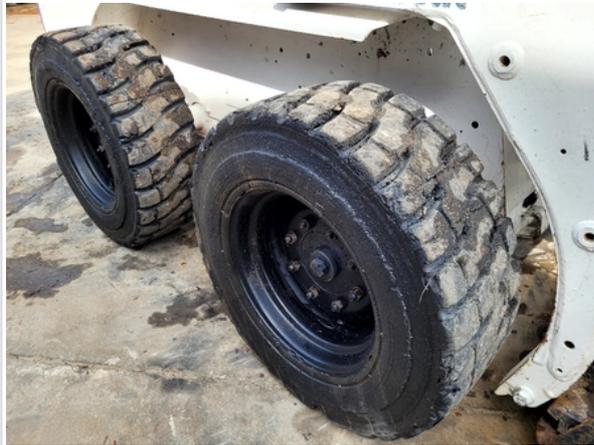
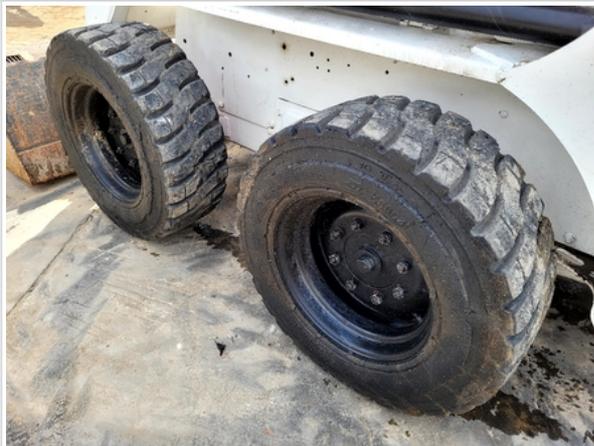
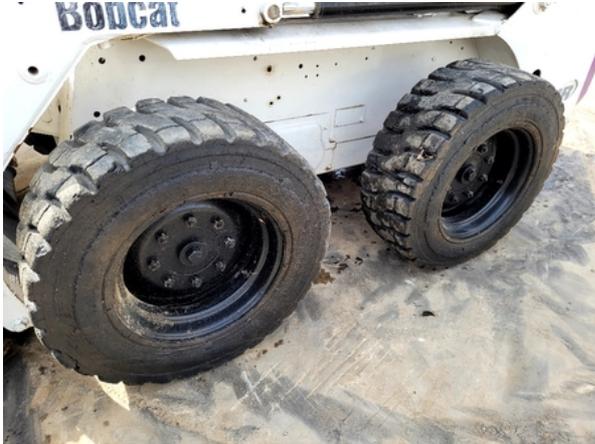
Stance	3 - Normal Wear & Tear	
Wheels & Tires	3 - Normal Wear & Tear	
Comments	Tires in good condition	
Wheels & Tires Photos

Tire Brand	N/A
Tire Size	N/A
Front Left Tire - Ratio Remaining	50%
Rear Left Tire - Ratio Remaining	50%
Front Right Tire - Ratio Remaining	50%
Rear Right Tire - Ratio Remaining	50%
Lift Arm	3 - Normal Wear & Tear
Chassis to Arm Pins	3 - Normal Wear & Tear
Quick Coupler	3 - Normal Wear & Tear
Quick Coupler Photos

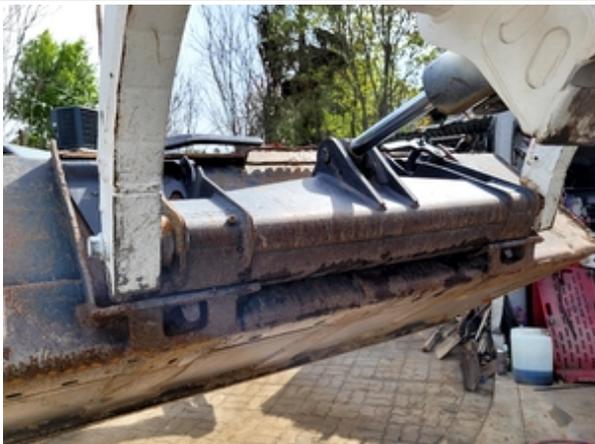
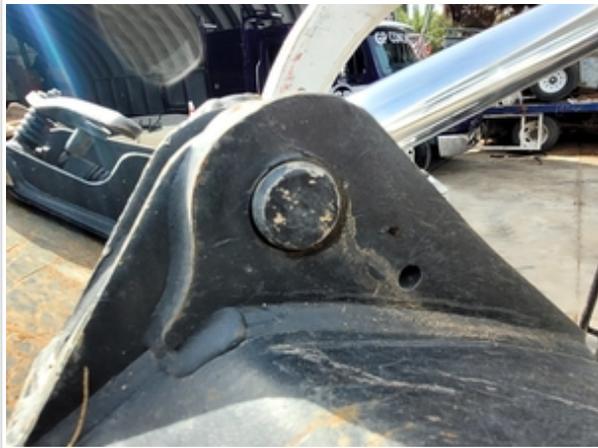
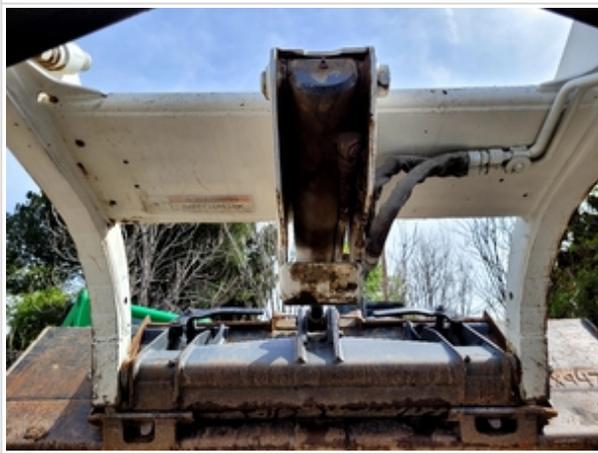
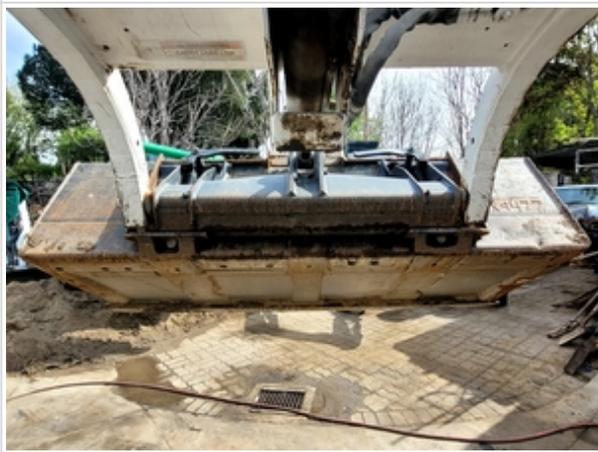
Quick Coupler to Arms Pins	3 - Normal Wear & Tear	
Overall Chassis	3 - Normal Wear & Tear	
Overall Chassis Comments	Overall chassis in good shape with frame and implements being in solid condition.

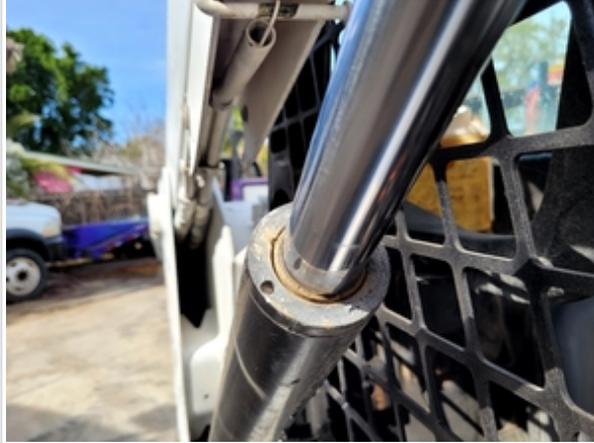
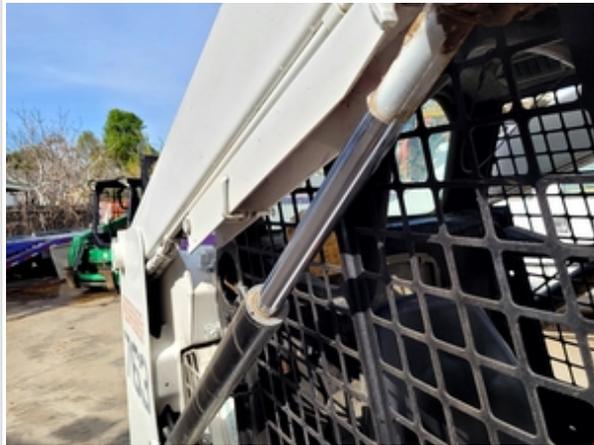
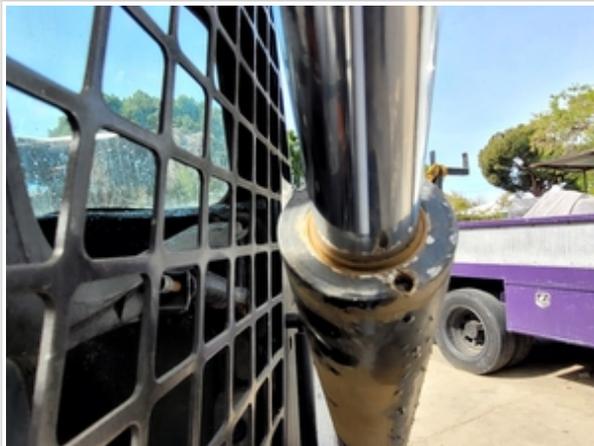
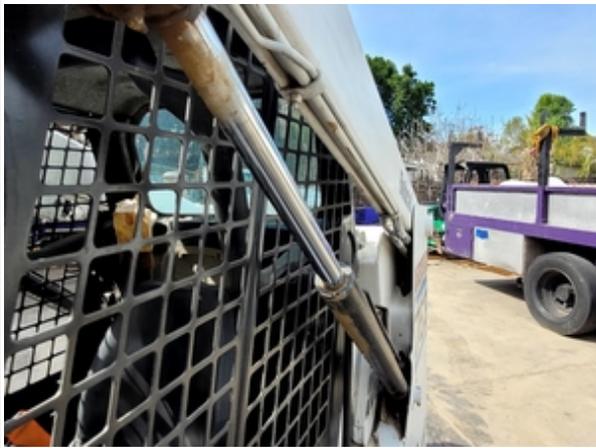
Lift Cylinder Photos

Lift Cylinder	Check the lift cylinder. Note any wear, pitting, discoloration, etc. Take photos.	
Lift Cylinder: Mounting Pin	3	
Lift Cylinder: Oil Leaks	No

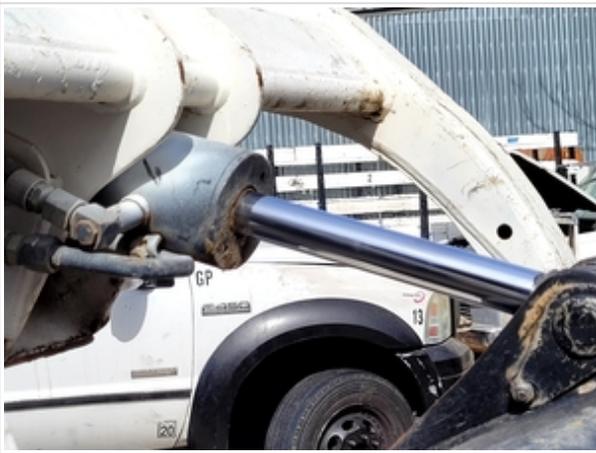
Bucket Cylinder	Check the bucket cylinder. Note any wear, pitting, discoloration, etc. Take photos.
Bucket Cylinder: Mounting Pin	3
Bucket Cylinder: Oil Leaks	No
Bucket Cylinder Photos

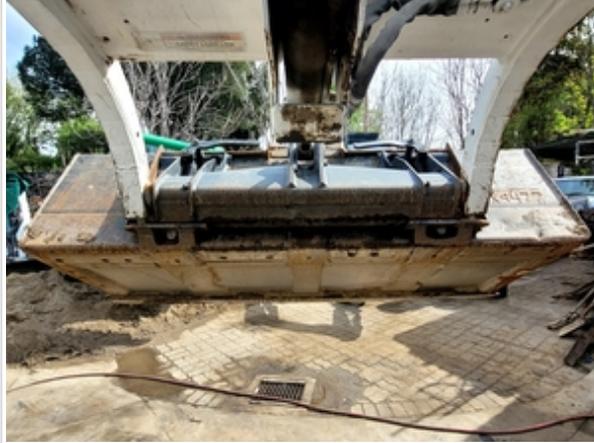
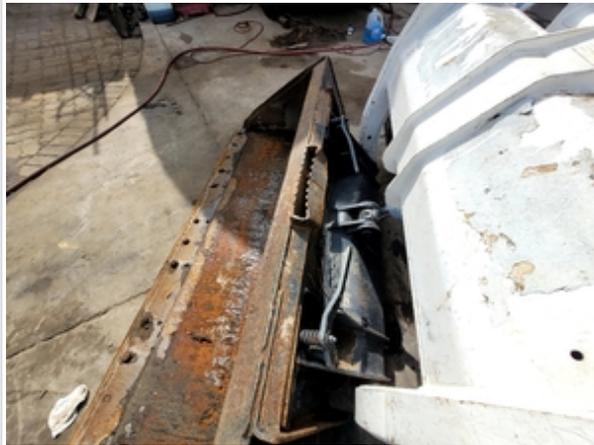
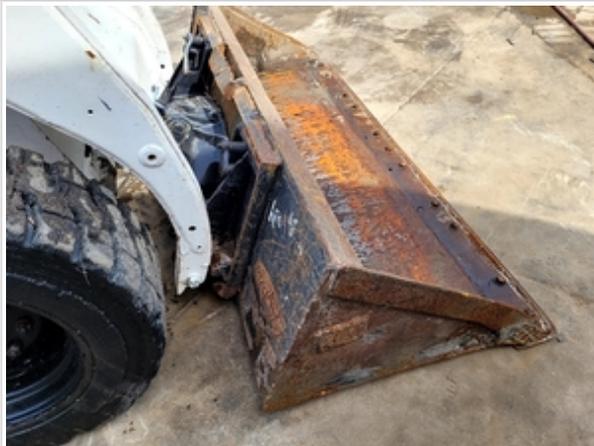
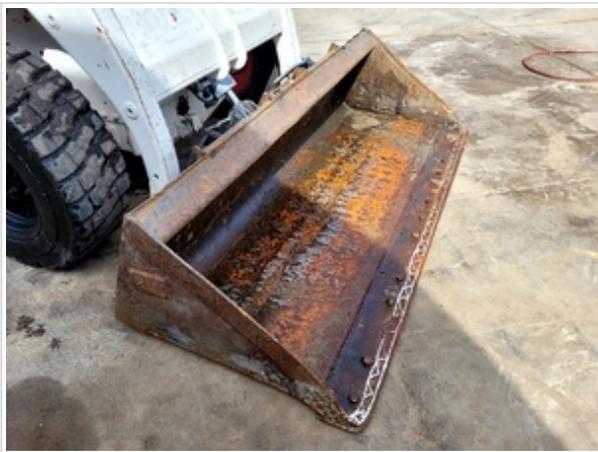
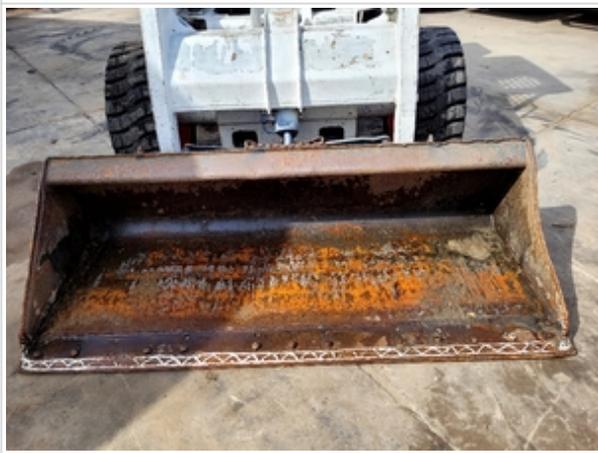
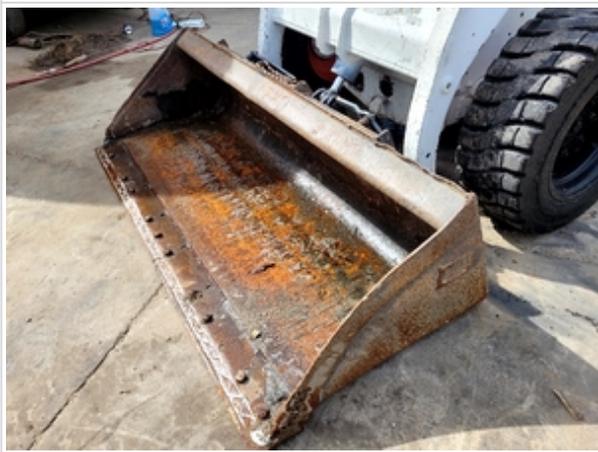
Bucket Photos

Steering Cylinder	Check the steering cylinder. Note any wear, pitting, discoloration, etc. Take photos.
Steering Cylinder: Mounting Pin	0
Bucket Inspection Points	
Bucket Condition	3 - Normal Wear & Tear

Bucket Edge / Deflectors	3 - Normal Wear & Tear
