Inspection Report (Boom Lift)

Year	2003
Make	JLG
Model	450 AJ
Serial Number	03000720160
Hour Meter Reading	3,336 Hours
Previous Application (e.g., earth moving, mining, demolition, etc)	Masonry General Construction

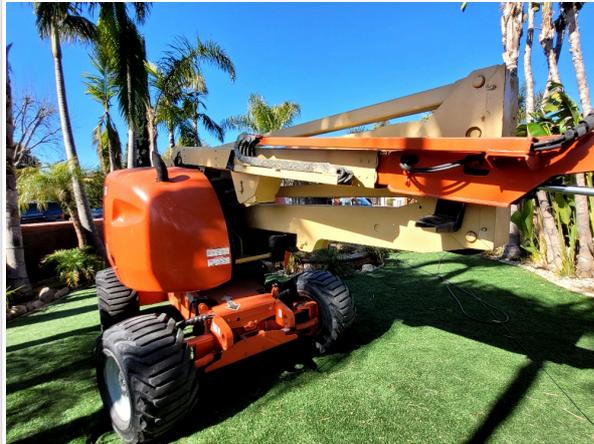
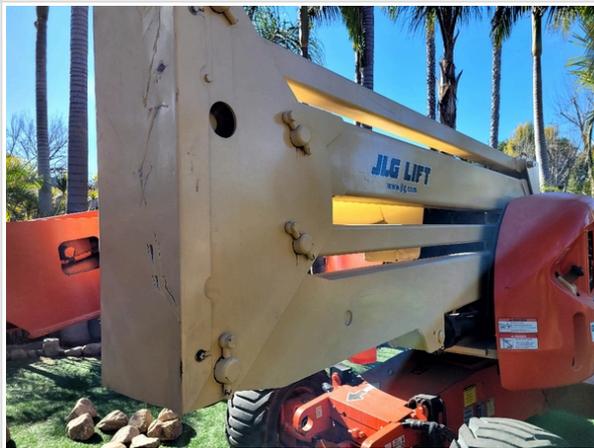
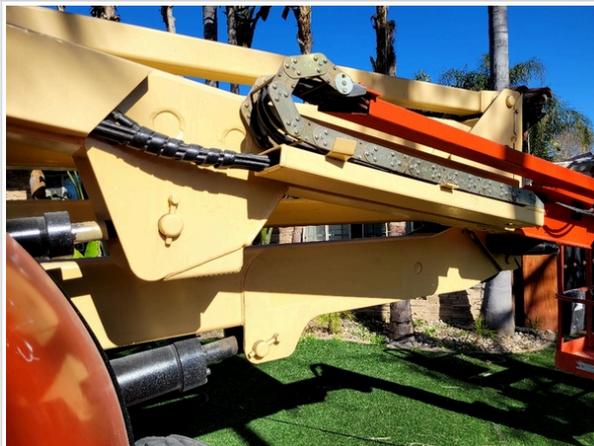
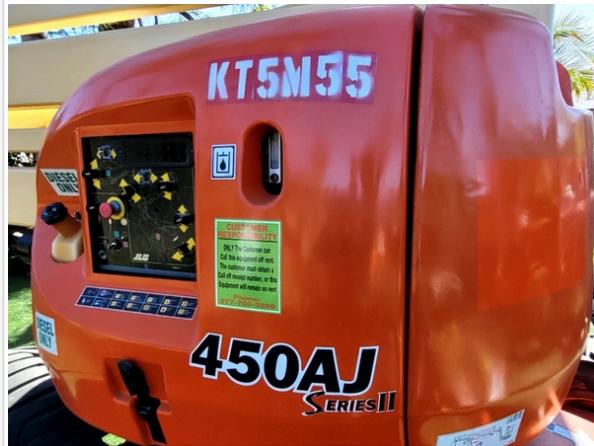
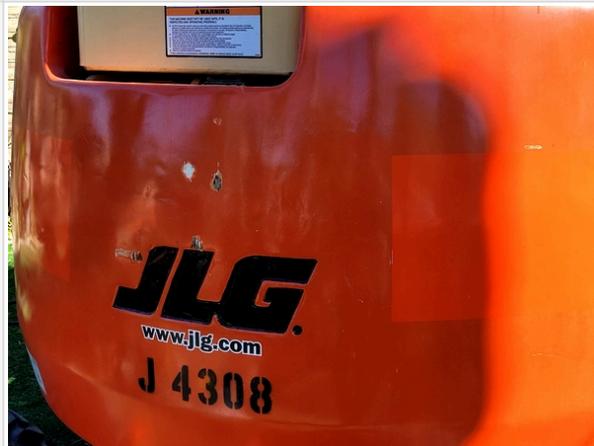
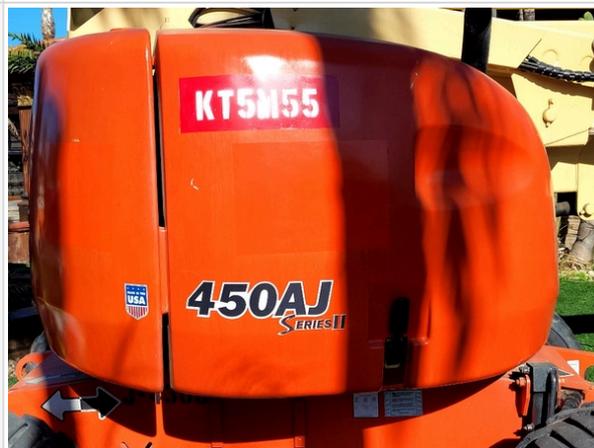
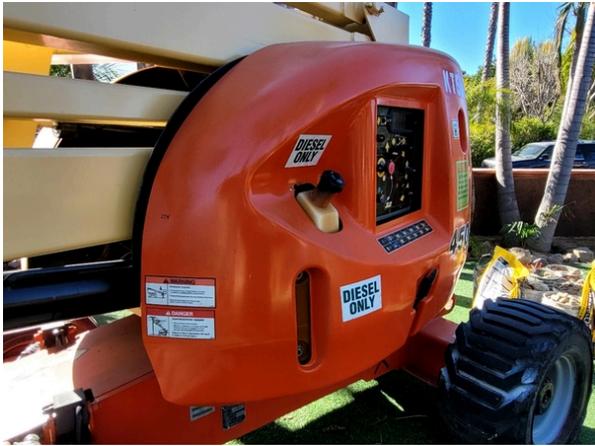
Close-up Exterior Photos

Body Panels	3 - Normal Wear & Tear
Body Panel Condition	No visible damage, good paint condition and panel fitment
Doors / Canopy Latches	3 - Normal Wear & Tear
Doors / Canopy Latches Condition	No visible damage
Steps / Ladders	0
Handrails	3 - Normal Wear & Tear
Handrails Condition	Handrails are fully intact and appear structurally sound
Glass	0
Mirrors	0
Exterior Lights	0

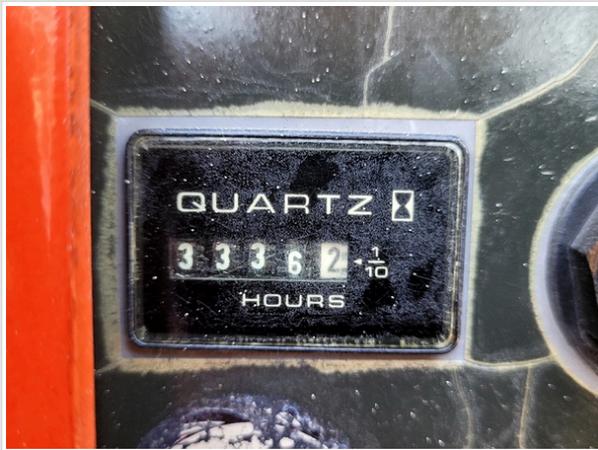
Hour Meter Activity Photos

Hour Meter Activity	3 - Normal Wear & Tear

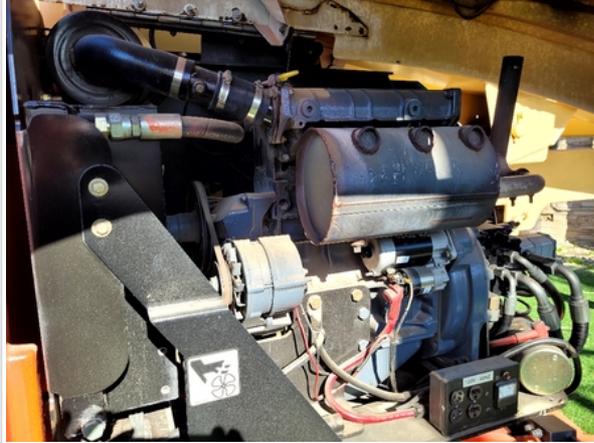
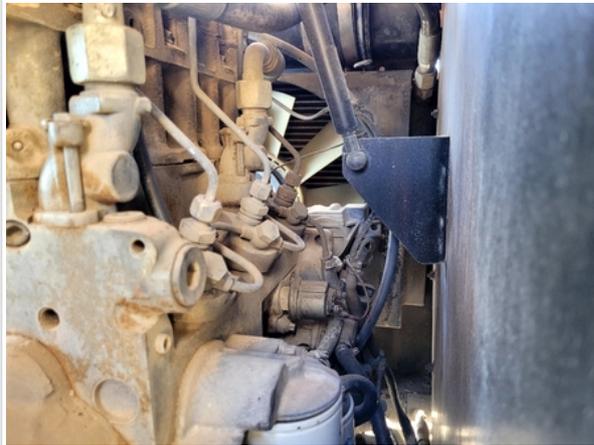
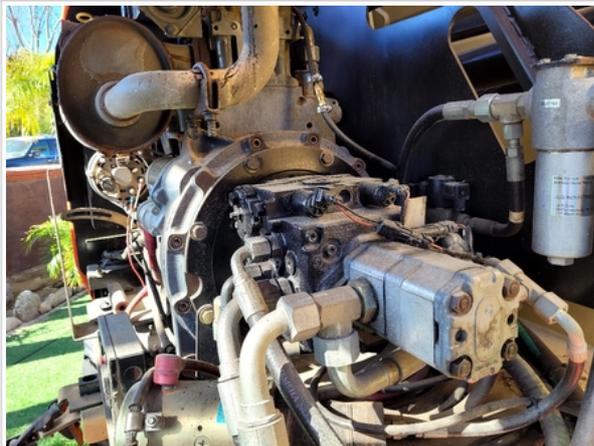
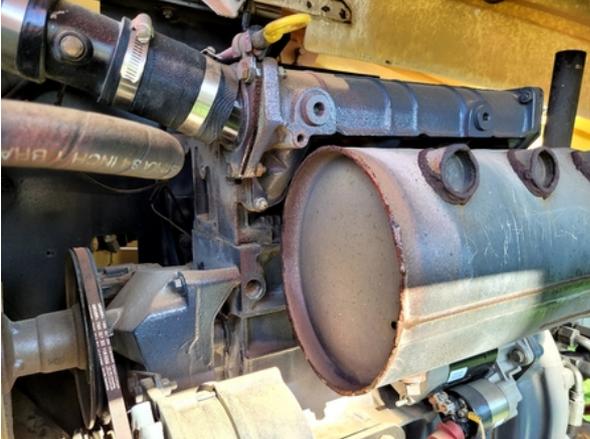
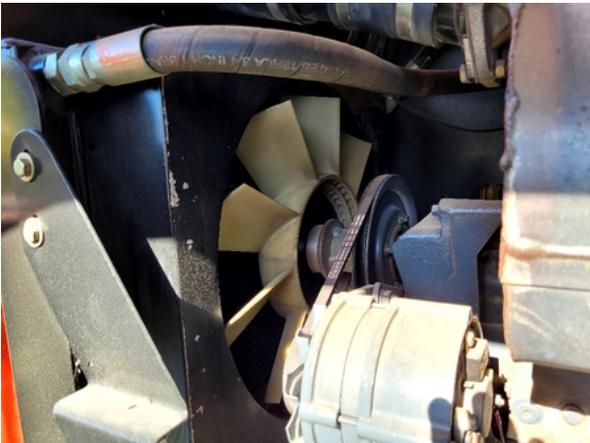
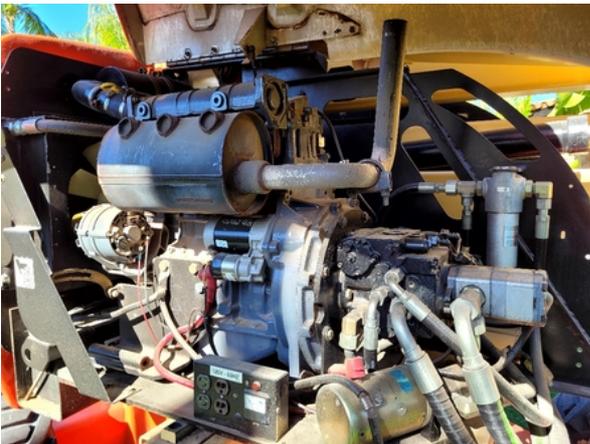
Engine Photos

Blow-by (Visual Observation Check)	No	
Unusual Noises (Upon Start-up, Idle, Shutdown)	No	
Unusual Noise Notes	No unusual noises heard	
Engine Smoke (Upon Start-up, Idle, Shutdown)	No	
Engine Smoke Notes	No engine smoke issues observed	
Engine Exhaust Color	Clear

Battery	3 - Normal Wear & Tear
Battery Condition	Clean & dry appearance, tight connections
Radiator	3 - Normal Wear & Tear
Radiator Condition	Radiator fins & components appear to be in good working order, no signs of damage or leaks
Belts	3 - Normal Wear & Tear
Belt Condition	Belts appear in good condition & alignment with proper tension
Hoses	3 - Normal Wear & Tear
Hose Condition	Firm, pliant hoses with no signs of wear or leaks
Water Pump	3 - Normal Wear & Tear
Water Pump Condition	No unusual pump noises heard
Cooling System Leaks	No
Coolant Color / Appearance	3 - Normal Wear & Tear
Coolant Color/Appearance Notes	Normal Translucent appearance, no visual signs of contamination
Oil Leaks	No
Oil Color / Appearance	3 - Normal Wear & Tear
Oil Color / Appearance Notes	Clean oil appearance, no signs of cross contamination, Appropriate oil level
Fuel Leaks	No
Requires DEF (Diesel Exhaust Fluid)	No
Overall Engine Appearance	Clean & dry

Overall Engine Comments	Engine in well maintained condition. No active leaks seen during the inspection. Engine runs and sounds healthy.

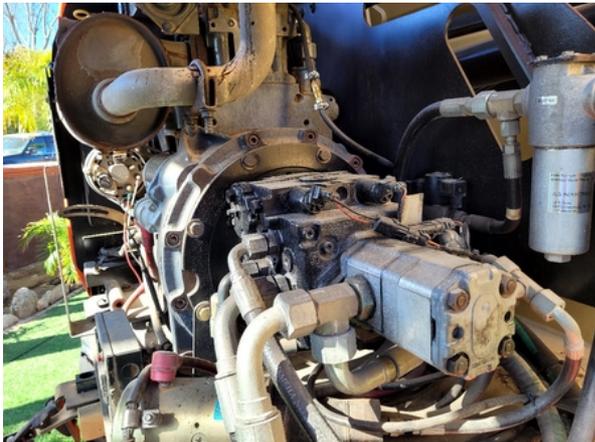
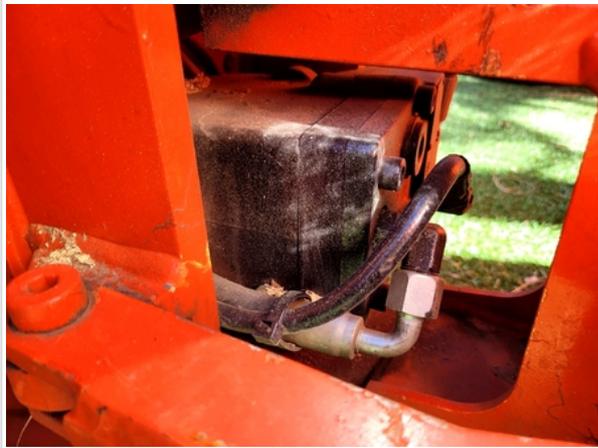
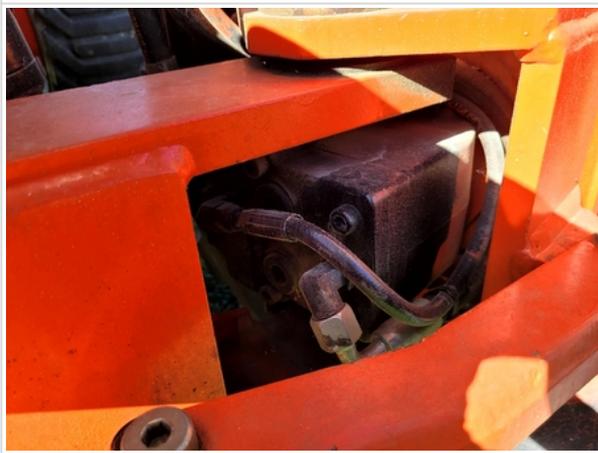
Hydrostatic Transmission?	Yes	
2 Speed?	Yes	
Hydrostatic Drive Configuration	Split Transmission	
Drive Motors	4 - Like New, Recently Replaced	
Hydrostatic Parking Brake	3 - Normal Wear & Tear	
Hydrostatic Parking Brake Condition	Good brake function	
Overall Drivetrain Comments	Machine travels well in all directions. Steer system works normally and no active leaks observed.

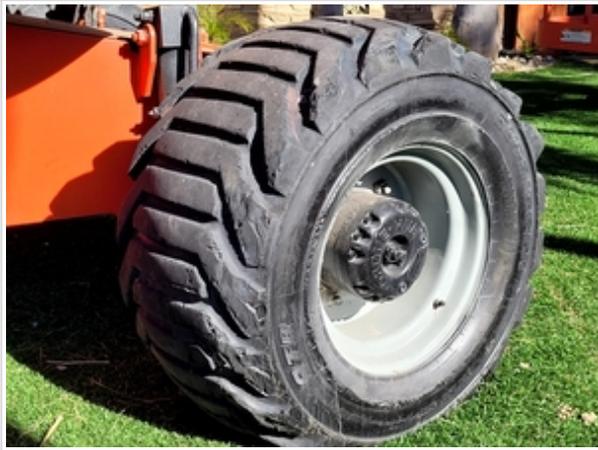
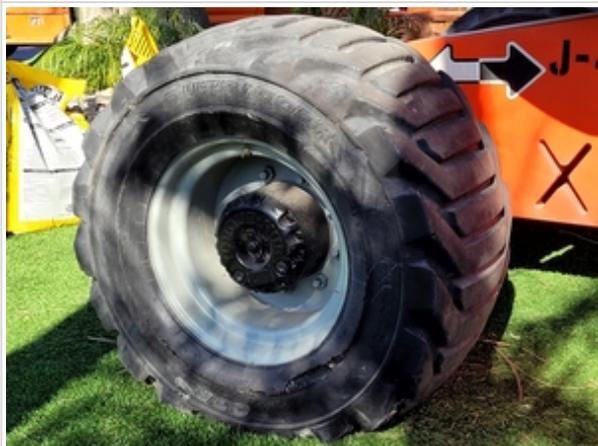
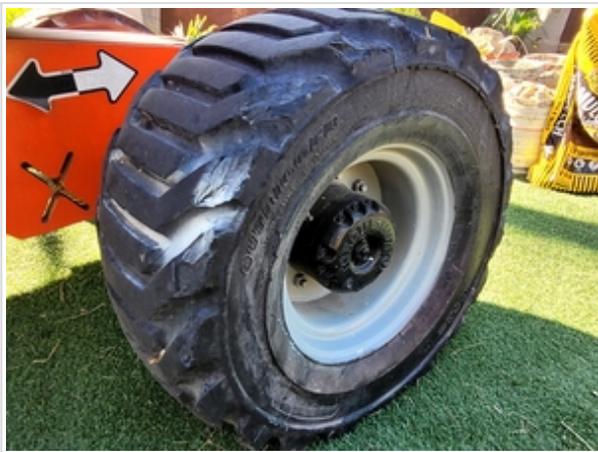
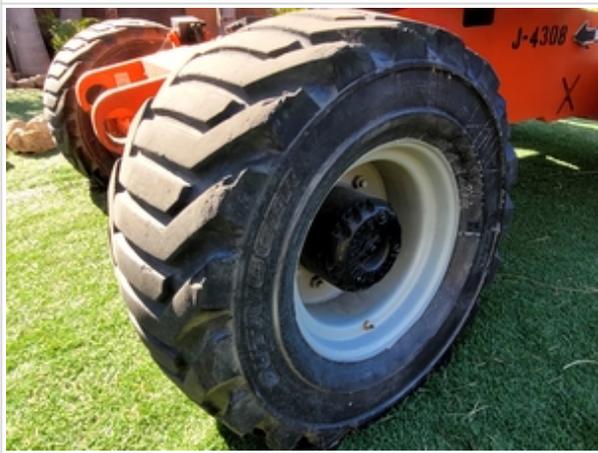
Rear Axle Appearance	3 - Normal Wear & Tear
Wheels & Tires	3 - Normal Wear & Tear
Comments	Foam Filled
Wheels & Tires Photos

Tire Brand	OTR Outrigger
Front Left Tire - Ratio Remaining	30%
Rear Left Tire - Ratio Remaining	30%
Front Right Tire - Ratio Remaining	30%
Rear Right Tire - Ratio Remaining	30%
Swivel Bearing	3 - Normal Wear & Tear
Swivel Motor	3 - Normal Wear & Tear
Swivel Joint	3 - Normal Wear & Tear
Boom Condition	3 - Normal Wear & Tear

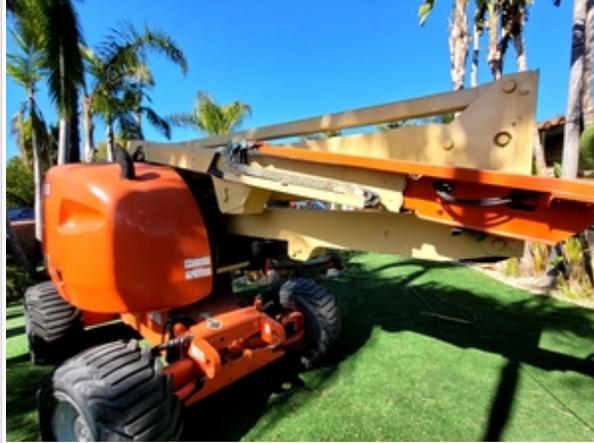
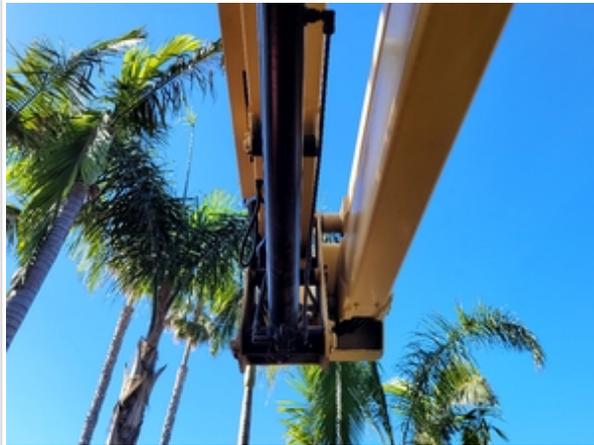
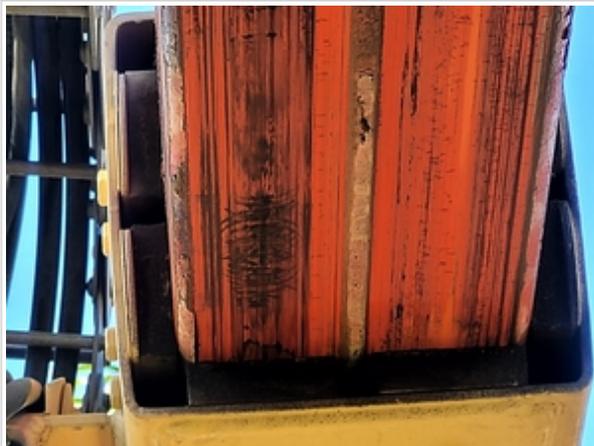
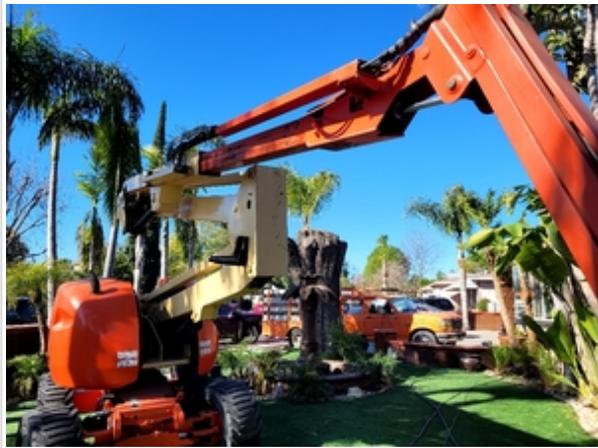
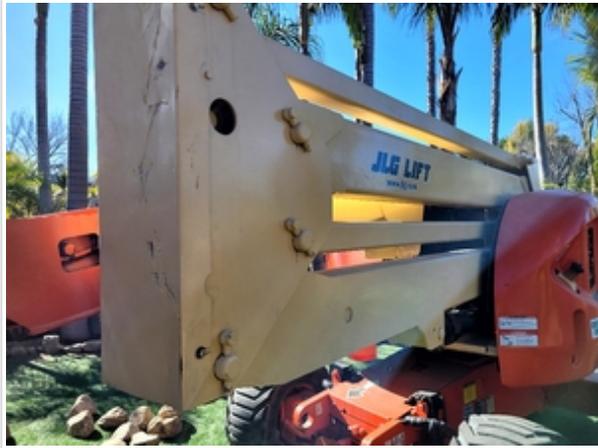
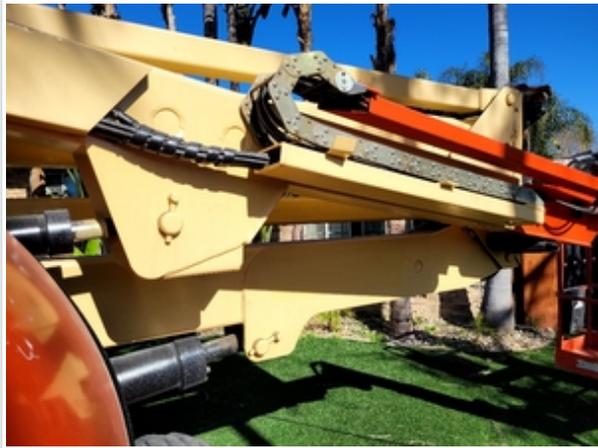
Boom Condition Photos

Boom Wear Guides	3 - Normal Wear & Tear
Jib Condition	3 - Normal Wear & Tear
Overall Chassis	3 - Normal Wear & Tear
Overall Chassis Comments	Chassis in good shape. Machine's implements and functions in good condition.

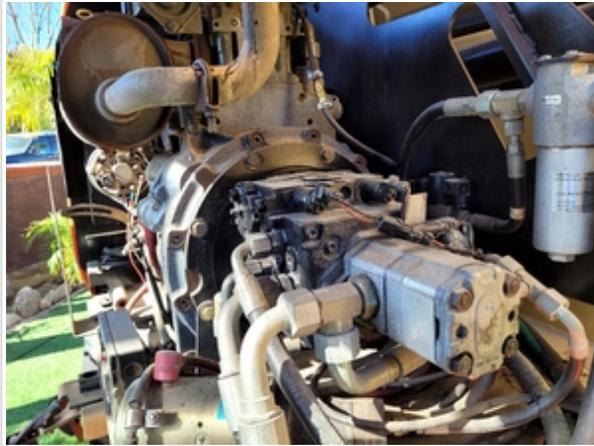
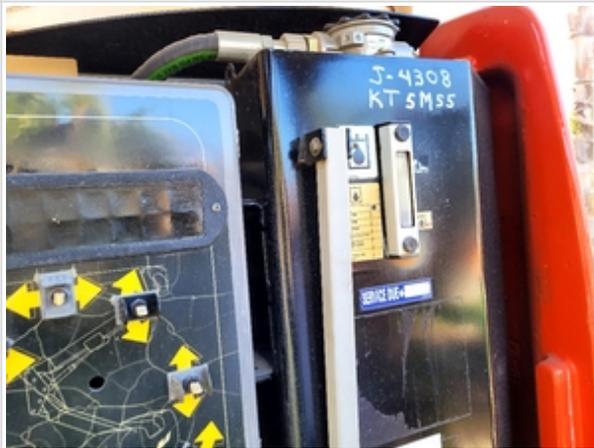
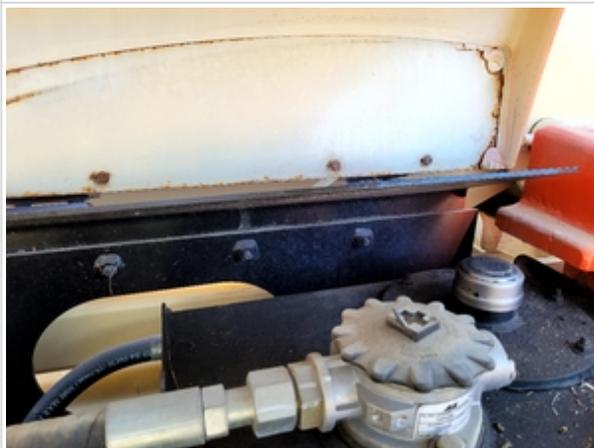
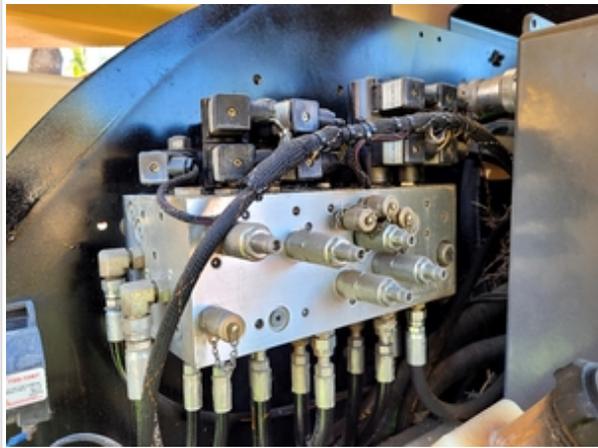
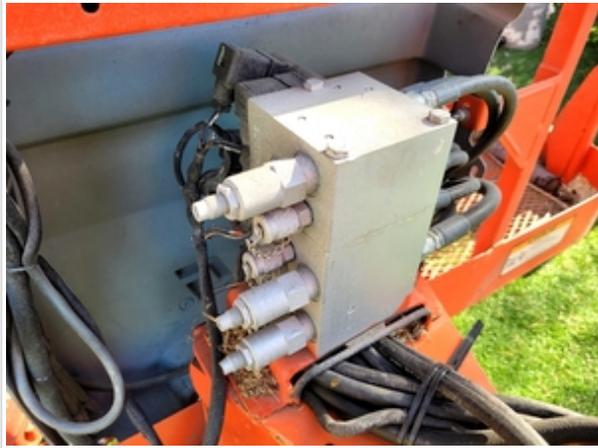
Hydraulic System Photos

Wet or Damp Hydraulic Lines / Fittings	No
Appearance of Hydraulic Lines / Fittings	3 - Normal Wear & Tear
Hydraulic Lines / Fittings Condition	Hydraulic lines & fittings are clean and in good condition
Unusual Noises (Hydraulic Pump)	No
Hydraulic Pump Notes	No unusual noises heard during operation

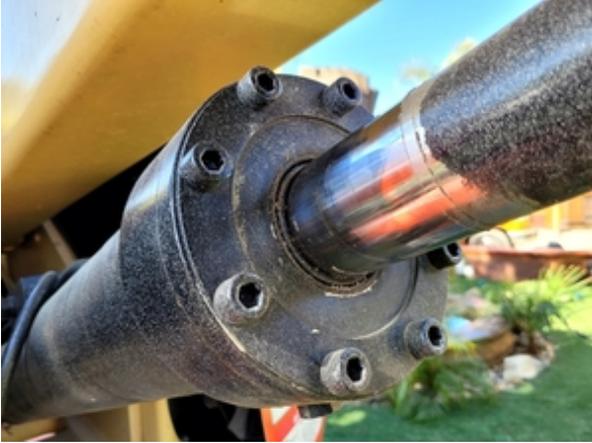
Boom Lift Cylinders Photos

Boom Lift Cylinders	Check the boom lift cylinders. Note any wear, pitting, discoloration, etc. Take photos.
Boom Lift Cylinders: Mounting Pin	3
Boom Lift Cylinders: Oil Leaks	No

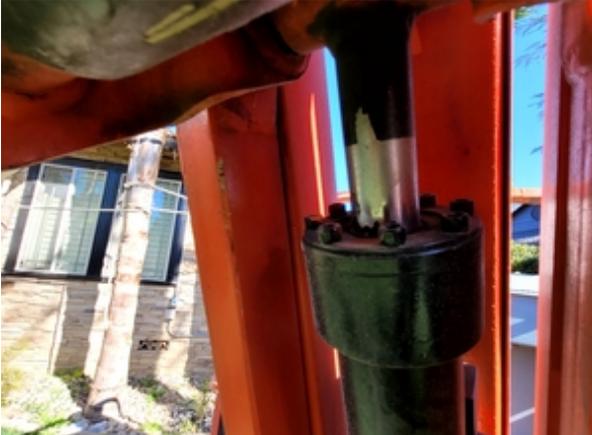
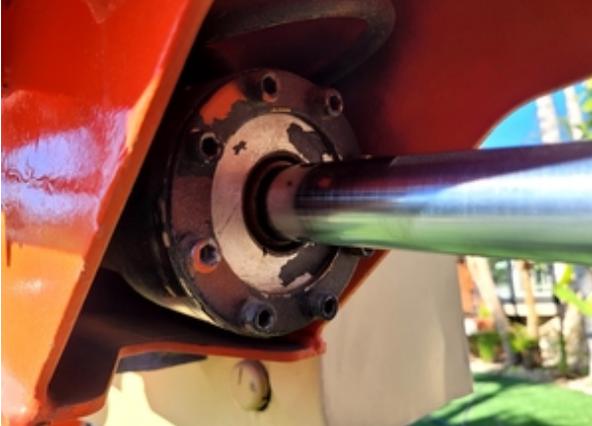
Boom Extension Cylinder	Check the boom extension cylinder. Note any wear, pitting, discoloration, etc. Take photos.	
Boom Extension Cylinder: Mounting Pin	3	
Boom Extension Cylinder: Oil Leaks	No	
Jib Cylinder	Check the jib cylinder. Note any wear, pitting, discoloration, etc. Take photos.	
Jib Cylinder: Oil Leaks	No	
Jib Cylinder: Mounting Pin	3	
Jib Cylinder Photos

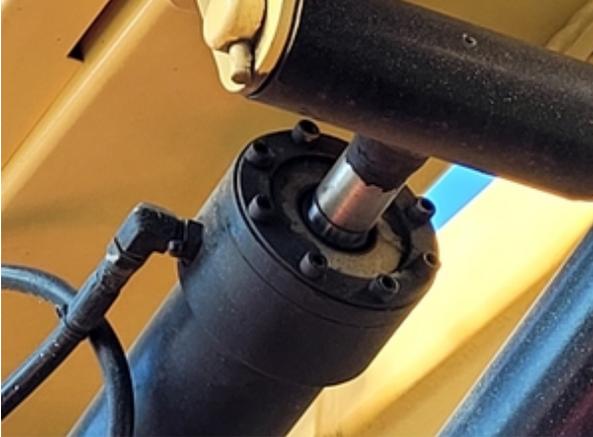
Basket Tilt Cylinder	Check the basket tilt cylinders. Note any wear, pitting, discoloration, etc. Take photos.
Basket Tilt Cylinder: Mounting Pin	3
Basket Tilt Cylinder: Oil Leaks	No
Basket Tilt Cylinder Photos

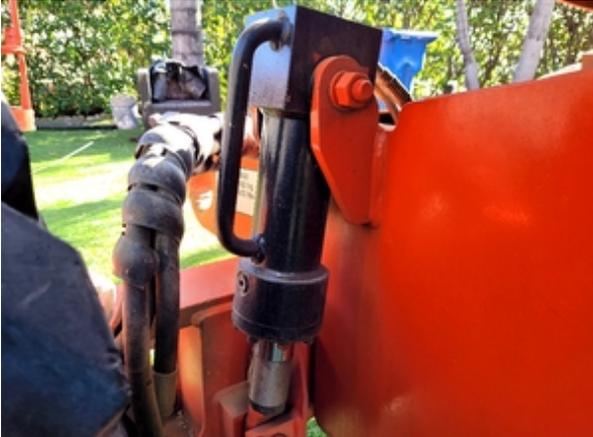
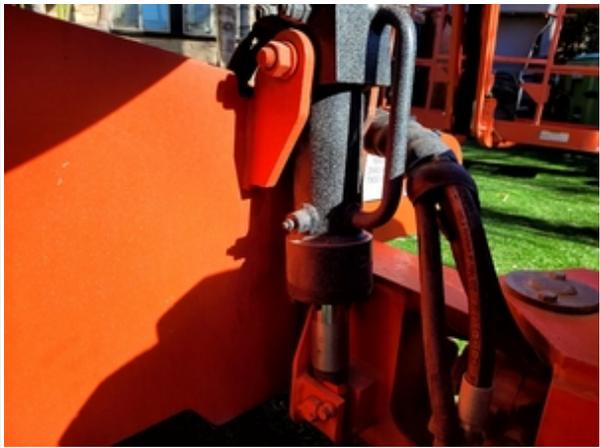
Frame Leveling Cylinders	Check the frame leveling cylinders. Note any wear, pitting, discoloration, etc. Take photos.
Frame Leveling Cylinders: Mounting Pin	3
Frame Leveling Cylinders: Oil Leaks	No
Frame Leveling Cylinders Photos

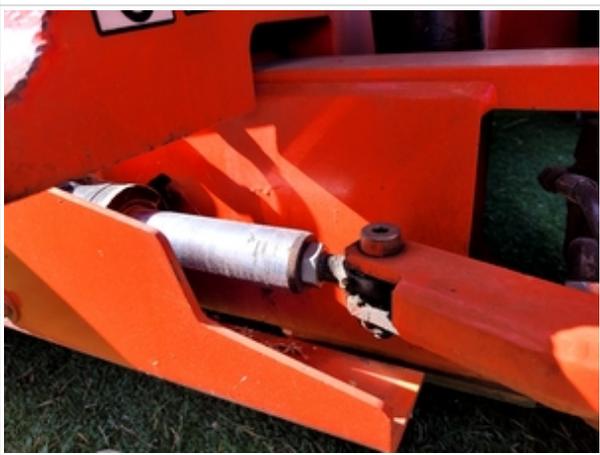
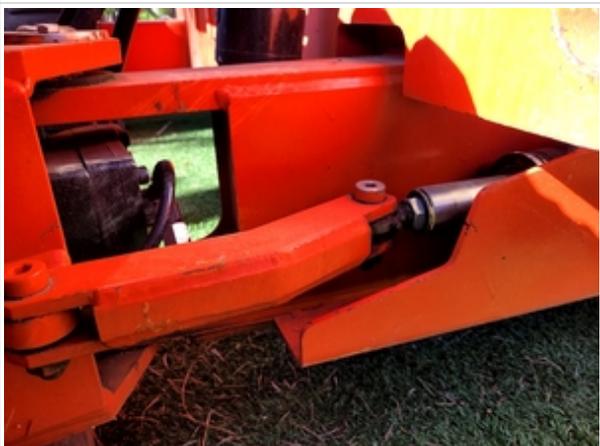
Outrigger Cylinders	Check the outrigger cylinders. Note any wear, pitting, discoloration, etc. Take photos.	
Steering Cylinders	Check the steering cylinders. Note any wear, pitting, discoloration, etc. Take photos.	
Steering Cylinders: Mounting Pin	3	
Steering Cylinders: Oil Leaks	No	
Steering Cylinders Photos
