Inspection Report (Excavator)

Year	2013
Make	CAT
Model	320E
Serial Number	*CATO320ELTFX00642*
Hour Meter Reading	3,680 Hrs.
Previous Application (e.g., earth moving, mining, demolition, etc)	Masonry General Construction

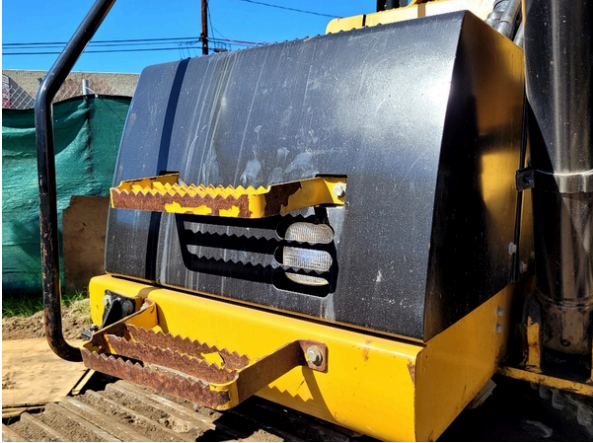
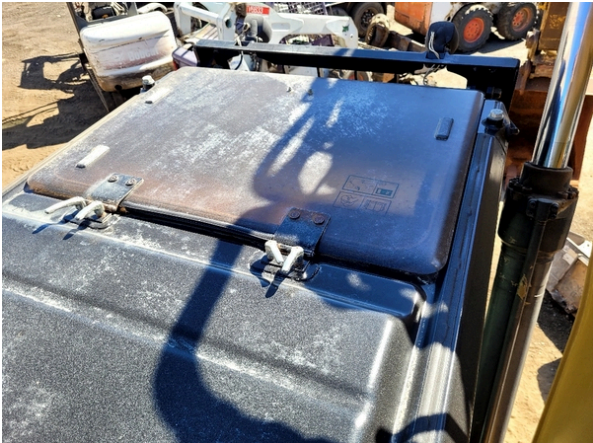
Body Panels	3 - Normal Wear & Tear
Body Panel Condition	No visible damage, good paint condition and panel fitment
Doors / Canopy Latches	3 - Normal Wear & Tear
Doors / Canopy Latches Condition	No visible damage
Steps / Ladders	3 - Normal Wear & Tear
Steps / Ladders Condition	Steps/ladders are fully intact and appear structurally sound
Handrails	3 - Normal Wear & Tear
Handrails Condition	Handrails are fully intact and appear structurally sound
Glass	3 - Normal Wear & Tear
Glass Condition	Glass intact, no visible damage
Mirrors	3 - Normal Wear & Tear
Mirror Condition	Mirrors present and intact, no visible damage
Exterior Lights	3 - Normal Wear & Tear
Exterior Lights Condition	No visible damage, lighting system is operational

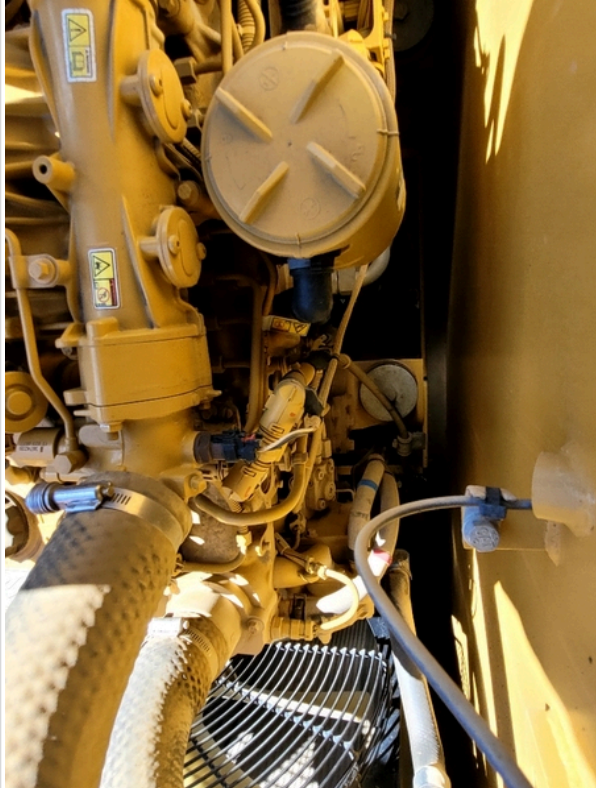
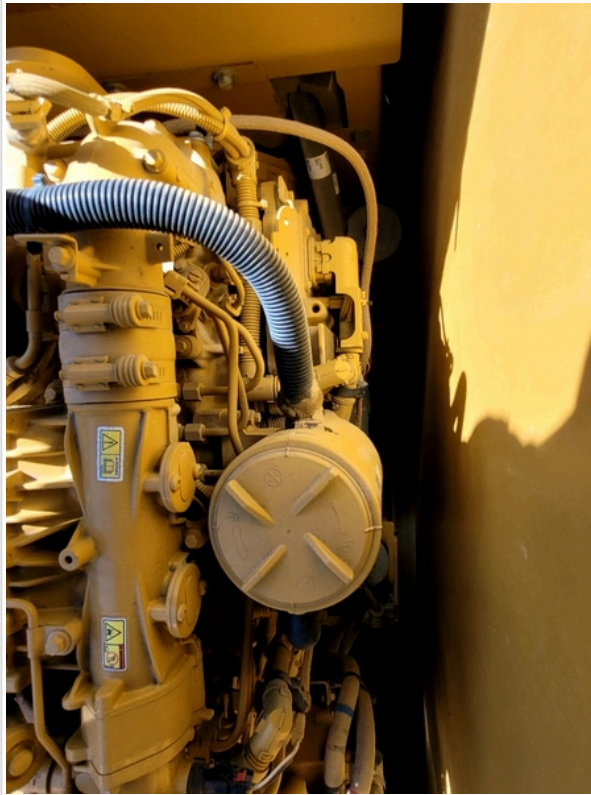
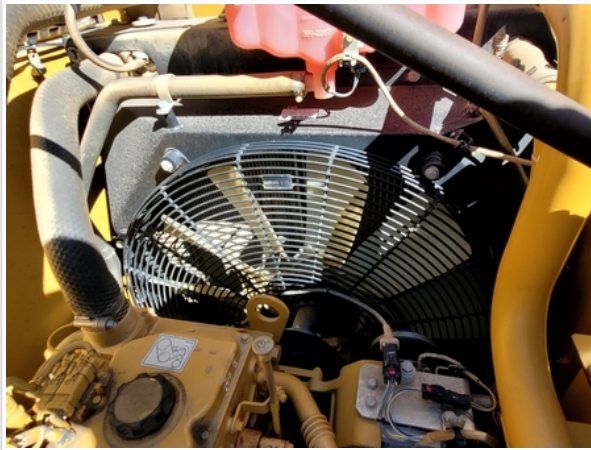
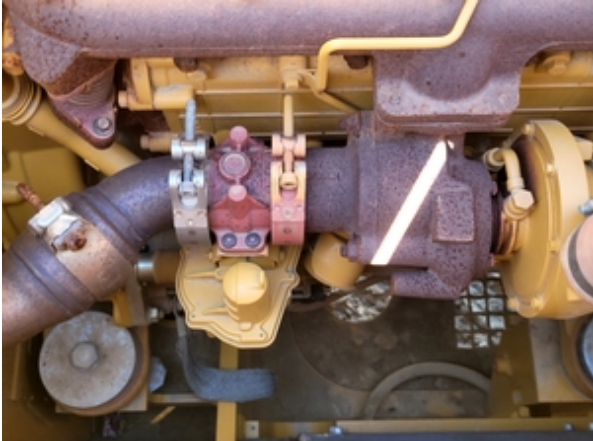
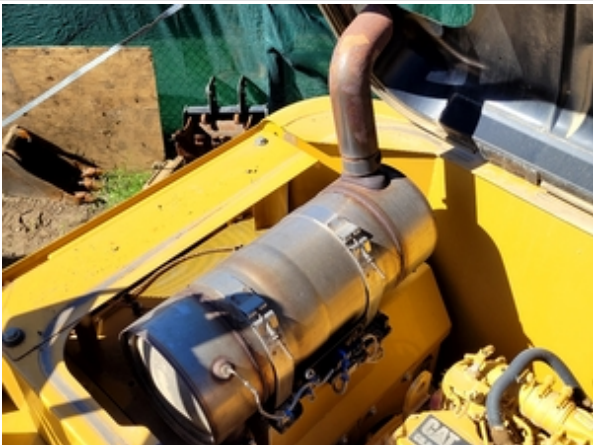
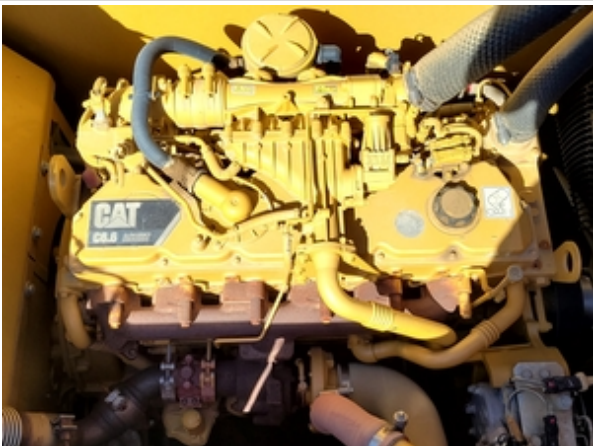
Blow-by (Visual Observation Check)	No	
Unusual Noises (Upon Start-up, Idle, Shutdown)	No	
Unusual Noise Notes	No unusual noises heard	
Engine Smoke (Upon Start-up, Idle, Shutdown)	No	
Engine Smoke Notes	No engine smoke issues observed	
Engine Exhaust Color	Clear

Battery	3 - Normal Wear & Tear
Battery Condition	Clean & dry appearance, tight connections
Radiator	3 - Normal Wear & Tear
Radiator Condition	Radiator fins & components appear to be in good working order, no signs of damage or leaks
Belts	3 - Normal Wear & Tear
Belt Condition	Belts appear in good condition & alignment with proper tension
Hoses	3 - Normal Wear & Tear
Hose Condition	Firm, pliant hoses with no signs of wear or leaks
Water Pump	3 - Normal Wear & Tear
Water Pump Condition	No unusual pump noises heard
Cooling System Leaks	No
Coolant Color / Appearance	3 - Normal Wear & Tear
Coolant Color/Appearance Notes	Normal Translucent appearance, no visual signs of contamination
Oil Leaks	No
Oil Color / Appearance	3 - Normal Wear & Tear
Oil Color / Appearance Notes	Clean oil appearance, no signs of cross contamination, Appropriate oil level
Fuel Leaks	No
Requires DEF (Diesel Exhaust Fluid)	No
Overall Engine Appearance	Clean & dry

Overall Engine Comments	Engine in great shape with no active leaks observed.

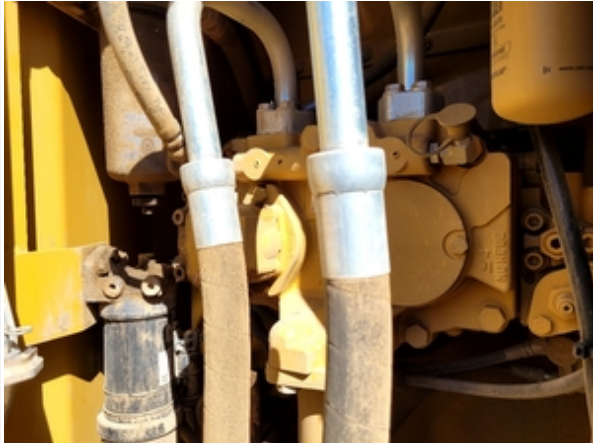
2 Speed?	Yes
Hydrostatic Drive Configuration	Split Transmission
Drive Motors	2 - Above Average Wear
Hydrostatic Parking Brake	3 - Normal Wear & Tear
Hydrostatic Parking Brake Condition	Good brake function
Overall Drivetrain Comments	Machine's drivetrain operating well with no active leaks seen.

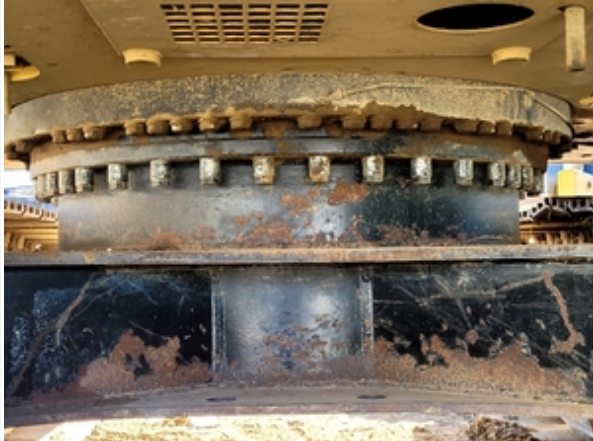
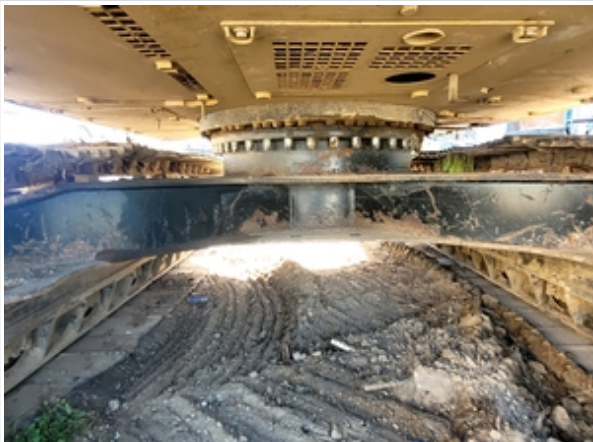
Boom Base Pin & Bushings	3 - Normal Wear & Tear	
Boom to Stick Pin & Bushings	3 - Normal Wear & Tear	
Stick to Bucket Pin & Bushings	3 - Normal Wear & Tear	
Turntable Bearing	3 - Normal Wear & Tear	
Turntable Bearing Photos

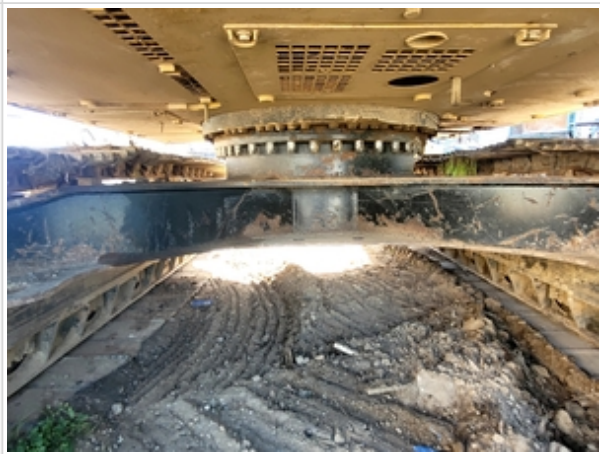
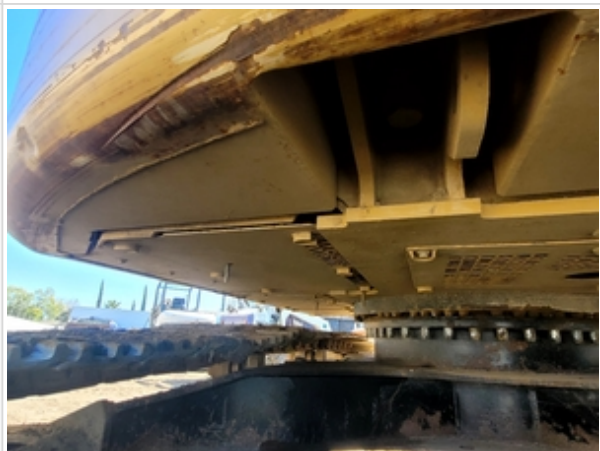
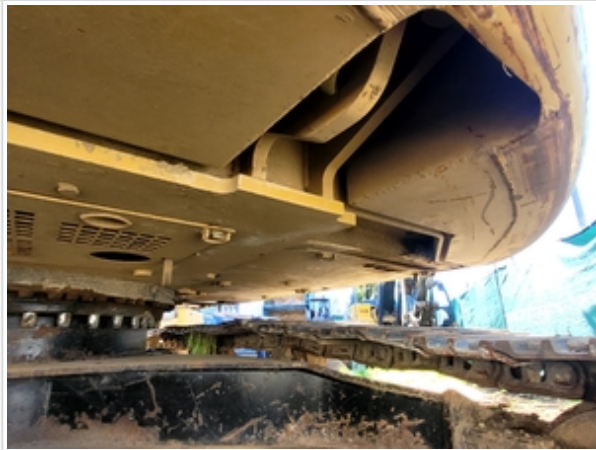
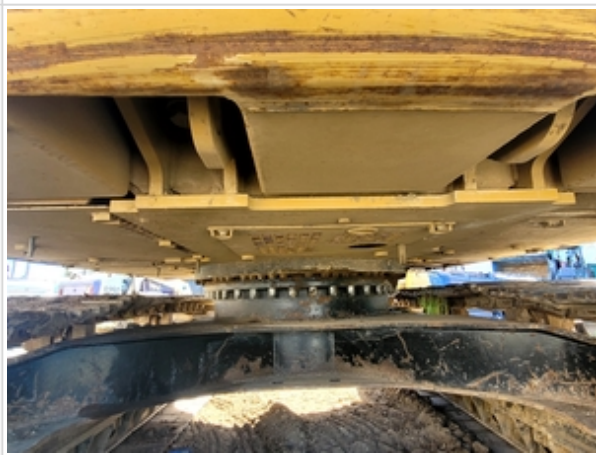
<p>Bottom Covers</p>	<p>3 - Normal Wear & Tear</p>	
<p>Bottom Covers Photos</p>

Overall Chassis	3 - Normal Wear & Tear
Overall Chassis Comments	Chassis in solid shape from the implements to the main frame. Normal wear and tear seen throughout the machine but no obvious major issues observed during the inspection.

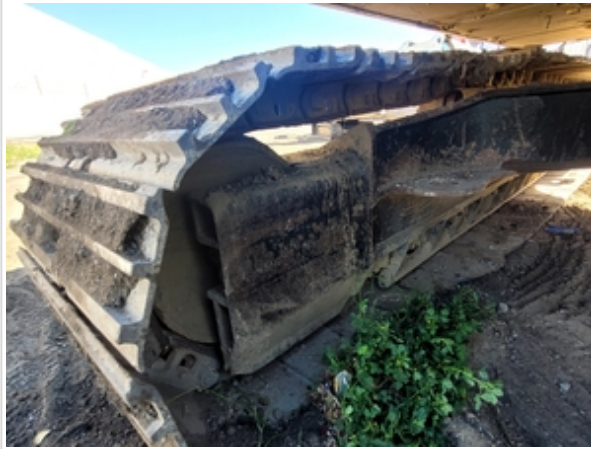
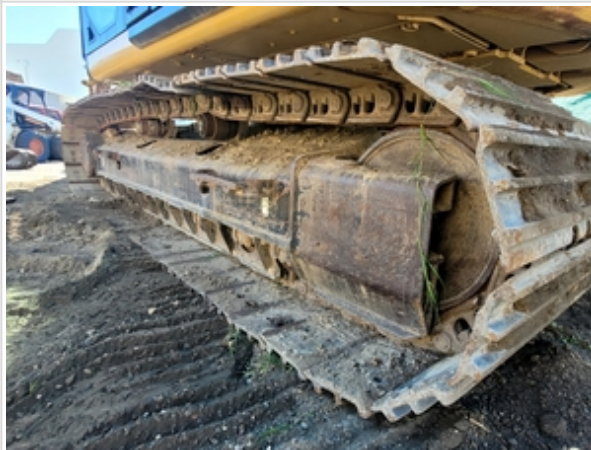
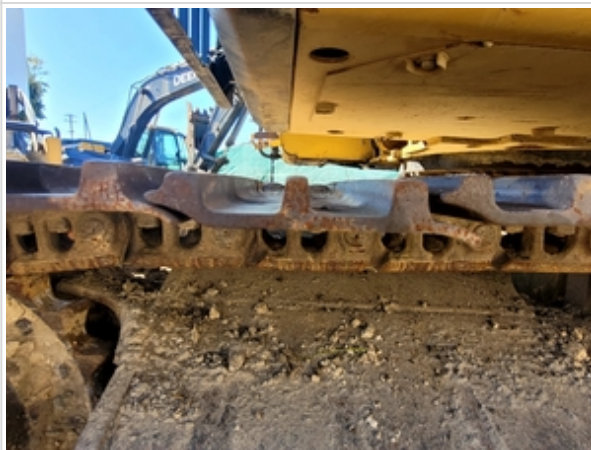
Undercarriage Overall Condition	3 - Normal Wear & Tear
Comments	Overall track undercarriage, visually, in solid shape with plenty of life left. from the main tracks to the idlers and rollers all look to have low use.
Undercarriage Overall Photos

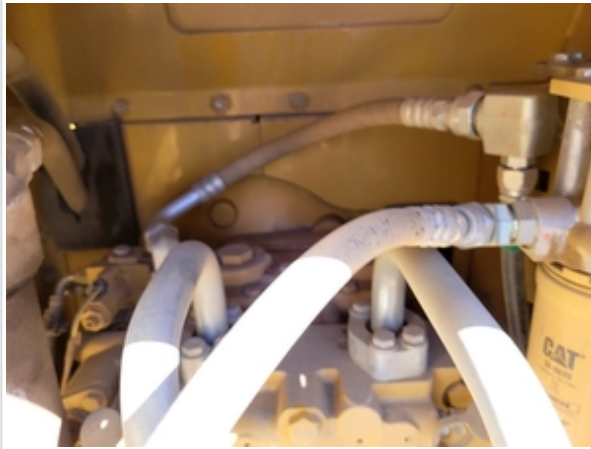
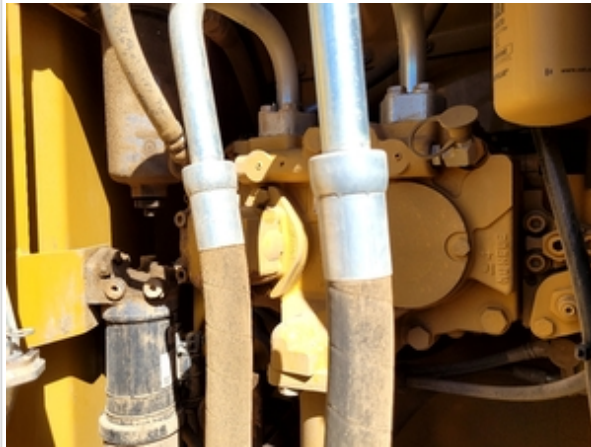
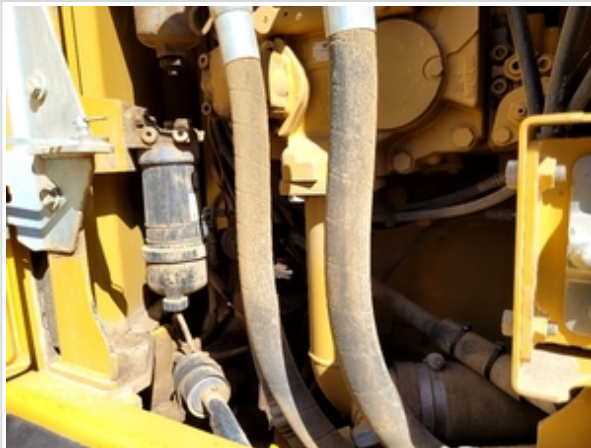
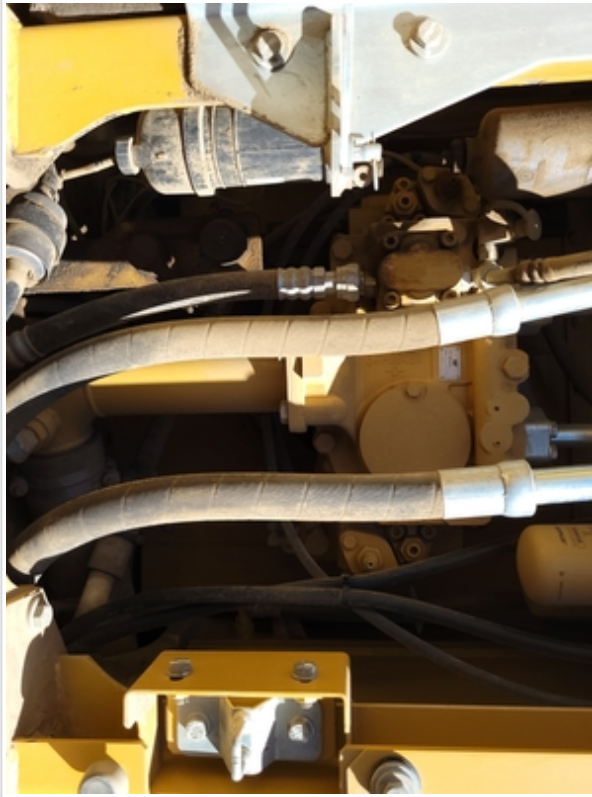
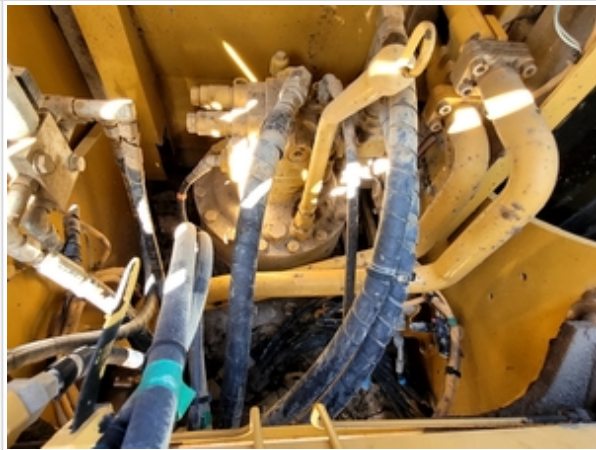
Wet or Damp Hydraulic Lines / Fittings	No
Appearance of Hydraulic Lines / Fittings	3 - Normal Wear & Tear
Hydraulic Lines / Fittings Condition	Hydraulic lines & fittings are clean and in good condition
Unusual Noises (Hydraulic Pump)	No
Hydraulic Pump Notes	No unusual noises heard during operation
Comments	Hydraulics work well and main pump sounds healthy under load. No active leaks observed.

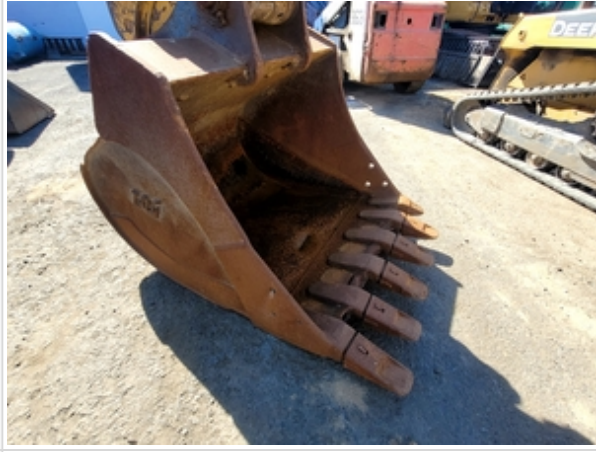
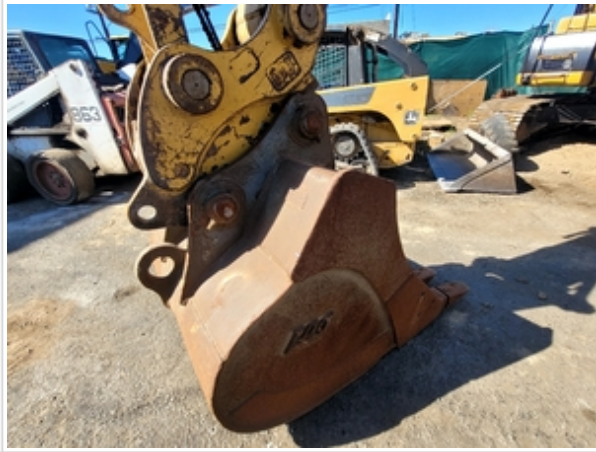
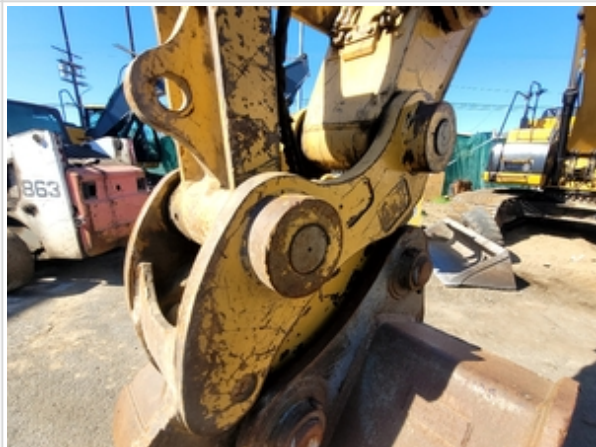
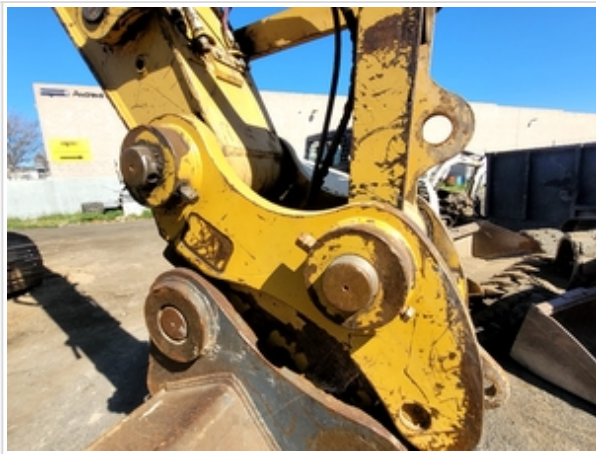
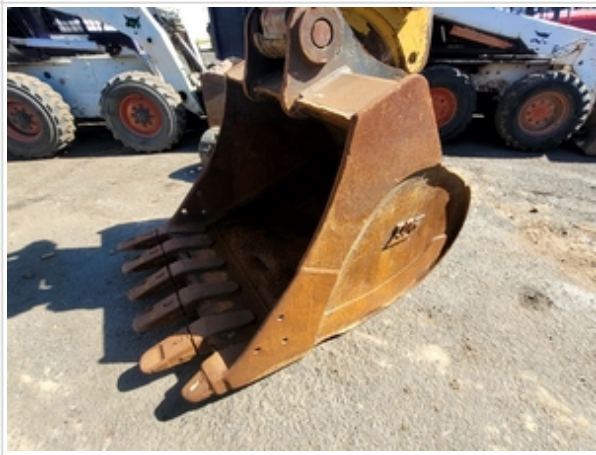
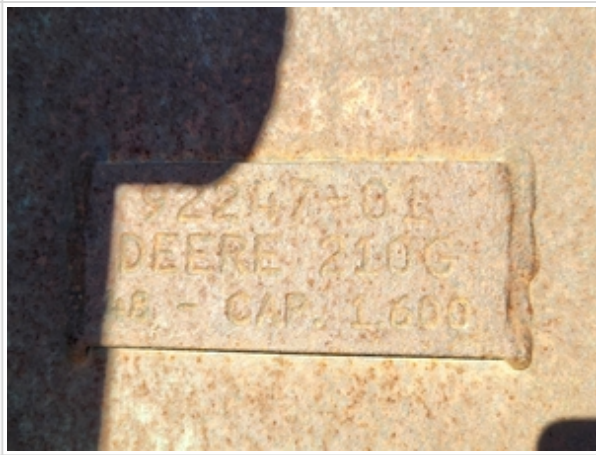
Bucket Condition	3 - Normal Wear & Tear
Comments	large dent at bottom rear side of bucket & outer tooth missing
Bucket Photos
