Inspection Report (Excavator)

| Year | 2013 |
| Make | John Deere |
| Model | 210G |

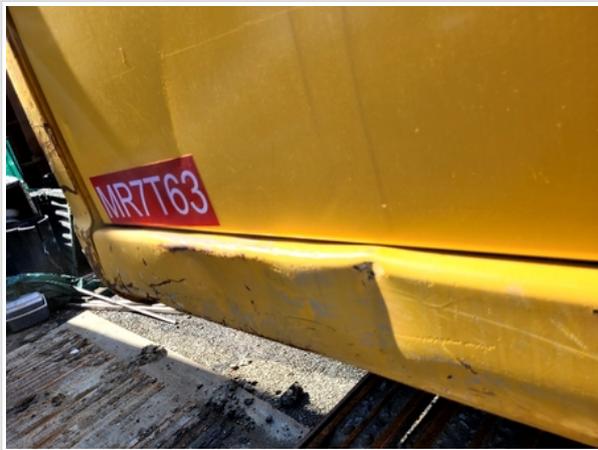
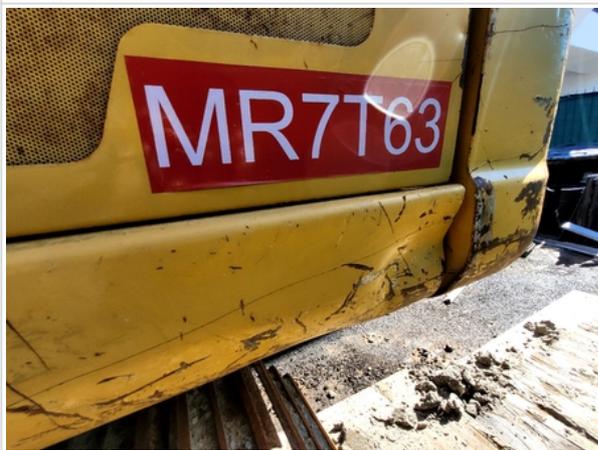
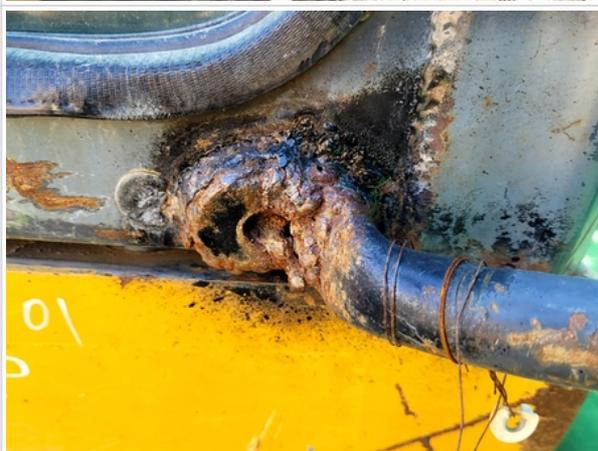
| Body Panels Photos | |

| Body Panels | 3 - Normal Wear & Tear |
| Body Panel Condition | Visible chipped paint or dents, Some panel misalignment observed, Large dents or cracks, Other (see comments) |
| Comments | Rear left side and right side body damage at compartment door and bottom part of counter weight dented |

| What Needs Work | Cosmetic damage to rear side of door panels. |

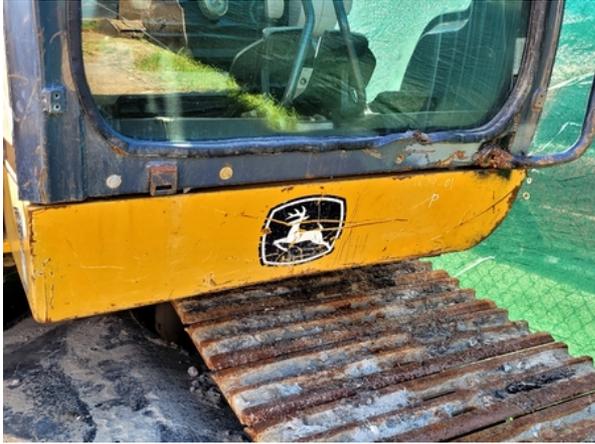
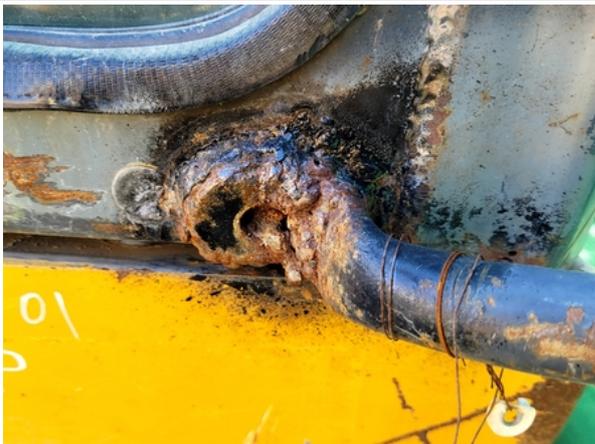
| Handrail Photos | |

| Handrails | 2 - Above Average Wear |

| Handrails Condition | Bent or broken railings, Other (see comments) |
| Comments | Front cab handrail bent and has been repaired |

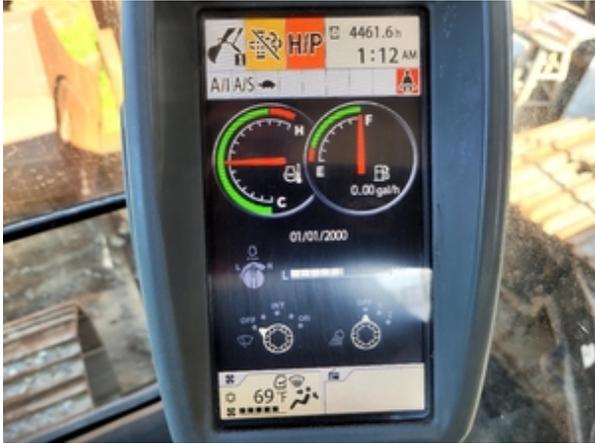
| Hour Meter Activity Photos | |

| Hour Meter Activity | 3 - Normal Wear & Tear |
| Hour Meter Condition | Hour meter is functional and in good condition |

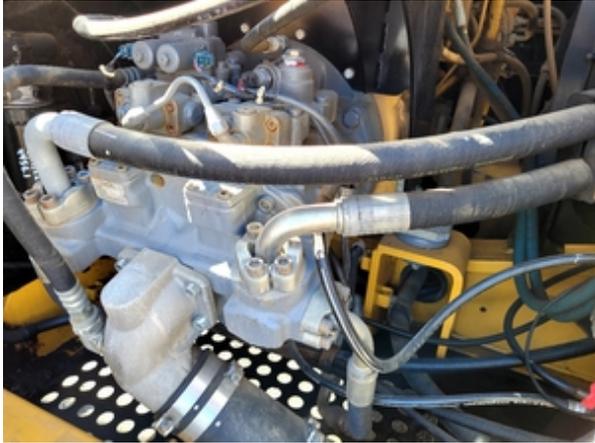
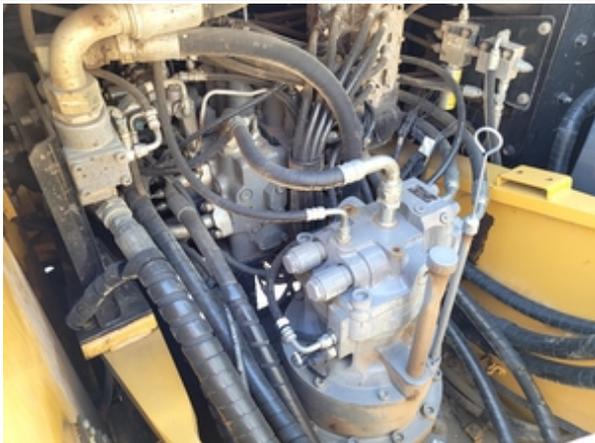
| Drivetrain Photos | |

| Drive Motors | 2 - Above Average Wear |
| Overall Drivetrain Comments | Machine traveled in all directions normally with no powertrain issues observed. Parking brake works well. |

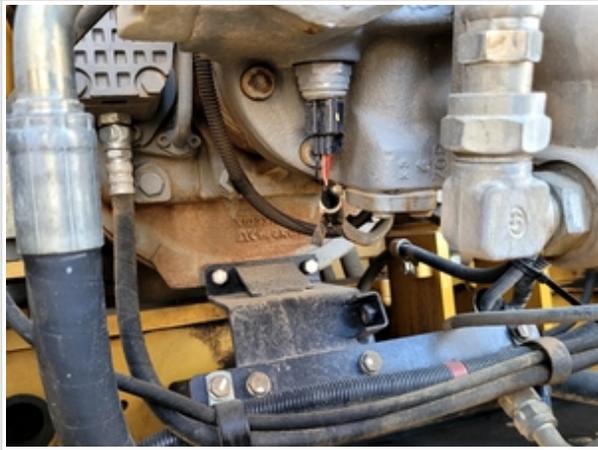
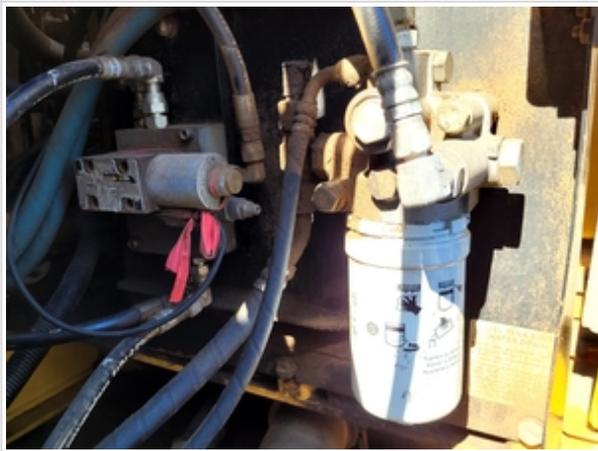
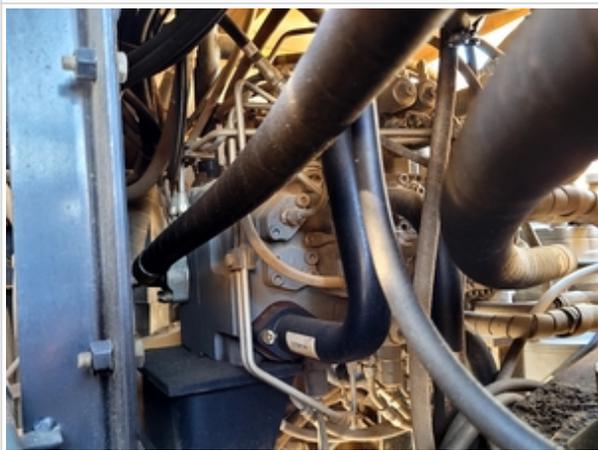
| Hydraulic System Photos | |

| Hydraulic Lines / Fittings Condition | Hydraulic lines & fittings are clean and in good condition |
| Comments | hydraulics in great working condition with no active leaks observed |

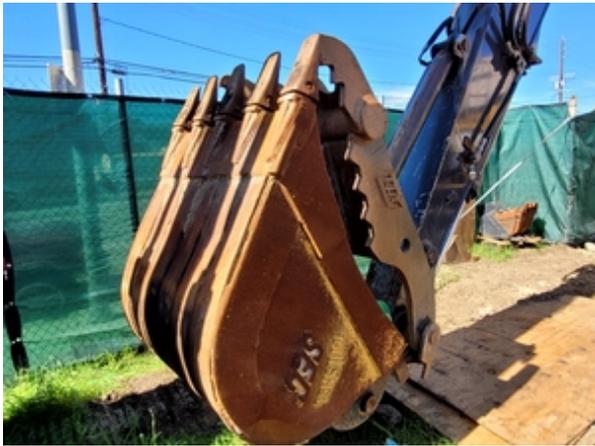
Attachment Photos

| Attachment Condition | 3 - Normal Wear & Tear |
| Comments | works great |
