Inspection Report (Wood Chipper)

Year	2006
Make	Morbark
Model	2070XL
Serial Number	4S8SZ15134W070501
Hour Meter Reading	N/A
Previous Application (e.g., earth moving, mining, demolition, etc)	Inhouse Property Landscape Maintenance

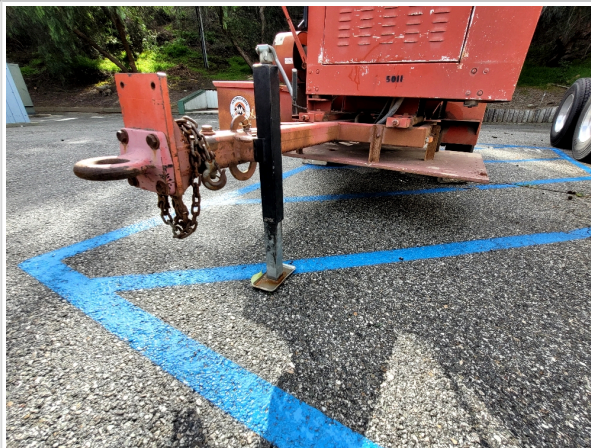
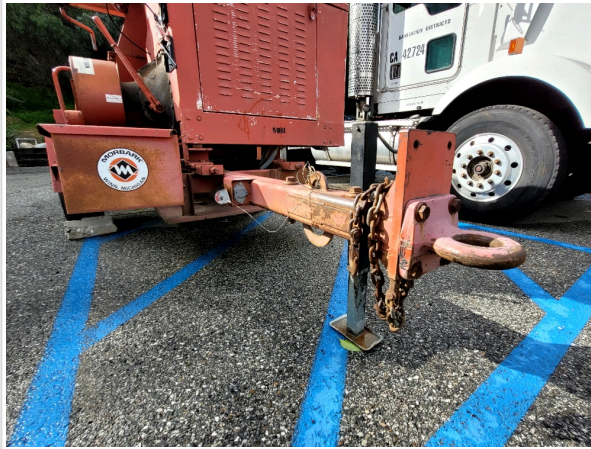
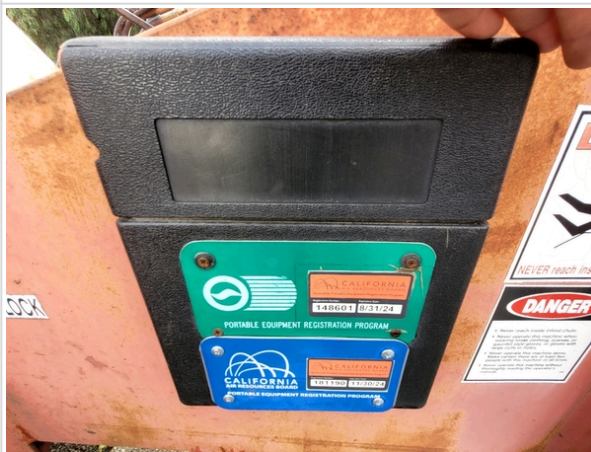
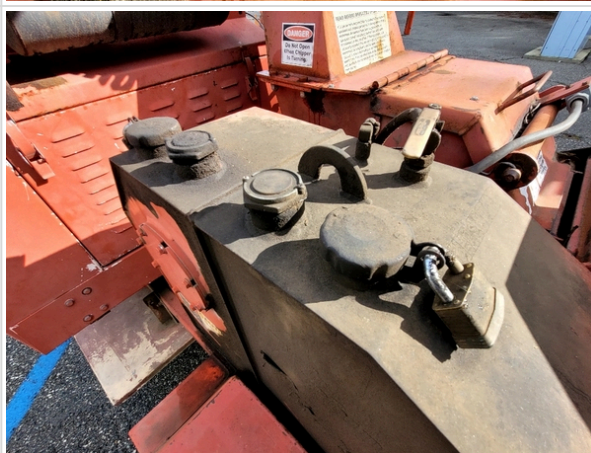
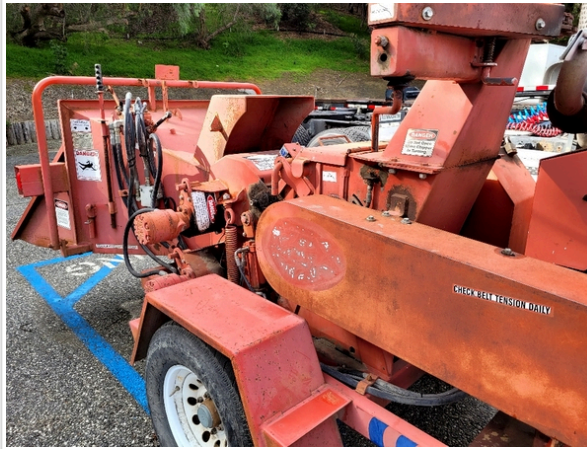
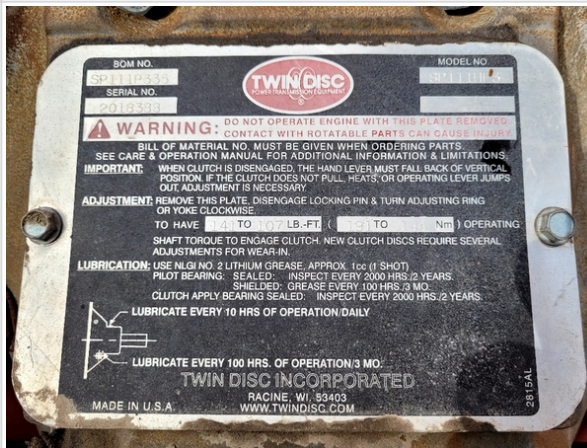
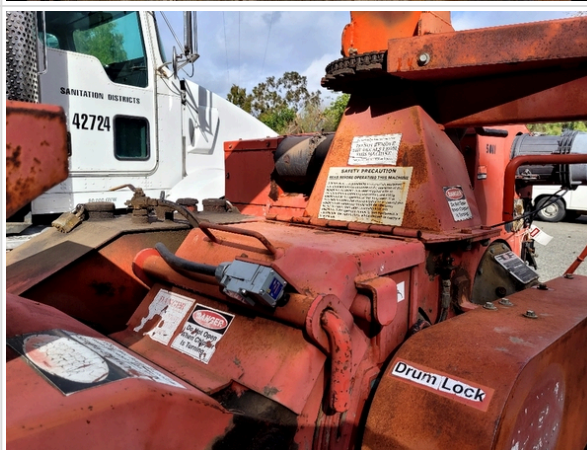
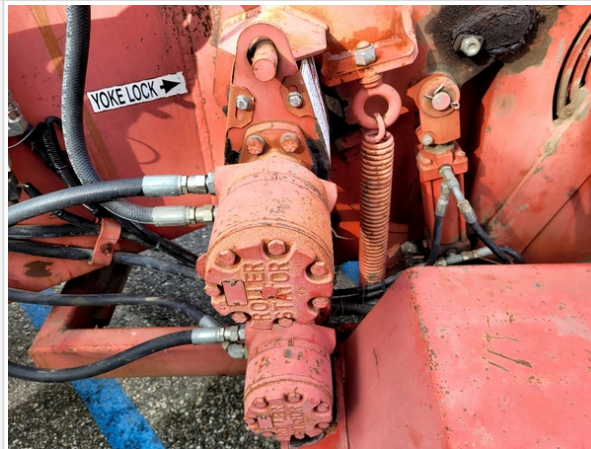
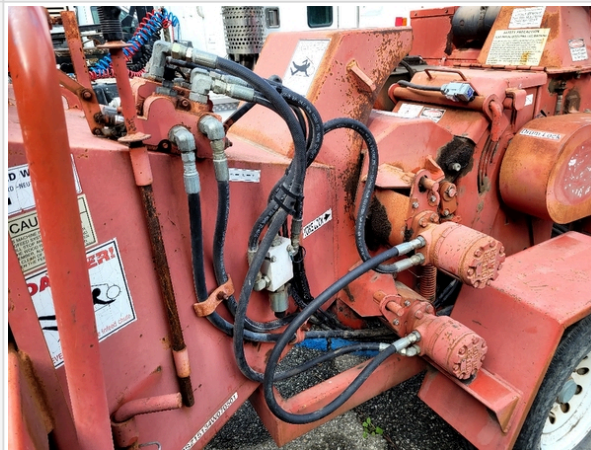
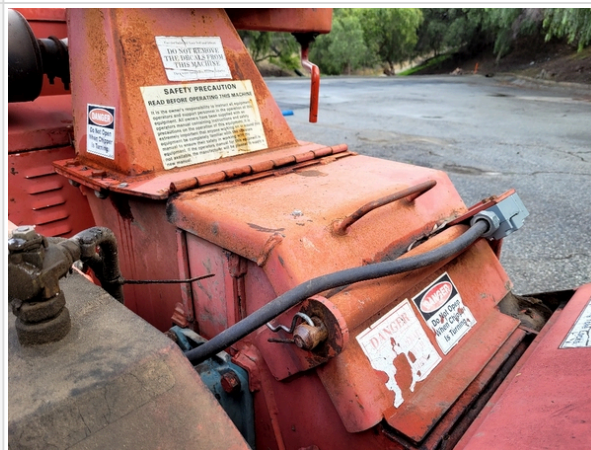
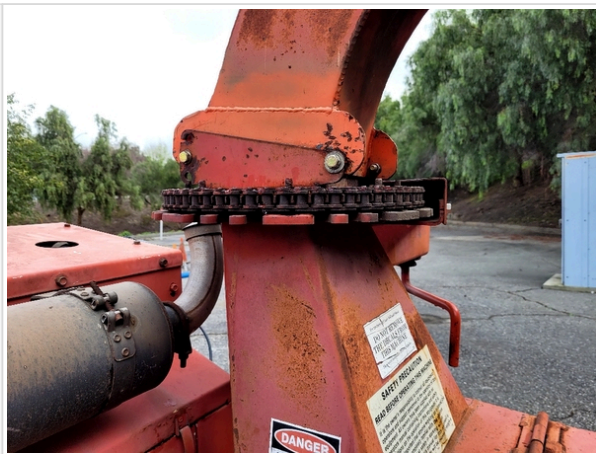
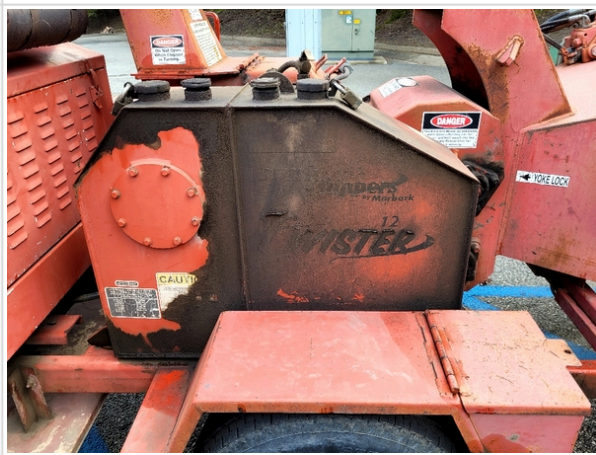
Close-up Exterior Photos

General Appearance Rating	3 - Normal Wear & Tear
General Appearance Comments	Exterior paint faded

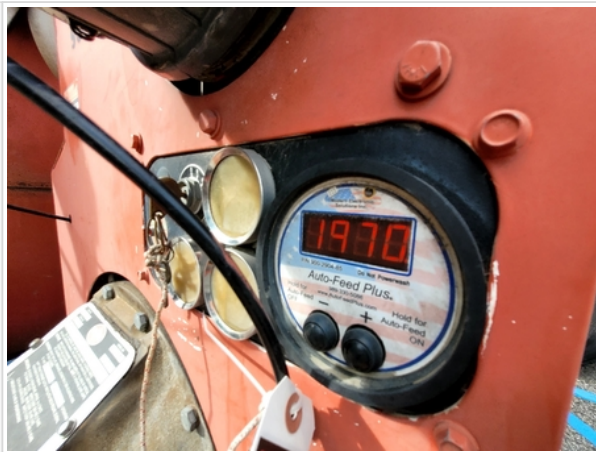
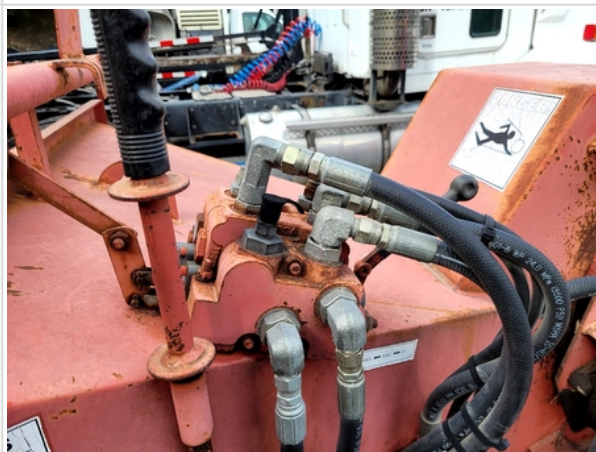
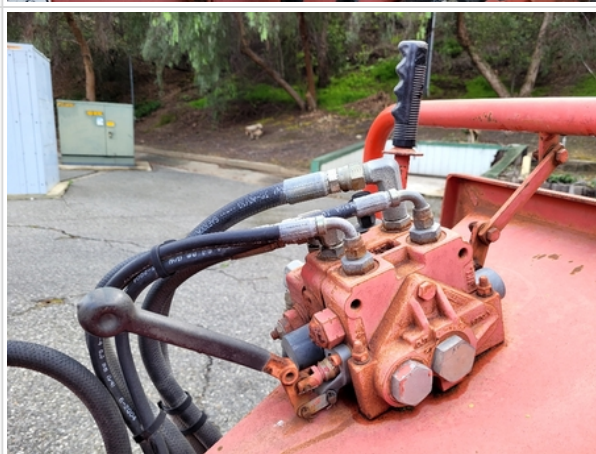
Control Station Photos

Control Station Overall Rating	3 - Normal Wear & Tear
Control Station Overall Condition	Minor cosmetic wear to cabin surfaces, floors, panels, and ceiling. Other (see comments)
Comments	Battery Charge, Coolant Temp and Oil PSI Gauge unreadable due to worn gauge surface
Operator Seat	0
Cabin Lights	0
Safety Lock Out / Stop	0

Controls & Switches	3 - Normal Wear & Tear
Controls & Switches Condition	All switches are installed and functional
Hour Meter Activity	0
Other Gauge Activity	2 - Above Average Wear
Other Gauge Condition	One or more gauges are unreadable or not functioning (specify in comments)
Heater & A/C	0
Travel Alarm	0
Horn	0
Backup Camera	0

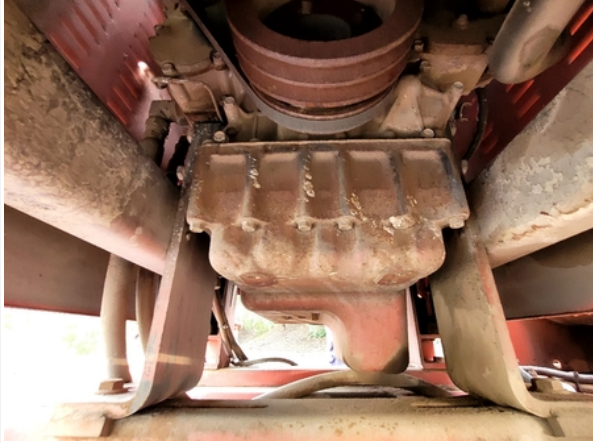
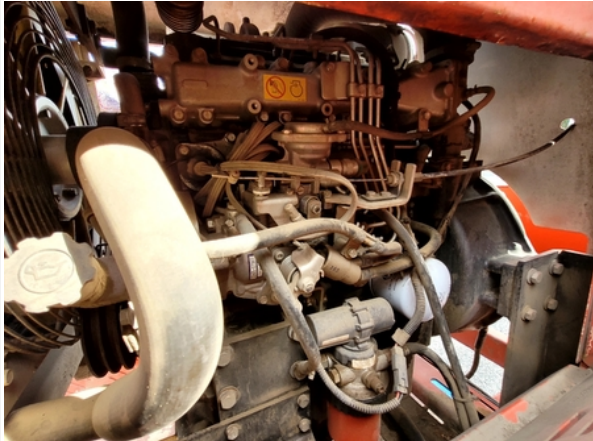
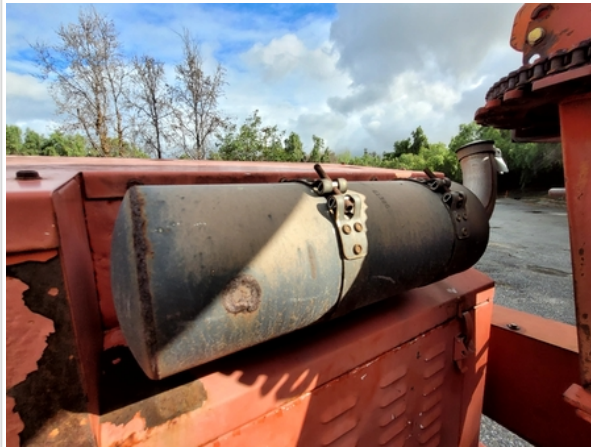
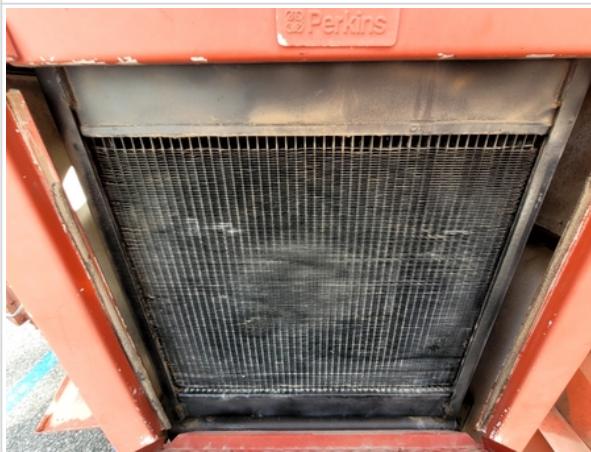
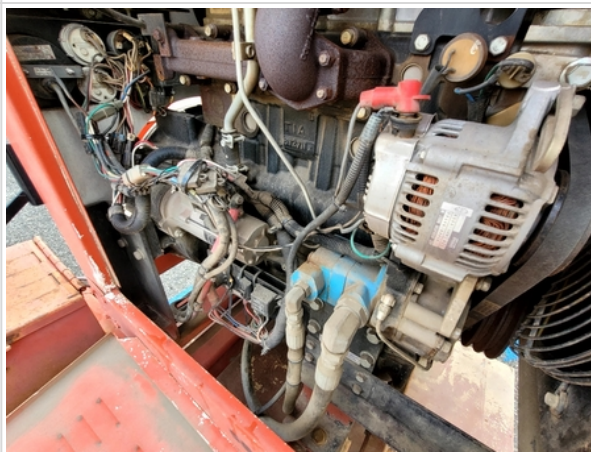
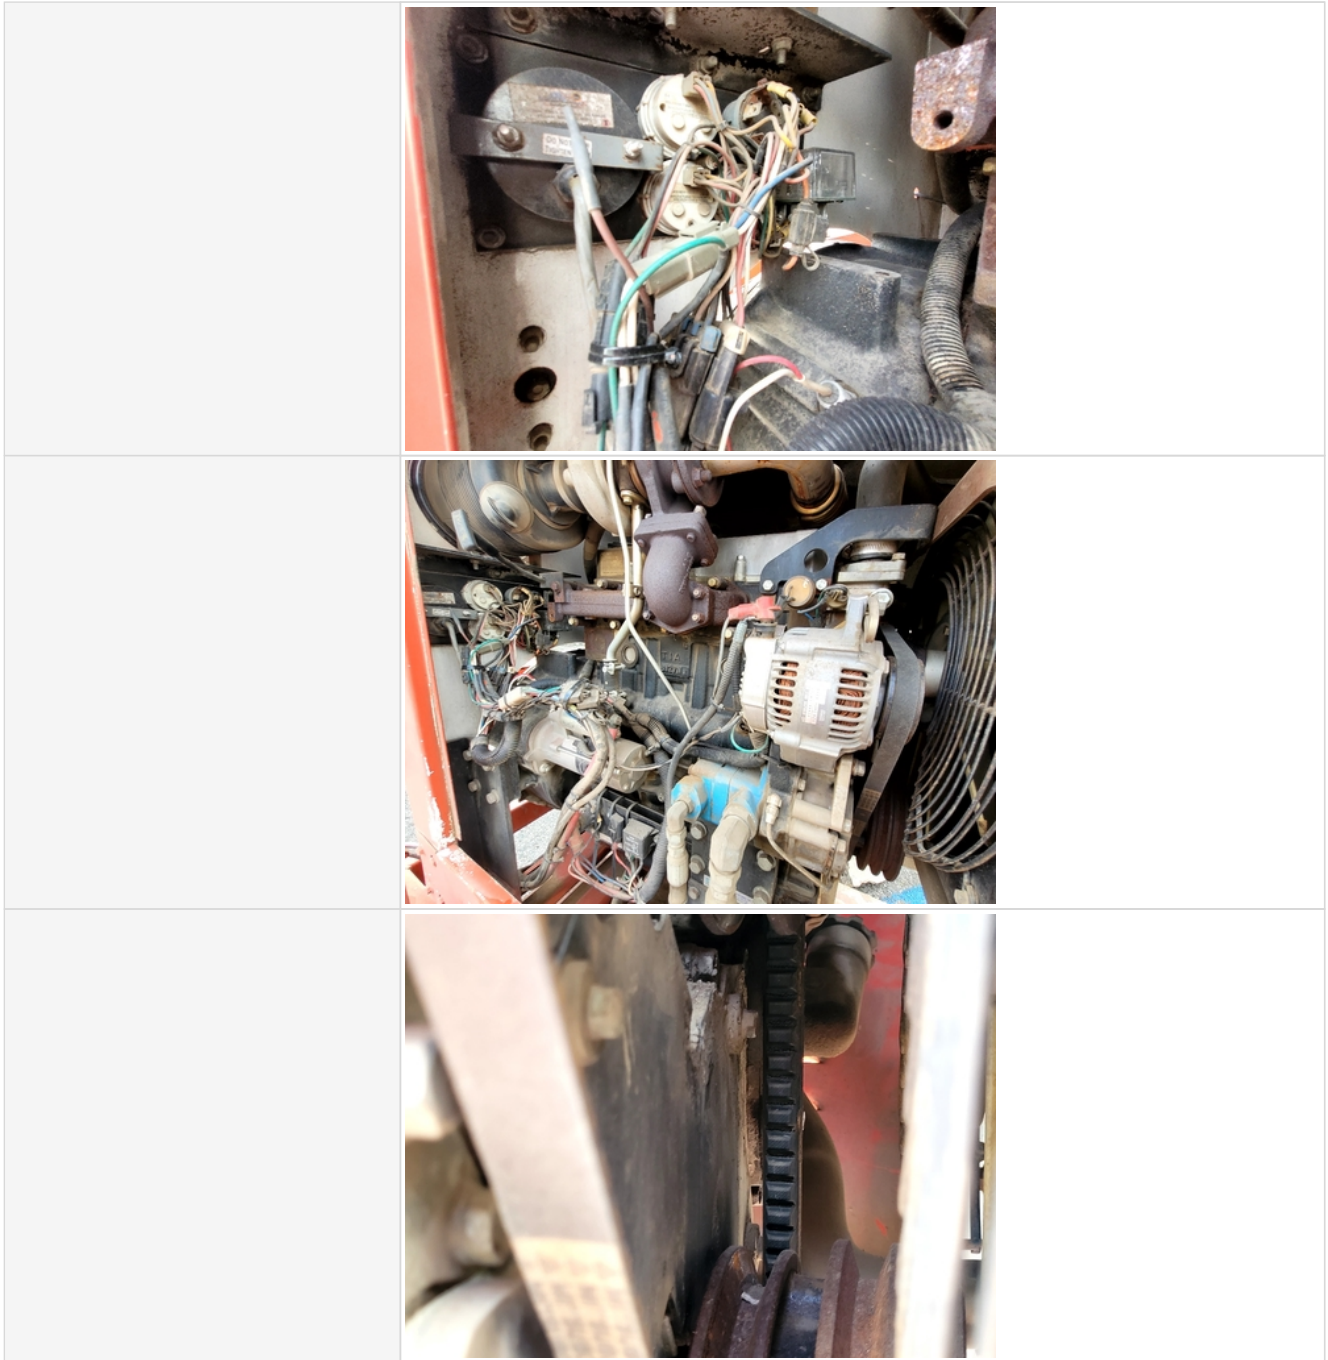
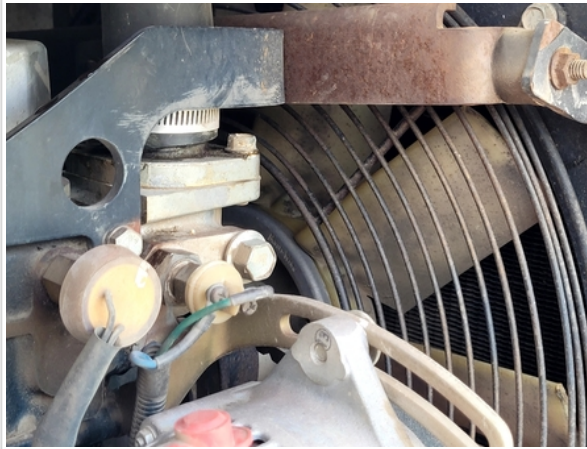
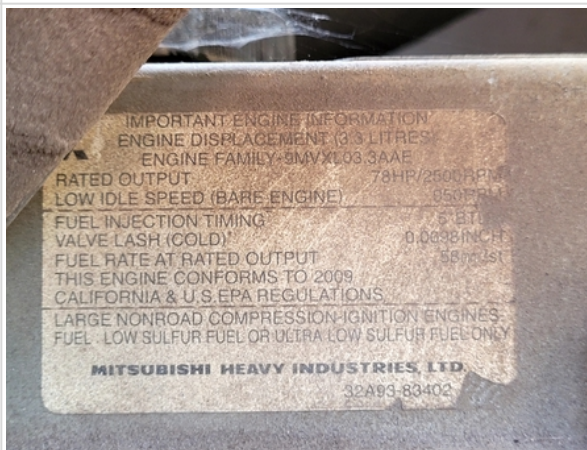
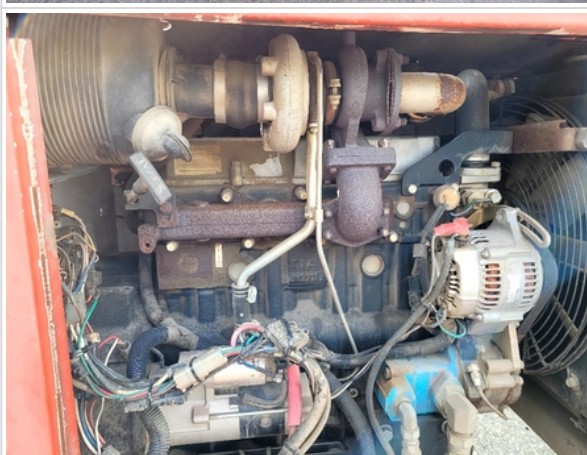
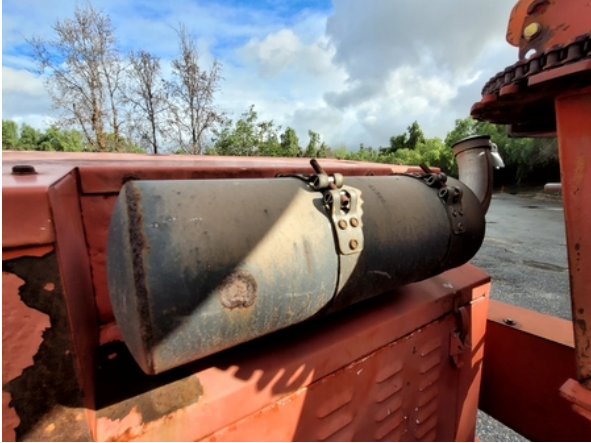
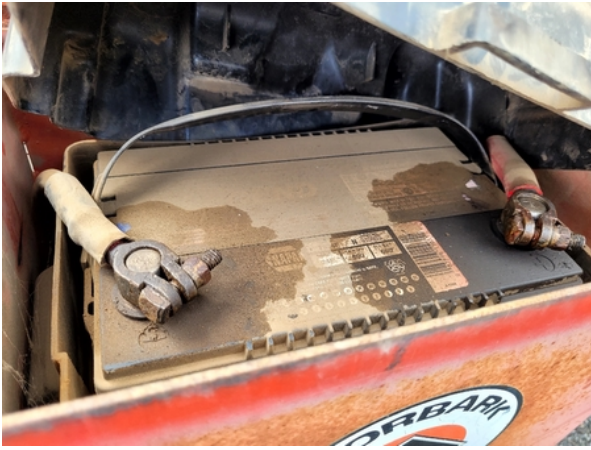
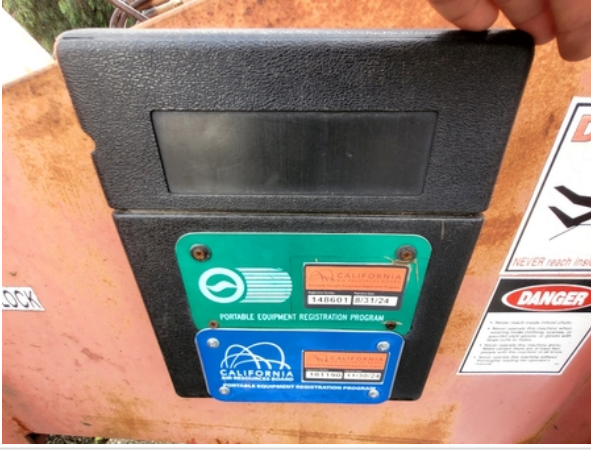
Overall Engine Appearance	Clean & dry
Overall Engine Comments	Engine runs good and sounds healthy under load. No active leaks seen.

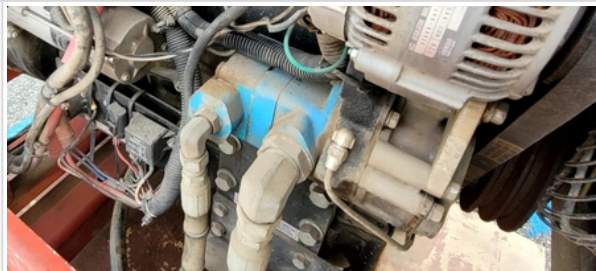
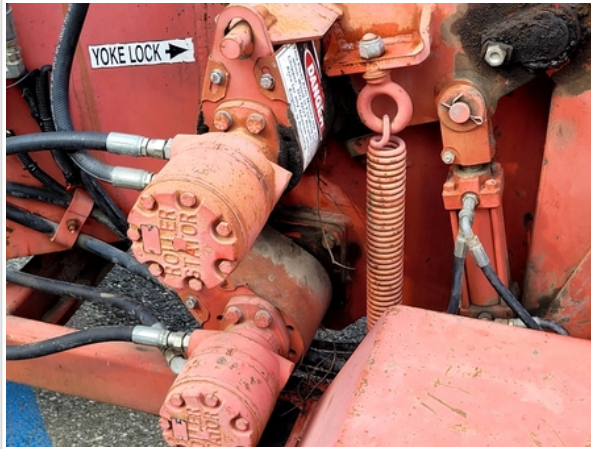
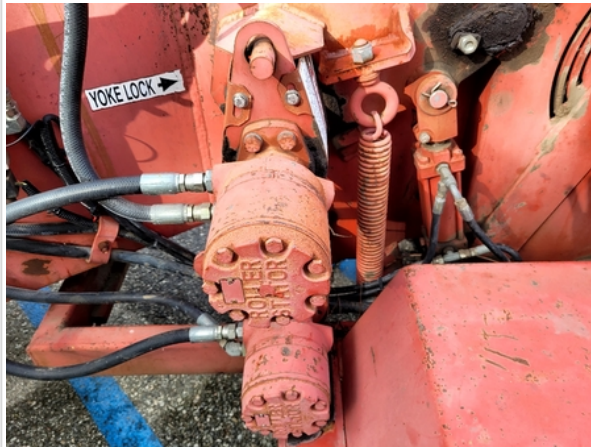
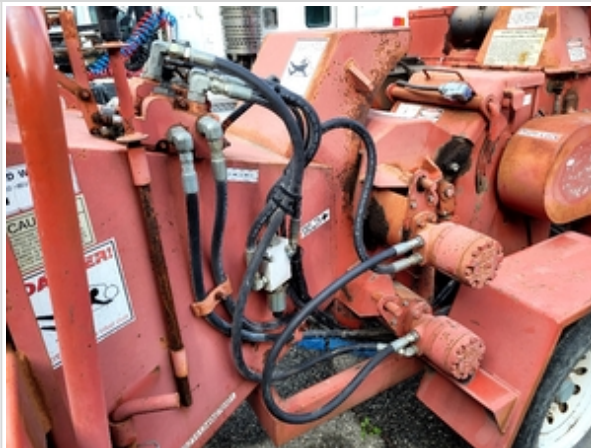
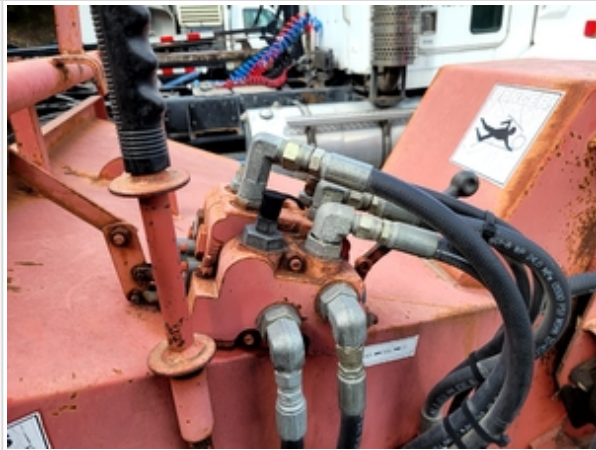
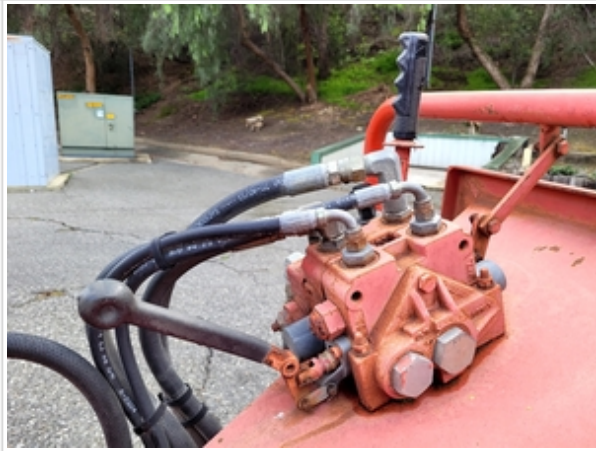
Wet or Damp Hydraulic Lines / Fittings	No
Appearance of Hydraulic Lines / Fittings	3 - Normal Wear & Tear
Hydraulic Lines / Fittings Condition	Hydraulic lines & fittings are clean and in good condition
Unusual Noises (Hydraulic Pump)	No
Hydraulic Pump Notes	No unusual noises heard during operation
Comments	Hydraulics operating normally

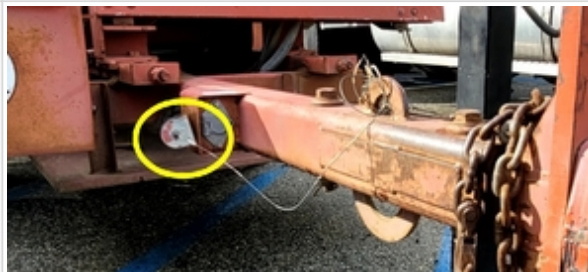
Brake Type	Electric Brakes
Brake Controller	No
Wire Connections	3 - Normal Wear & Tear
Emergency Brake/Break-Away	2 - Above Average Wear
Comments	Cable system present but not tested
Emergency Brake/Break-Away Photos

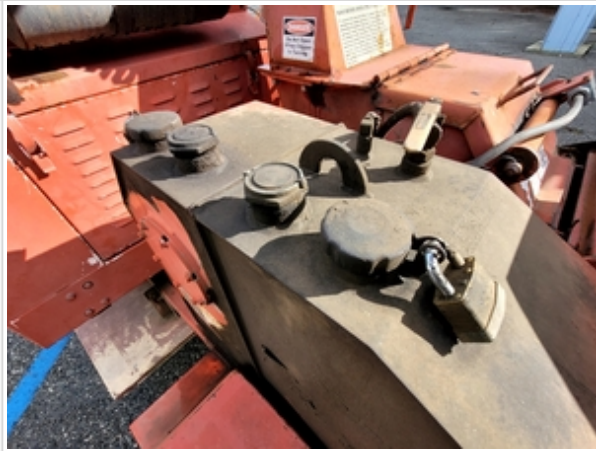
Fuel Tank Photos

Overall Trailer Condition	3 - Normal Wear & Tear
Overall Trailer Comments	Brake shoes not visible. Electric brakes and lights were not tested but visually look okay.
Fuel Tank Condition	3 - Normal Wear & Tear
