Inspection Report (Skid Steer)

Year	2013
Make	Bobcat
Model	S130
Serial Number	AU4Y13361
Hour Meter Reading	1,585 Hrs.
Previous Application (e.g., earth moving, mining, demolition, etc)	Waste water maintenance machine

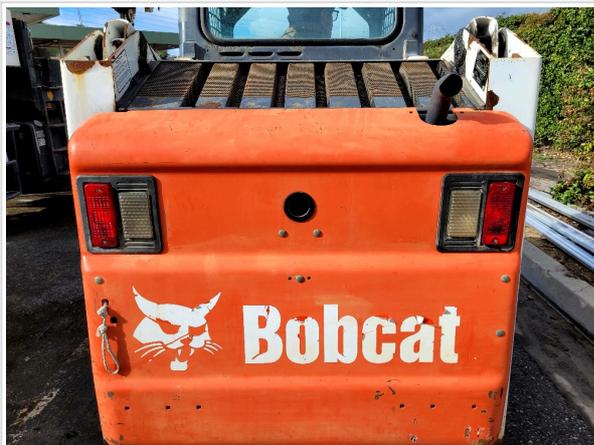
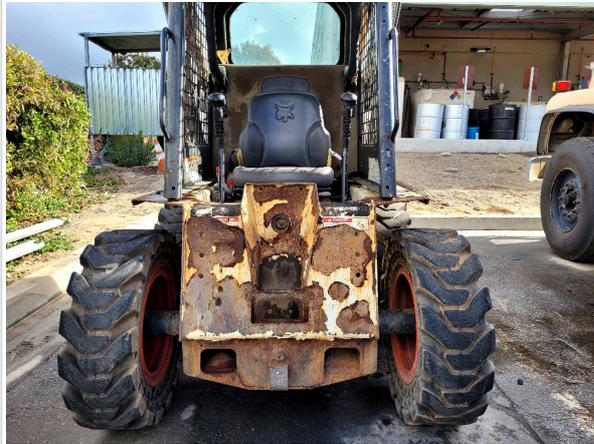
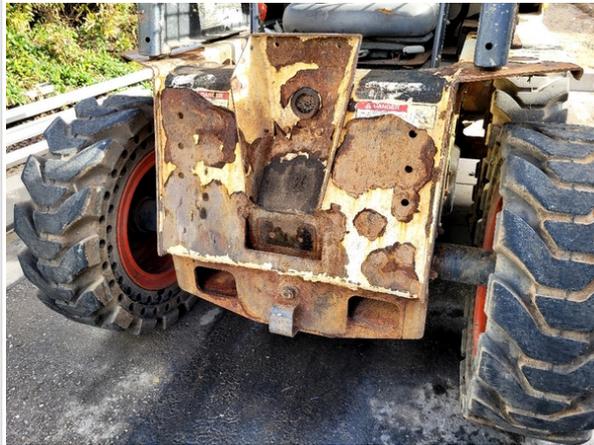
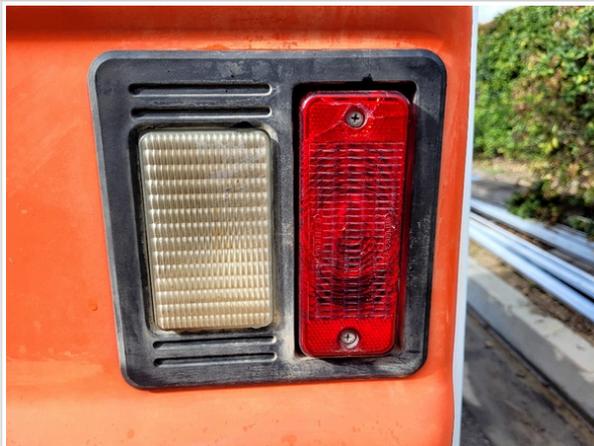
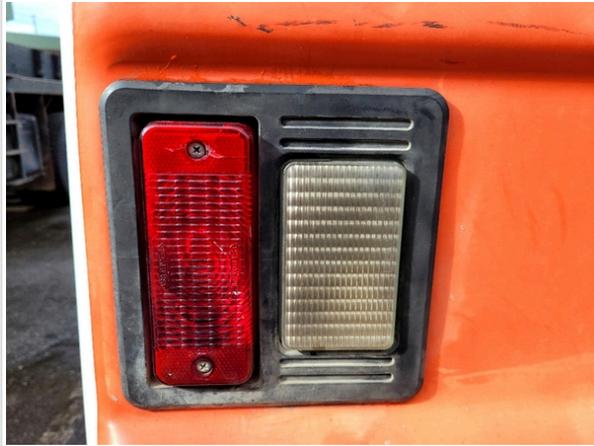
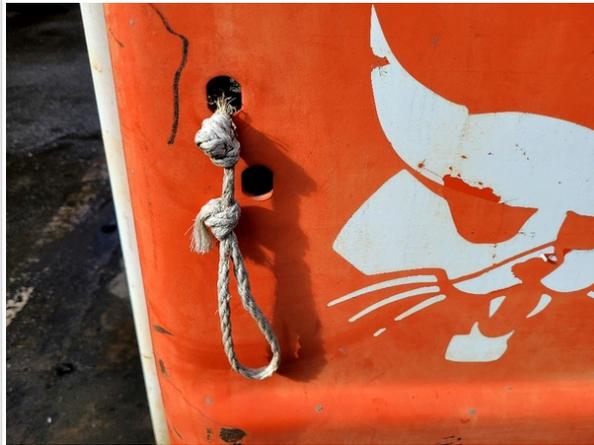
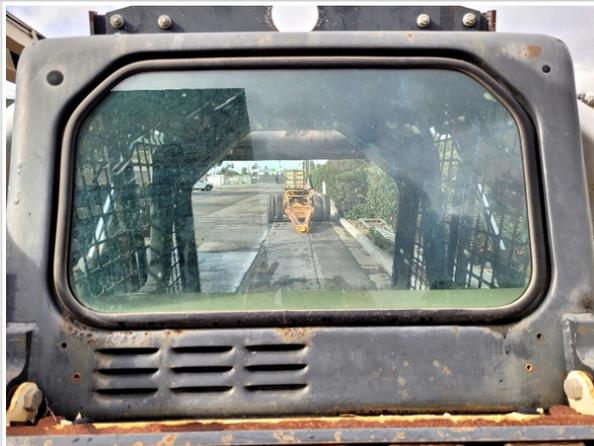
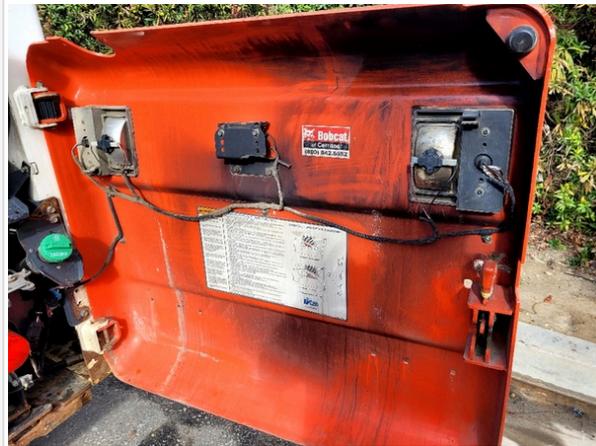
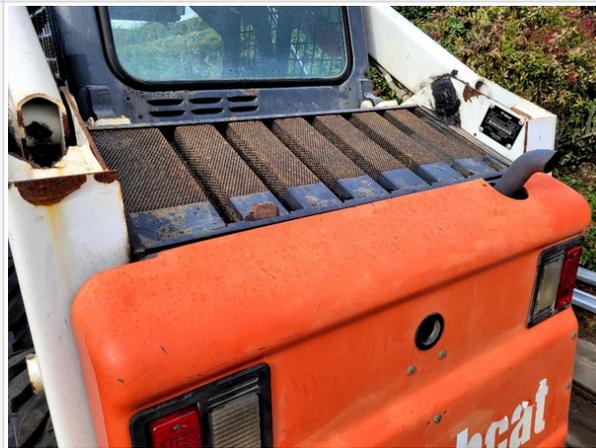
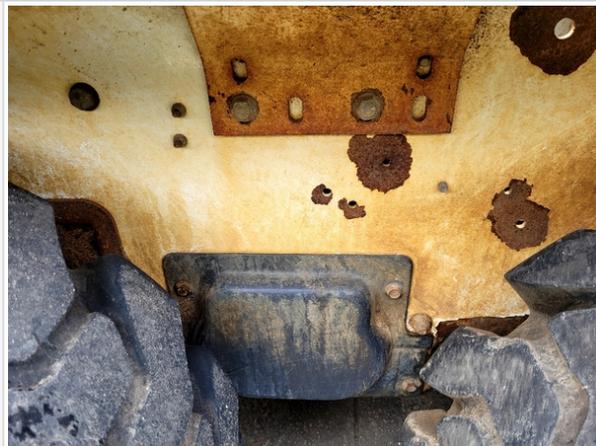
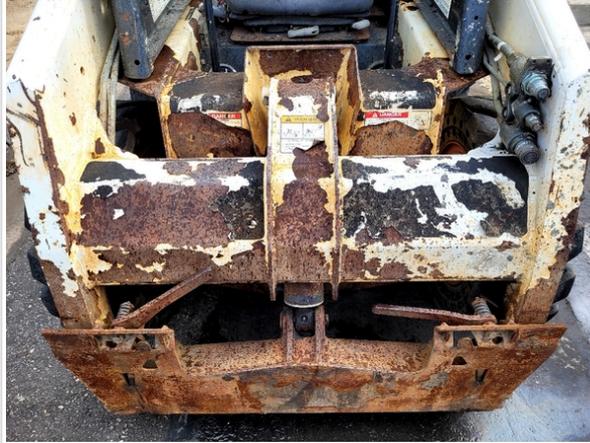
Close-up Exterior Photos

Body Panels	3 - Normal Wear & Tear
Body Panel Condition	Areas of surface rust observed, Other (see comments)
Comments	surface rust all around exterior of machine
Doors / Canopy Latches	2 - Above Average Wear
Doors / Canopy Latches Condition	Loose or missing latches, hinges or handles, Other (see comments)
Comments	rear engine compartment door missing latch
Steps / Ladders	0
Handrails	3 - Normal Wear & Tear
Handrails Condition	Handrails are fully intact and appear structurally sound
Glass	3 - Normal Wear & Tear
Glass Condition	Glass intact, no visible damage
Mirrors	0
Exterior Lights	3 - Normal Wear & Tear
Exterior Lights Condition	No visible damage, lighting system is operational

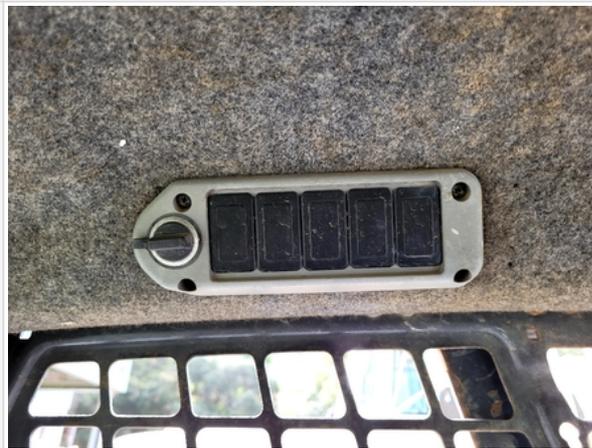
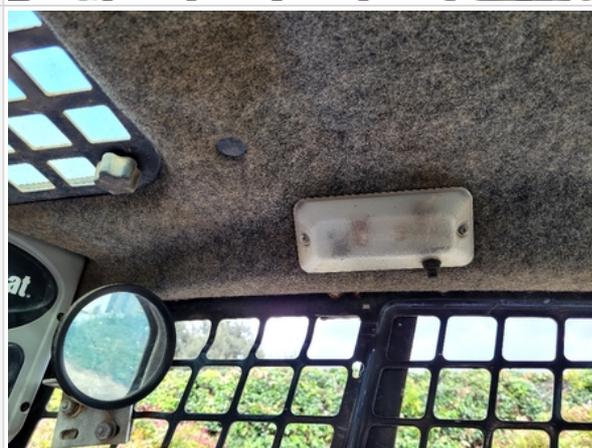
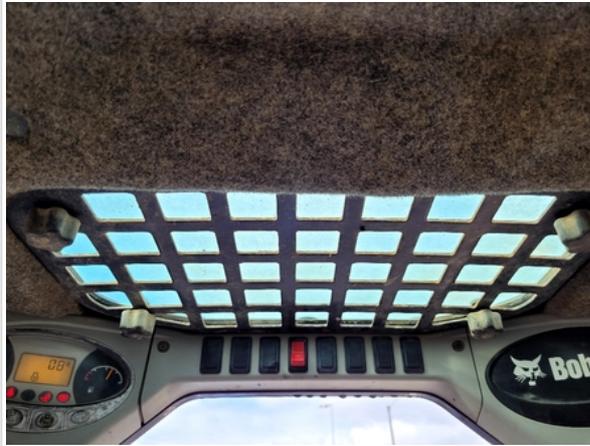
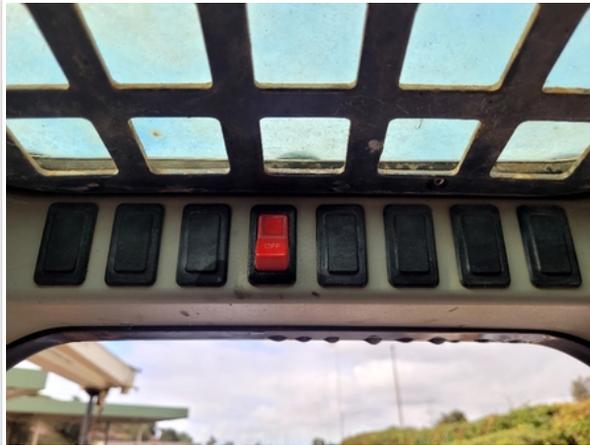
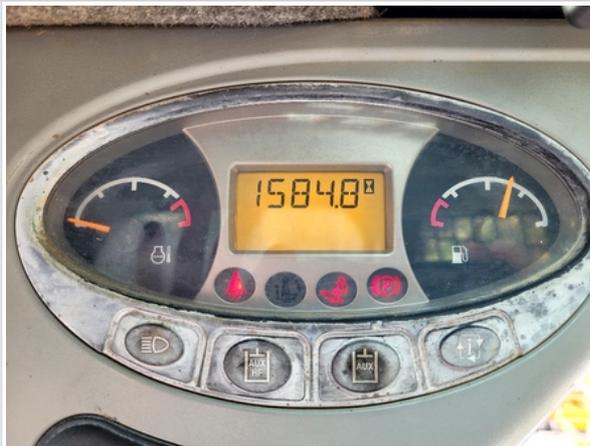
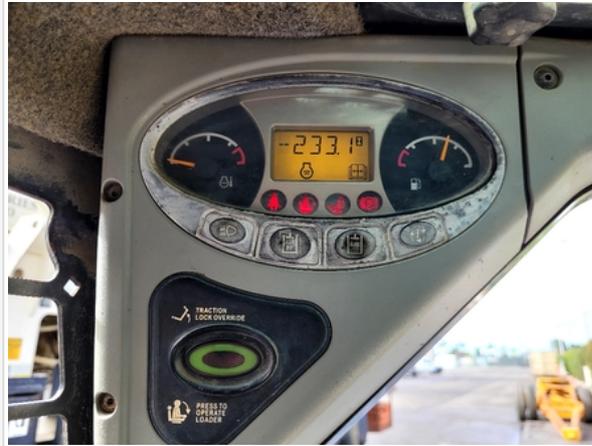
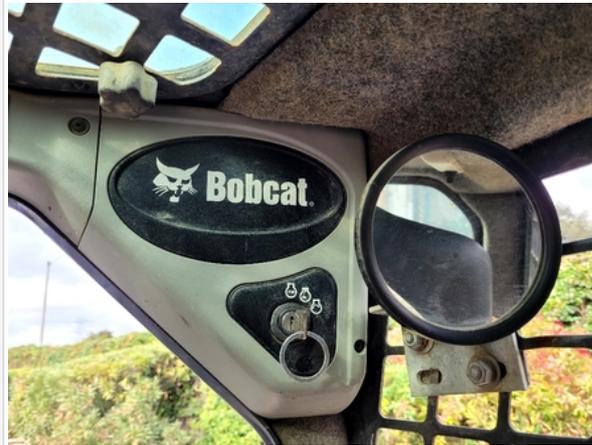
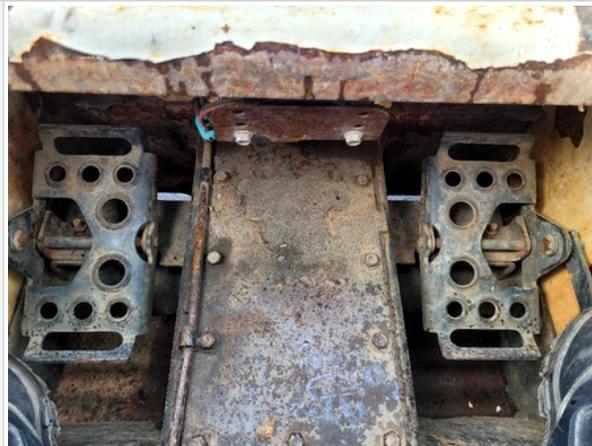
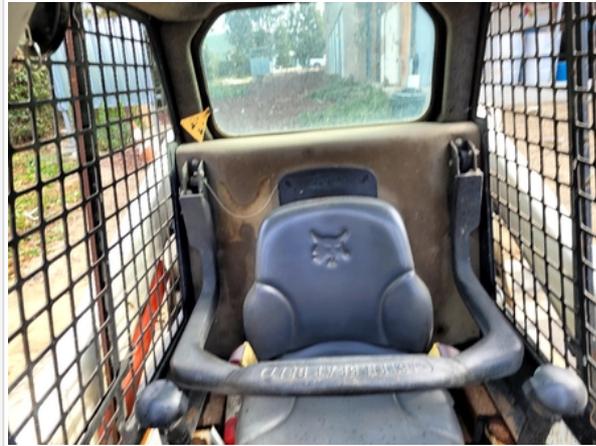
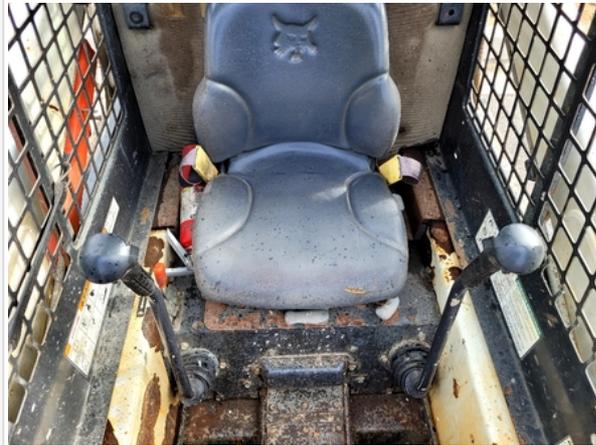
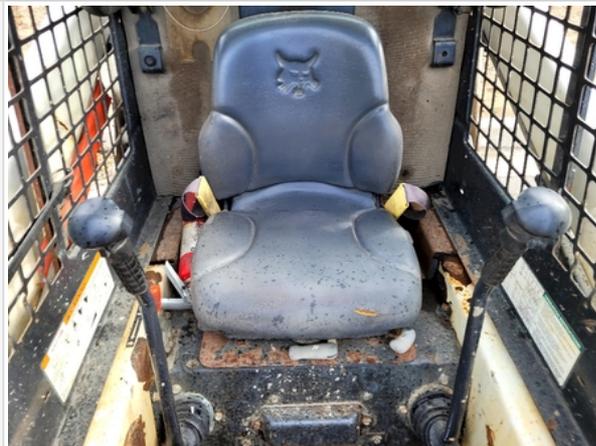
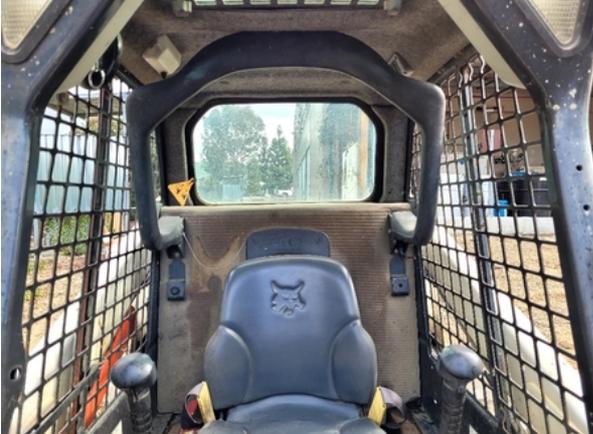
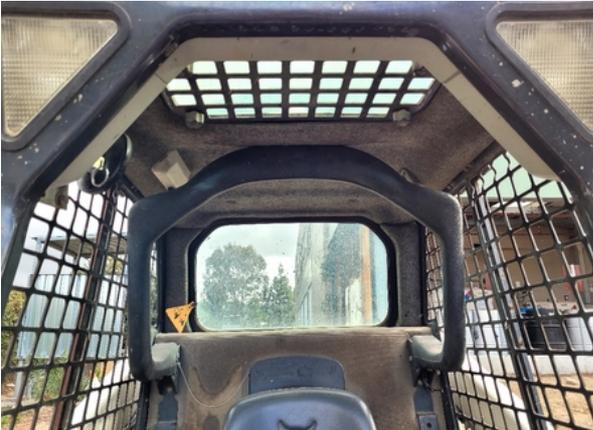
Operator Cabin Photos

Operator Cabin Overall	3 - Normal Wear & Tear
Operator Cabin Overall Condition	Minor cosmetic wear to cabin surfaces, floors, panels, and ceiling
Operator Seat	3 - Normal Wear & Tear
Operator Seat Condition	Seat(s) have minor surface staining or small tears
Cabin Lights	3 - Normal Wear & Tear
Cabin Lights Condition	Cabin lights are installed with all light covers in place, bulbs are installed and working properly
Safety Lock Out / Stop	3 - Normal Wear & Tear
Safety Lock Out / Stop Condition	Safety lock out device is present, in good condition, and functional
Controls & Switches	3 - Normal Wear & Tear
Controls & Switches Condition	All switches are installed and functional
Hour Meter Activity	3 - Normal Wear & Tear
Hour Meter Condition	Hour meter is functional and in good condition
Other Gauge Activity	3 - Normal Wear & Tear
Other Gauge Condition	All cockpit gauges are functional and in good condition

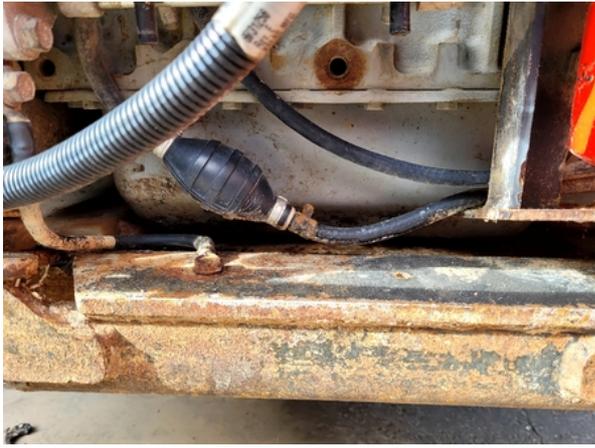
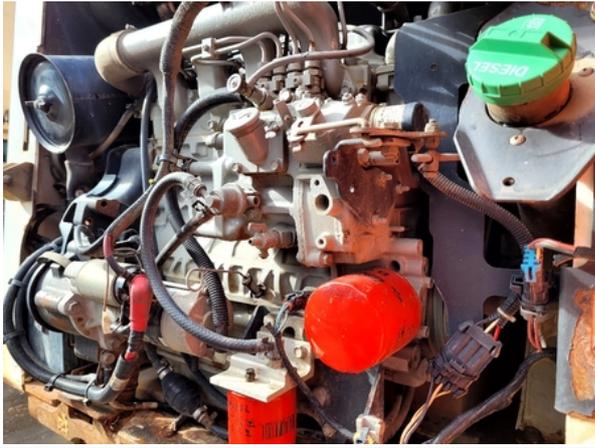
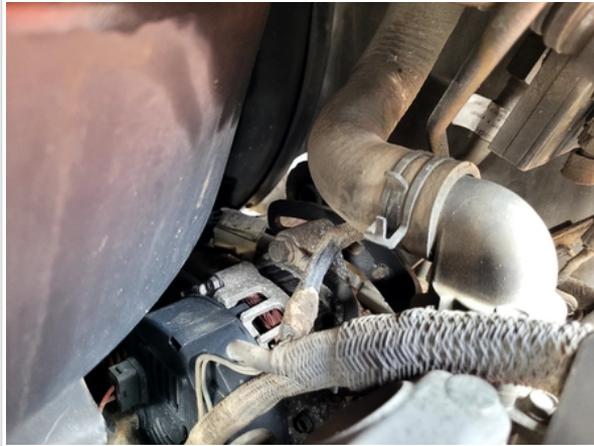
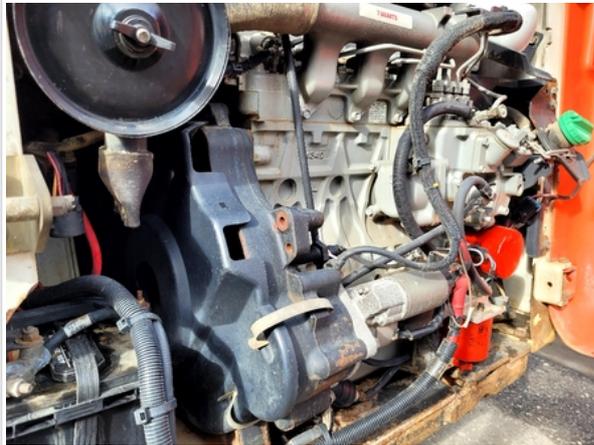
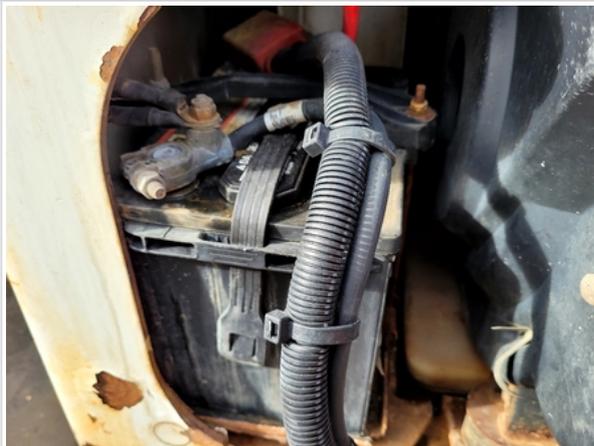
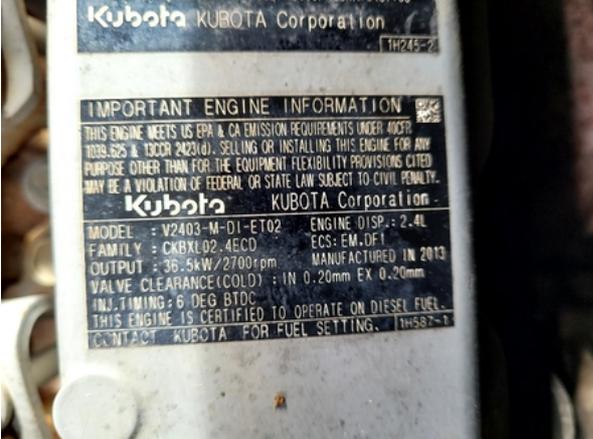
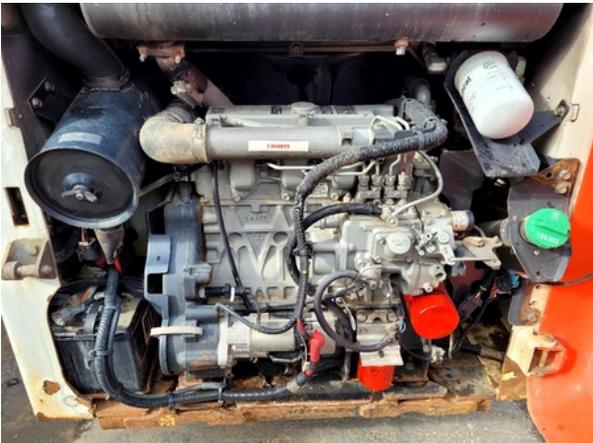
Blow-by (Visual Observation Check)	No
Unusual Noises (Upon Start-up, Idle, Shutdown)	No
Unusual Noise Notes	No unusual noises heard
Engine Smoke (Upon Start-up, Idle, Shutdown)	No
Engine Smoke Notes	No engine smoke issues observed

Engine Exhaust Color	Clear
Battery	3 - Normal Wear & Tear
Battery Condition	Clean & dry appearance, tight connections
Radiator	3 - Normal Wear & Tear
Radiator Condition	Radiator fins & components appear to be in good working order, no signs of damage or leaks
Belts	3 - Normal Wear & Tear
Belt Condition	Belts appear in good condition & alignment with proper tension
Hoses	3 - Normal Wear & Tear
Hose Condition	Firm, pliant hoses with no signs of wear or leaks

Water Pump	3 - Normal Wear & Tear
Water Pump Condition	No unusual pump noises heard
Cooling System Leaks	No
Coolant Color / Appearance	3 - Normal Wear & Tear
Coolant Color/Appearance Notes	Normal Translucent appearance, no visual signs of contamination
Oil Leaks	No
Oil Color / Appearance	3 - Normal Wear & Tear
Oil Color / Appearance Notes	Clean oil appearance, no signs of cross contamination, Appropriate oil level
Fuel Leaks	No
Requires DEF (Diesel Exhaust Fluid)	No
Overall Engine Appearance	Clean & dry
Overall Engine Comments	Overall engine runs well with no active leaks seen. Engine and its compartment in clean condition and has well maintained appearance.

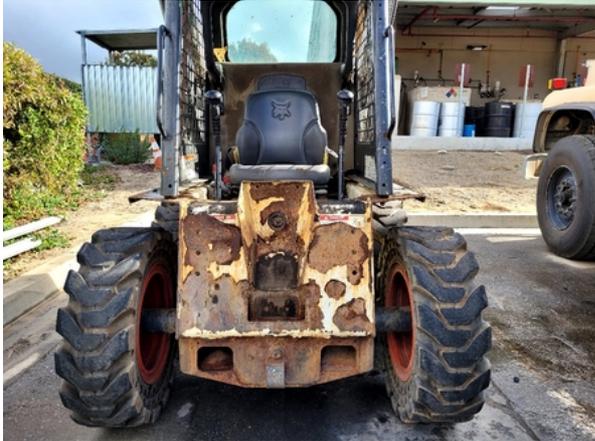
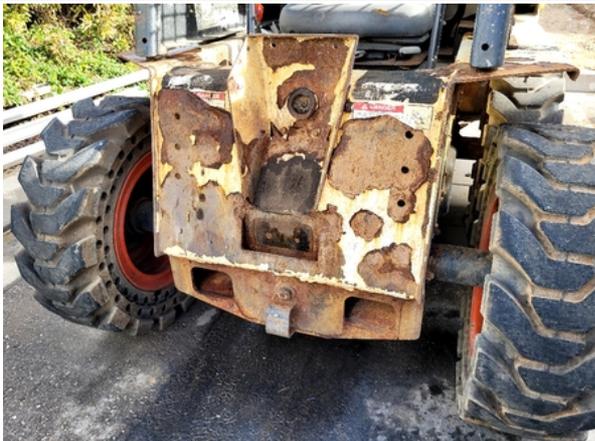
Hydrostatic Transmission?	Yes
2 Speed?	No
Hydrostatic Drive Configuration	Split Transmission
Drive Motors	2 - Above Average Wear
Hydrostatic Parking Brake	3 - Normal Wear & Tear
Hydrostatic Parking Brake Condition	Good brake function
Overall Drivetrain Comments	Machine parking brake releases and activates just fine. Skid steer travels in all directions well with no abnormal issues observed. Adjustment to neutralize control levers recommended.

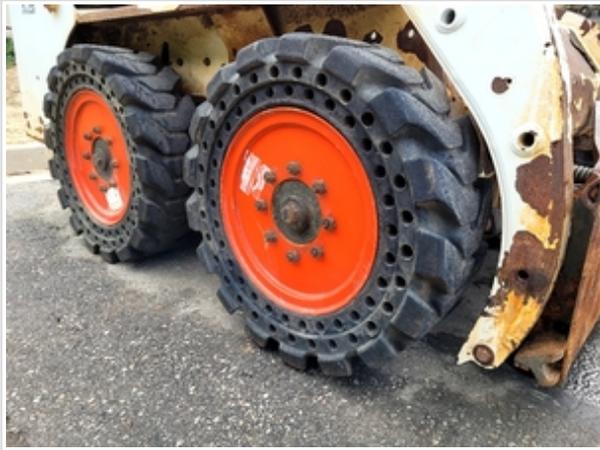
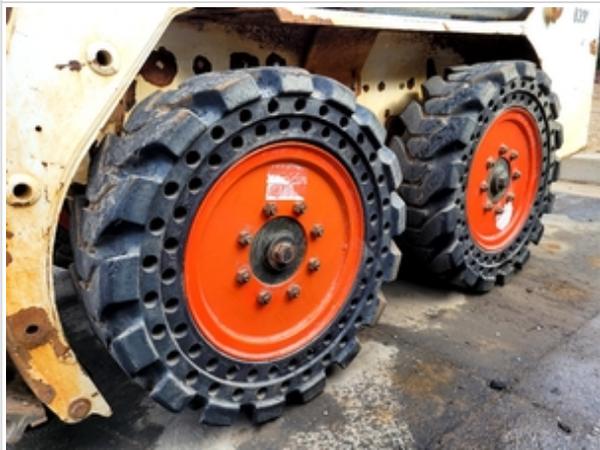
Stance	3 - Normal Wear & Tear	
Wheels & Tires	3 - Normal Wear & Tear	
Comments	Wheels are solid rubber and look to be like new	
Wheels & Tires Photos
