## Inspection Report (Vibratory Compactor)

Year	2015
Make	JCB
Model	VM1500
Serial Number	JCBV1500EF2704941
Hour Meter Reading	2,478 Hrs.
Previous Application (e.g., earth moving, mining, demolition, etc)	Masonry General Construction

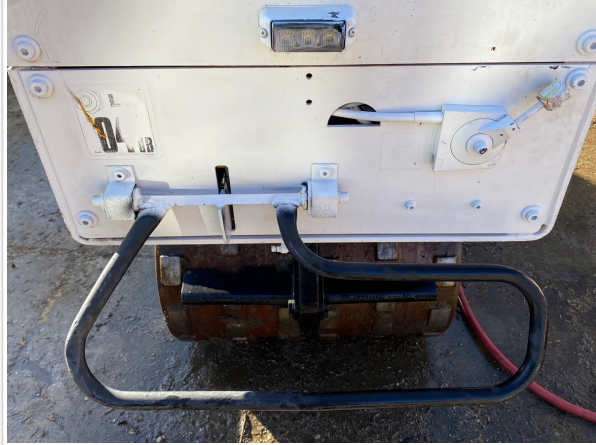
Close-up Exterior Photos

<b>Body Panels</b>	3 - Normal Wear & Tear
<b>Body Panel Condition</b>	No visible damage, good paint condition and panel fitment
<b>Doors / Canopy Latches</b>	3 - Normal Wear & Tear
<b>Doors / Canopy Latches Condition</b>	No visible damage
<b>Steps / Ladders</b>	0

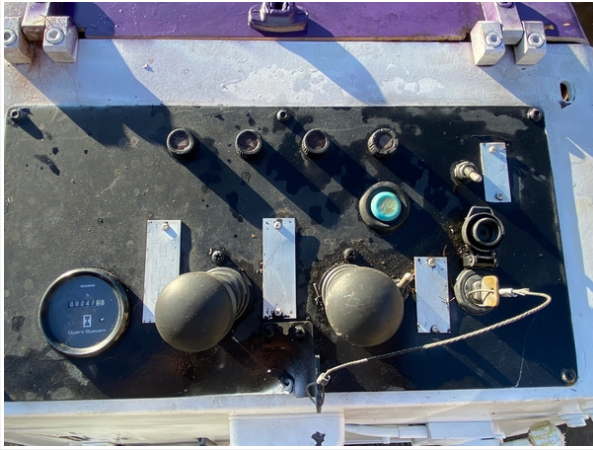
Operator Cabin Photos

Operator Cabin Overall	3 - Normal Wear & Tear
Operator Cabin Overall Condition	Good cabin appearance, solid floors, panels, and ceiling
Operator Seat	0
Cabin Lights	0
Safety Lock Out / Stop	0
Controls & Switches	3 - Normal Wear & Tear
Controls & Switches Condition	All switches are installed and functional
Hour Meter Activity	3 - Normal Wear & Tear

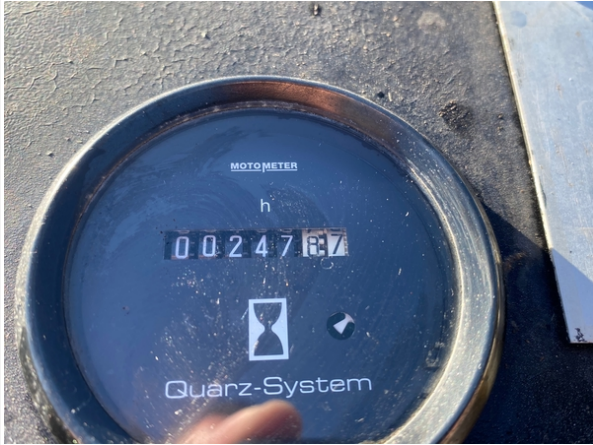
Hour Meter Condition	Hour meter is functional and in good condition
Hour Meter Activity Photos

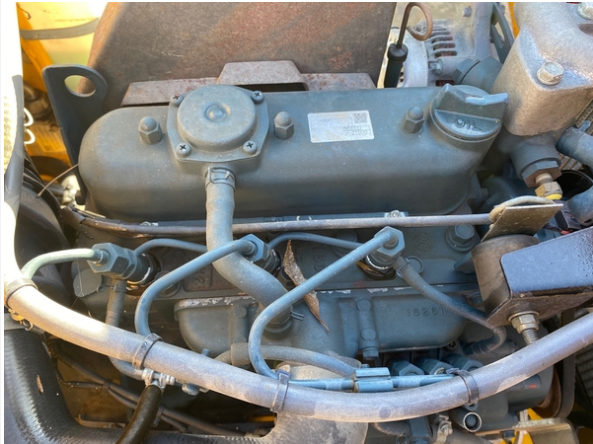
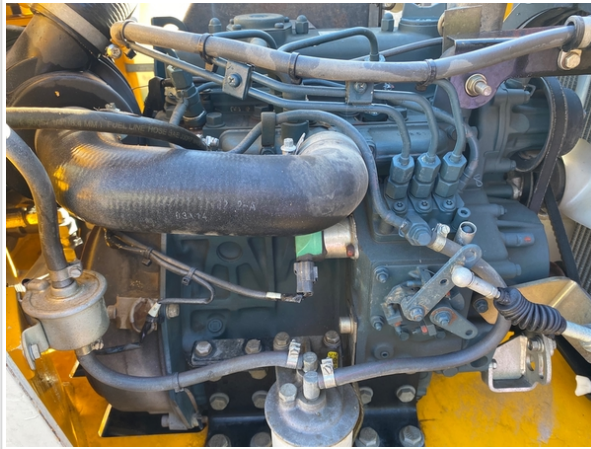
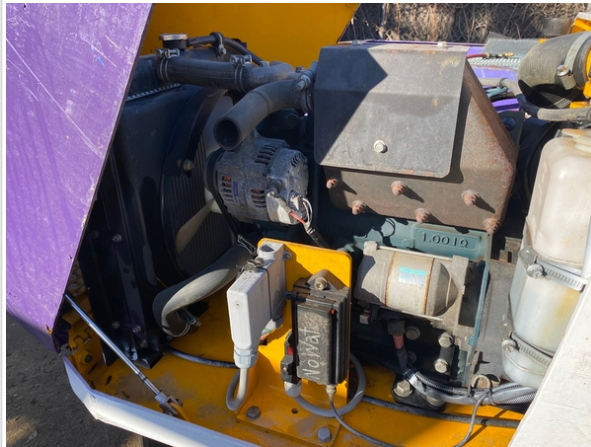
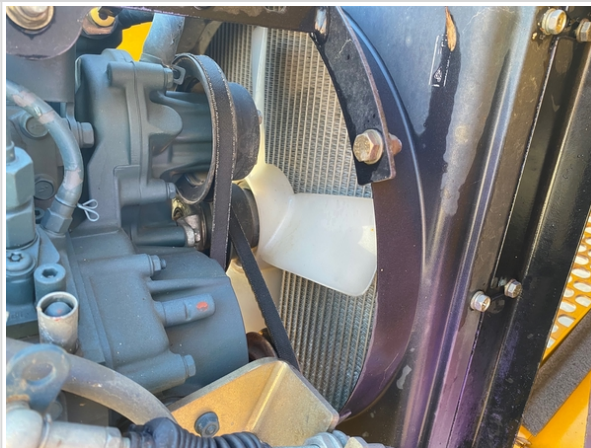
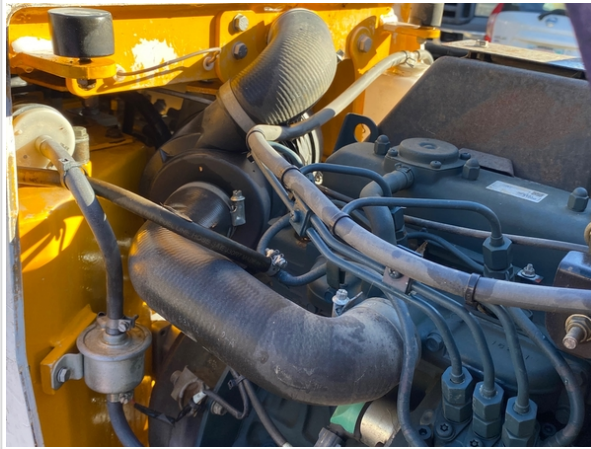
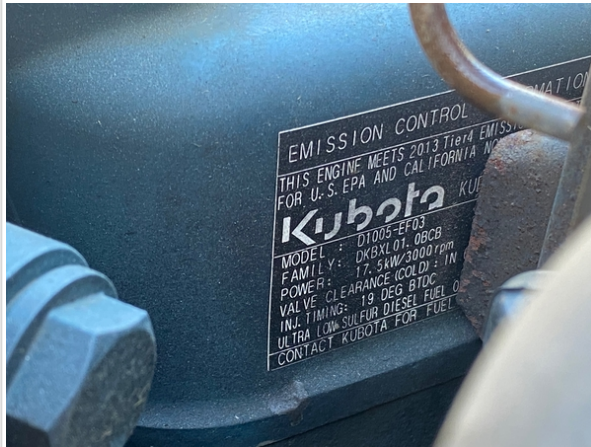
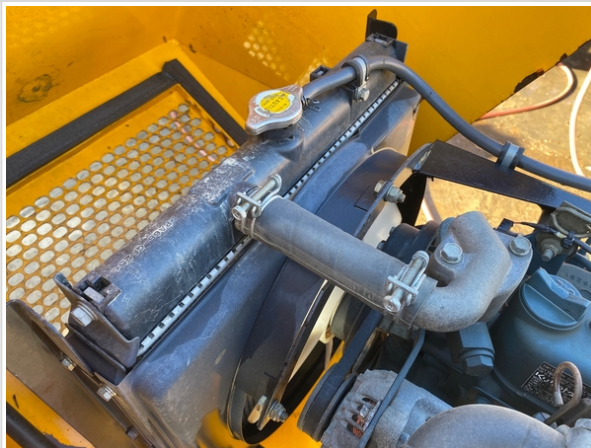
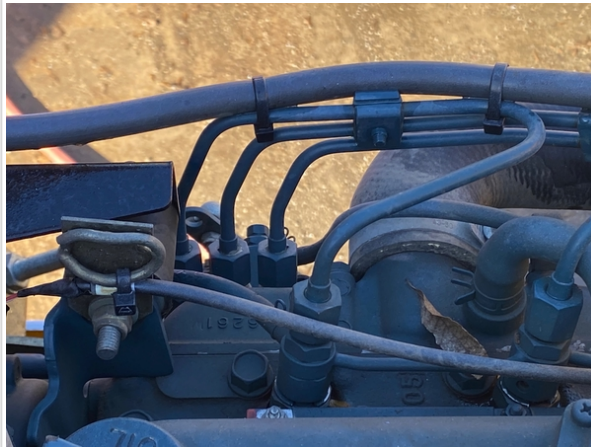
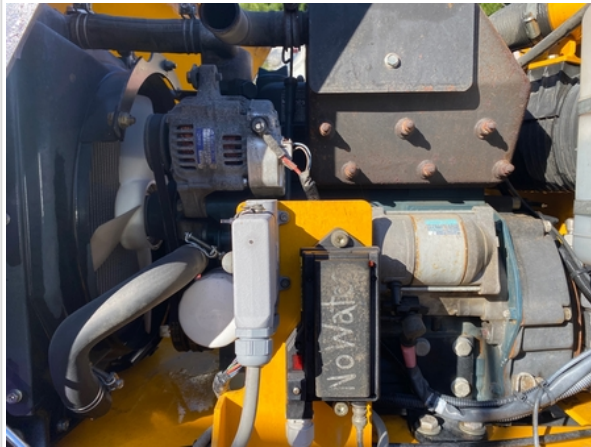
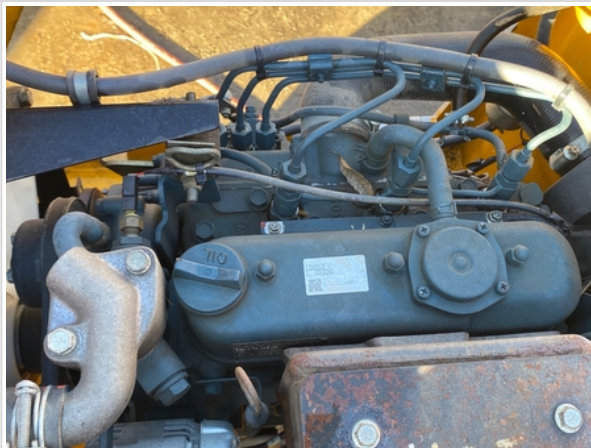
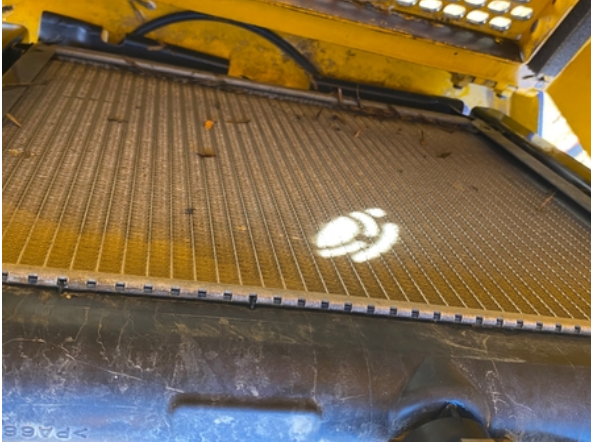
<b>Blow-by (Visual Observation Check)</b>	No
<b>Unusual Noises (Upon Start-up, Idle, Shutdown)</b>	No
<b>Unusual Noise Notes</b>	No unusual noises heard
<b>Engine Smoke (Upon Start-up, Idle, Shutdown)</b>	No
<b>Engine Smoke Notes</b>	No engine smoke issues observed
<b>Engine Exhaust Color</b>	Clear
<b>Battery</b>	3 - Normal Wear & Tear
<b>Battery Condition</b>	Clean & dry appearance, tight connections
<b>Radiator</b>	3 - Normal Wear & Tear
<b>Radiator Condition</b>	Radiator fins & components appear to be in good working order, no signs of damage or leaks
<b>Belts</b>	3 - Normal Wear & Tear
<b>Belt Condition</b>	Belts appear in good condition & alignment with proper tension
<b>Hoses</b>	3 - Normal Wear & Tear
<b>Hose Condition</b>	Firm, pliant hoses with no signs of wear or leaks
<b>Water Pump</b>	3 - Normal Wear & Tear
<b>Water Pump Condition</b>	No unusual pump noises heard
<b>Cooling System Leaks</b>	No

<b>Coolant Color / Appearance</b>	3 - Normal Wear & Tear
<b>Coolant Color/Appearance Notes</b>	Normal Translucent appearance, no visual signs of contamination
<b>Oil Leaks</b>	No
<b>Oil Color / Appearance</b>	3 - Normal Wear & Tear
<b>Oil Color / Appearance Notes</b>	Clean oil appearance, no signs of cross contamination, Appropriate oil level
<b>Fuel Leaks</b>	No

Requires DEF (Diesel Exhaust Fluid)	No
Overall Engine Appearance	Clean & dry
Overall Engine Comments	Overall engine in good appearance with no active leaks seen and no signs of operational problems.

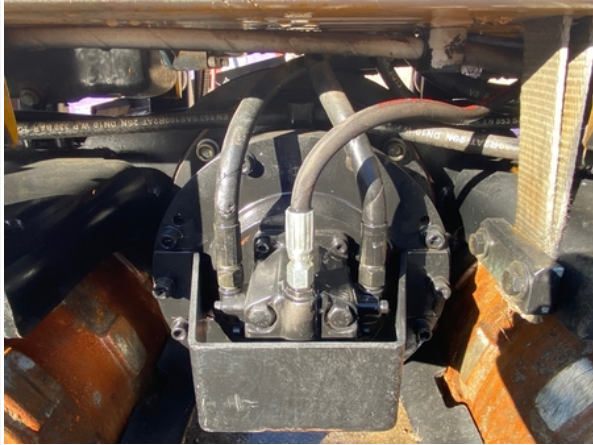
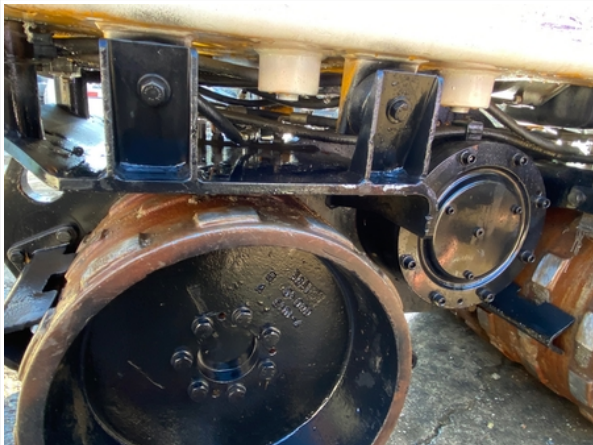
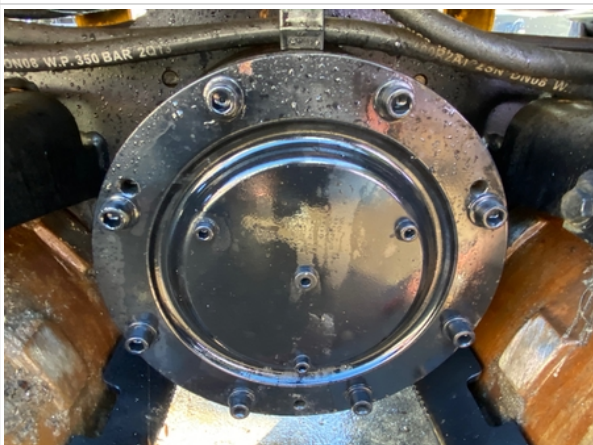
Hydrostatic Transmission?	Yes
2 Speed?	No
Hydrostatic Drive Configuration	Split Transmission
Drive Motors	1 - Service Required
Hydrostatic Parking Brake	3 - Normal Wear & Tear
Hydrostatic Parking Brake Condition	Good brake function
Overall Drivetrain Comments	Machine travels well in all directions and parking brake works good.

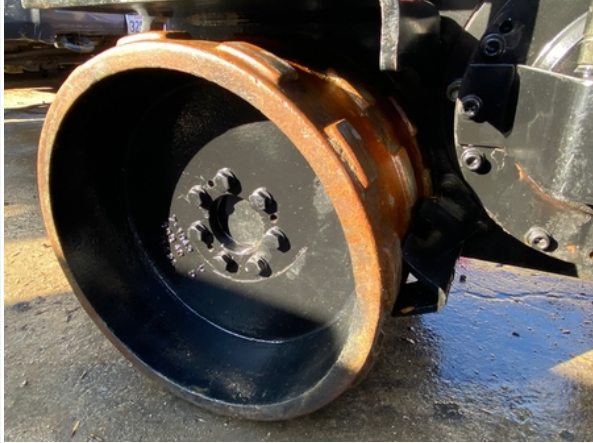
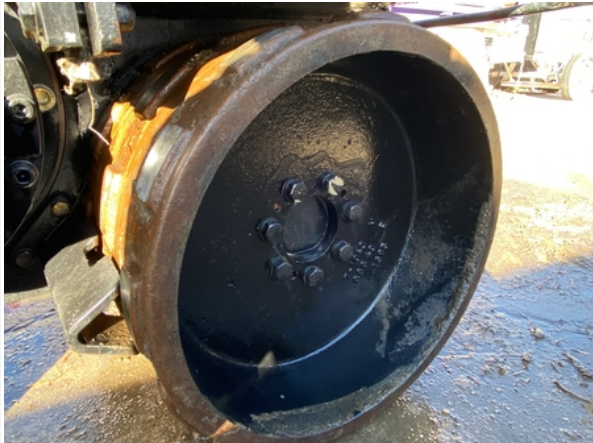
Frame	3 - Normal Wear & Tear
Level Stance	3 - Normal Wear & Tear
Drum(s) Condition	3 - Normal Wear & Tear
Drum(s) Photos

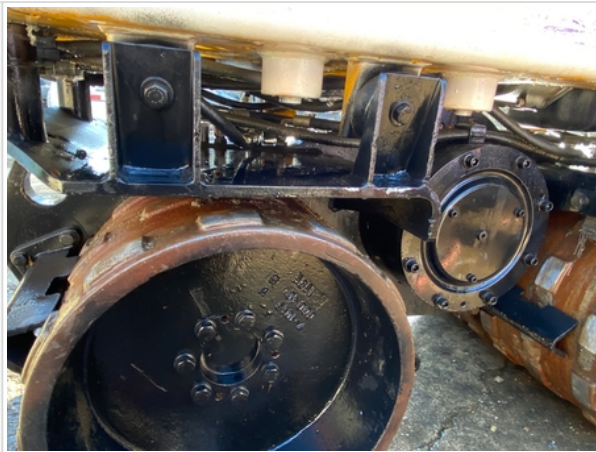
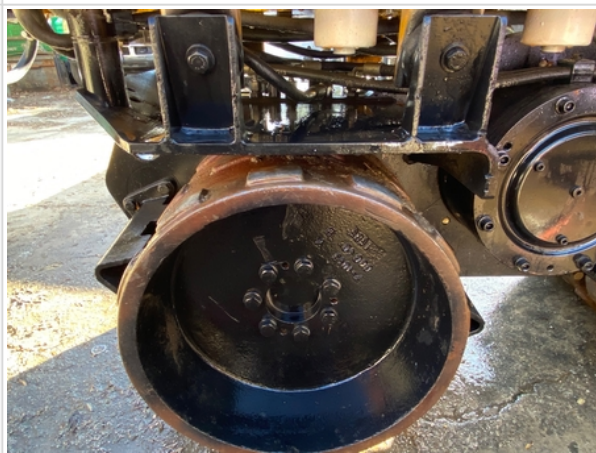
Vibratory Rubber Mounts (Front & Rear) Photos

Vibratory Rubber Mounts (Front & Rear)	3 - Normal Wear & Tear

<b>Drum Scraper</b>	3 - Normal Wear & Tear
<b>Padfoot Feet Condition</b>	3 - Normal Wear & Tear
<b>Padfoot Fitment</b>	3 - Normal Wear & Tear
<b>Padfoot Hardware</b>	3 - Normal Wear & Tear
<b>Overall Chassis</b>	3 - Normal Wear & Tear
<b>Overall Chassis Comments</b>	Chassis solid with no loose components seen during the inspection.

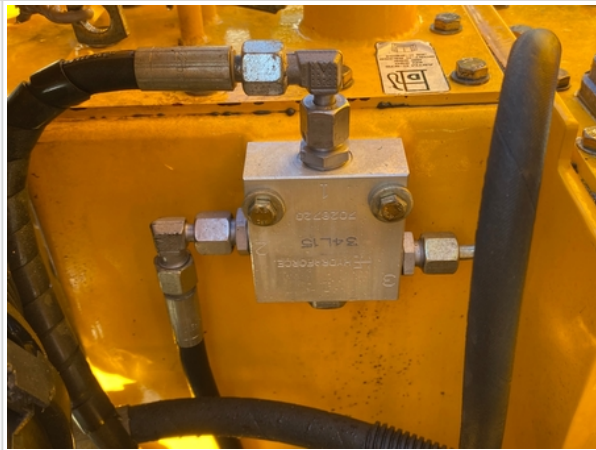
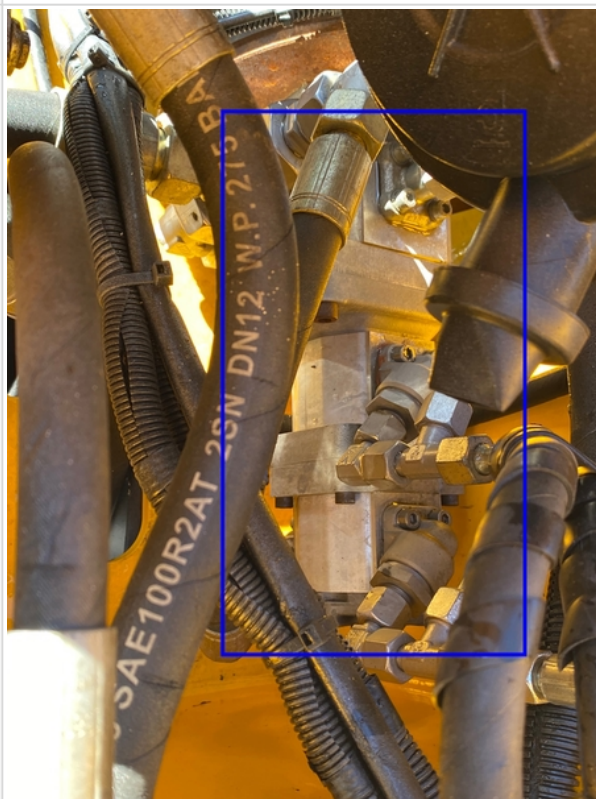
<p>Main hydraulic pump highlighted in outline</p>
<b>Wet or Damp Hydraulic Lines / Fittings</b>	No
<b>Appearance of Hydraulic Lines / Fittings</b>	3 - Normal Wear & Tear
<b>Hydraulic Lines / Fittings Condition</b>	Hydraulic lines & fittings are clean and in good condition
<b>Unusual Noises (Hydraulic Pump)</b>	No
<b>Hydraulic Pump Notes</b>	No unusual noises heard during operation
