Inspection Report (On-Highway Lube Truck)

Year	2020
Make	Peterbilt
Model	337
Serial Number	2NP2HM6X0LM675179
Truck Odometer Reading	56,740 Miles
Current Inspection / State Cert / DOT	N/A
Previous Application (e.g., earth moving, mining, demolition, etc)	Concrete Cutting / Demolition

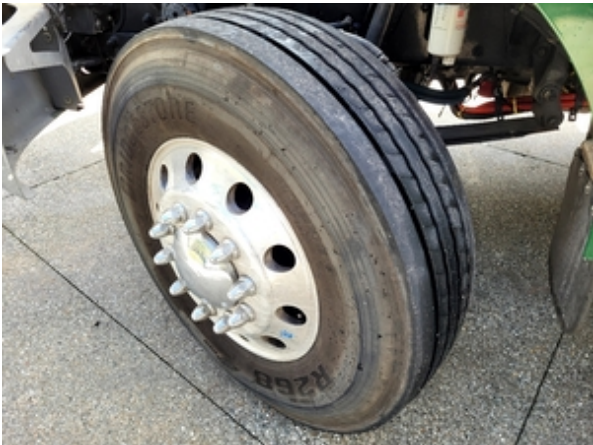
Wheel Seal Leaks	No	
Tire Brand	Bridgestone	
Tire Size	11R22.5	
Front Left Tire - Ratio Remaining	70%	
Front Left Tire Photos

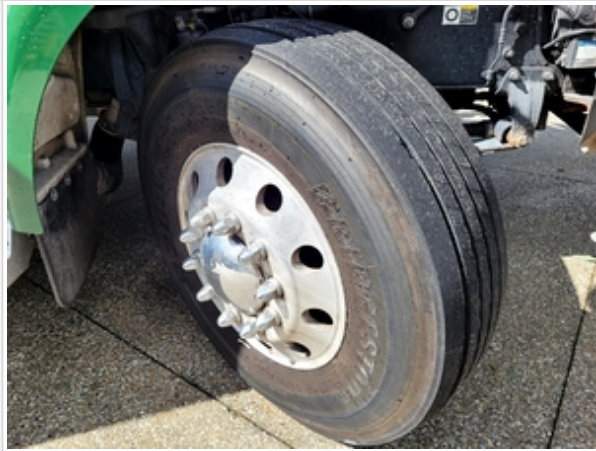
Front Right Tire - Ratio Remaining	70%

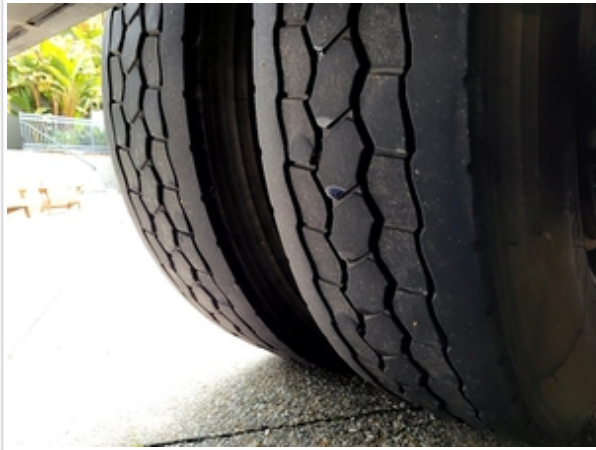
Frame	3 - Normal Wear & Tear
Suspension	3 - Normal Wear & Tear
Steer Axle Condition	3 - Normal Wear & Tear
Steering Components	3 - Normal Wear & Tear
Overall Chassis Condition	3 - Normal Wear & Tear
Overall Chassis Comments	Chassis in good condition. Rear tires showing small signs of abnormal wear possibly due to worn shocks and low tire tread.

Rear Right Tire - Ratio Remaining	30%
Rear Right Tire Photos

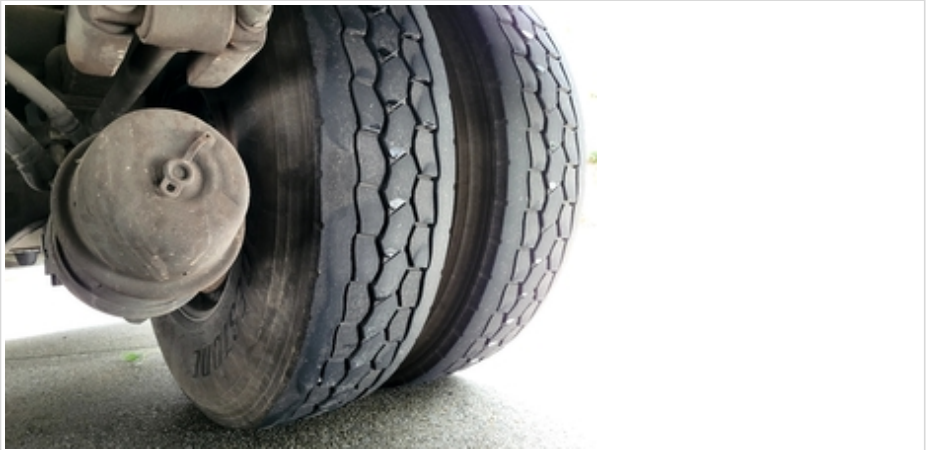
Rear Left Tire - Ratio Remaining	30%
Rear Left Tire Photos

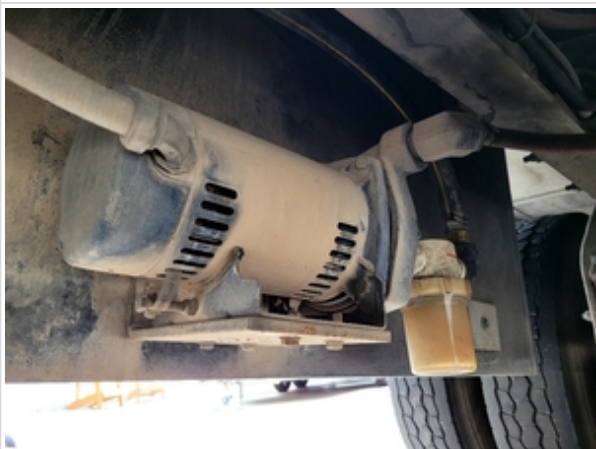
Mounting Bolts	3	
Interior Tank(s) Condition	0	
Pump(s) Appearance	3	
Comments	Water pump not tested during inspection	
Pump(s) Photos

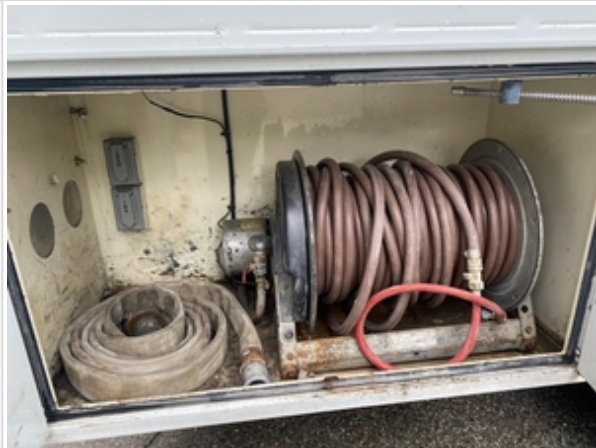
Pump(s) Functionality	0	
Grease Pump Installed	N/A	
Hose Reels & Nozzles	3	
Comments	Water hose reel Installed at rear right side tool box storage compartment	
Hose Reels & Nozzles Photos

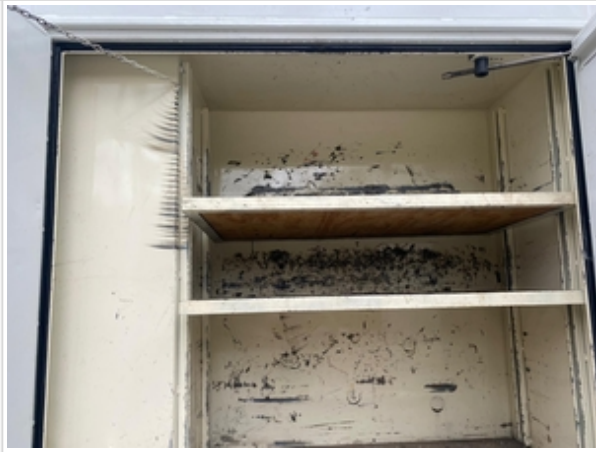
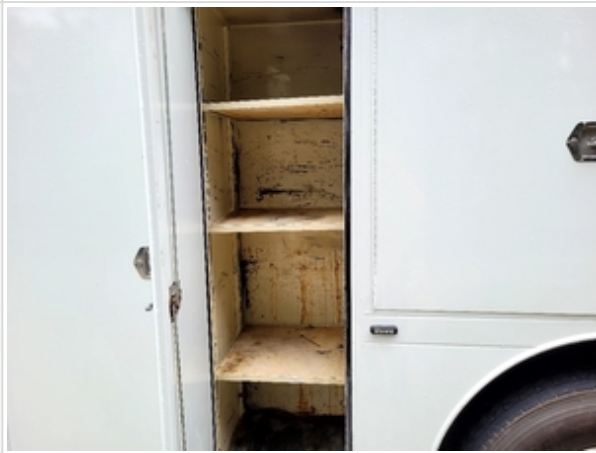
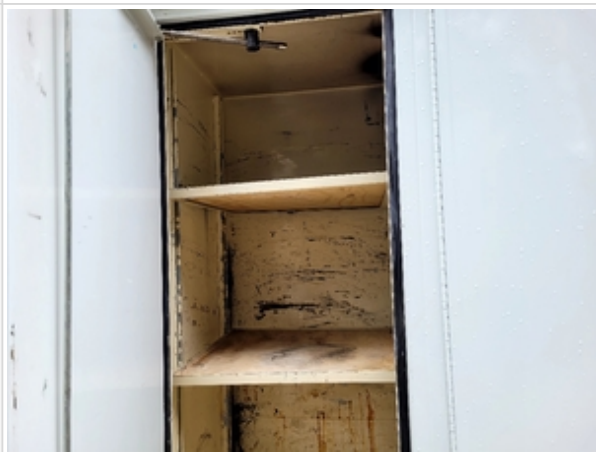
Comments	Left side above tire tool storage compartment out of service (fixed shut and unusable)
Toolboxes & Cabinets Photos
