## Inspection Report (On-Highway Service Truck)

Year	2015
Make	Ford
Model	F350
Serial Number	1FDBF3A64FEC15562
Truck Odometer Reading	130,495
Current Inspection / State Cert / DOT	N/A
Previous Application (e.g., earth moving, mining, demolition, etc)	Concrete Cutting General Contractor

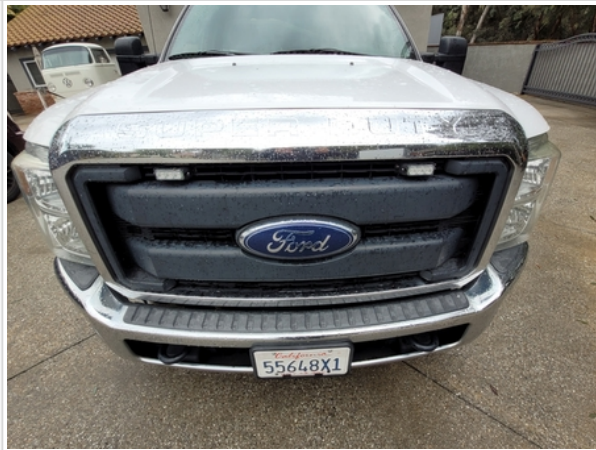
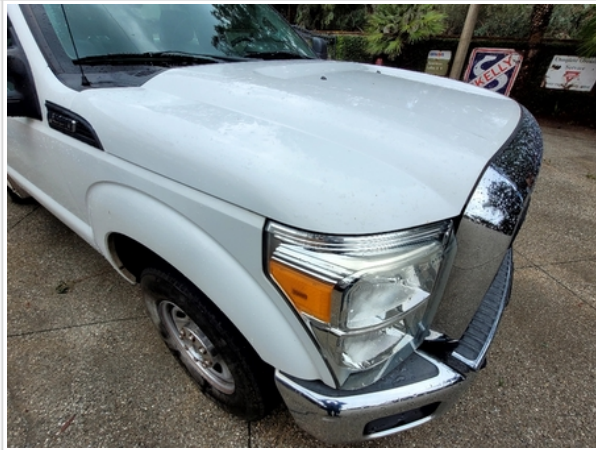
<b>Body Panels</b>	3 - Normal Wear & Tear	
<b>Body Panel Condition</b>	No visible damage, good paint condition and panel fitment	
<b>Doors / Canopy Latches</b>	3 - Normal Wear & Tear	
<b>Doors / Canopy Latches Condition</b>	No visible damage	
<b>Steps / Ladders</b>	3 - Normal Wear & Tear	
<b>Steps / Ladders Condition</b>	Steps/ladders are fully intact and appear structurally sound	
<b>Handrails</b>	3 - Normal Wear & Tear	
<b>Handrails Condition</b>	Handrails are fully intact and appear structurally sound	
<b>Glass</b>	3 - Normal Wear & Tear	
<b>Glass Condition</b>	Glass intact, no visible damage	
<b>Mirrors</b>	3 - Normal Wear & Tear	
<b>Mirror Condition</b>	Mirrors present and intact, no visible damage	
<b>Exterior Lights</b>	3 - Normal Wear & Tear	
<b>Exterior Lights Condition</b>	No visible damage, lighting system is operational

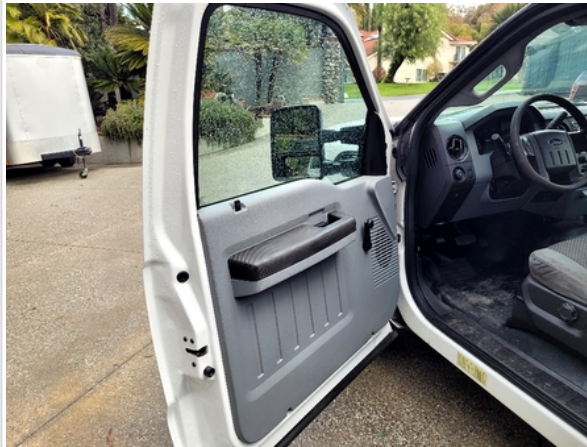
Odometer Activity	3 - Normal Wear & Tear
Odometer Condition	Odometer is working and in good condition
Controls/Switches/Gauges	3 - Normal Wear & Tear
Controls/Switches/Gauges Condition	All switches/gauges are in good condition and functioning
Brake System Type	Hydraulic
Clutch	0
Horn	3 - Normal Wear & Tear
Horn Condition	Horn is functioning as expected
Reverse Alarm / Backup Camera	0
Heater & A/C	3 - Normal Wear & Tear
Heat & A/C Condition	Heater and A/C work as expected
Interior Lights	3 - Normal Wear & Tear
Interior Lights Condition	All interior lights are installed and functioning
Seats/Seat Belts	3 - Normal Wear & Tear
Seats/Seat Belt Condition	Seat(s) in good condition, no stains or tears in upholstery
Cab Interior Overall Rating	3 - Normal Wear & Tear

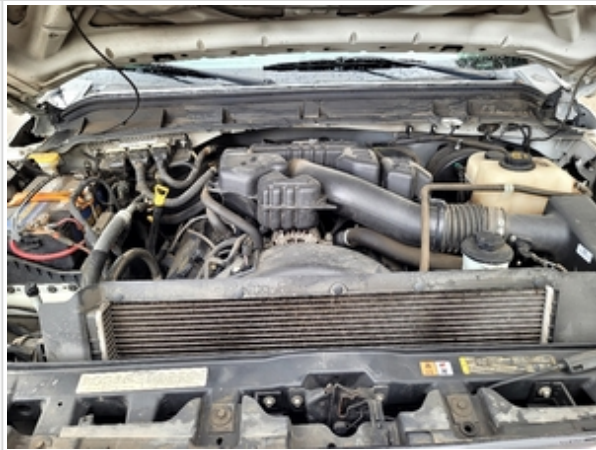
<b>Blow-by (Visual Observation Check)</b>	No
<b>Unusual Noises (Upon Start-up, Idle, Shutdown)</b>	No
<b>Unusual Noise Notes</b>	No unusual noises heard
<b>Engine Smoke (Upon Start-up, Idle, Shutdown)</b>	No
<b>Engine Smoke Notes</b>	No engine smoke issues observed
<b>Engine Exhaust Color</b>	Clear
<b>Battery</b>	3 - Normal Wear & Tear
<b>Battery Condition</b>	Clean & dry appearance, tight connections
<b>Radiator</b>	3 - Normal Wear & Tear
<b>Radiator Condition</b>	Radiator fins & components appear to be in good working order, no signs of damage or leaks
<b>Belts</b>	3 - Normal Wear & Tear
<b>Belt Condition</b>	Belts appear in good condition & alignment with proper tension
<b>Hoses</b>	3 - Normal Wear & Tear
<b>Hose Condition</b>	Firm, pliant hoses with no signs of wear or leaks
<b>Water Pump</b>	3 - Normal Wear & Tear
<b>Water Pump Condition</b>	No unusual pump noises heard
<b>Cooling System Leaks</b>	No

<b>Coolant Color / Appearance</b>	3 - Normal Wear & Tear
<b>Coolant Color/Appearance Notes</b>	Normal Translucent appearance, no visual signs of contamination
<b>Oil Leaks</b>	No
<b>Oil Color / Appearance</b>	3 - Normal Wear & Tear
<b>Oil Color / Appearance Notes</b>	Clean oil appearance, no signs of cross contamination, Appropriate oil level
<b>Fuel Leaks</b>	No

Equipped with DPF (Diesel Particulate Filter)	No
Requires DEF (Diesel Exhaust Fluid)	No
Overall Engine Appearance	Clean & dry
Overall Engine Comments	Overall engine has well maintained appearance and no issues observed during inspection.

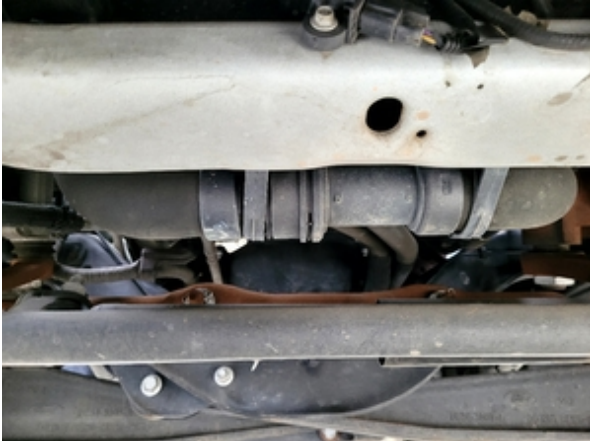
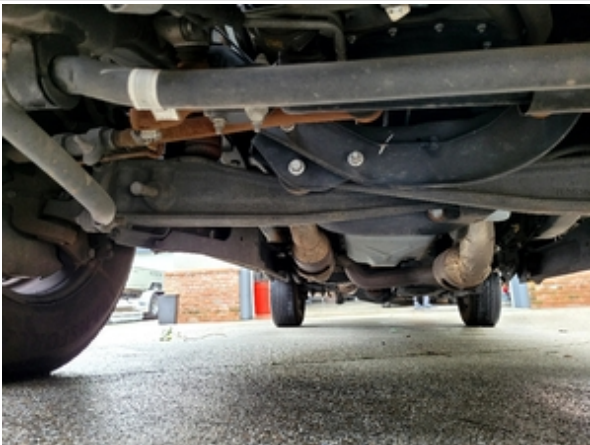
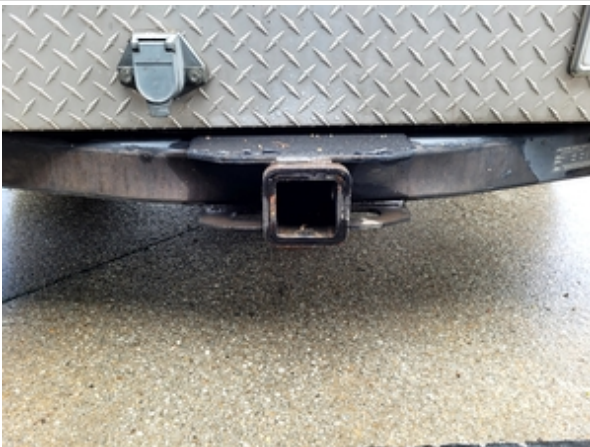
<b>Frame</b>	3 - Normal Wear & Tear	
<b>Suspension</b>	3 - Normal Wear & Tear	
<b>Steer Axle Condition</b>	0	
<b>Steering Components</b>	3 - Normal Wear & Tear	
<b>Overall Chassis Condition</b>	3 - Normal Wear & Tear	
<b>Overall Chassis Comments</b>	Overall Chassis in good shape. Suspension and rear axle have no signs of issues. Frame solid and steering components working well.

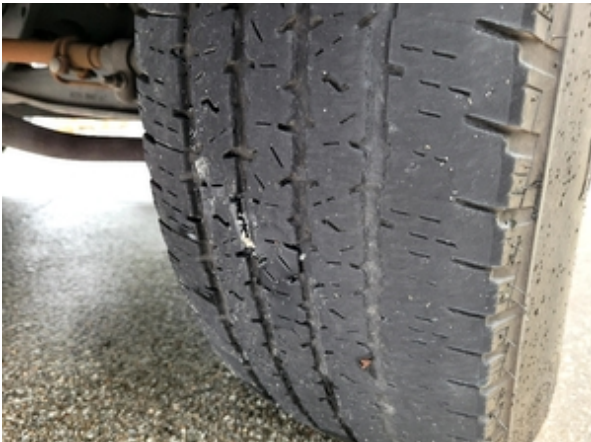
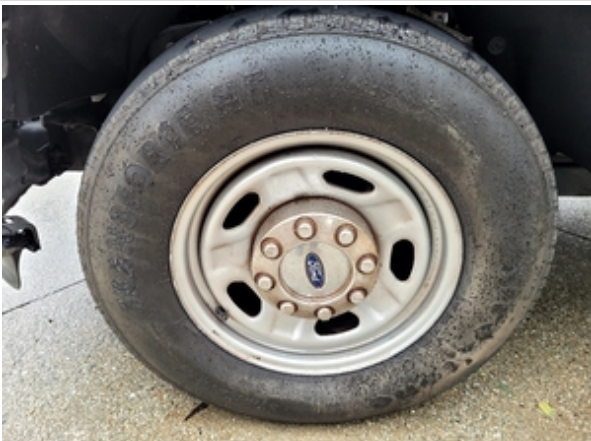
<b>Wheel Seal Leaks</b>	No
<b>Tire Brand</b>	Firestone
<b>Tire Size</b>	LT245/75R/17
<b>Front Left Tire - Ratio Remaining</b>	30%
<b>Front Left Tire Photos</b>

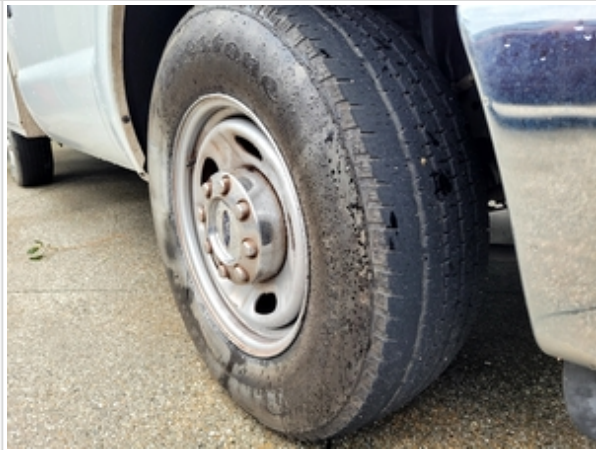
<b>Front Right Tire - Ratio Remaining</b>	30%

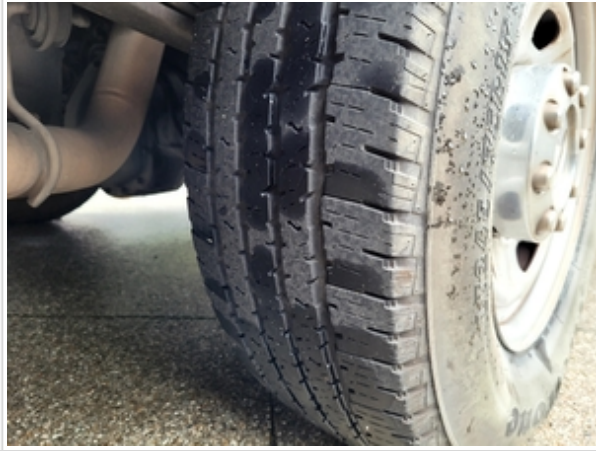
<b>Rear Right Tire - Ratio Remaining</b>	30%
<b>Rear Right Tire Photos</b>

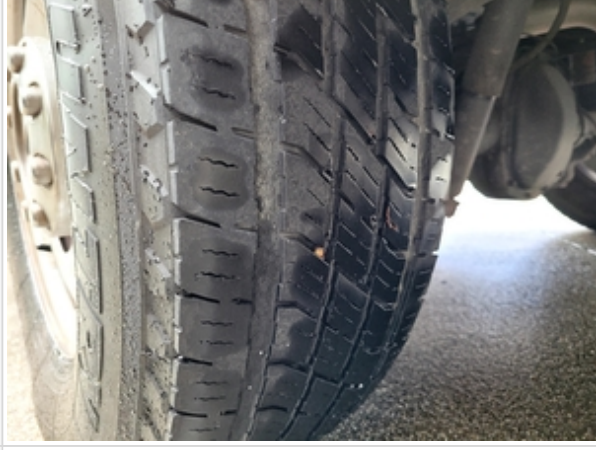
<b>Rear Left Tire - Ratio Remaining</b>	30%
<b>Rear Left Tire Photos</b>

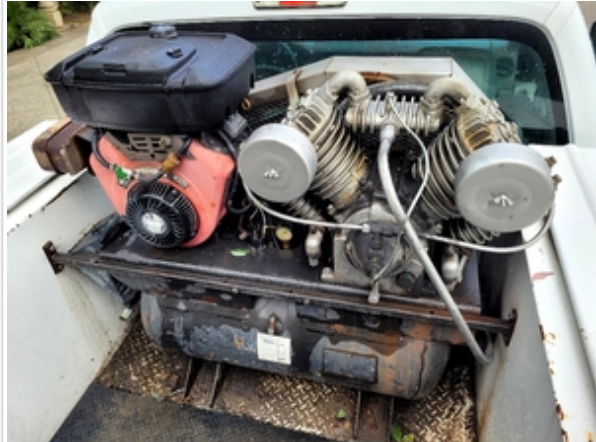
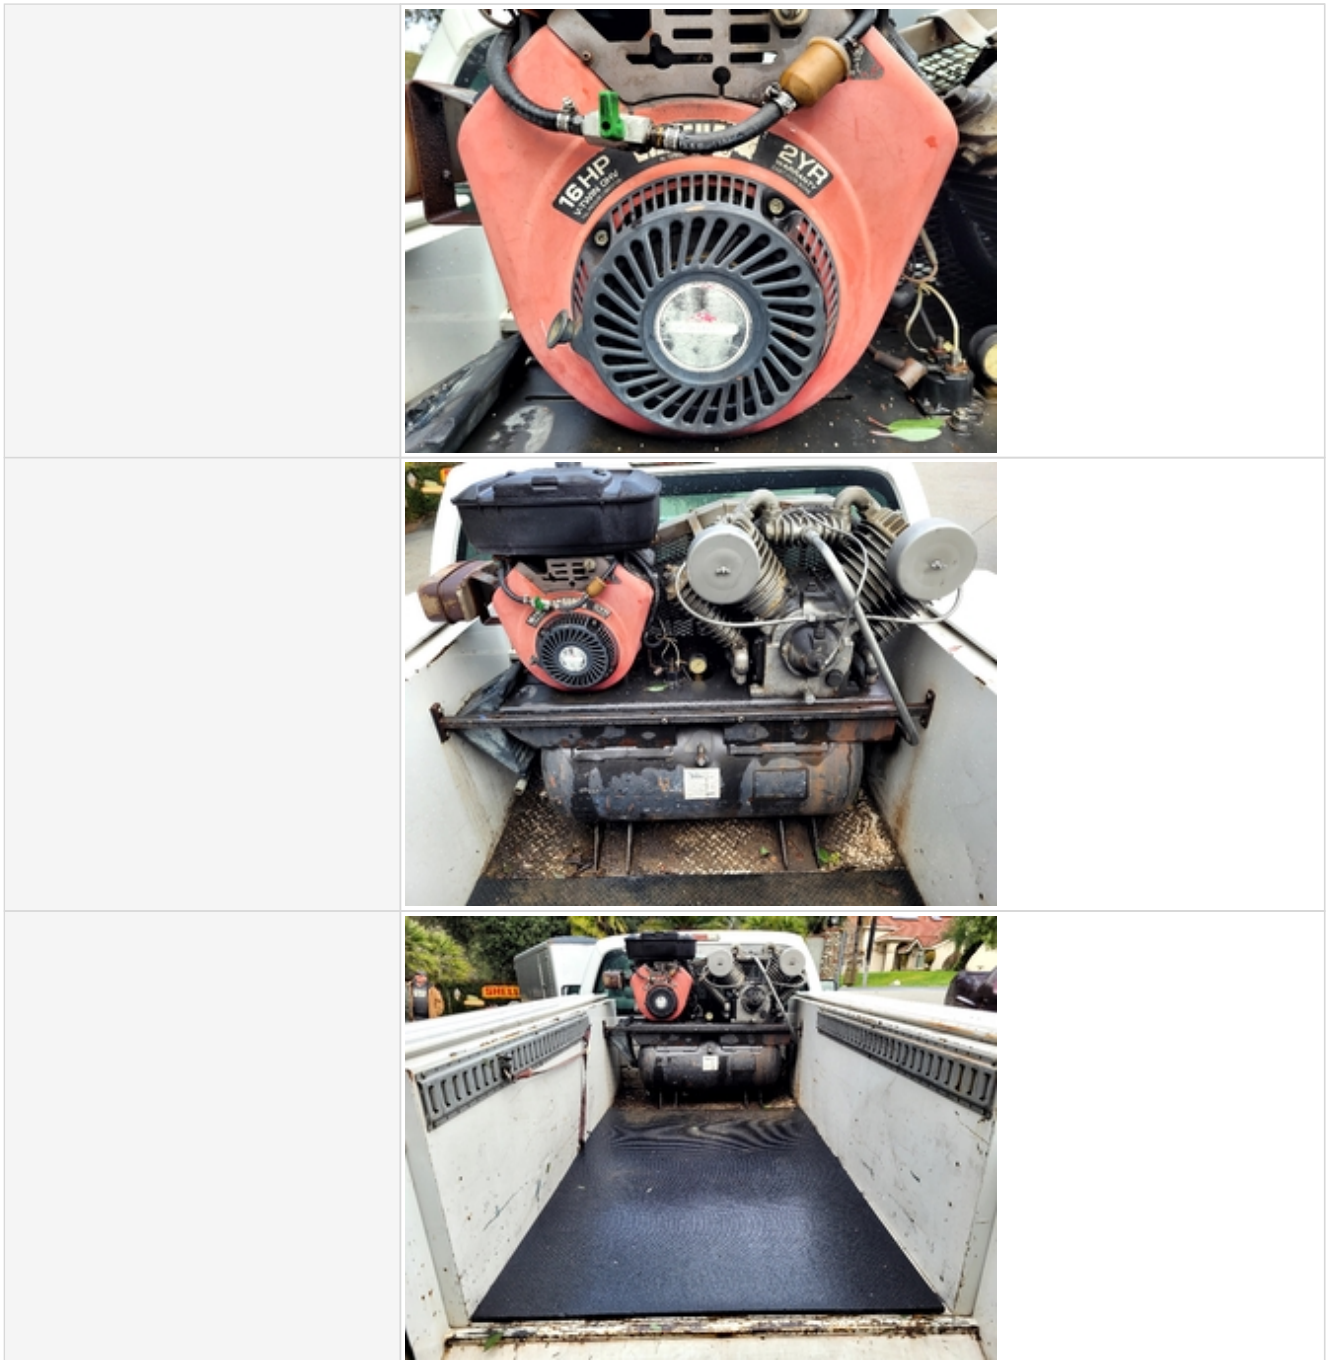
Air Compressor Condition	3 - Normal Wear & Tear
Air Compressor Functionality	Partial or abnormal function
Comments	Engine Choke needs minor linkage repair
Air Compressor Photos
