Inspection Report (Skid Steer)

Year	2015
Make	Bobcat
Model	S530
Serial Number	ALR813107
Hour Meter Reading	2,660 Hours
Previous Application (e.g., earth moving, mining, demolition, etc)	Rental Equipment

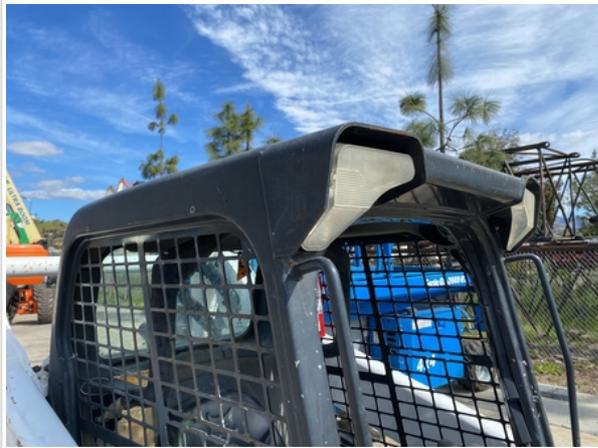
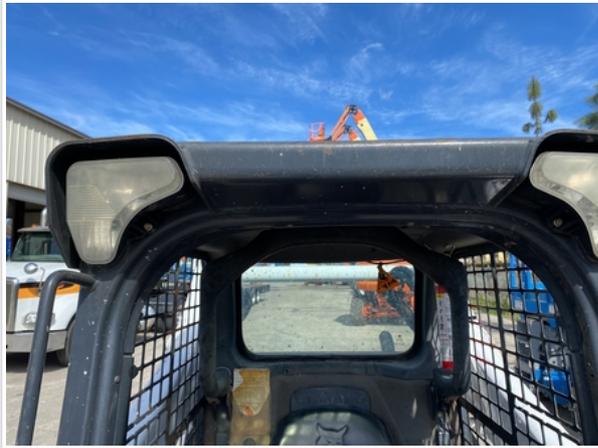
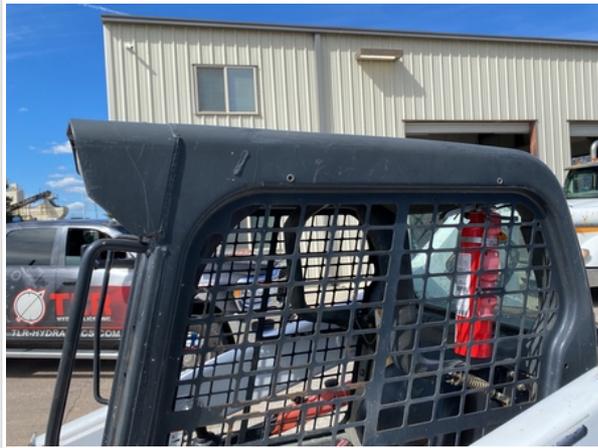
Body Panels	3 - Normal Wear & Tear
Body Panel Condition	No visible damage, good paint condition and panel fitment, Other (see comments), Areas of rust corrosion or rust cancer observed
Comments	Minor surface runs observed at front, below cab, on frame area
Doors / Canopy Latches	3 - Normal Wear & Tear
Doors / Canopy Latches Condition	No visible damage
Steps / Ladders	3 - Normal Wear & Tear
Steps / Ladders Condition	Bent or broken steps or rungs, Other (see comments)

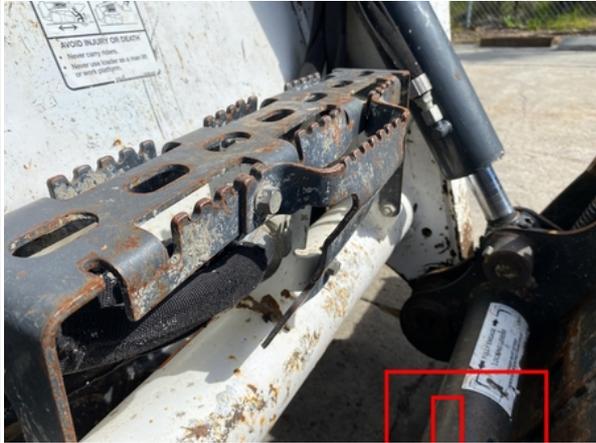
Comments	Front step slightly bent
Steps / Ladders Photos

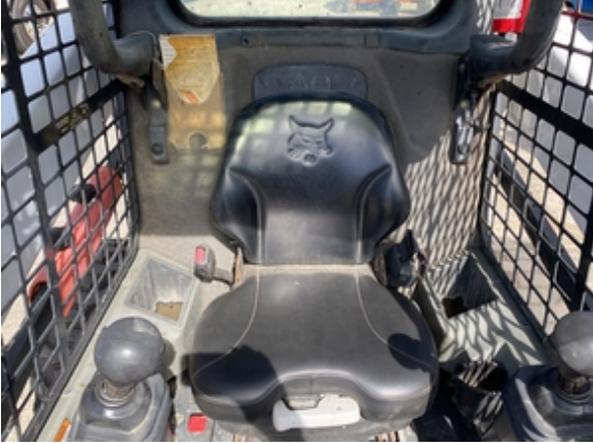
Operator Seat Photos

Operator Cabin Overall	3 - Normal Wear & Tear
Operator Cabin Overall Condition	Minor cosmetic wear to cabin surfaces, floors, panels, and ceiling
Comments	Normal wear and tear. Seat in good shape.
Operator Seat	3 - Normal Wear & Tear
Operator Seat Condition	Seat(s) in good condition, no stains or tears in upholstery

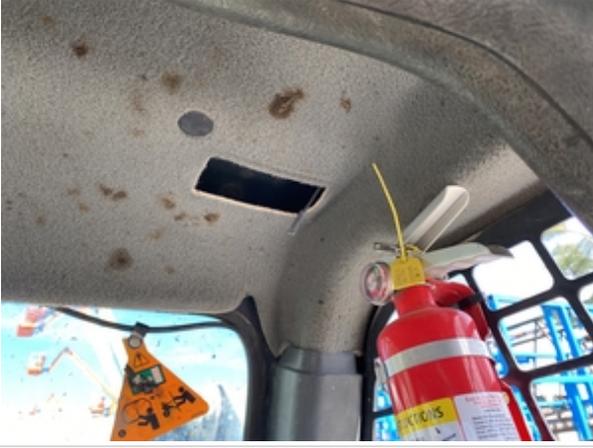
Cabin Lights	1 - Service Required
Cabin Lights Condition	Cabin light system is not operational, Other (see comments)
Comments	Missing
Cabin Lights Photos

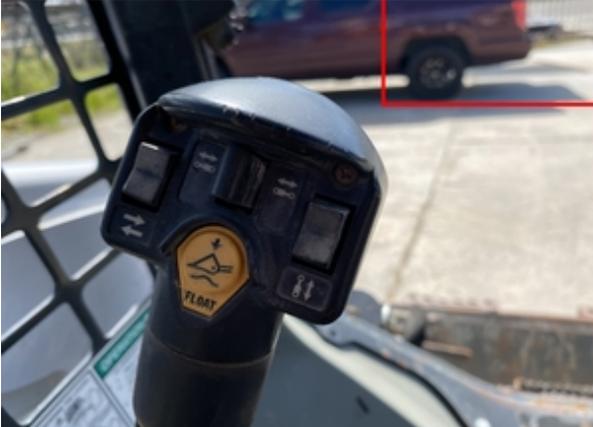
Safety Lock Out / Stop	3 - Normal Wear & Tear
Safety Lock Out / Stop Condition	Safety lock out device is present, in good condition, and functional
Controls & Switches	3 - Normal Wear & Tear
Controls & Switches Condition	All switches are installed and functional
Controls & Switches Photos

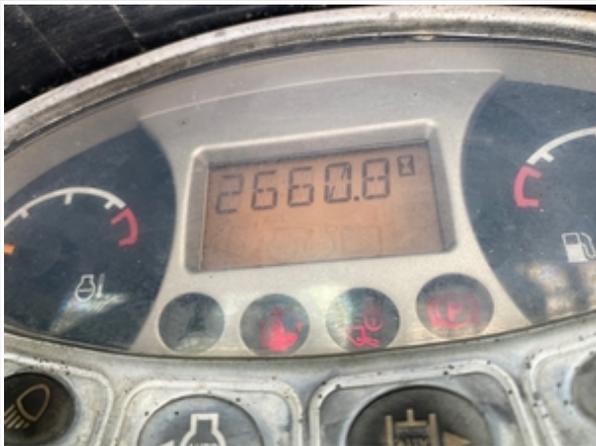
Hour Meter Activity	3 - Normal Wear & Tear
Hour Meter Condition	Hour meter is functional and in good condition
Hour Meter Activity Photos

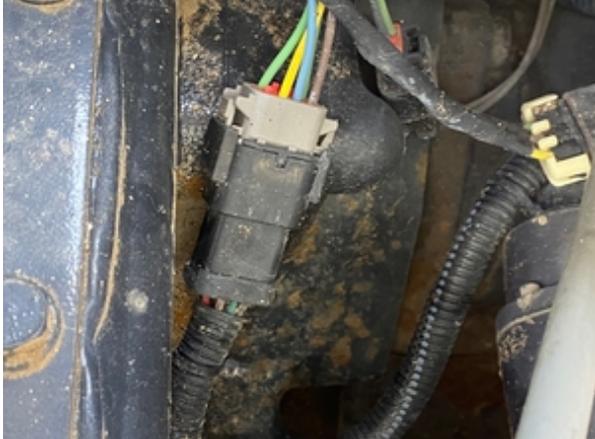
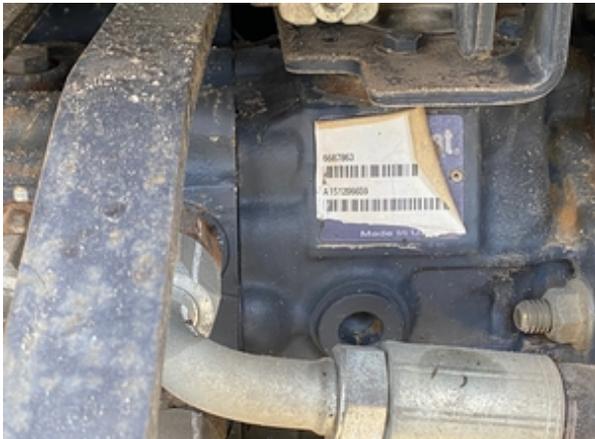
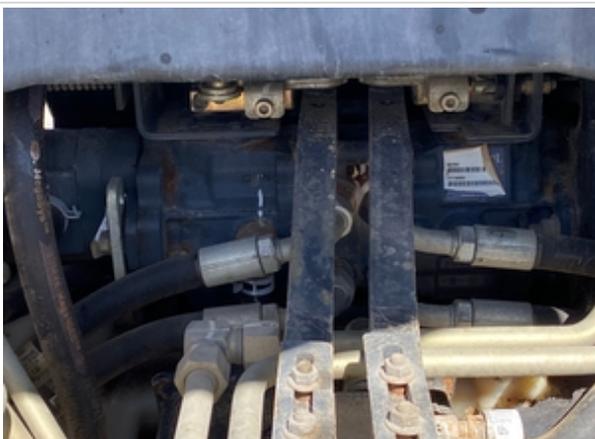
Hydrostatic Transmission?	Yes
2 Speed?	No
Hydrostatic Drive Configuration	Split Transmission
Drive Motors	2 - Above Average Wear
Hydrostatic Parking Brake	3 - Normal Wear & Tear
Hydrostatic Parking Brake Condition	Good brake function
Overall Drivetrain Comments	Machine travels well in all directions and parking brake works normally.

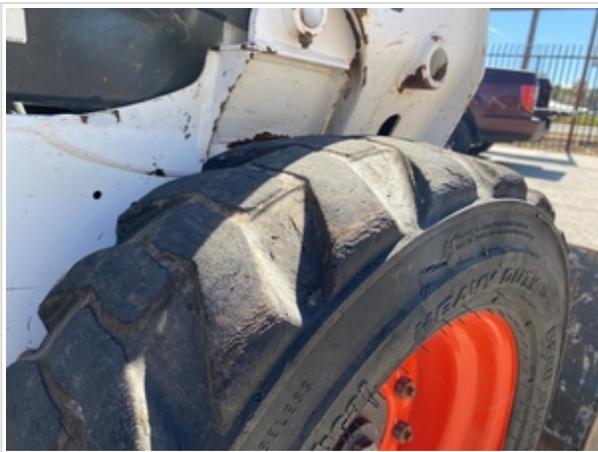
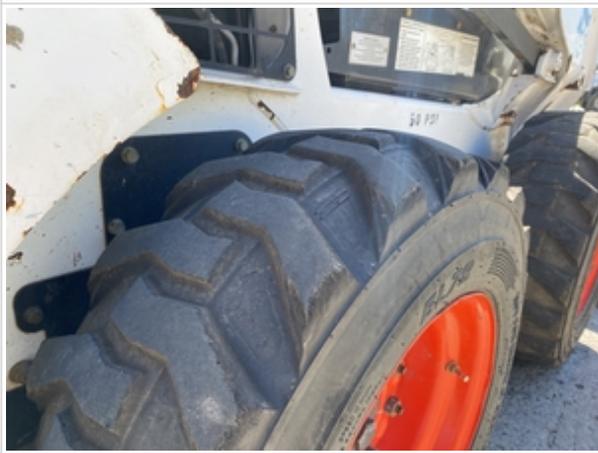
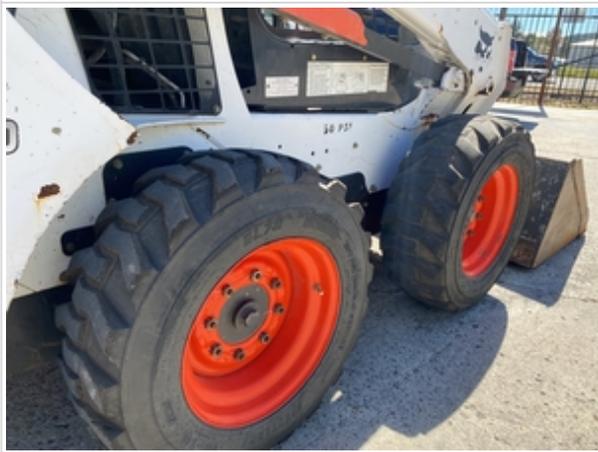
Wheels & Tires Photos

Wheels & Tires	2 - Above Average Wear
Comments	Most tires worn down to 10%

Tire Brand	Bobcat
Tire Size	10-16.5
Front Left Tire - Ratio Remaining	10%
Rear Left Tire - Ratio Remaining	10%
Front Right Tire - Ratio Remaining	10%
Rear Right Tire - Ratio Remaining	50%
Lift Arm	3 - Normal Wear & Tear

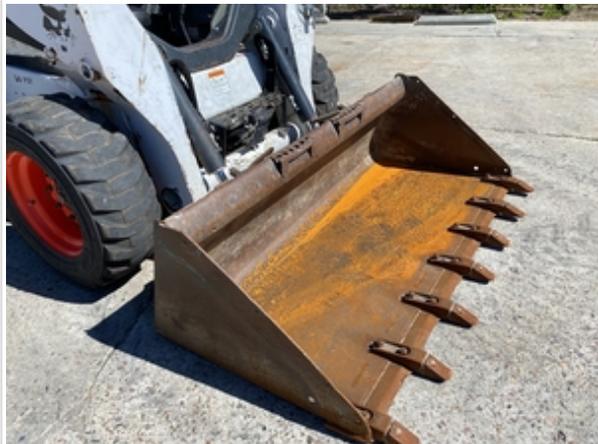
Bucket Condition	3 - Normal Wear & Tear
Comments	Normal wear & minor damage seen at bucket edges. Teeth getting low and will need to be replaced soon.
Bucket Photos
