Inspection Report (Scissor Lift)

Year	2012
Make	Genie
Model	GS-2669
Serial Number	GS6912-994
Hour Meter Reading	1,981Hrs.
Previous Application (e.g., earth moving, mining, demolition, etc)	Equipment Rental

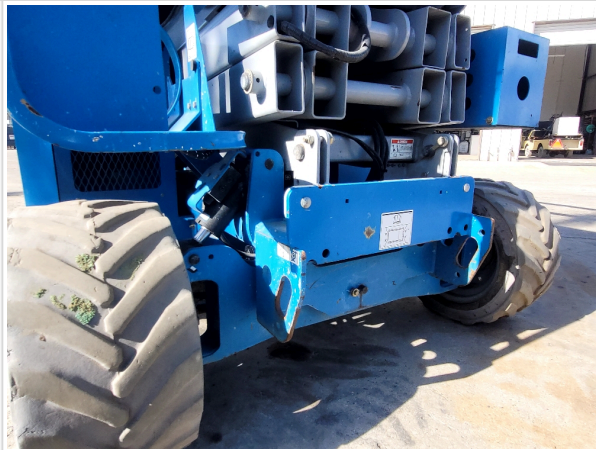
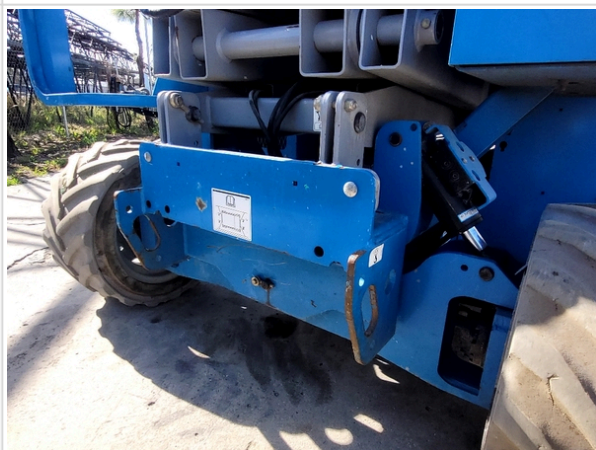
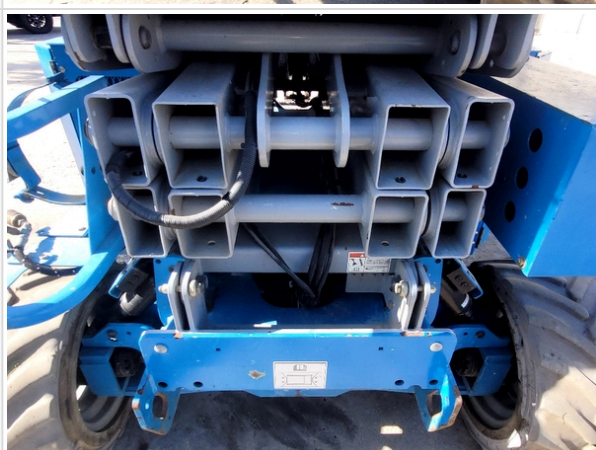
Front Photos

Front	3 - Normal Wear & Tear
-------	------------------------

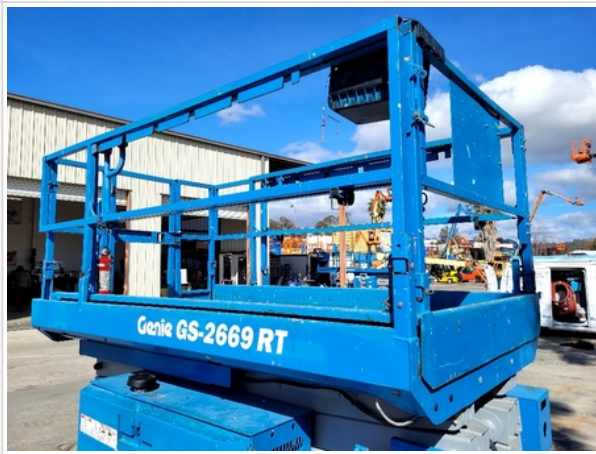
Upper	3 - Normal Wear & Tear	
Upper Photos

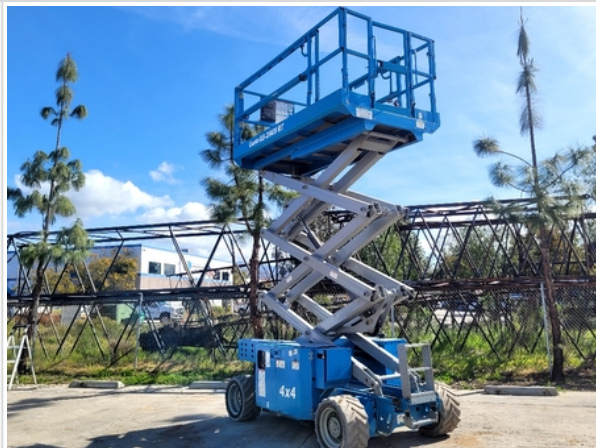
Body Panels (Any Damage?)	3 - Normal Wear & Tear	
Scissor Linkage	3 - Normal Wear & Tear	
Scissor Linkage Photos

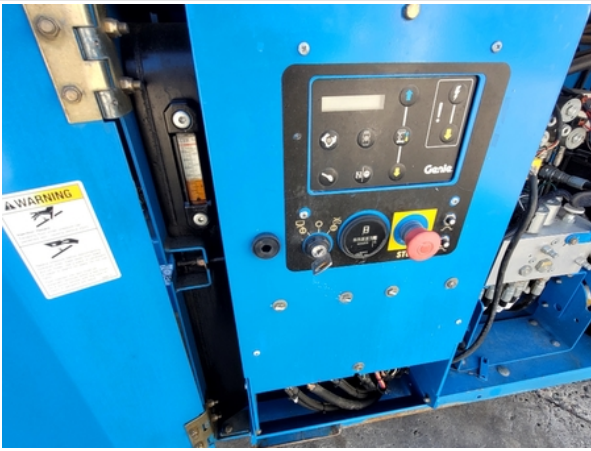
Hour Meter Activity	3 - Normal Wear & Tear
Other Gauge Activity	3 - Normal Wear & Tear
Controls & Switches	3 - Normal Wear & Tear
Controls & Switches Photos

Horn	3 - Normal Wear & Tear
Travel Alarm	2 - Above Average Wear
Comments	Travel alarm weak and should be replaced
Safety Lock Out / Stop	3 - Normal Wear & Tear
Platform Safety Rails & Appearance	3 - Normal Wear & Tear

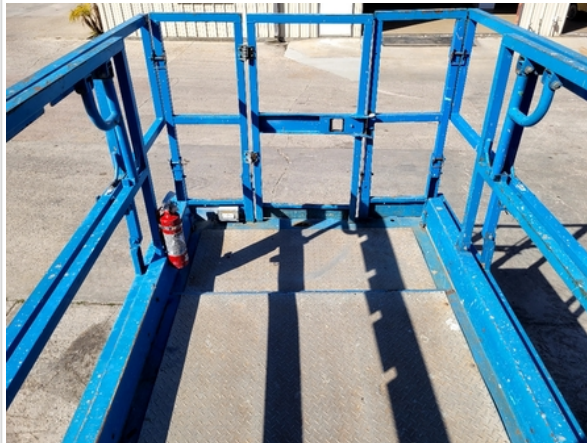
Platform Floor Photos

3 - Normal Wear & Tear

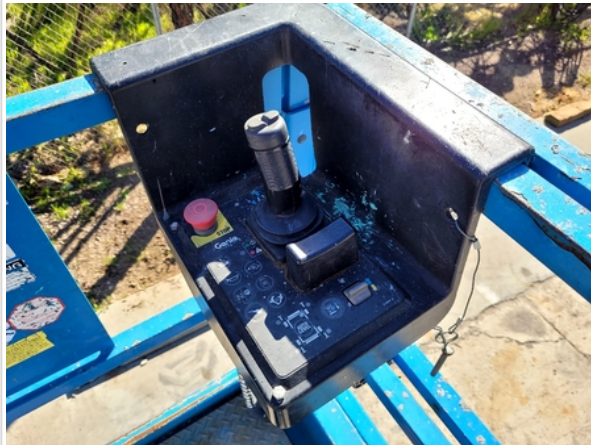
Platform Controls Photos

3 - Normal Wear & Tear

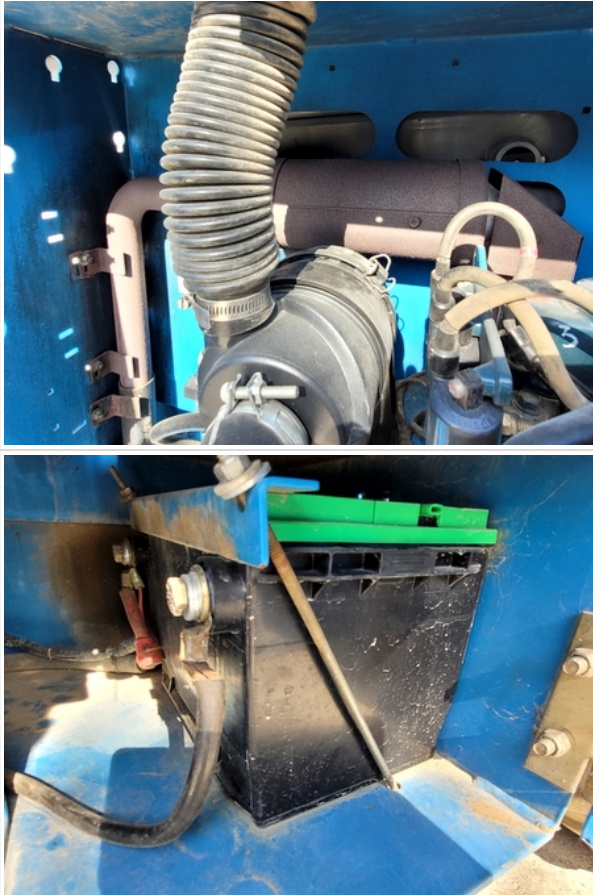
Engine Type (Make, Model, Cylinders, Hp)	Kubota - 3Cyl. - 58.7 CU.IN. - 32HP
Emissions Tier	Tier 4F
Engine Serial Number	N/A
Engine Fuel Type	Dual-Fuel (Gas, LPG)
Engine Photos

Blow-by (Visual Observation Check)	No
Unusual Noises (Upon Start-up, Idle, Shutdown)	No
Unusual Noise Notes	No unusual noises heard
Engine Smoke (Upon Start-up, Idle, Shutdown)	No
Engine Smoke Notes	No engine smoke issues observed
Engine Exhaust Color	Clear
Battery	3 - Normal Wear & Tear
Battery Condition	Clean & dry appearance, tight connections
Radiator	3 - Normal Wear & Tear
Radiator Condition	Radiator fins & components appear to be in good working order, no signs of damage or leaks
Belts	3 - Normal Wear & Tear
Belt Condition	Belts appear in good condition & alignment with proper tension
Hoses	3 - Normal Wear & Tear
Hose Condition	Firm, pliant hoses with no signs of wear or leaks

Water Pump	3 - Normal Wear & Tear
Water Pump Condition	No unusual pump noises heard
Cooling System Leaks	No
Coolant Color / Appearance	3 - Normal Wear & Tear
Coolant Color/Appearance Notes	Normal Translucent appearance, no visual signs of contamination
Oil Leaks	No
Oil Color / Appearance	3 - Normal Wear & Tear
Oil Color / Appearance Notes	Clean oil appearance, no signs of cross contamination, Appropriate oil level
Fuel Leaks	No
Requires DEF (Diesel Exhaust Fluid)	No
Overall Engine Appearance	Clean & dry
Overall Engine Comments	Engine has well maintained appearance & operating well under load.

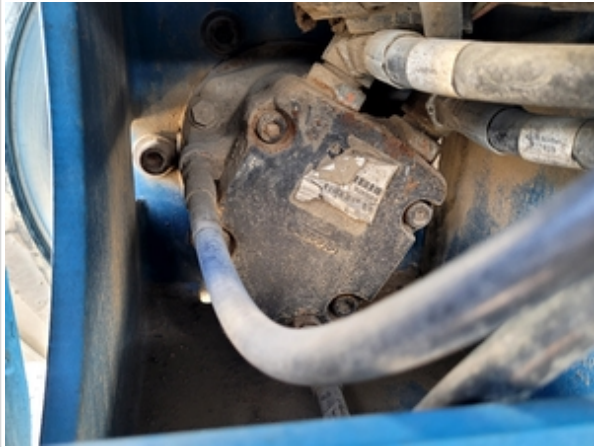
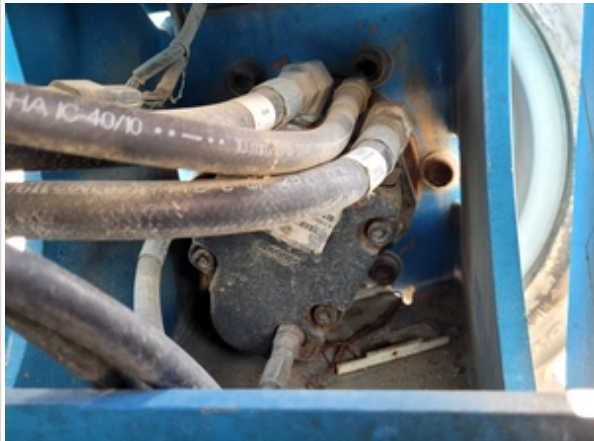
Drivetrain	Take close-up photos of the drivetrain components including transmission housing, drive shaft, drive motors, fittings, and hoses. Note any damage or wear.	
Drivetrain Photos

Hydrostatic Transmission?	Yes
2 Speed?	N/A
Hydrostatic Drive Configuration	Split Transmission
Drive Motors	4 - Like New, Recently Replaced
Hydrostatic Parking Brake	3 - Normal Wear & Tear
Hydrostatic Parking Brake Condition	Good brake function
Overall Drivetrain Comments	Drivetrain In good condition and no operating issues observed during inspection.

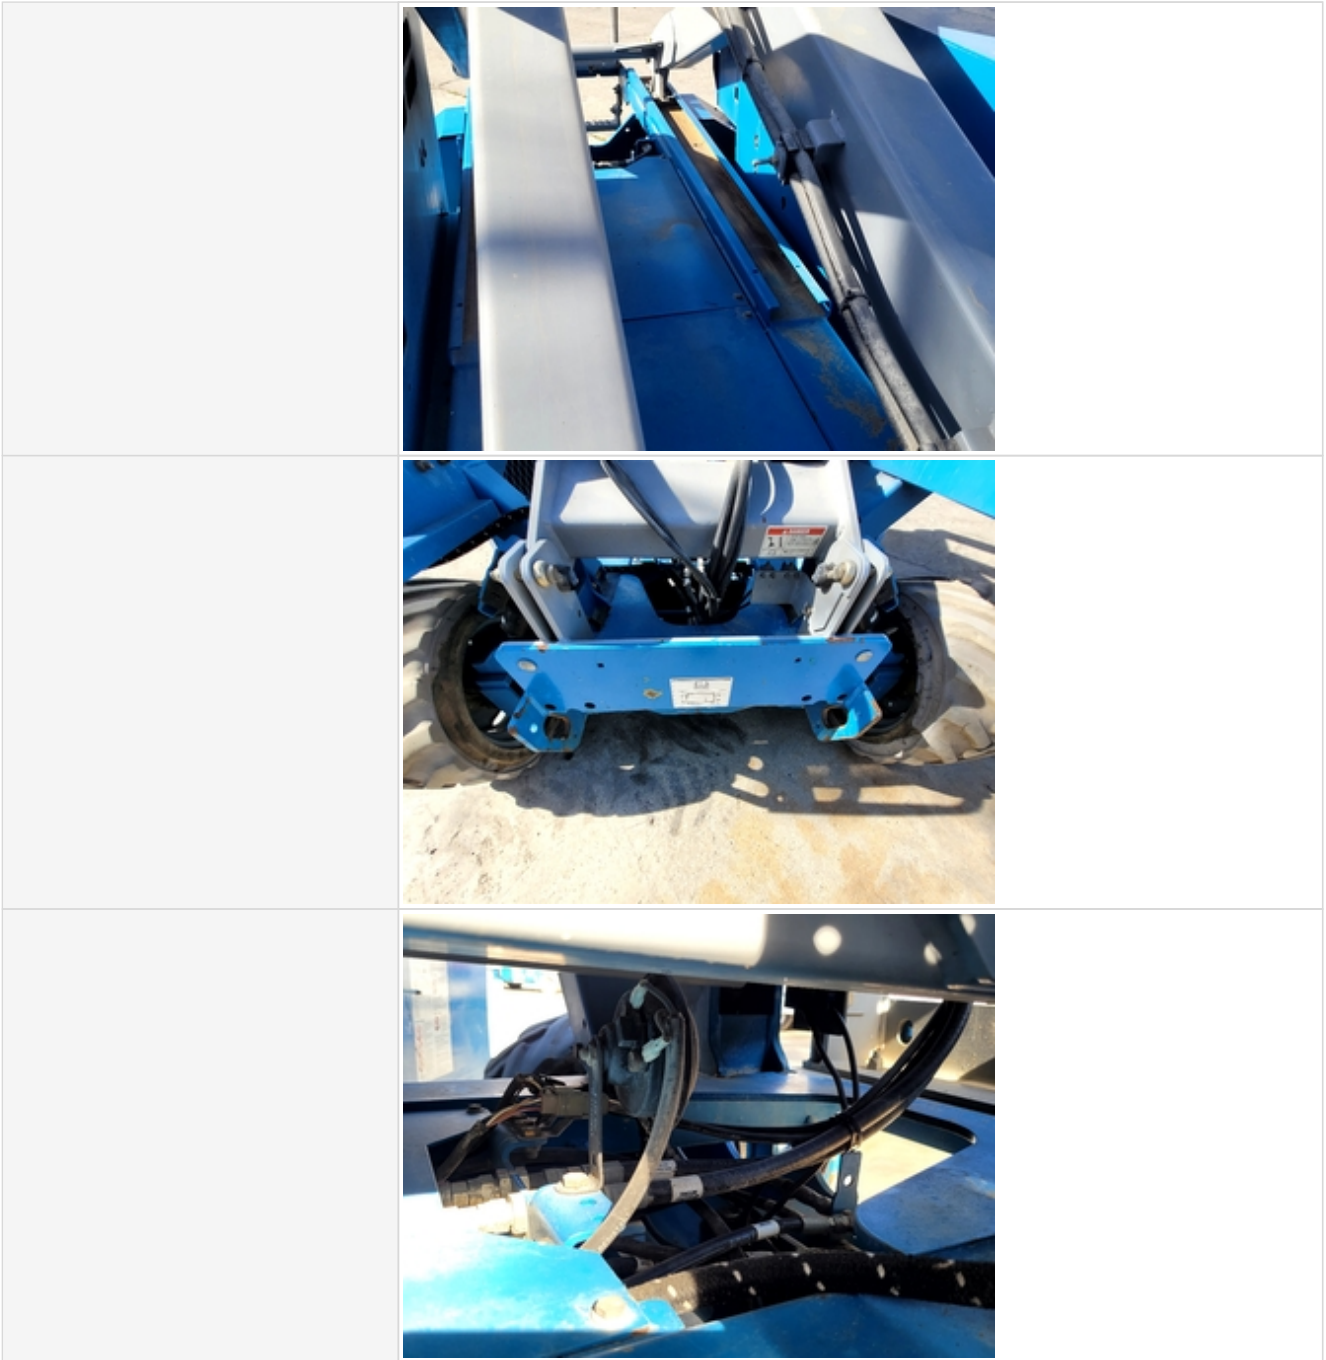
Frame	3 - Normal Wear & Tear
Frame Photos

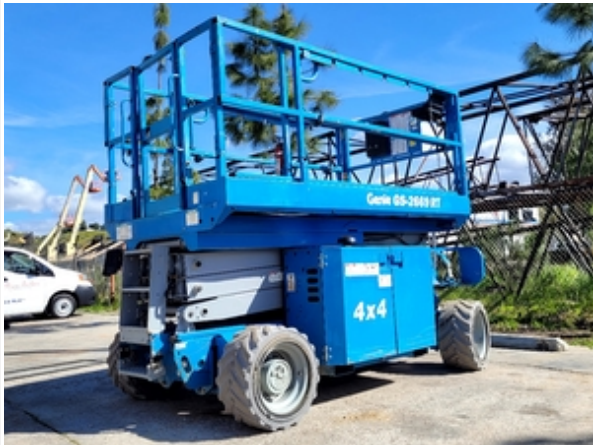
Stance	3 - Normal Wear & Tear
Stance Photos

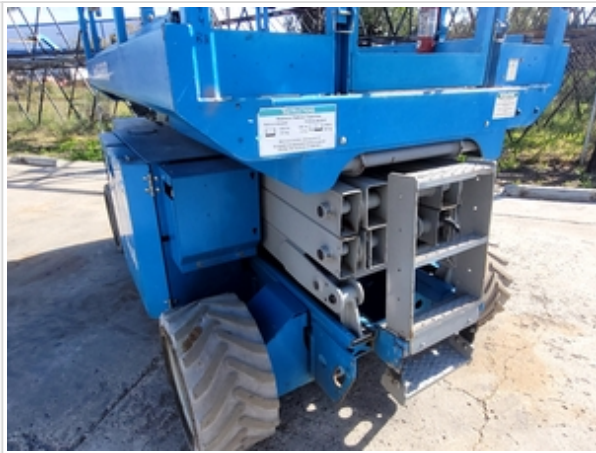
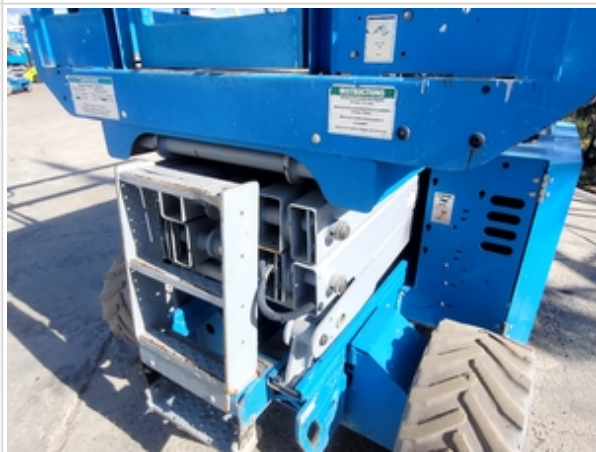
Rear Axle Appearance Photos

Rear Axle Appearance	3 - Normal Wear & Tear

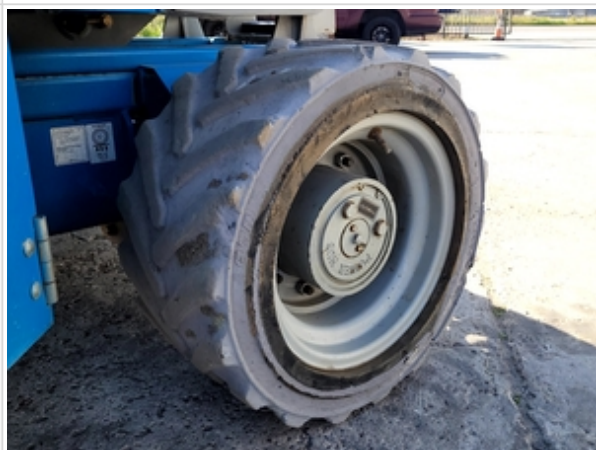
Wheels & Tires	3 - Normal Wear & Tear
Comments	Tires are foam filled
Wheels & Tires Photos

Tire Brand	OTR Outrigger	
Tire Size	26x12x380	
Front Left Tire - Ratio Remaining	30%	
Rear Left Tire - Ratio Remaining	30%	
Front Right Tire - Ratio Remaining	30%	
Rear Right Tire - Ratio Remaining	30%	
Overall Chassis	3 - Normal Wear & Tear

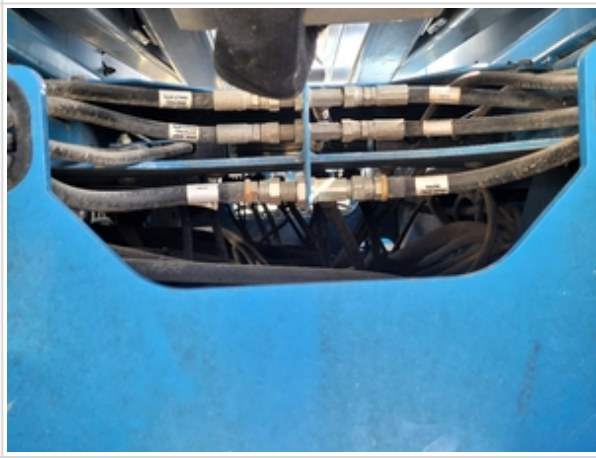
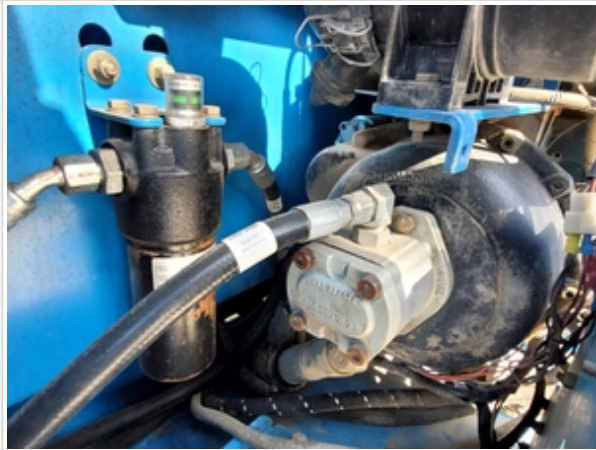
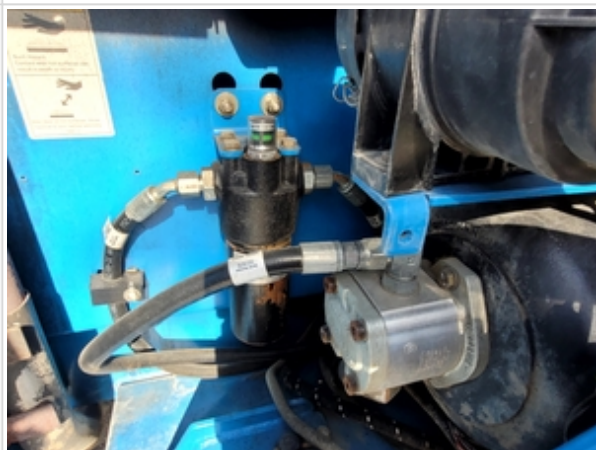
Hydraulic System Photos

Wet or Damp Hydraulic Lines / Fittings	No
Appearance of Hydraulic Lines / Fittings	3 - Normal Wear & Tear
Hydraulic Lines / Fittings Condition	Hydraulic lines & fittings are clean and in good condition
Unusual Noises (Hydraulic Pump)	No
Hydraulic Pump Notes	No unusual noises heard during operation

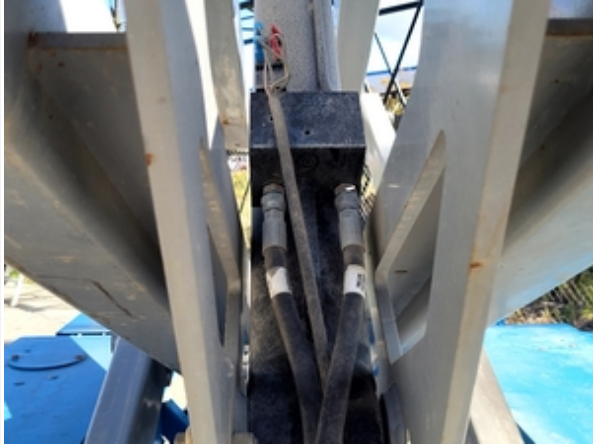
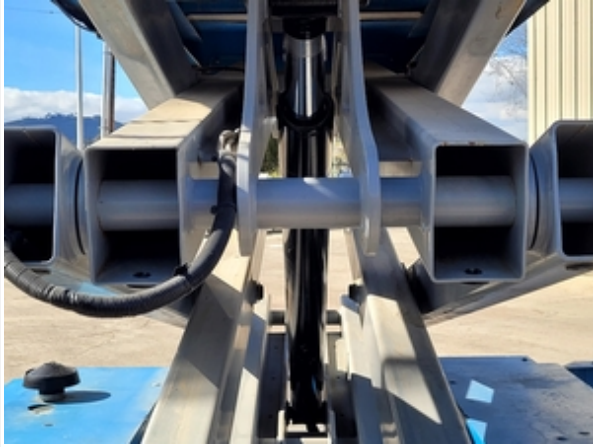
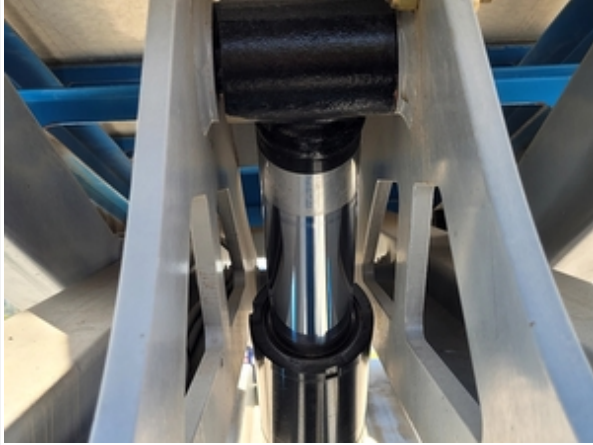
Lift Cylinders	Check the lift cylinders. Note any wear, pitting, discoloration, etc. Take photos.
Lift Cylinders: Mounting Pin	3
Lift Cylinders: Oil Leaks	No
Lift Cylinders Photos

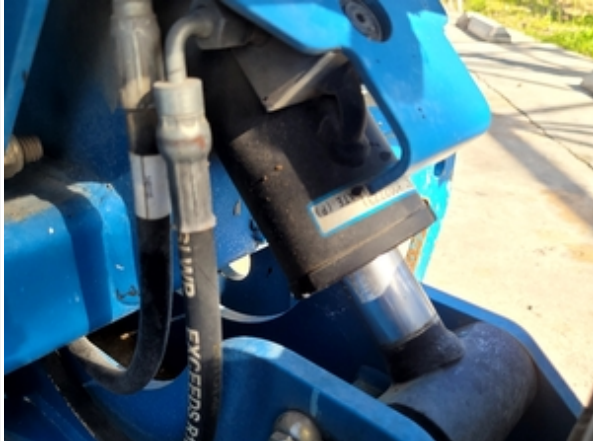
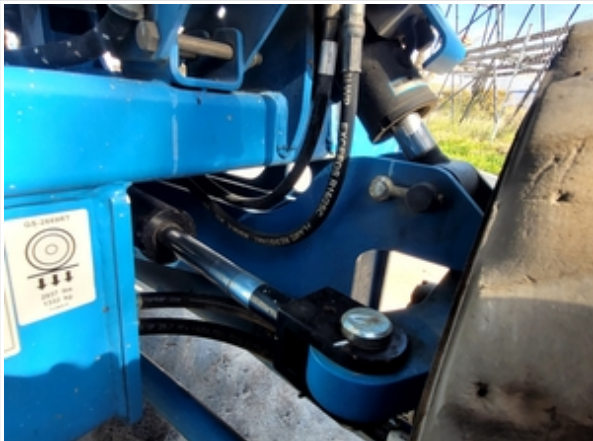
Frame Leveling Cylinders Photos

Frame Leveling Cylinders	Check the frame leveling cylinders. Note any wear, pitting, discoloration, etc. Take photos.
Frame Leveling Cylinders: Mounting Pin	3
Frame Leveling Cylinders: Oil Leaks	No

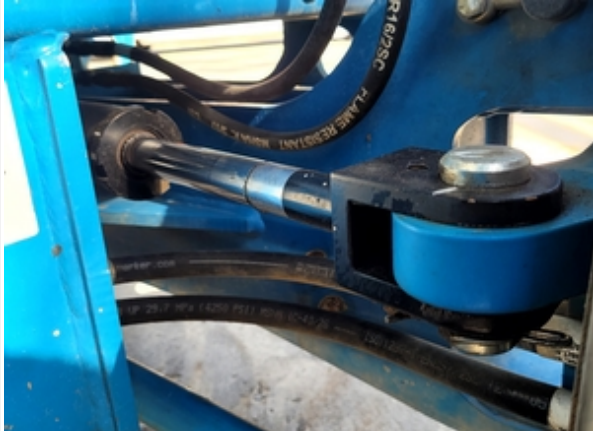
Outrigger Cylinders	Check the outrigger cylinders. Note any wear, pitting, discoloration, etc. Take photos.
Steering Cylinders	Check the steering cylinders. Note any wear, pitting, discoloration, etc. Take photos.
Steering Cylinders: Mounting Pin	3
Steering Cylinders: Oil Leaks	No
Steering Cylinders Photos
