Inspection Report (Scissor Lift)

Year	2012
Make	Genie
Model	GS-2669
Serial Number	GS6912-793
Hour Meter Reading	1,796 Hrs.
Previous Application (e.g., earth moving, mining, demolition, etc)	Equipment Rental

Max Lift Height	26'
Max Lift Capacity	1,500Lbs.
Electric Powertrain	No
Hydraulic Leveling	Yes
Power to Platform	Yes
Deck Extensions	Yes
Deck Extension Measurements	N/A
Outriggers	No
Additional Attachment(s)?	No
OMM (Operator & Maintenance Manual)	Yes

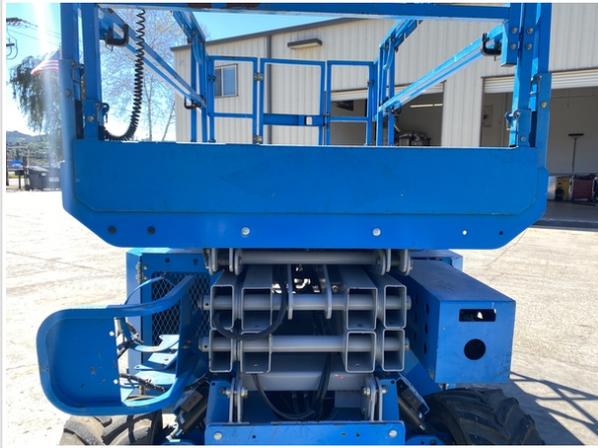
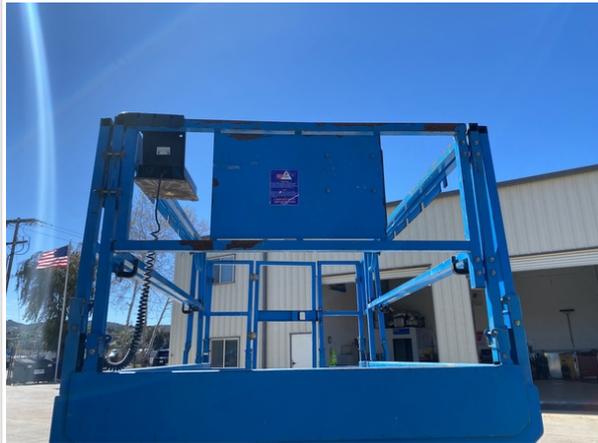
<p>Rear</p>	<p>3 - Normal Wear & Tear</p>
<p>Rear Photos</p>

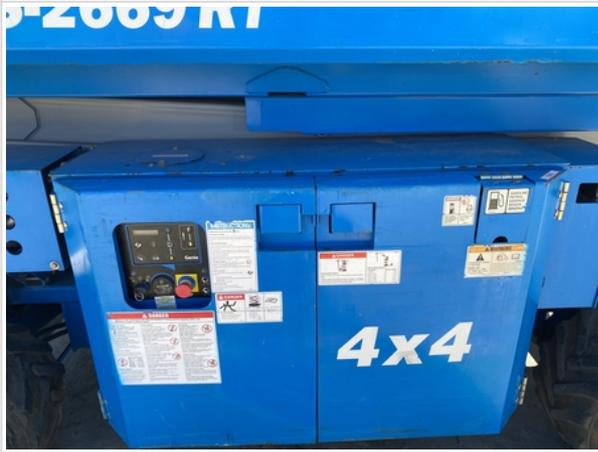
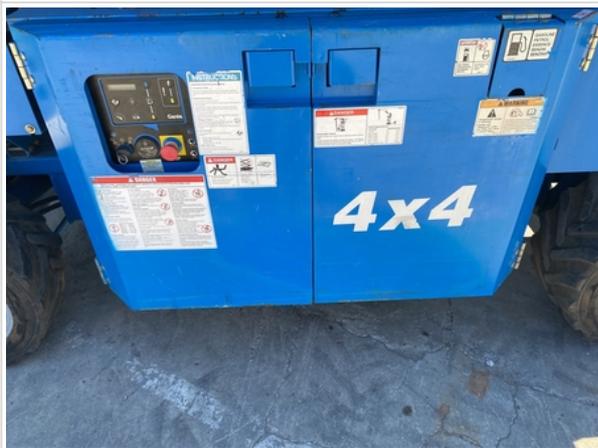
<p>Left</p>	<p>3 - Normal Wear & Tear</p>	
<p>Left Photos</p>

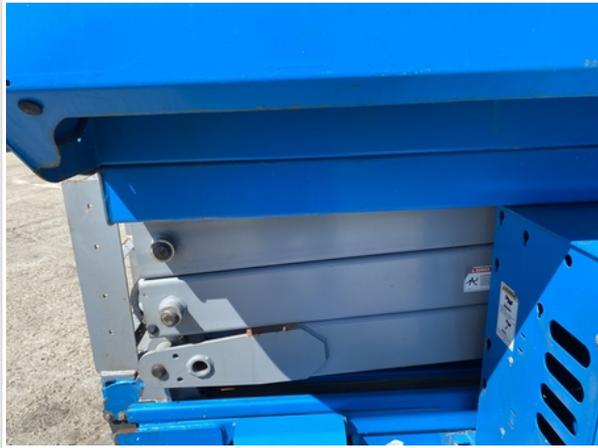
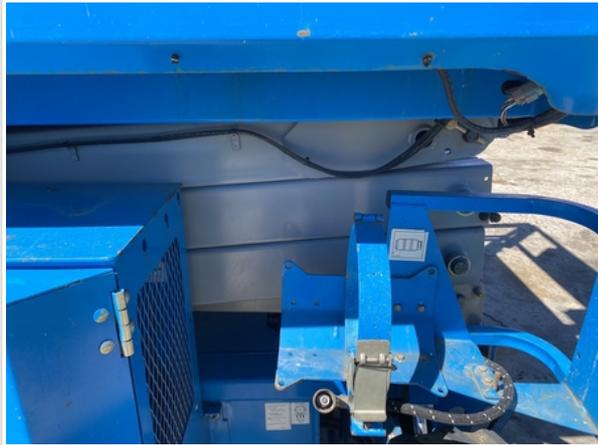
<p>Right</p>	<p>3 - Normal Wear & Tear</p>	
<p>Right Photos</p>

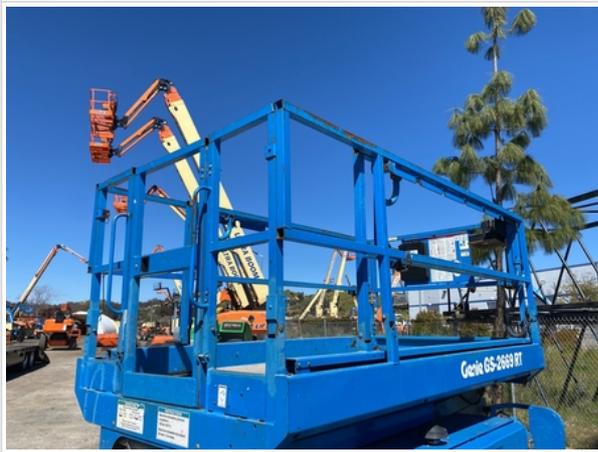
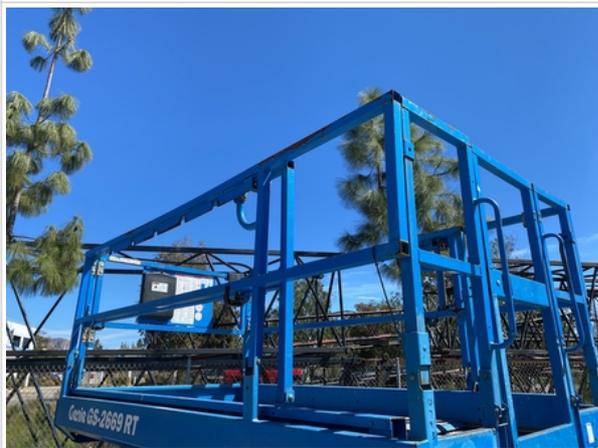
Upper	3 - Normal Wear & Tear
Upper Photos

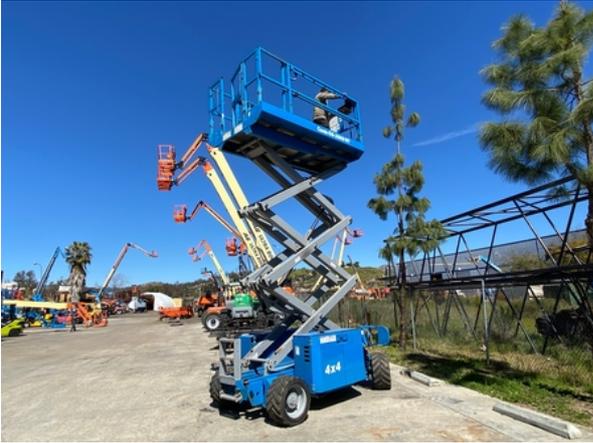
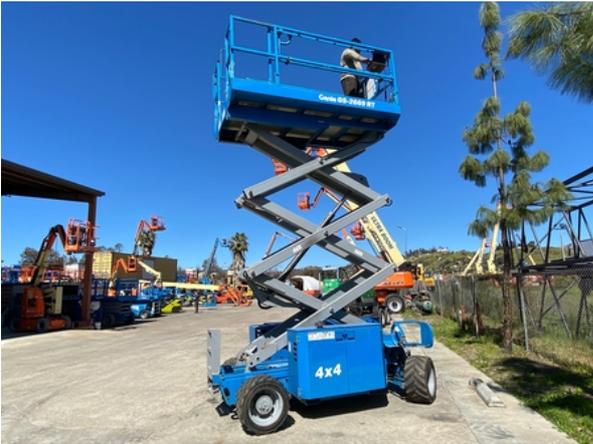
Body Panels (Any Damage?)	3 - Normal Wear & Tear	
Scissor Linkage	3 - Normal Wear & Tear	
Scissor Linkage Photos

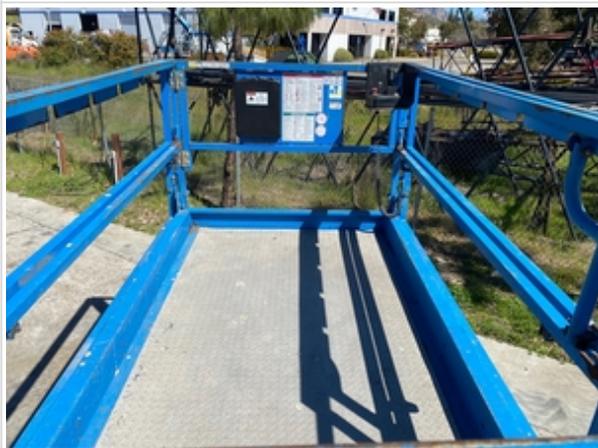
<p>Hand Rails</p>	<p>3 - Normal Wear & Tear</p>
<p>Hand Rails Photos</p>

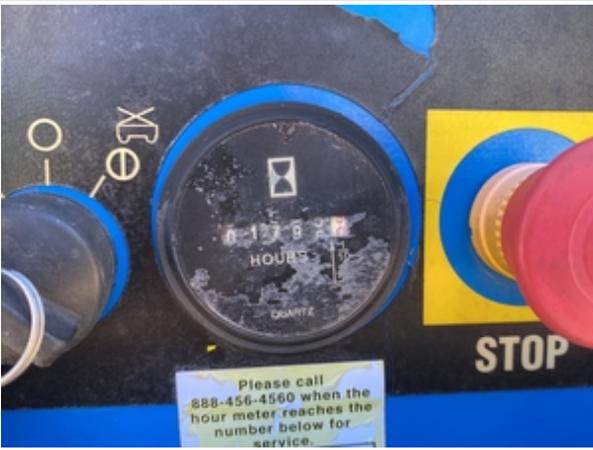
Hour Meter Activity	3 - Normal Wear & Tear
Hour Meter Activity Photos

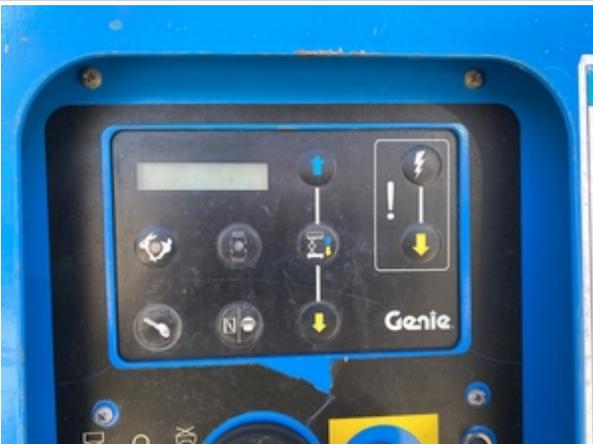
Other Gauge Activity	3 - Normal Wear & Tear
Controls & Switches	3 - Normal Wear & Tear
Controls & Switches Photos

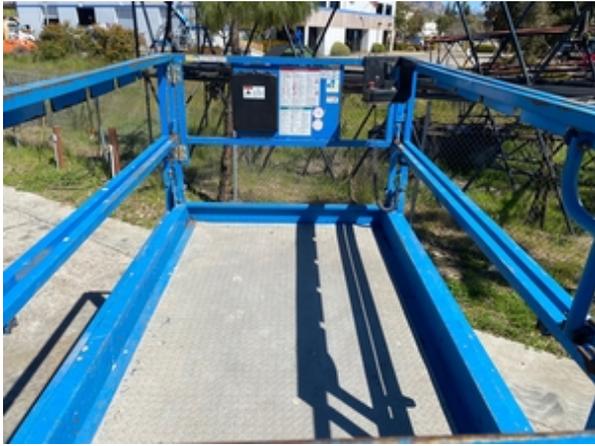
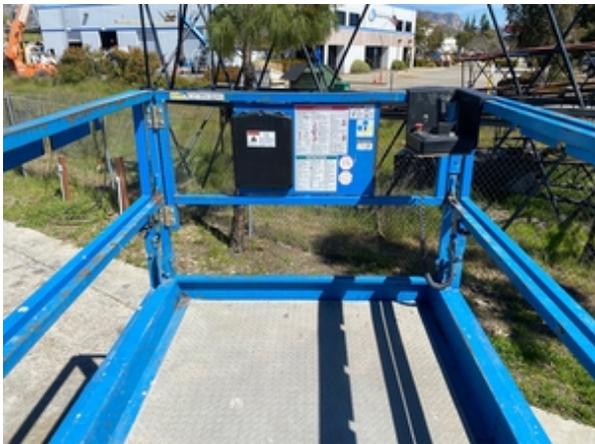
Horn	3 - Normal Wear & Tear
Travel Alarm	3 - Normal Wear & Tear
Safety Lock Out / Stop	3 - Normal Wear & Tear
Platform Safety Rails & Appearance	3 - Normal Wear & Tear
Platform Safety Rails & Appearance Photos

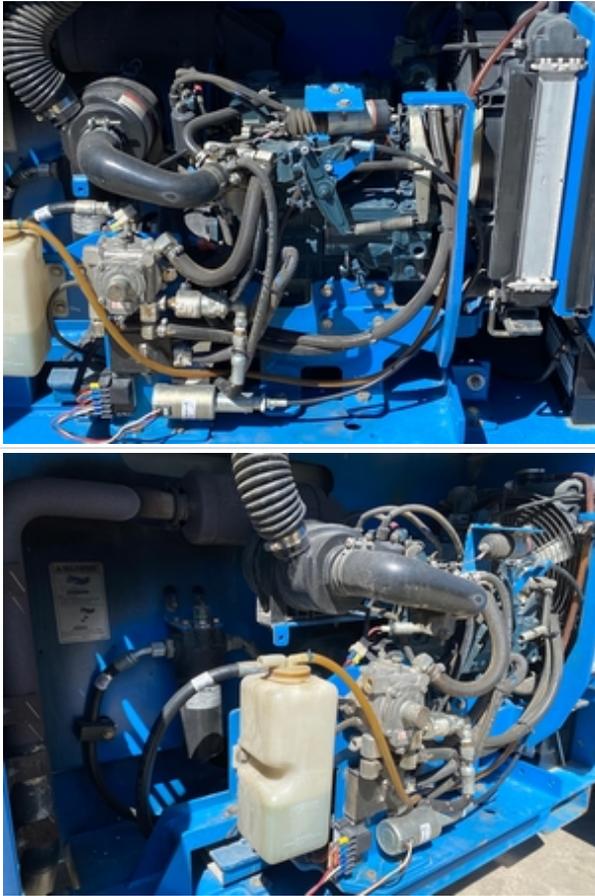
Engine	
Engine Type (Make, Model, Cylinders, Hp)	Kubota - 3Cyl. - 58.7 CU.IN - 32HP
Emissions Tier	Tier 4F
Engine Serial Number	N/A
Engine Fuel Type	Dual-Fuel (Gas, LPG)
Engine Photos

Radiator	3 - Normal Wear & Tear
Radiator Condition	Radiator fins & components appear to be in good working order, no signs of damage or leaks
Belts	3 - Normal Wear & Tear
Belt Condition	Belts appear in good condition & alignment with proper tension
Hoses	3 - Normal Wear & Tear
Hose Condition	Firm, pliant hoses with no signs of wear or leaks
Water Pump	3 - Normal Wear & Tear
Water Pump Condition	No unusual pump noises heard
Cooling System Leaks	No
Coolant Color / Appearance	3 - Normal Wear & Tear
Coolant Color/Appearance Notes	Normal Translucent appearance, no visual signs of contamination
Oil Leaks	Yes
Oil Leak Notes	Wetness & discoloration observed
Oil Color / Appearance	3 - Normal Wear & Tear
Oil Color / Appearance Notes	Clean oil appearance, no signs of cross contamination, Appropriate oil level
Fuel Leaks	No
Requires DEF (Diesel Exhaust Fluid)	No
Overall Engine Appearance	Clean & dry
Overall Engine Comments	Possible Minor oil leak at valve cover. (Highlighted in valve cover photo)

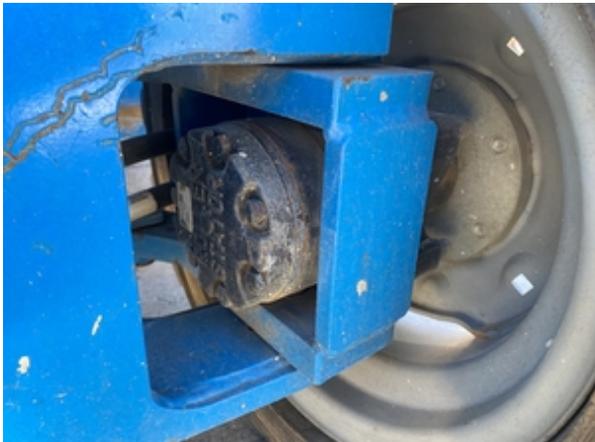
Hydrostatic Transmission?	Yes
2 Speed?	N/A
Hydrostatic Drive Configuration	Split Transmission
Drive Motors	4 - Like New, Recently Replaced
Hydrostatic Parking Brake	3 - Normal Wear & Tear
Hydrostatic Parking Brake Condition	Good brake function
Overall Drivetrain Comments	Drive train functions with no operational issues.

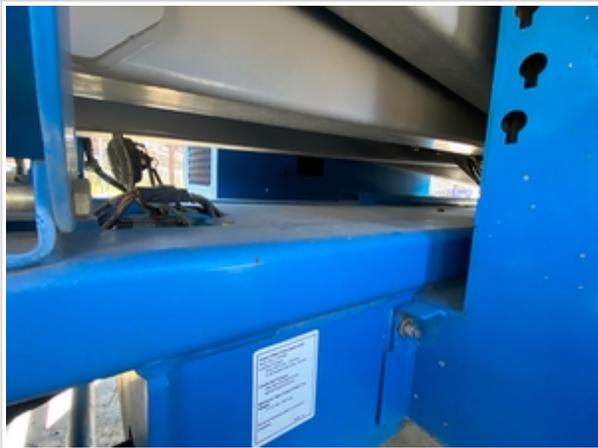
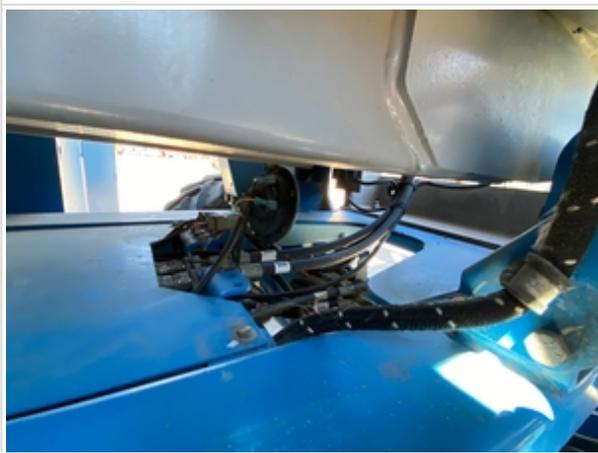
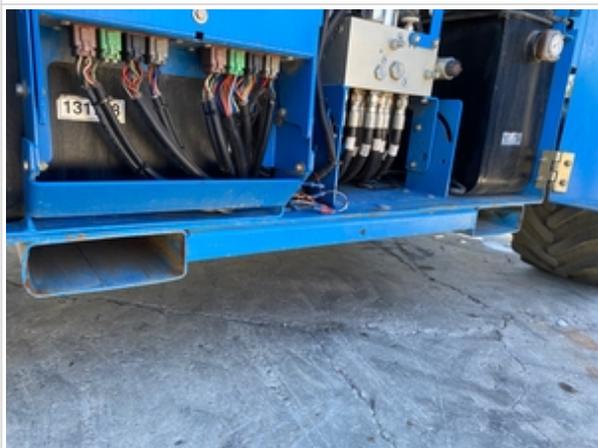
Frame	3 - Normal Wear & Tear
Frame Photos

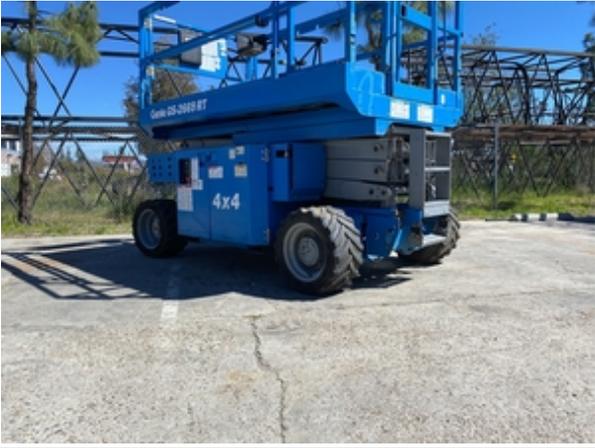
Stance	3 - Normal Wear & Tear	
Stance Photos

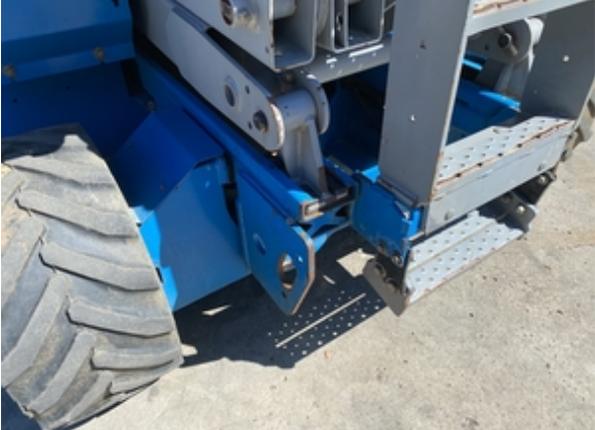
Drive Motors	3 - Normal Wear & Tear	
Front Axle Appearance	3 - Normal Wear & Tear	
Front Axle Appearance Photos

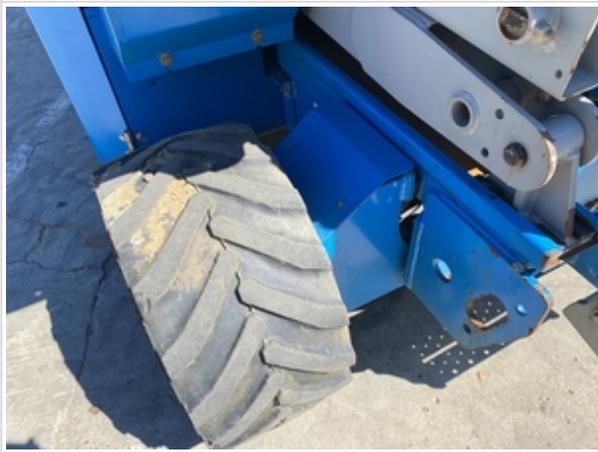
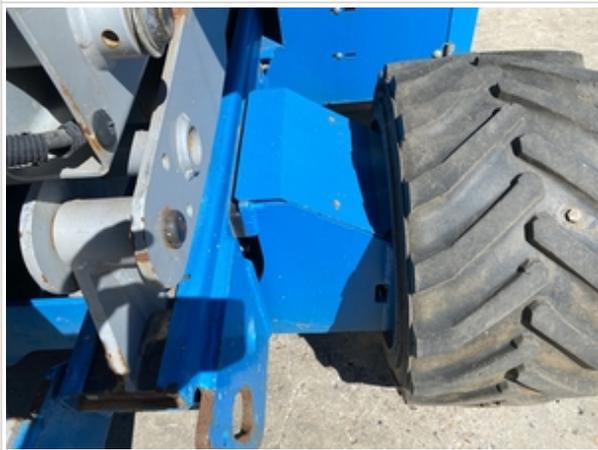
<p>Rear Axle Appearance</p>	<p>3 - Normal Wear & Tear</p>
<p>Rear Axle Appearance Photos</p>

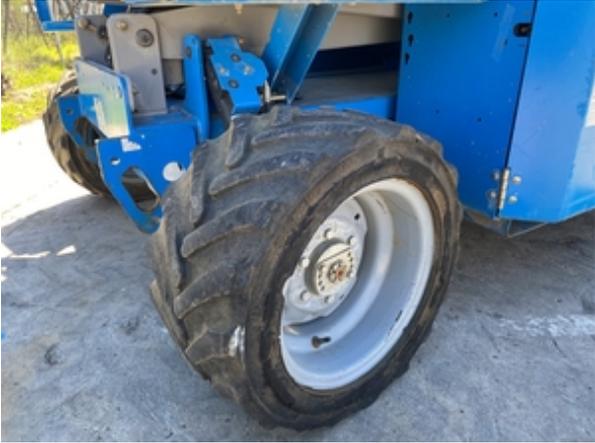
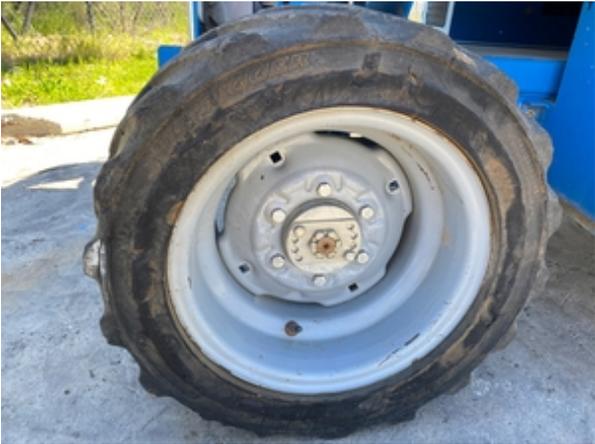
Wheels & Tires	3 - Normal Wear & Tear	
Comments	Tires are foam filled	
Wheels & Tires Photos

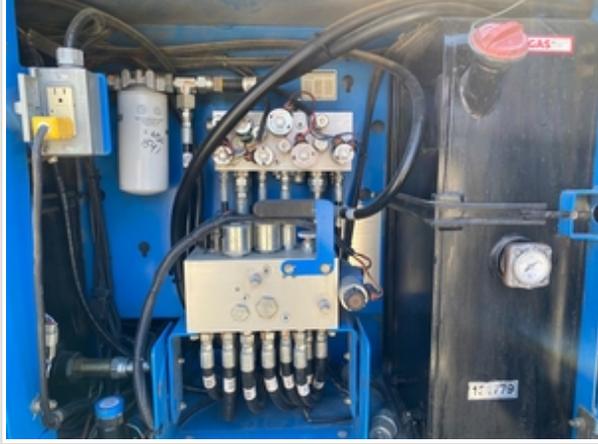
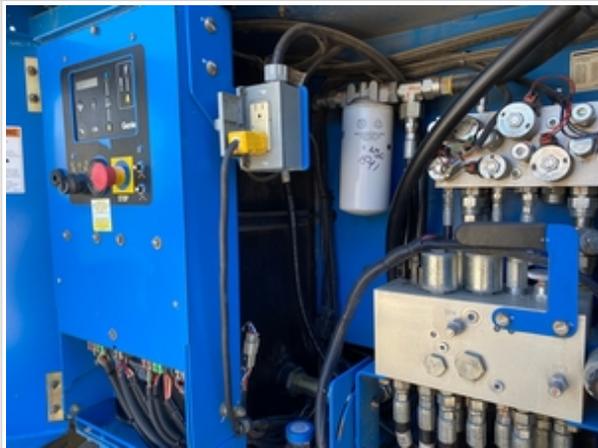
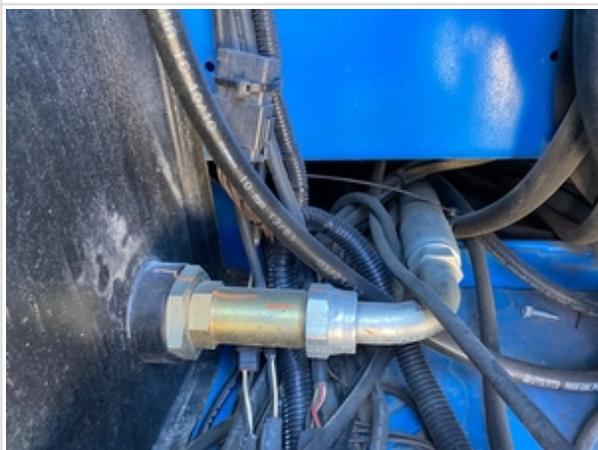
Wet or Damp Hydraulic Lines / Fittings	No
Appearance of Hydraulic Lines / Fittings	3 - Normal Wear & Tear
Hydraulic Lines / Fittings Condition	Hydraulic lines & fittings are clean and in good condition
Unusual Noises (Hydraulic Pump)	No
Hydraulic Pump Notes	No unusual noises heard during operation

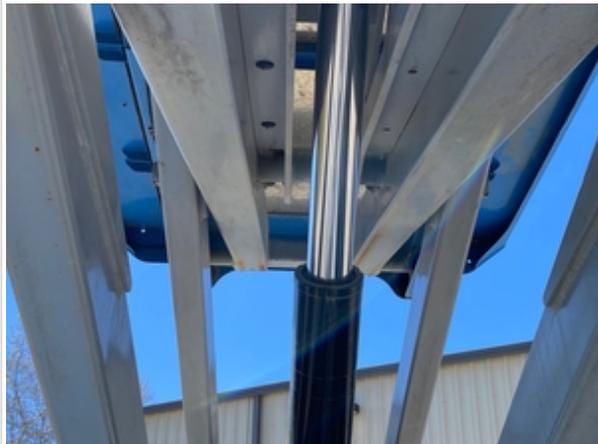
Lift Cylinders	Check the lift cylinders. Note any wear, pitting, discoloration, etc. Take photos.
Lift Cylinders: Mounting Pin	3
Lift Cylinders: Oil Leaks	No
Lift Cylinders Photos

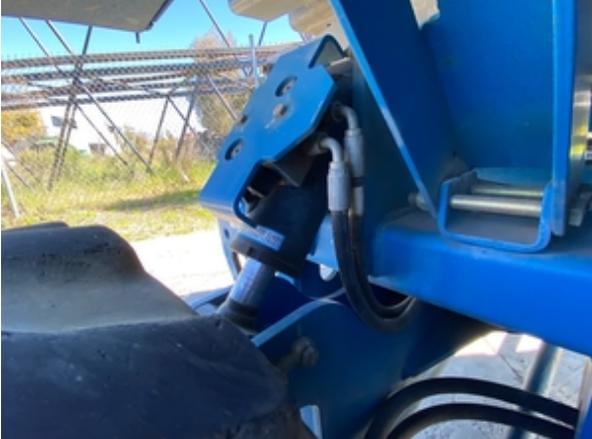
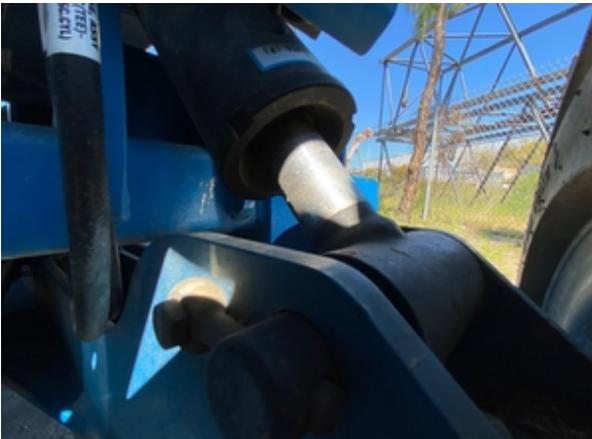
Frame Leveling Cylinders	Check the frame leveling cylinders. Note any wear, pitting, discoloration, etc. Take photos.	
Frame Leveling Cylinders: Mounting Pin	3	
Frame Leveling Cylinders: Oil Leaks	No	
Frame Leveling Cylinders Photos

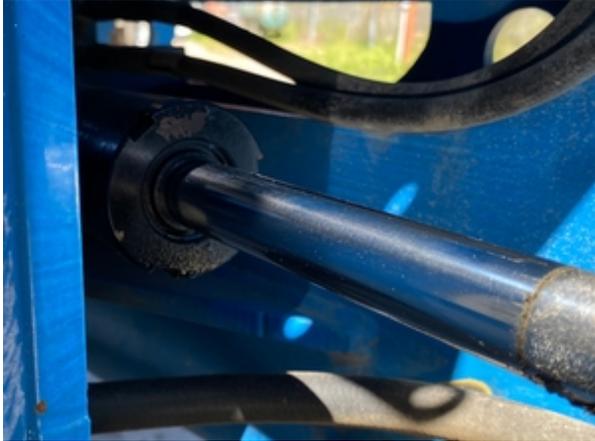
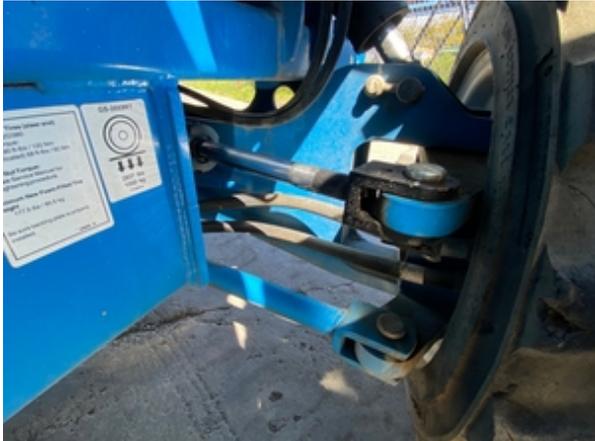
Steering Cylinders: Mounting Pin	3
Steering Cylinders: Oil Leaks	Yes
Comments	Small leak seen at r/s of steer cylinder
Steering Cylinders Photos
