## Inspection Report (Boom Lift)

Year	2010
Make	Genie
Model	Z-40/23NRJ
Serial Number	Z40N10-924
Hour Meter Reading	1,075 Hrs.
Previous Application (e.g., earth moving, mining, demolition, etc)	Rental Equipment

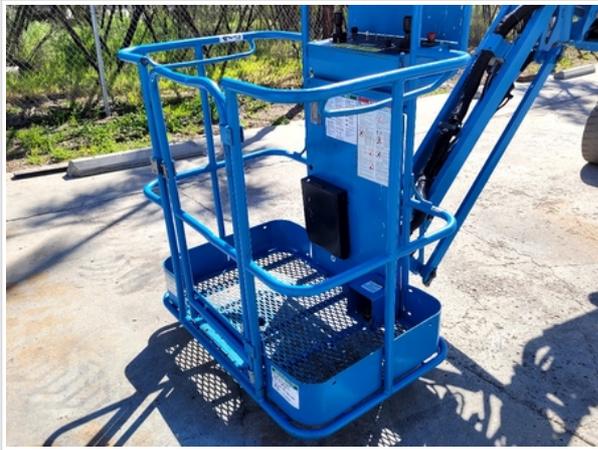
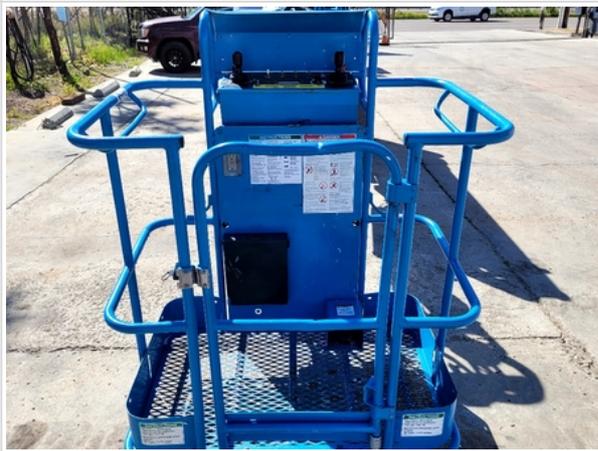
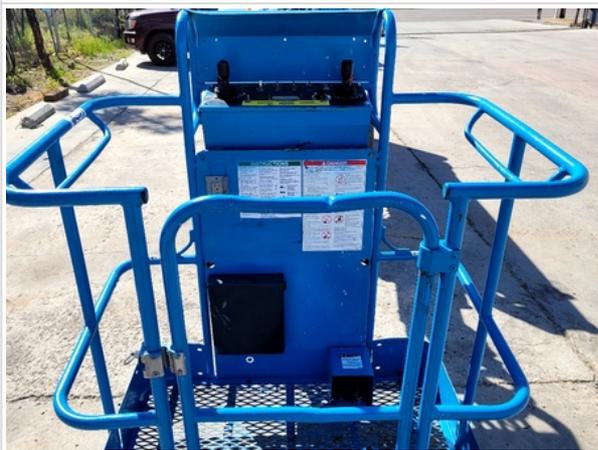
<p>Platform Safety Rails &amp; Appearance</p>	<p>3 - Normal Wear &amp; Tear</p>
<p>Platform Safety Rails &amp; Appearance Photos</p>

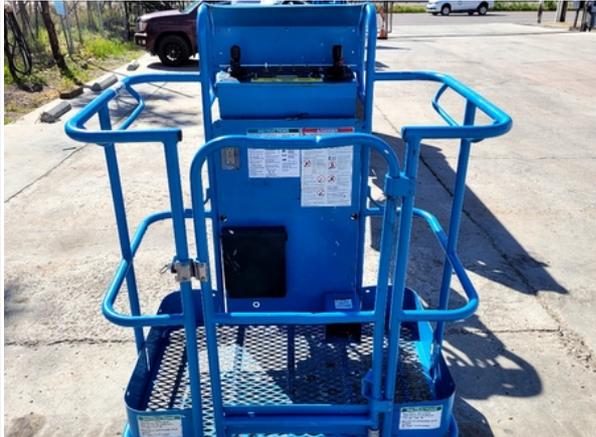
<b>Platform Floor</b>	<b>3 - Normal Wear &amp; Tear</b>
<b>Platform Floor Photos</b>

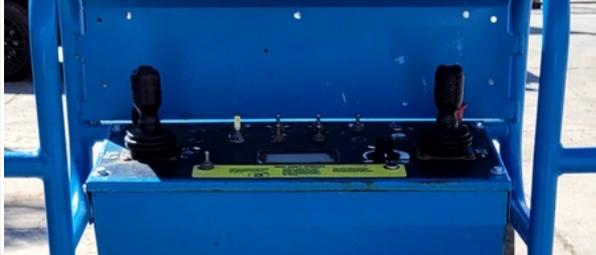
<b>Platform Controls</b>	<b>3 - Normal Wear &amp; Tear</b>
<b>Platform Controls Photos</b>

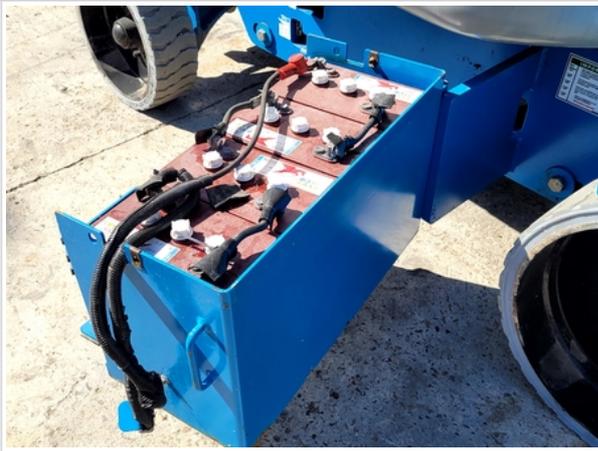
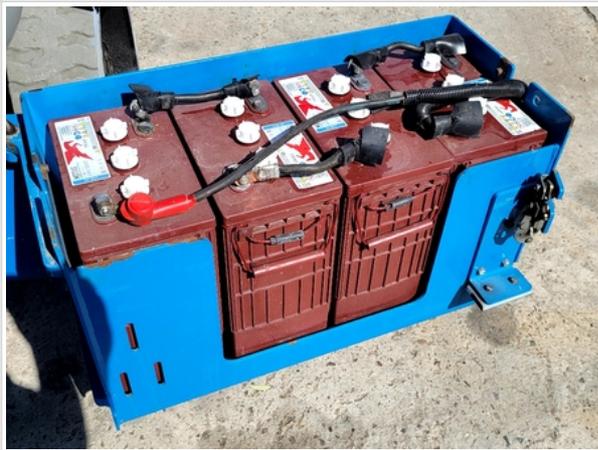
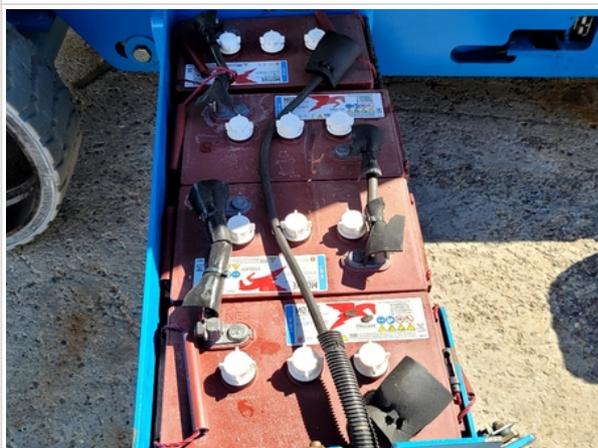
Battery Condition	3 - Normal Wear & Tear
Battery Condition Photos

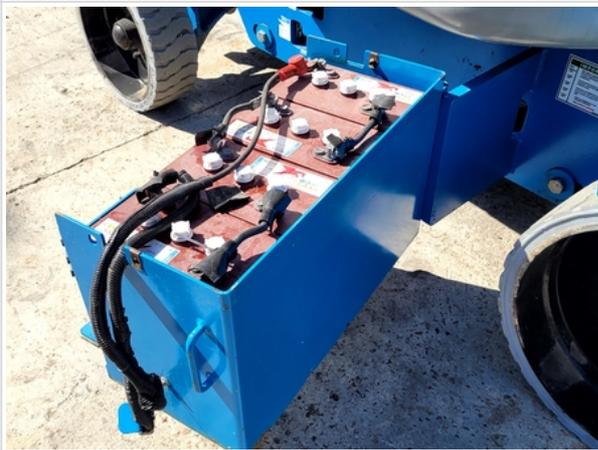
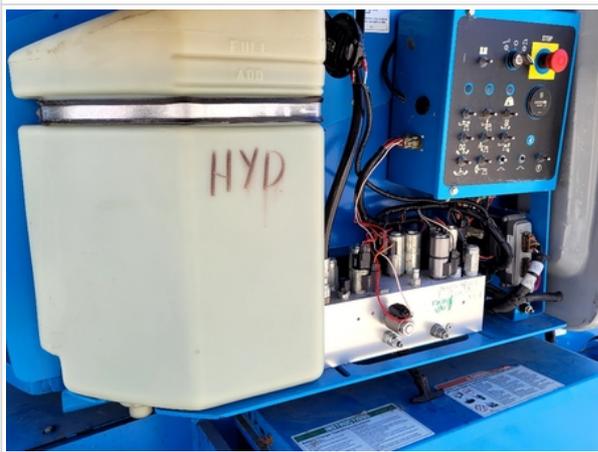
<p><b>Cables &amp; Connections</b></p>	<p>3 - Normal Wear &amp; Tear</p>	
<p><b>Cables &amp; Connections Photos</b></p>

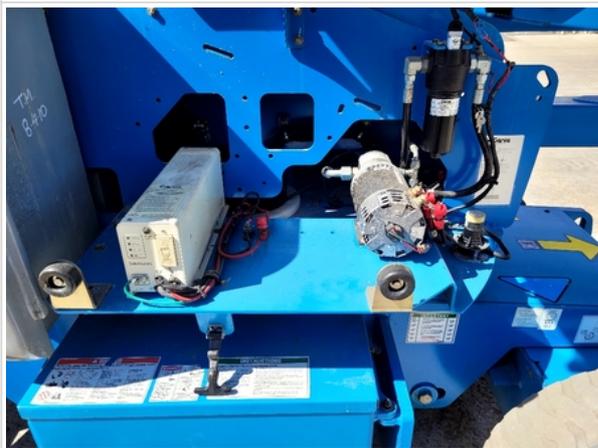
<b>Battery Charger</b>	3 - Normal Wear & Tear	
<b>Battery Charger Photos</b>

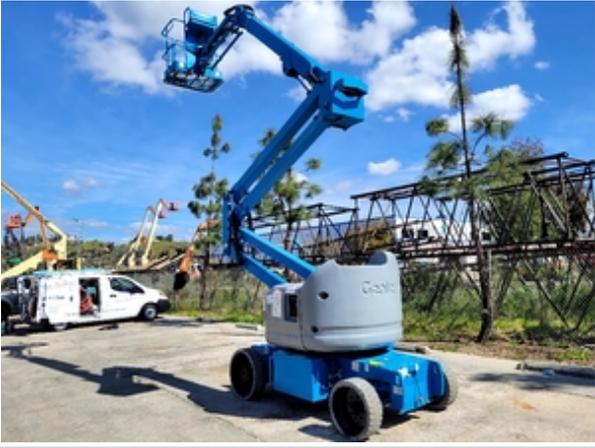
<b>Stance</b>	3 - Normal Wear & Tear	
<b>Stance Photos</b>

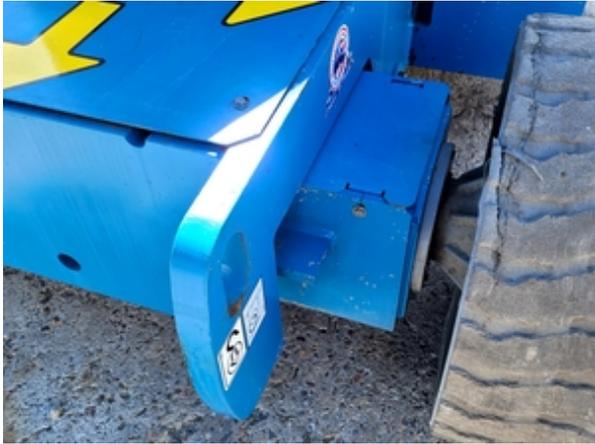
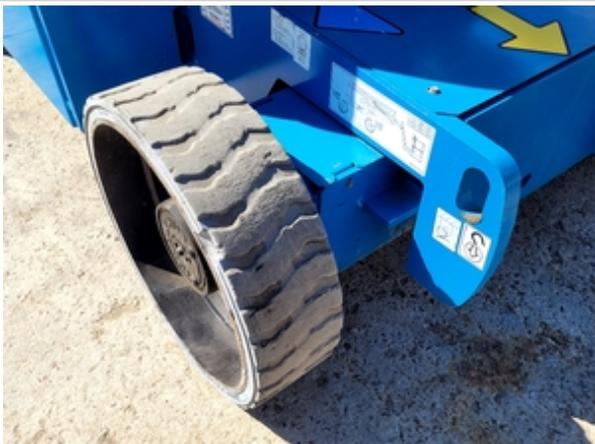
<b>Rear Axle Appearance</b>	3 - Normal Wear & Tear
<b>Rear Axle Appearance Photos</b>

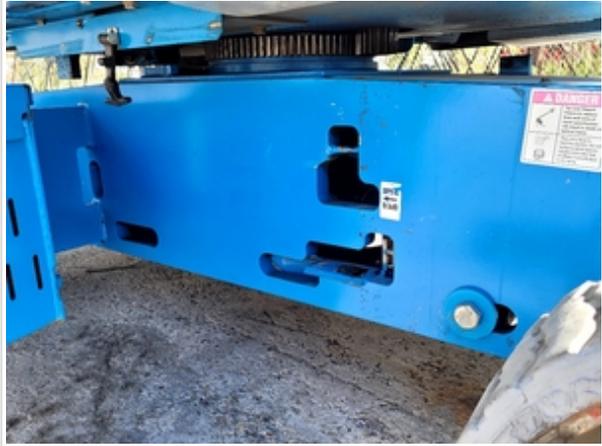
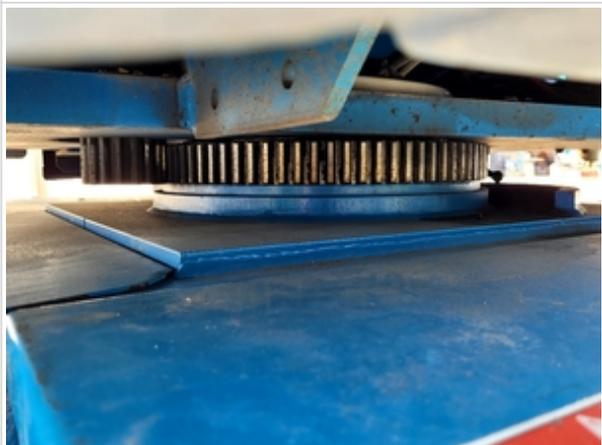
Tire Brand	OTR - Outrigger	
Tire Size	25.6x7	
Front Left Tire - Ratio Remaining	10%	
Rear Left Tire - Ratio Remaining	10%	
Front Right Tire - Ratio Remaining	10%	
Rear Right Tire - Ratio Remaining	10%	
Swivel Bearing	3 - Normal Wear & Tear	
Swivel Bearing Photos

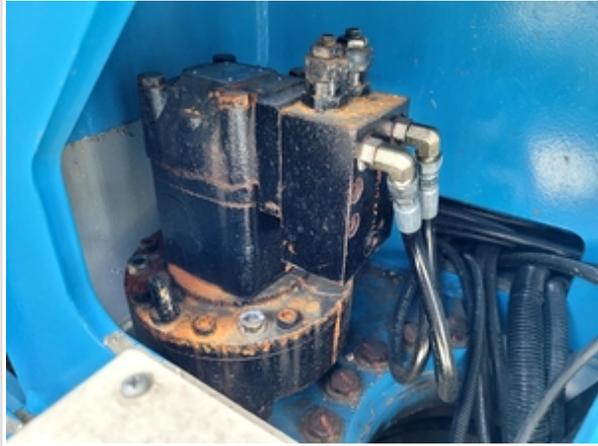
<b>Swivel Motor</b>	3 - Normal Wear & Tear	
<b>Swivel Bearing Photos</b>

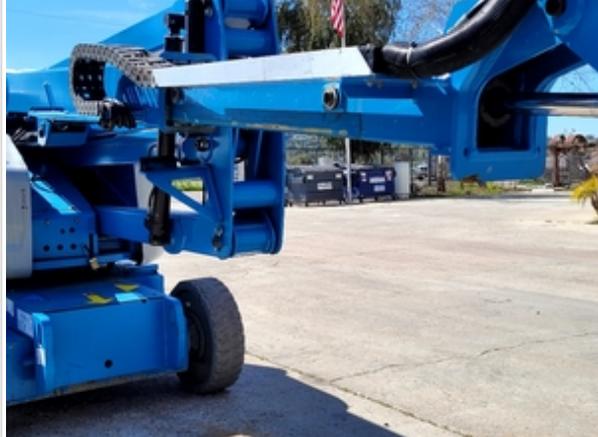
<b>Swivel Joint</b>	3 - Normal Wear & Tear	
<b>Boom Condition</b>	3 - Normal Wear & Tear	
<b>Boom Condition Photos</b>

Forward & Reverse	3 - Normal, Operating as Expected
Swing Table Rotation	3 - Normal, Operating as Expected
Boom Lift / Angle / Tilt	2 - Operable, but Diagnosis Needed
Comments	Boom main lift cuts out during operation. All other boom functions work well.
Overall Functional Test Comments	Travel, steering, main body swing, platform swing and tilt work well. Boom extension also working well.
Operating Video	<a href="#">Click to Download</a>
Additional Video	<a href="#">Click to Download</a>
Additional Video	<a href="#">Click to Download</a>

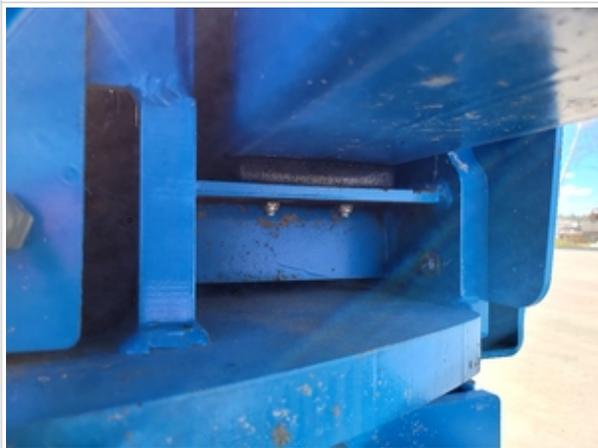
<p><b>Boom Wear Guides</b></p>	<p>3 - Normal Wear &amp; Tear</p>	
<p><b>Boom Wear Guides Photos</b></p>

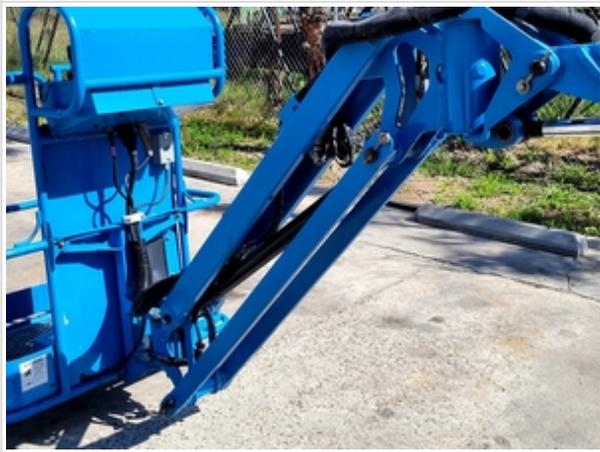
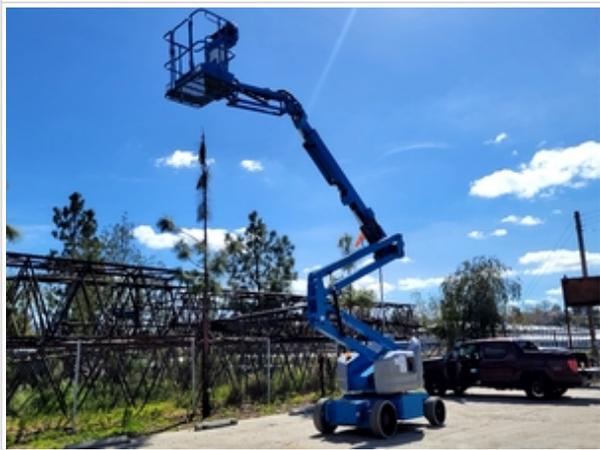
<p>Jib Condition</p>	<p>3 - Normal Wear &amp; Tear</p>	
<p>Jib Condition Photos</p>

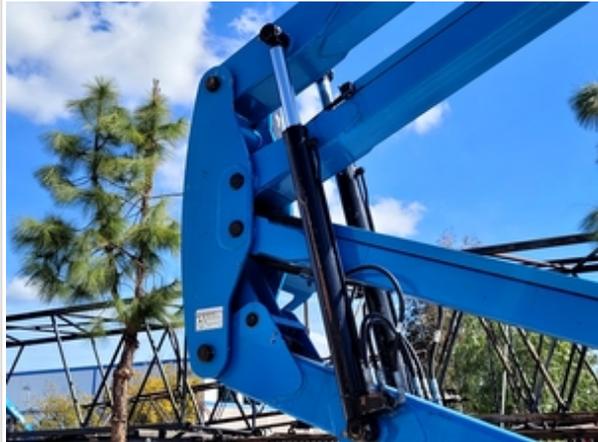
Boom Lift Cylinders	Check the boom lift cylinders. Note any wear, pitting, discoloration, etc. Take photos.
Boom Lift Cylinders: Mounting Pin	3
Boom Lift Cylinders: Oil Leaks	No
Boom Lift Cylinders Photos

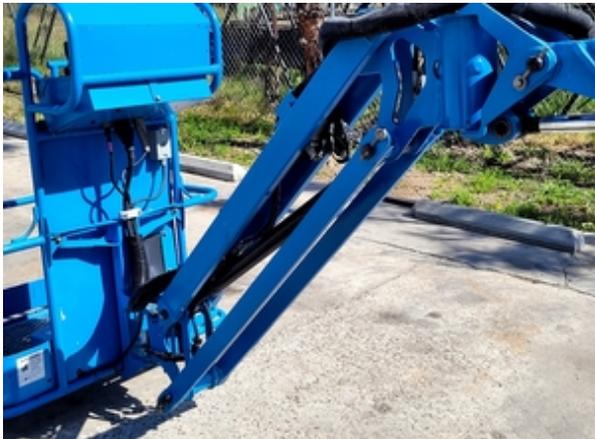
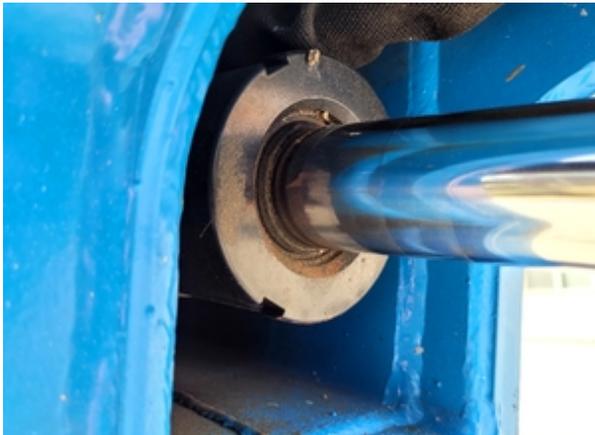
<b>Boom Extension Cylinder</b>	Check the boom extension cylinder. Note any wear, pitting, discoloration, etc. Take photos.	
<b>Boom Extension Cylinder: Mounting Pin</b>	3	
<b>Boom Extension Cylinder: Oil Leaks</b>	No	
<b>Jib Cylinder</b>	Check the jib cylinder. Note any wear, pitting, discoloration, etc. Take photos.	
<b>Jib Cylinder: Oil Leaks</b>	No	
<b>Jib Cylinder: Mounting Pin</b>	3	
<b>Jib Cylinder Photos</b>

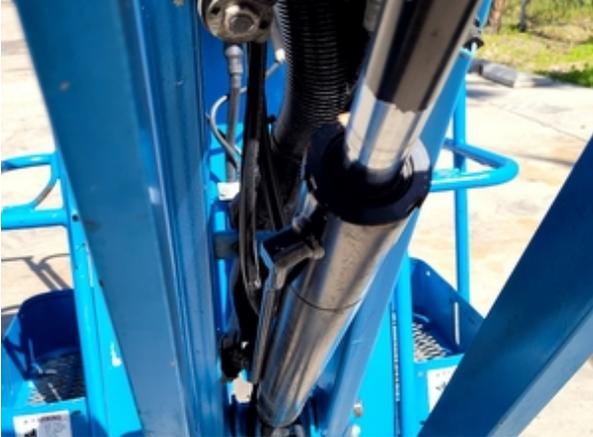
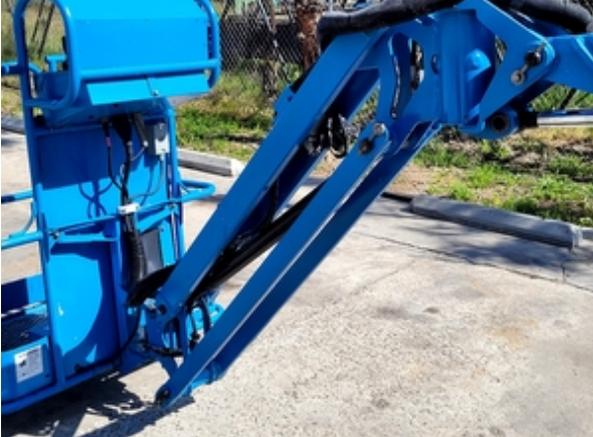
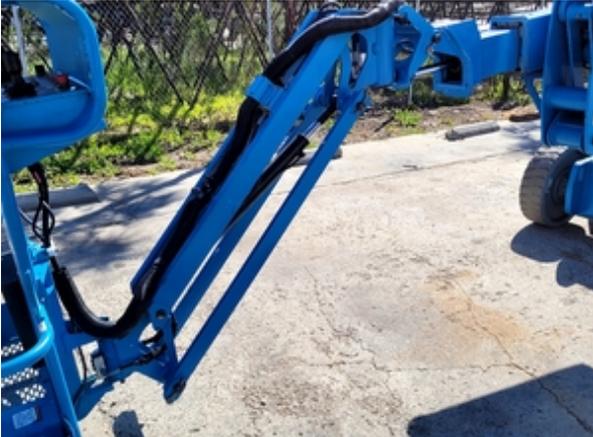
Basket Tilt Cylinder	Check the basket tilt cylinders. Note any wear, pitting, discoloration, etc. Take photos.
Basket Tilt Cylinder: Mounting Pin	3
Basket Tilt Cylinder: Oil Leaks	No
Basket Tilt Cylinder Photos

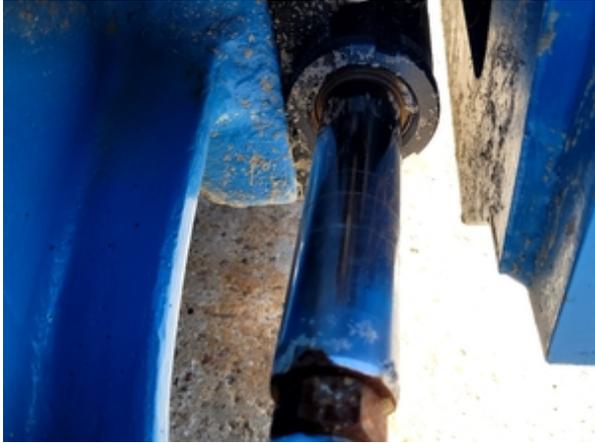
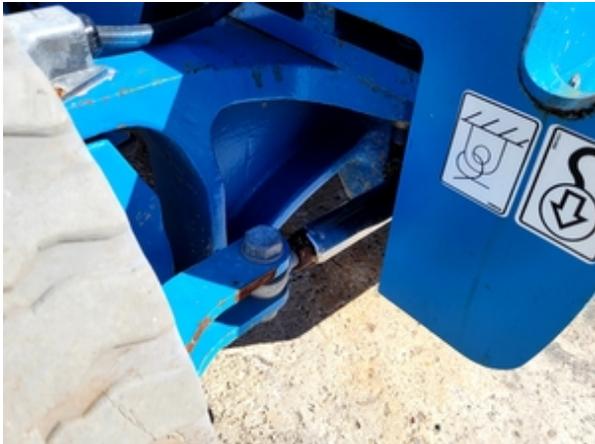
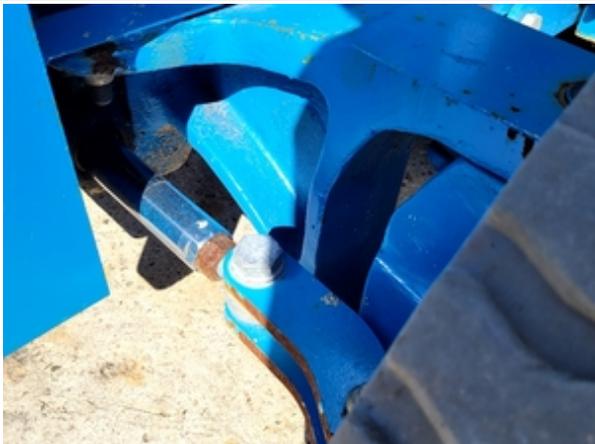
Frame Leveling Cylinders: Oil Leaks	No
Outrigger Cylinders	Check the outrigger cylinders. Note any wear, pitting, discoloration, etc. Take photos.
Steering Cylinders	Check the steering cylinders. Note any wear, pitting, discoloration, etc. Take photos.
Steering Cylinders: Mounting Pin	3
Steering Cylinders: Oil Leaks	No
Steering Cylinders Photos
