Inspection Report (Skid Steer)

Year	2021
Make	Bobcat
Model	S64
Serial Number	B4SC12665
Hour Meter Reading	446 Hrs.
Previous Application (e.g., earth moving, mining, demolition, etc)	Asphalt General Construction

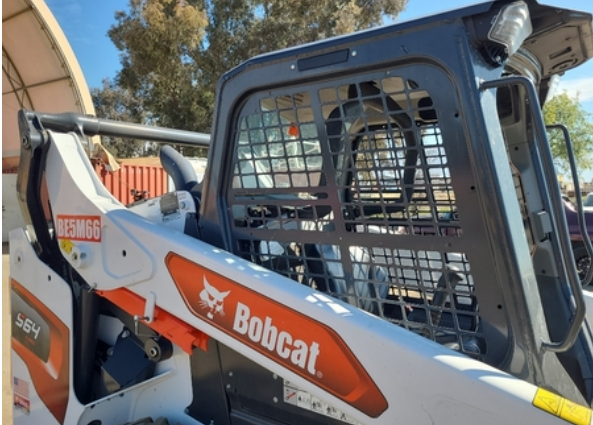
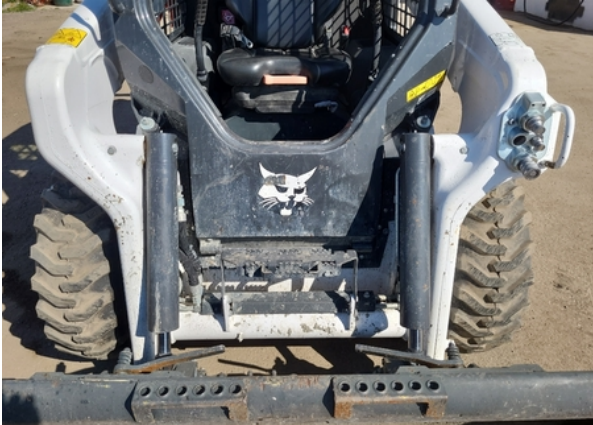
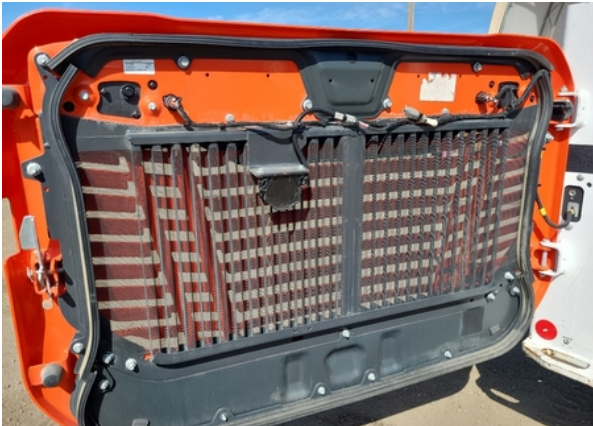
Body Panels	3 - Normal Wear & Tear
Body Panel Condition	No visible damage, good paint condition and panel fitment, Other (see comments)
Comments	Minor scuff marks
Doors / Canopy Latches	4 - Like New, Recently Replaced
Doors / Canopy Latches Condition	No visible damage
Steps / Ladders	4 - Like New, Recently Replaced
Steps / Ladders Condition	Steps/ladders are fully intact and appear structurally sound
Handrails	3 - Normal Wear & Tear

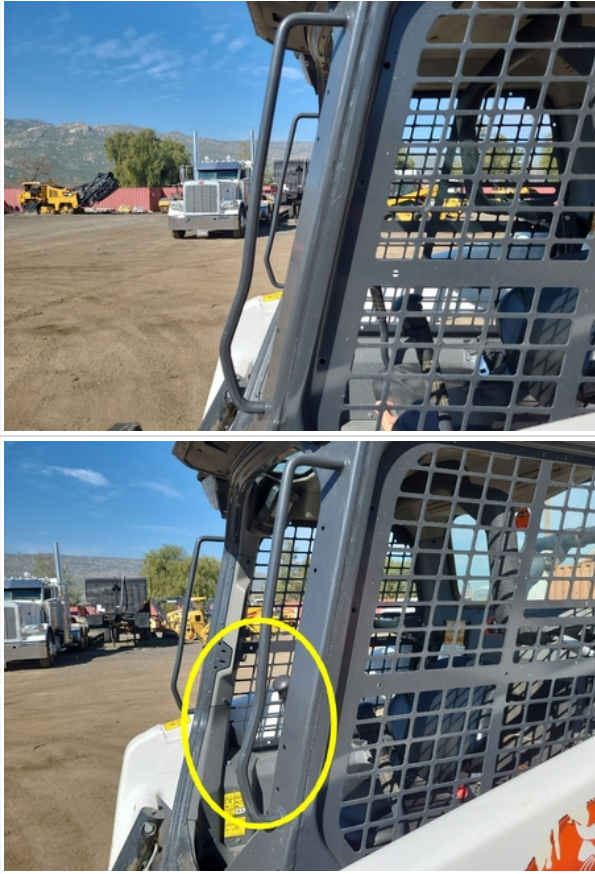
Handrails Condition	Bent or broken railings
Comments	L/S Handrail slightly bent
Handrail Photos

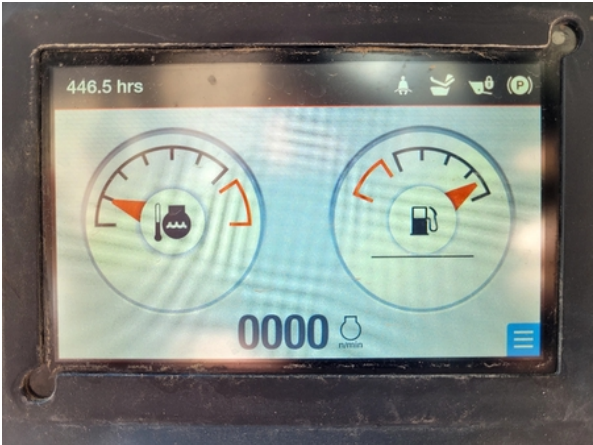
Operator Cabin Overall	3 - Normal Wear & Tear
Operator Cabin Overall Condition	Good cabin appearance, solid floors, panels, and ceiling
Operator Seat	4 - Like New, Recently Replaced
Operator Seat Condition	Seat(s) in good condition, no stains or tears in upholstery
Cabin Lights	0
Safety Lock Out / Stop	4 - Like New, Recently Replaced
Safety Lock Out / Stop Condition	Safety lock out device is present, in good condition, and functional
Controls & Switches	4 - Like New, Recently Replaced
Controls & Switches Condition	All switches are installed and functional
Hour Meter Activity	4 - Like New, Recently Replaced
Hour Meter Condition	Hour meter is functional and in good condition
Hour Meter Activity Photos

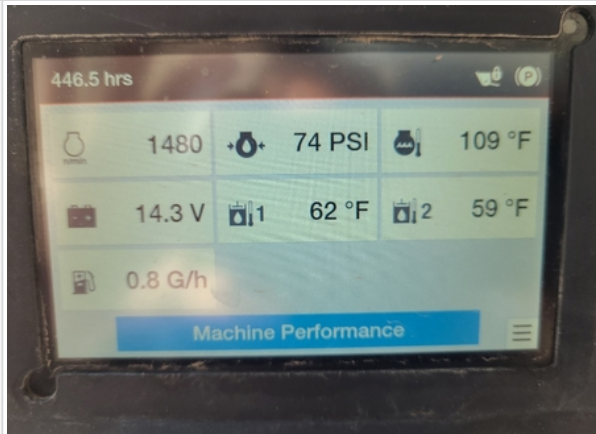
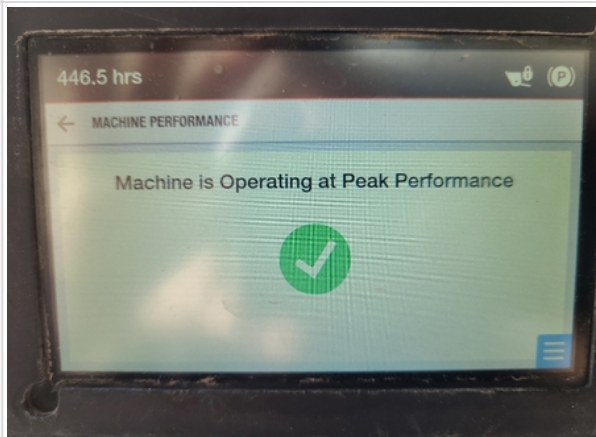
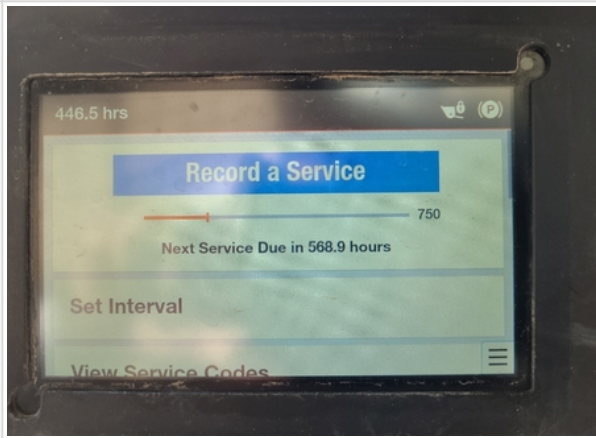
Other Gauge Activity Photos

Other Gauge Activity	4 - Like New, Recently Replaced
Other Gauge Condition	All cockpit gauges are functional and in good condition

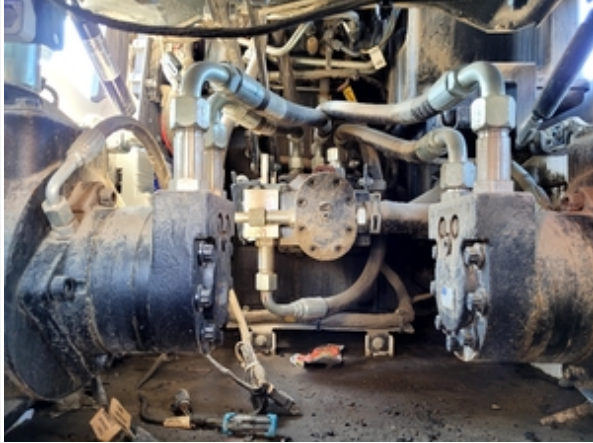
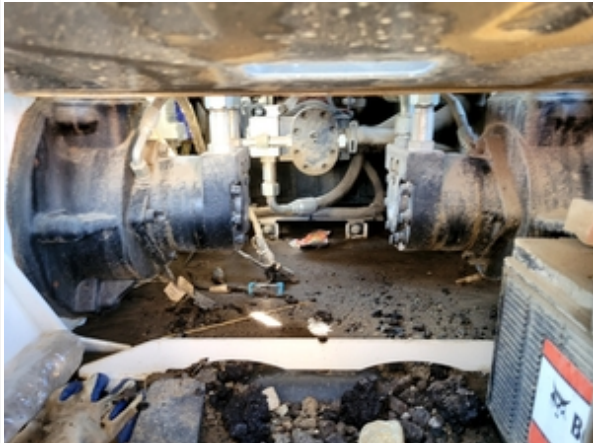
Hydrostatic Transmission?	Yes
2 Speed?	No
Hydrostatic Drive Configuration	Split Transmission
Drive Motors	2 - Above Average Wear
Hydrostatic Parking Brake	4 - Like New, Recently Replaced
Hydrostatic Parking Brake Condition	Good brake function
Overall Drivetrain Comments	Machine travels well in all directions and parking brake works great.

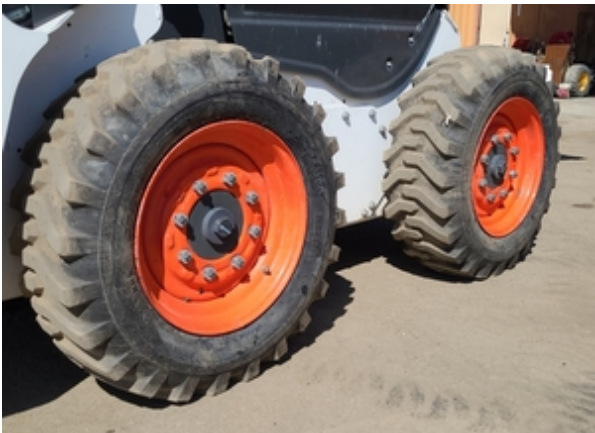
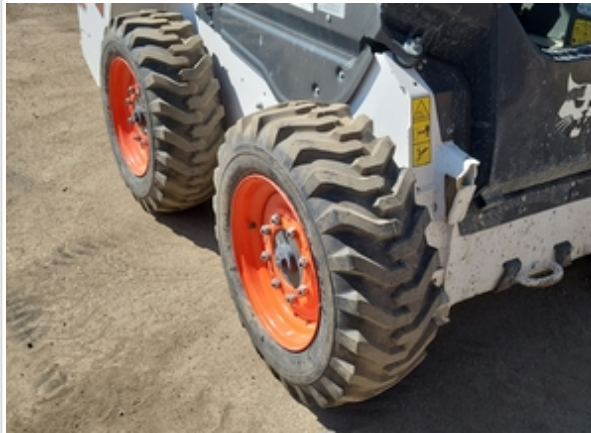
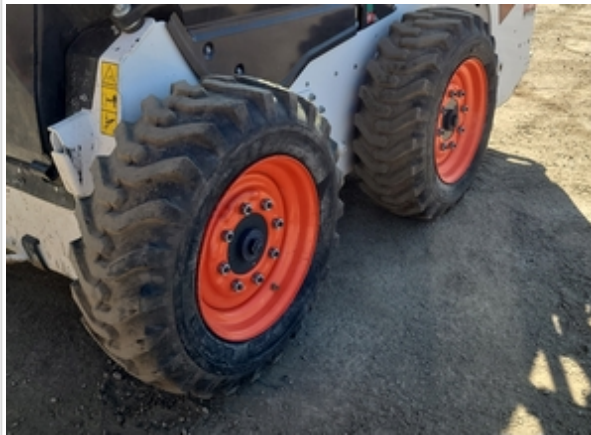
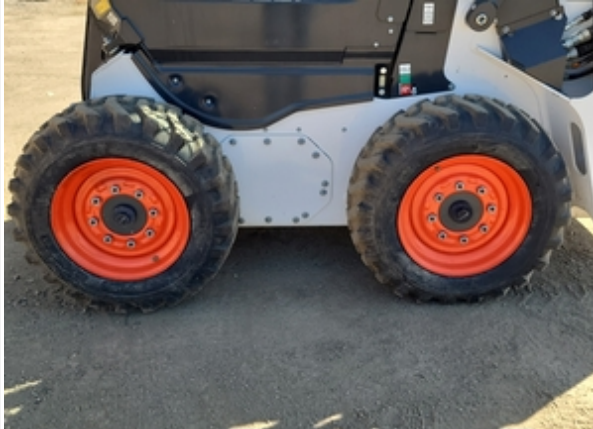
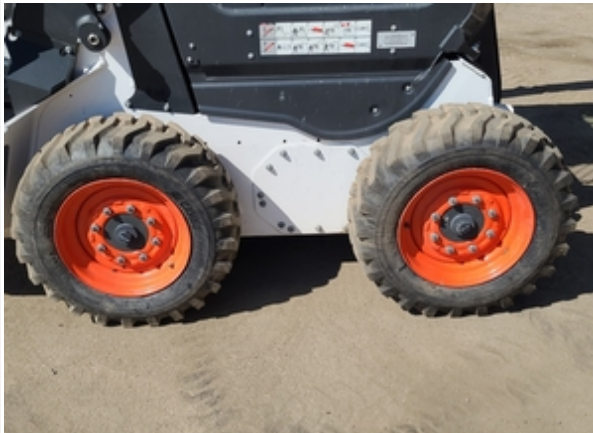
Wheels & Tires	4 - Like New, Recently Replaced
Wheels & Tires Photos

Tire Brand	Camso	
Tire Size	10-16.5	
Front Left Tire - Ratio Remaining	90%	
Rear Left Tire - Ratio Remaining	90%	
Front Right Tire - Ratio Remaining	90%	
Rear Right Tire - Ratio Remaining	90%	
Lift Arm	4 - Like New, Recently Replaced	
Lift Arm Photos

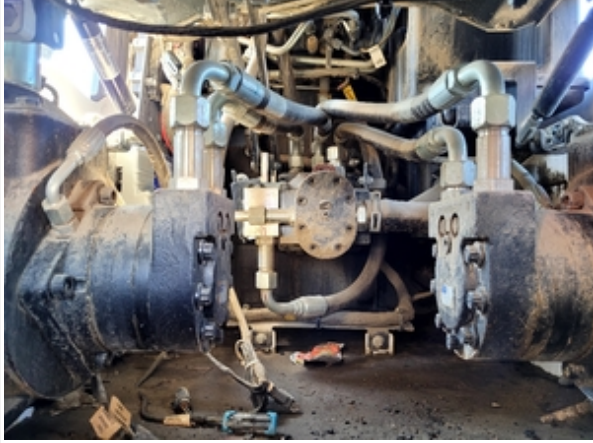
Wet or Damp Hydraulic Lines / Fittings	No
Appearance of Hydraulic Lines / Fittings	4 - Like New, Recently Replaced
Hydraulic Lines / Fittings Condition	Hydraulic lines & fittings are clean and in good condition
Unusual Noises (Hydraulic Pump)	No
Hydraulic Pump Notes	No unusual noises heard during operation

Overall Assessment	
Exterior Rating	4 - Like New, Recently Replaced
Interior Rating	4 - Like New, Recently Replaced
Safety Rating	4 - Like New, Recently Replaced
Quality Rating	4 - Like New, Recently Replaced
Functionality Rating	4 - Operating Within Factory Spec
Overall Rating	4 - Like New, Recently Replaced
What's Great About the Machine	Very low use and still in great shape all the way around. Machine is equipped with user friendly Operating Monitor with easy to read working parameters and the ability to display diagnostic codes. Machine is still in like new condition.
What Needs Work	Hydraulic fluid may need to be topped off.
Date/Time	03-09-2023

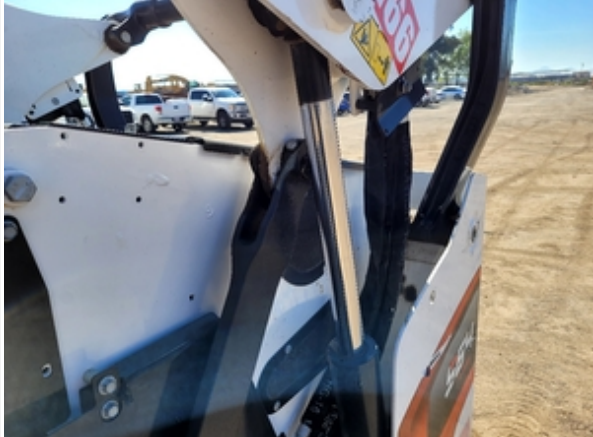
Lift Cylinder	Check the lift cylinder. Note any wear, pitting, discoloration, etc. Take photos.
Lift Cylinder: Mounting Pin	4
Lift Cylinder: Oil Leaks	No
Lift Cylinder Photos

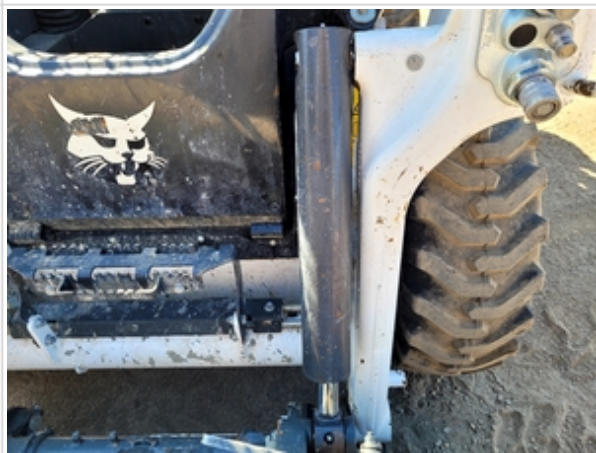
Bucket Cylinder Photos

Bucket Cylinder	Check the bucket cylinder. Note any wear, pitting, discoloration, etc. Take photos.
Bucket Cylinder: Mounting Pin	4
Bucket Cylinder: Oil Leaks	No

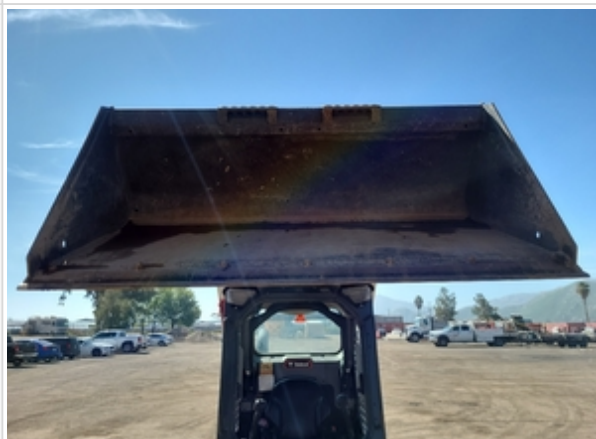
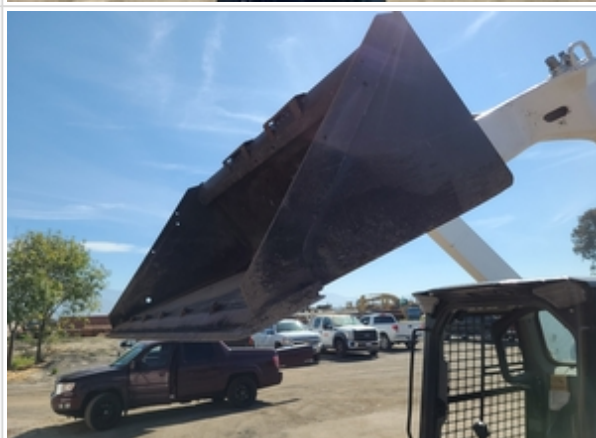
Bucket Photos

Bucket Edge / Deflectors	3 - Normal Wear & Tear
