## Inspection Report (Boom Lift)

Year	2016
Make	JLG
Model	860SJ
Serial Number	300224791
Hour Meter Reading	1233.3
Previous Application (e.g., earth moving, mining, demolition, etc)	General construction

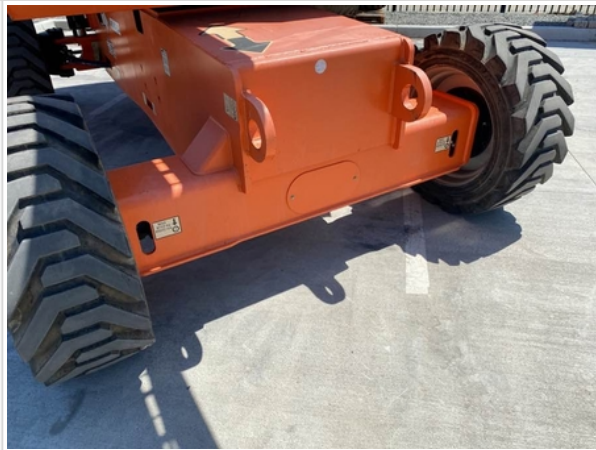
<b>Instructions</b>	<p>Evaluate the following on a 4 point scale (leave comments where an explanation is appropriate):</p> <p>4 = Like New, Recently Replaced          3 = Normal Wear &amp; Tear          2 = Above Average Wear          1 = Service Required</p> <p>Things to look for:</p> <ul style="list-style-type: none"> <li>- cosmetic damage</li> <li>- minor surface rust</li> <li>- repaint (and overspray)</li> <li>- cracked or damaged glass</li> <li>- major rust (cancer)</li> <li>- cracks / visible welds</li> </ul>
<b>Front</b>	3 - Normal Wear & Tear
<b>Comments</b>	Over spray on front of machine (paint)
<b>Front Photos</b>

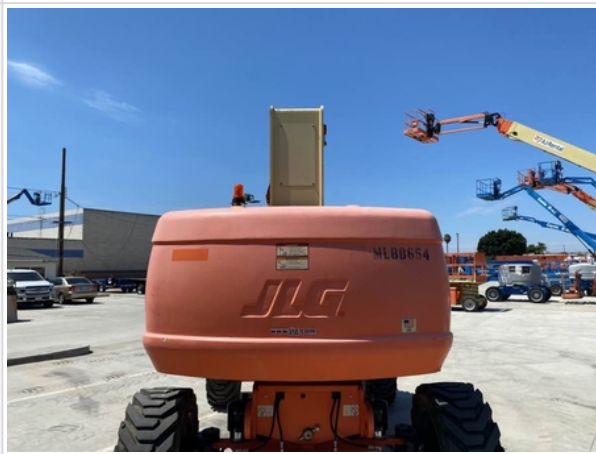
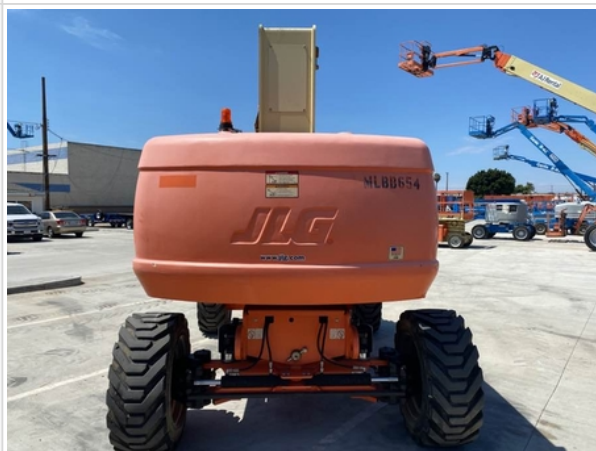
<p>Rear</p>	<p>3 - Normal Wear &amp; Tear</p>	
<p>Rear Photos</p>

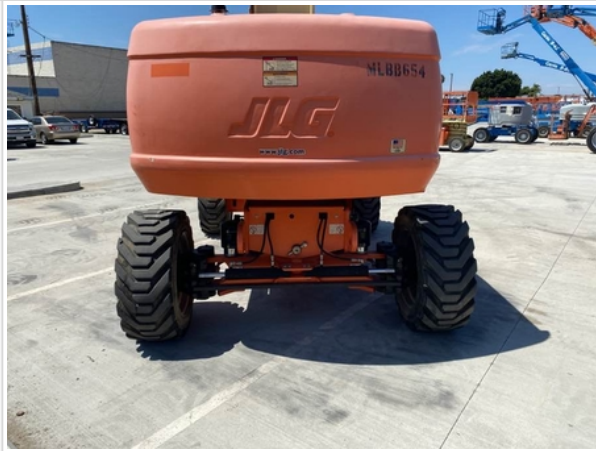
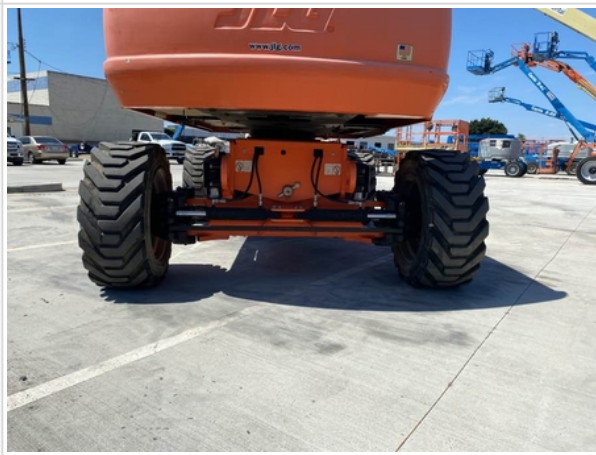
<p><b>Left</b></p>	<p>3 - Normal Wear &amp; Tear</p>	
<p><b>Comments</b></p>	<p>Left side key switch/operating panel small dent</p>	
<p><b>Left Photos</b></p>

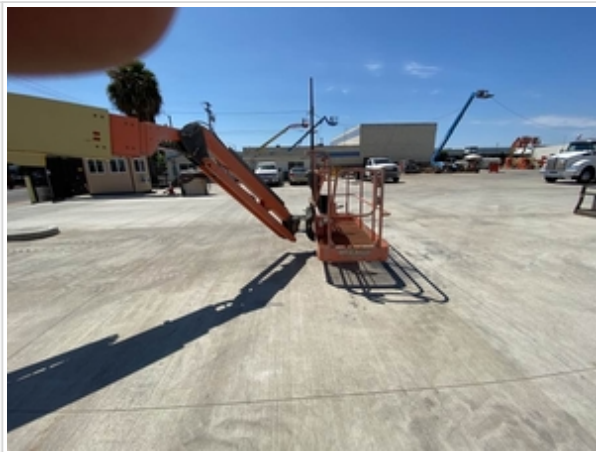
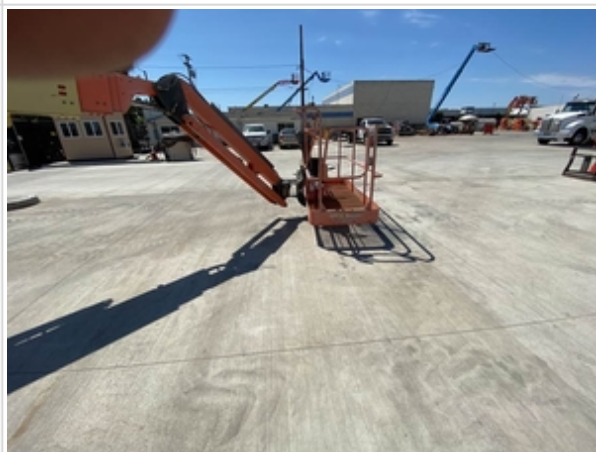
<p>Right</p>	<p>3 - Normal Wear &amp; Tear</p>	
<p>Right Photos</p>

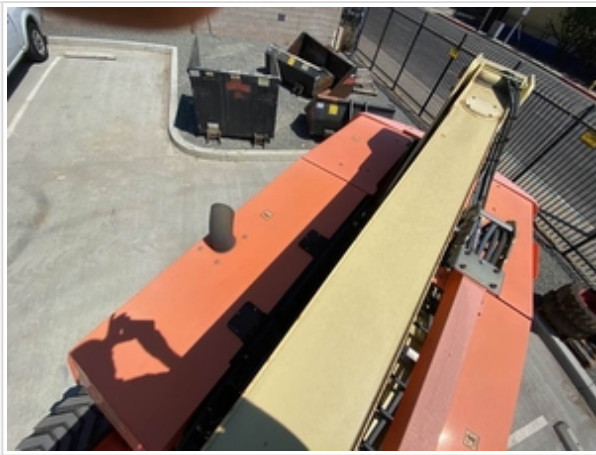
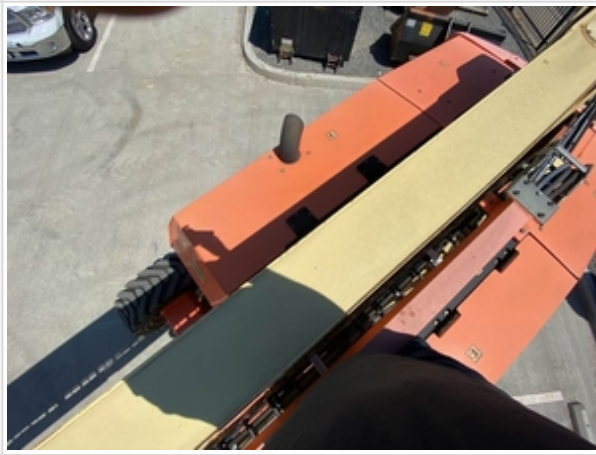
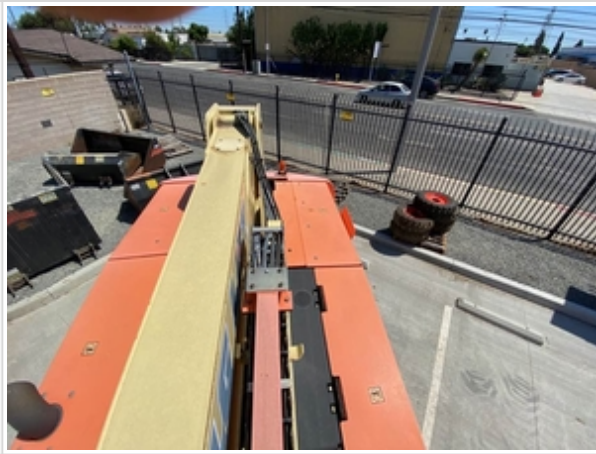
<b>Body Panels (Any Damage?)</b>	3 - Normal Wear & Tear
<b>Comments</b>	Some small dents on left side

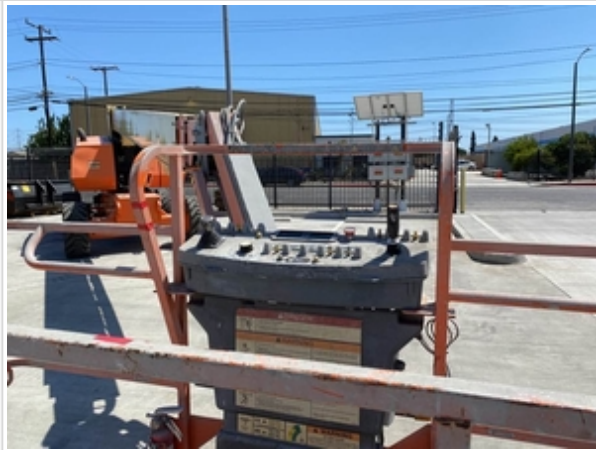
Hand Rails	3 - Normal Wear & Tear
Comments	Hand rails on man basket in safe condition

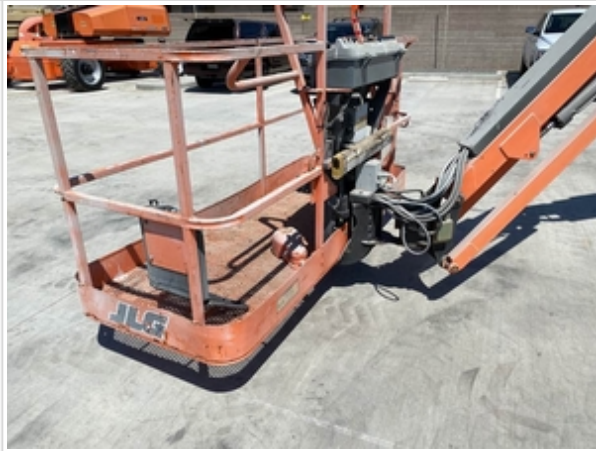
Platform Safety Rails & Appearance	3 - Normal Wear & Tear
Comments	Top back bar slightly bent

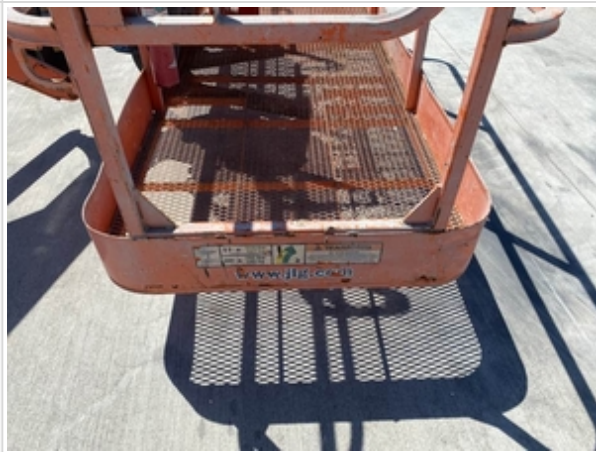
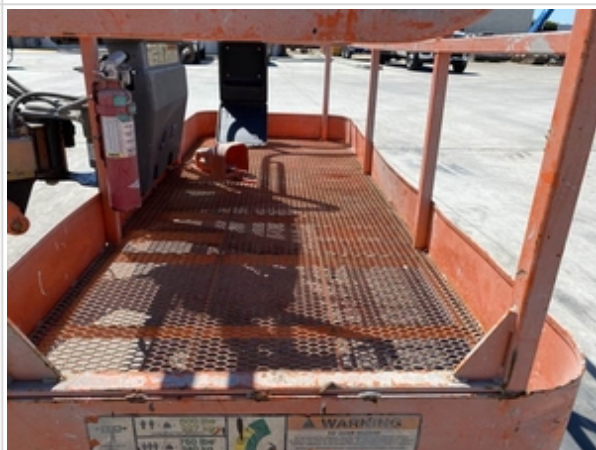
<b>Platform Floor</b>	3 - Normal Wear & Tear	
<b>Comments</b>	Nice and straight	
<b>Platform Floor Photos</b>

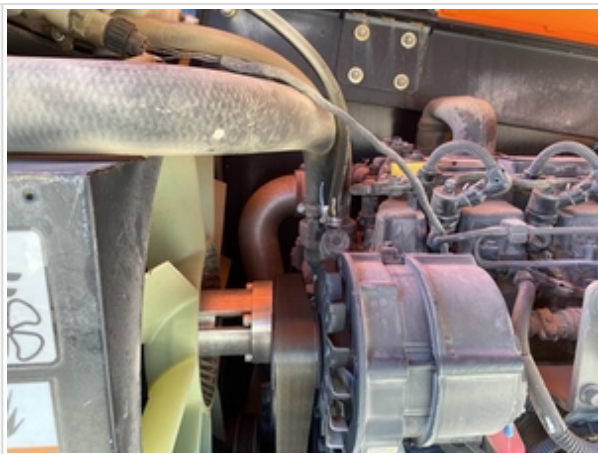
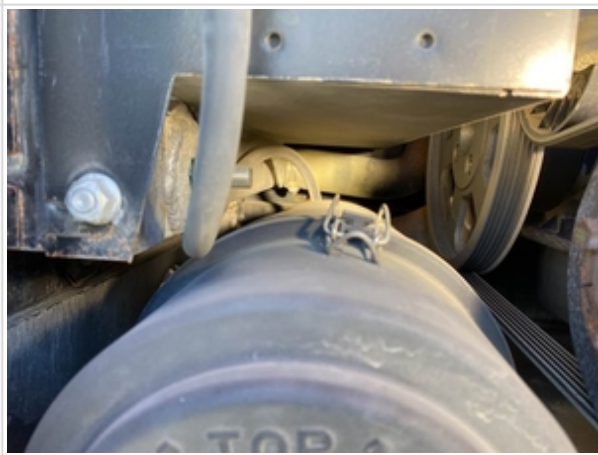
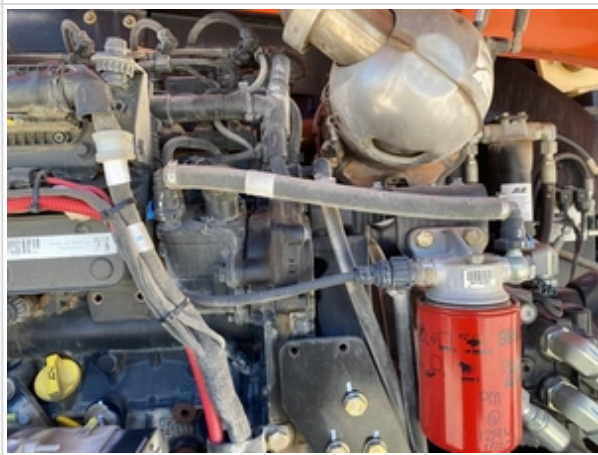
<b>Water Pump</b>	3 - Normal Wear & Tear	
<b>Water Pump Condition</b>	No unusual pump noises heard	
<b>Cooling System Leaks</b>	No	
<b>Coolant Color / Appearance</b>	3 - Normal Wear & Tear	
<b>Coolant Color/Appearance Notes</b>	Other (see comments)	
<b>Comments</b>	May need to be serviced, seems aged (normal)	
<b>Oil Leaks</b>	No

<b>Overall Rating</b>	4
<b>What's Great About the Machine</b>	The machine is well maintained and no obvious repairs required to put this machine to work. All functions work great.
<b>What Needs Work</b>	I recommend changing the coolant (standard service) simply because the coolant reservoir seemed to have a bit of dirt in it. The rest of the machine is in great condition. The hose track cover installed on the side of the boom has 2 mounting brackets that are slightly bent. This is mostly cosmetic since it's not causing an operational issue.
<b>Inspector's Name</b>	Mario Ramirez
<b>Date/Time</b>	08-17-2022

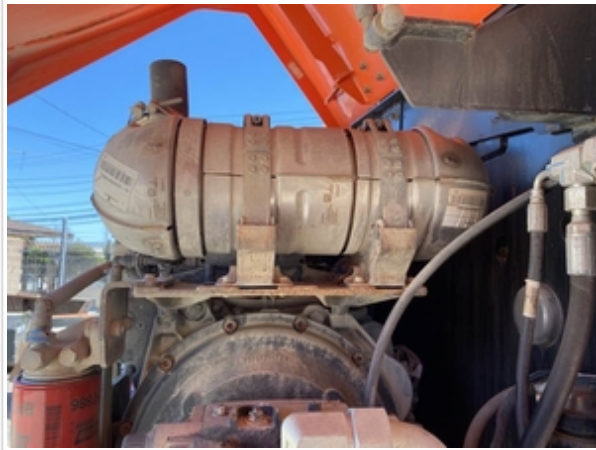
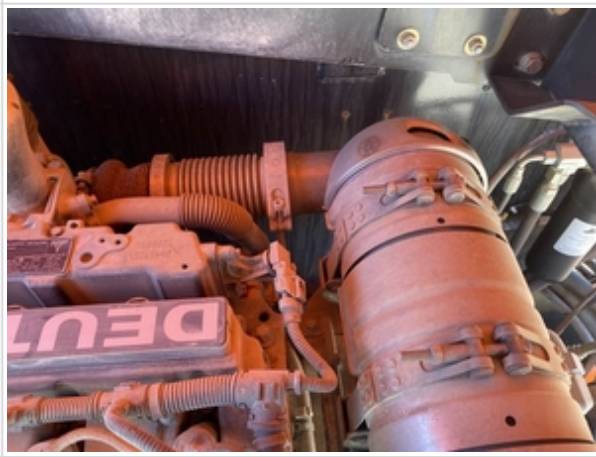
Oil Color / Appearance	3 - Normal Wear & Tear
Oil Color / Appearance Notes	Clean oil appearance, no signs of cross contamination, Appropriate oil level
Fuel Leaks	No
Equipped with DPF (Diesel Particulate Filter)	Yes
DPF Condition	3 - Normal Wear & Tear
DPF Condition Notes	Filter housing is intact with no signs of damage or malfunction, DPF indicator is not illuminated
DPF Photos

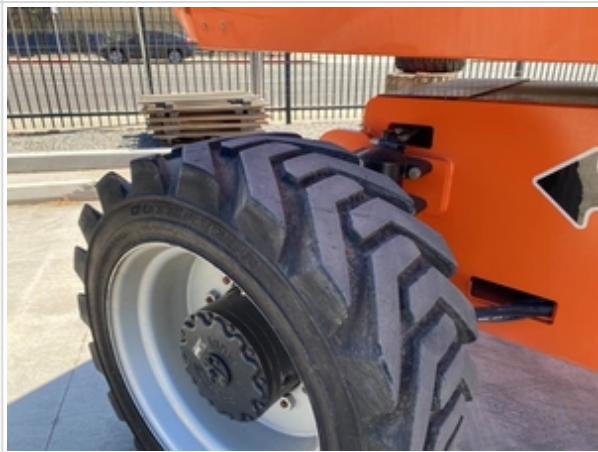
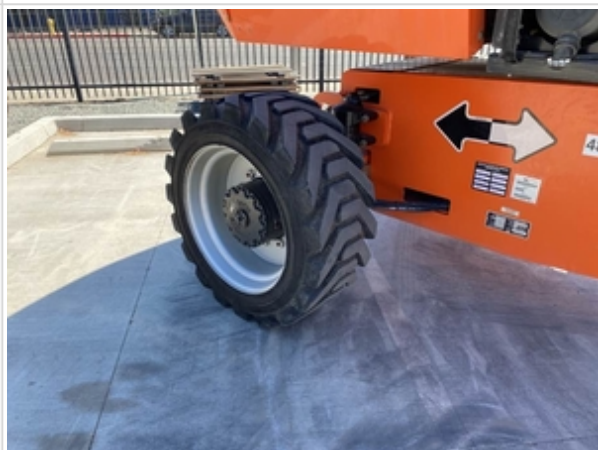
<b>Wheels &amp; Tires</b>	4 - Like New, Recently Replaced	
<b>Comments</b>	Like new, a few minor cuts here and there but	
<b>Wheels &amp; Tires Photos</b>

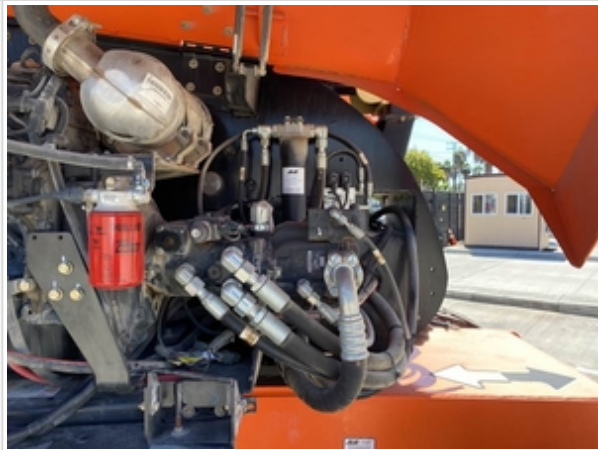
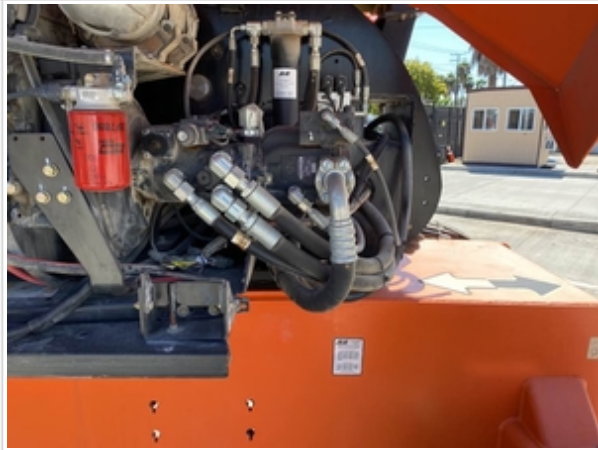
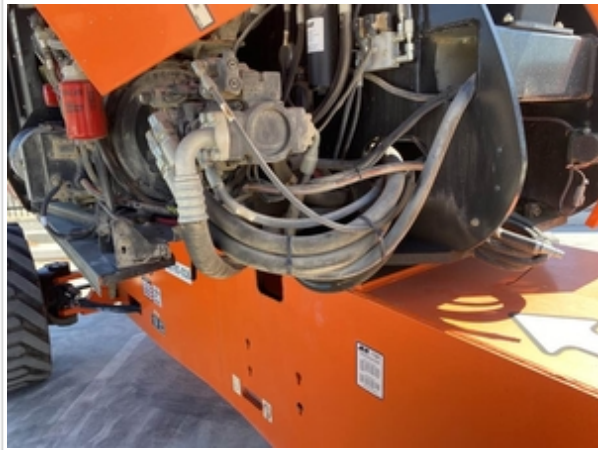
<b>Wet or Damp Hydraulic Lines / Fittings</b>	No
<b>Appearance of Hydraulic Lines / Fittings</b>	3
<b>Hydraulic Lines / Fittings Condition</b>	Hydraulic lines & fittings are clean and in good condition
