## Inspection Report (Boom Lift)

Year	2012
Make	Genie
Model	S60x
Serial Number	S60X12-23903
Hour Meter Reading	3881.5
Previous Application (e.g., earth moving, mining, demolition, etc)	General Construction Rental

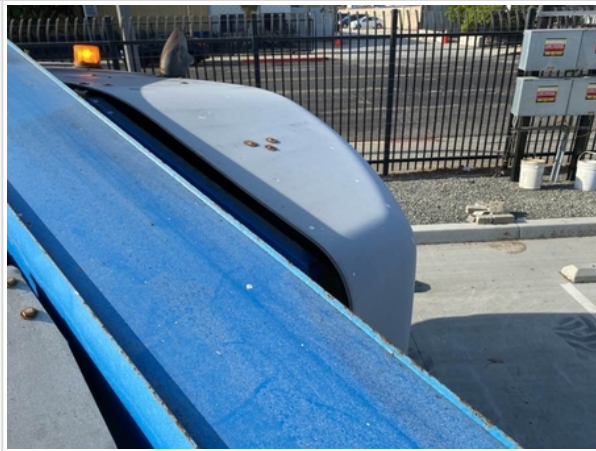
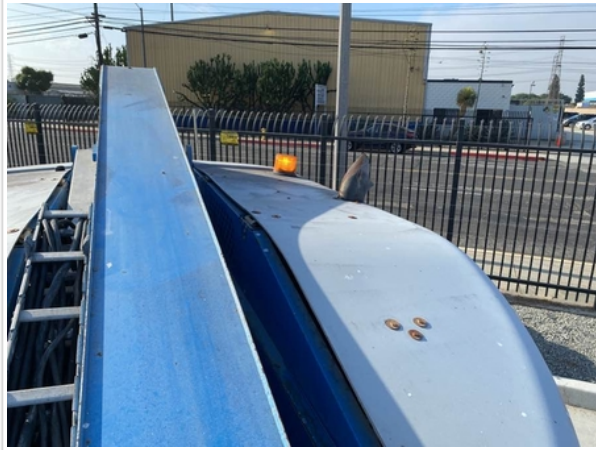
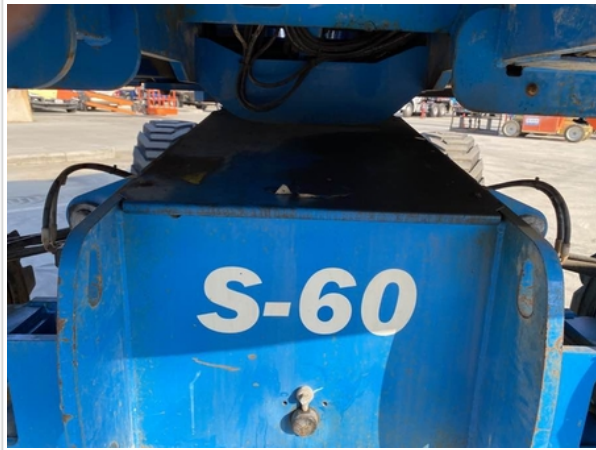
<b>Body Panels (Any Damage?)</b>	3 - Normal Wear & Tear
<b>Comments</b>	Minor fiberglass damage on l/s & r/s, Minor paint chips off of counterweight

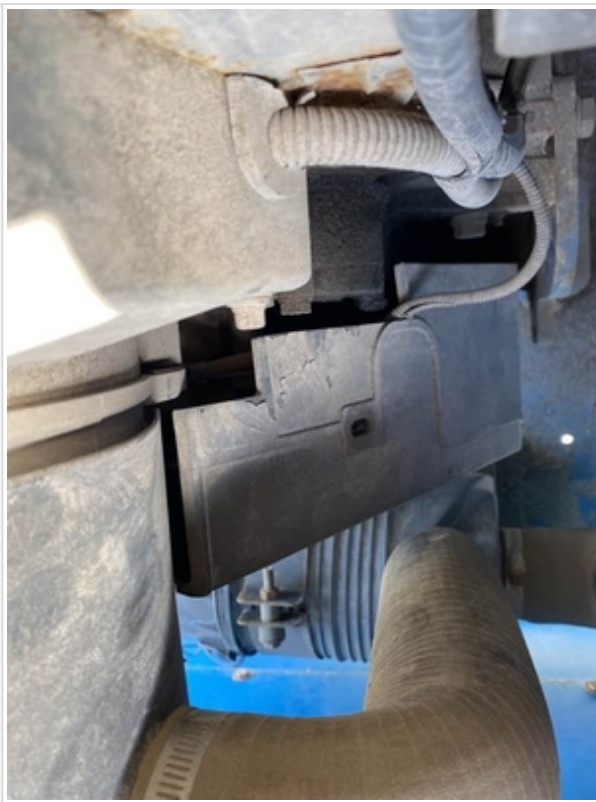
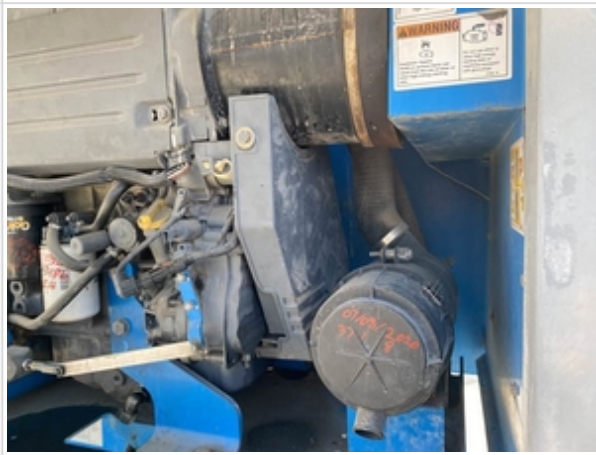
<p>Belt Photos</p>

<b>Belts</b>	3 - Normal Wear & Tear
<b>Belt Condition</b>	Belts appear in good condition & alignment with proper tension, Other (see comments)
<b>Comments</b>	Difficult to see entire belt, from a small view it looks okay

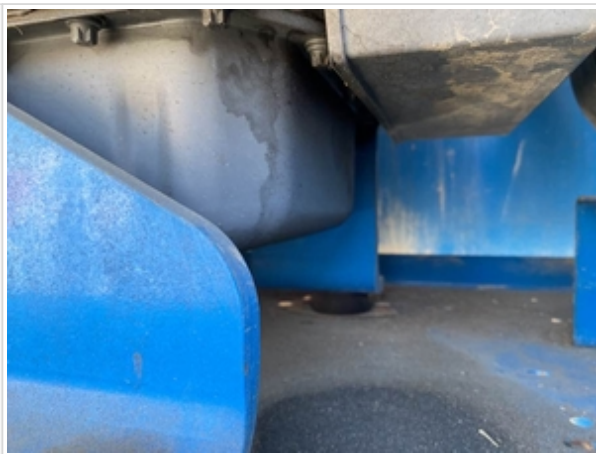
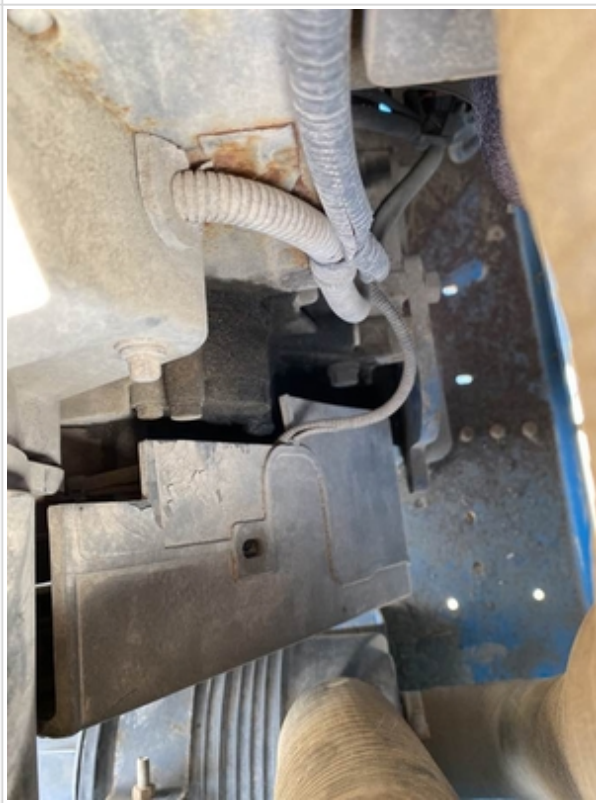
Water Pump	0
Cooling System Leaks	No
Coolant Color / Appearance	0
Oil Leaks	Yes
Oil Leak Notes	Dried oil seepages seen, Other (see comments)
Comments	Minor oil seepage from top side behind engine (no drips or puddles)
Oil Leak Photos

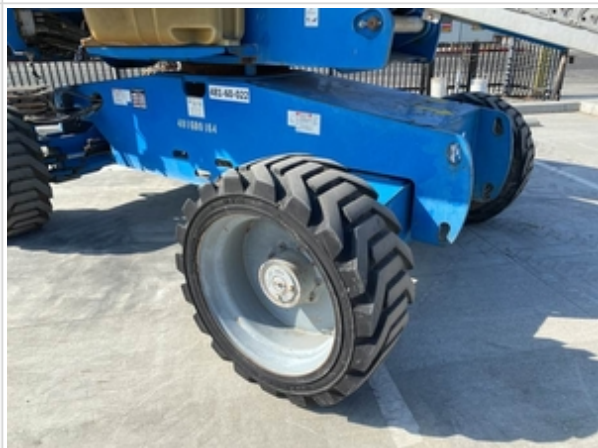
<b>Wheels &amp; Tires</b>	3 - Normal Wear & Tear	
<b>Comments</b>	Front right side rim on backwards, possibly swapping wheels across corners may fix the rotation	
<b>Wheels &amp; Tires Photos</b>

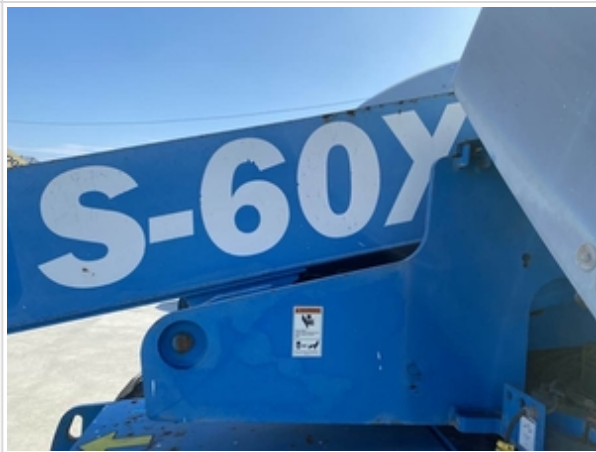
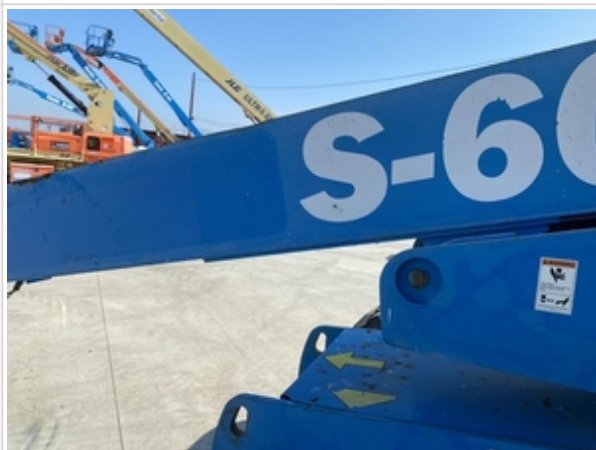
Boom Condition	3 - Normal Wear & Tear	
Comments	Inner boom section slightly bent at r/s end	
Boom Condition Photos

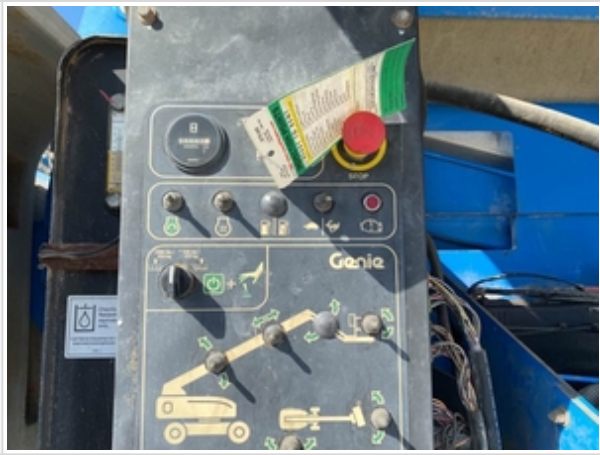
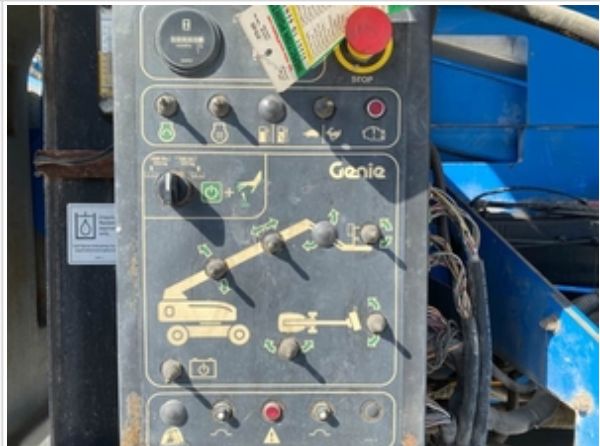
<b>Unusual Noises (Hydraulic Pump)</b>	No	
<b>Hydraulic Pump Notes</b>	No unusual noises heard during operation	
<b>External Controls / Levers</b>	3	
<b>External Controls / Levers Condition</b>	Good function & condition of hydraulic controls, Other (see comments)	
<b>Comments</b>	Control labels need to be replaced (hard to see)	
<b>External Controls / Levers Photos</b>

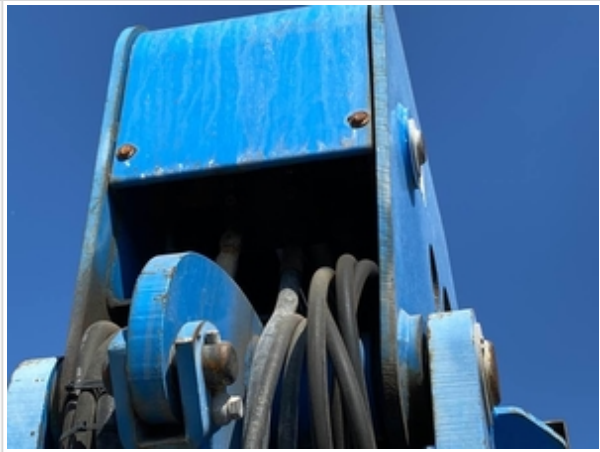
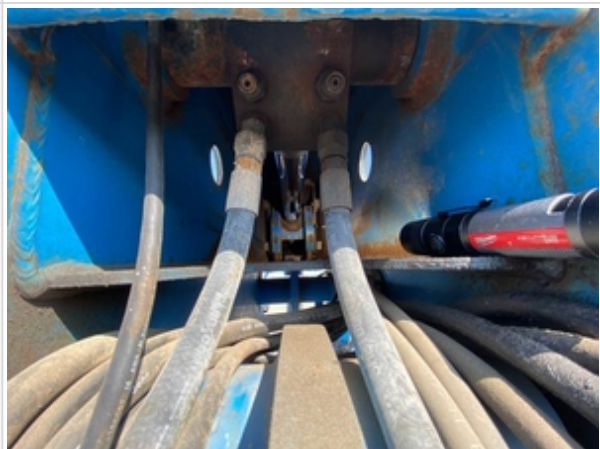
<b>Boom Extension Cylinder</b>	Check the boom extension cylinder. Note any wear, pitting, discoloration, etc. Take photos.	
<b>Boom Extension Cylinder: Mounting Pin</b>	4	
<b>Boom Extension Cylinder: Oil Leaks</b>	No	
<b>Comments</b>	Boom hose track slightly bent	
<b>Boom Extension Cylinder Photos</b>
