## Inspection Report (Vibratory Compactor)

Year	2005
Make	Ingersoll-Rand
Model	DD-158HFA
Serial Number	181360
Hour Meter Reading	2,491 Hours
Previous Application (e.g., earth moving, mining, demolition, etc)	Asphalt Paving Construction

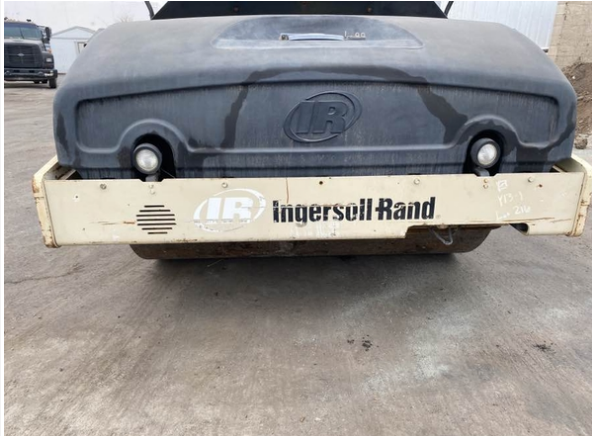
Rear	3 - Normal Wear & Tear	
Rear Condition	No visible damage, Visible chipped paint or dents, Other (see comments)	
Comments	Scuff marks present	
Rear Photos

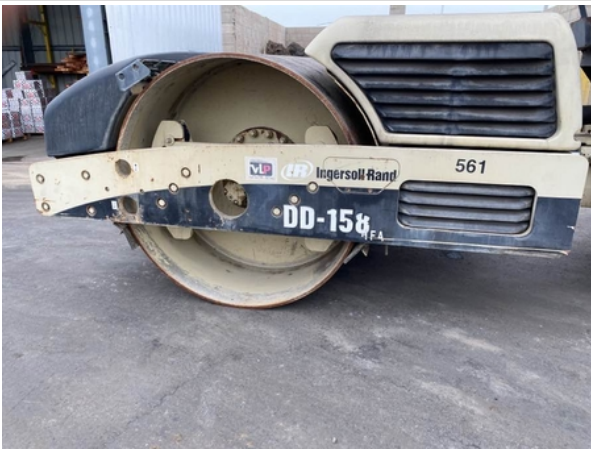
<b>Left</b>	3 - Normal Wear & Tear
<b>Left Condition</b>	No visible damage, Visible chipped paint or dents, Other (see comments)
<b>Comments</b>	Small paint chipped areas present

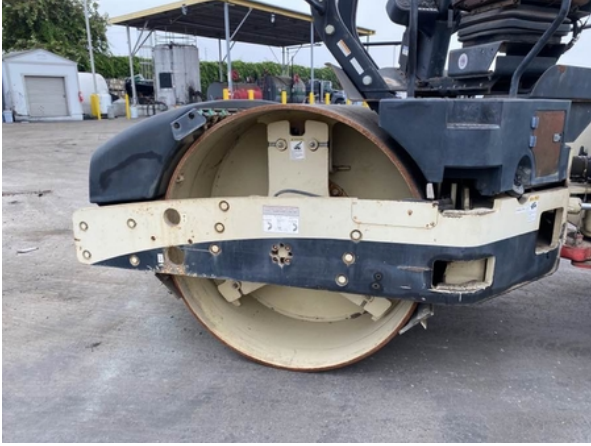
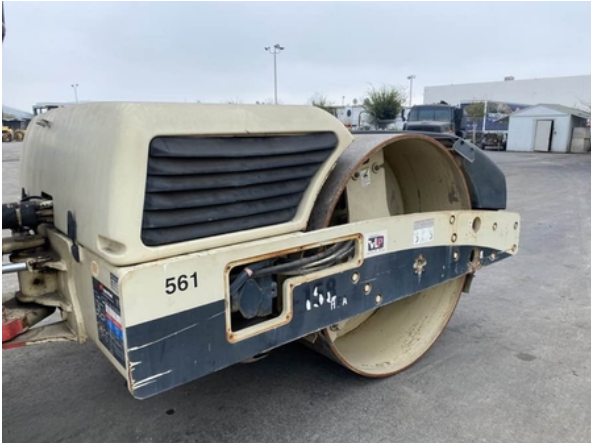
<b>Right</b>	3 - Normal Wear & Tear	
<b>Right Condition</b>	No visible damage, Visible chipped paint or dents, Other (see comments)	
<b>Comments</b>	Small chipped paint areas present	
<b>Right Photos</b>

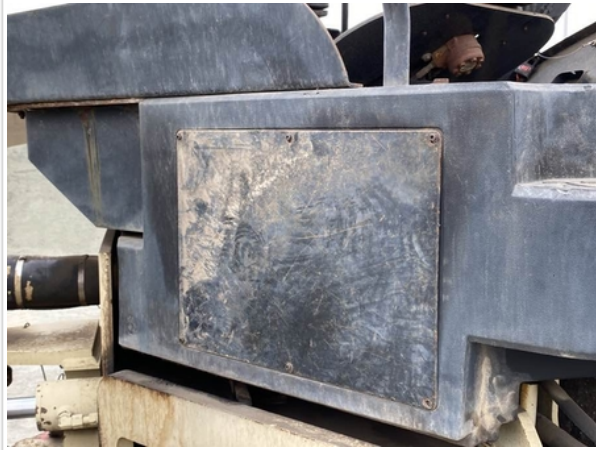
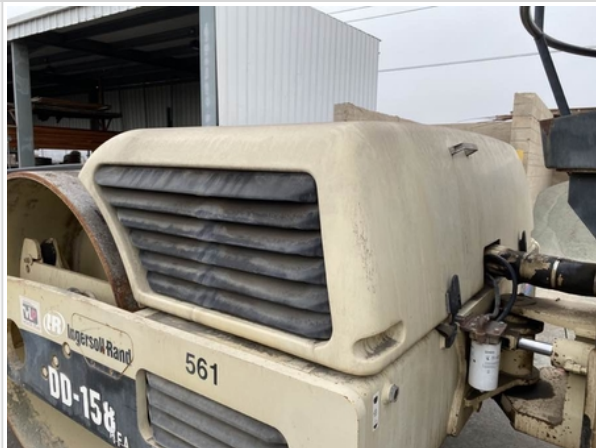
<b>Body Panels (Any Rust Damage?)</b>	3 - Normal Wear & Tear
<b>Body Panel Condition</b>	No visible damage, good paint condition and panel fitment, Other (see comments)
<b>Comments</b>	Body panel missing on r/s
<b>Body Panels Photos</b>

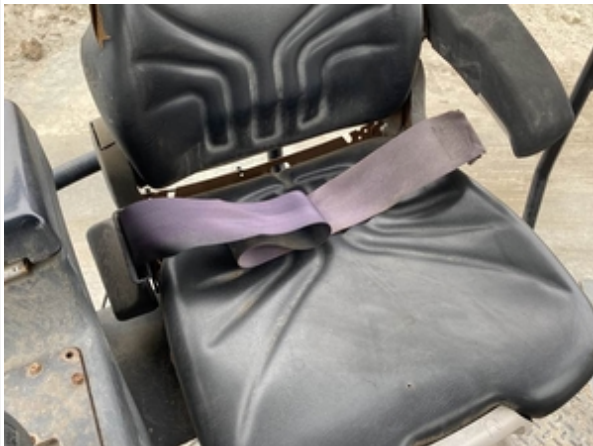
<b>Seat Belt</b>	1 - Service Required	
<b>Seat Belt Condition</b>	Seat belt is inoperative or not installed, Other (see comments)	
<b>Comments</b>	Seat belt locks in place but does not retract or extend properly	
<b>Seat Belt Photos</b>

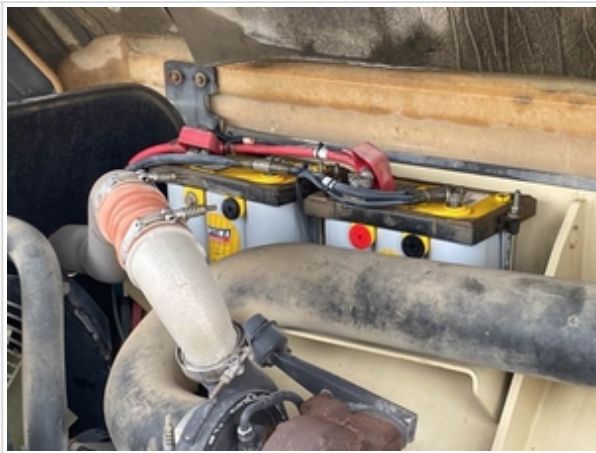
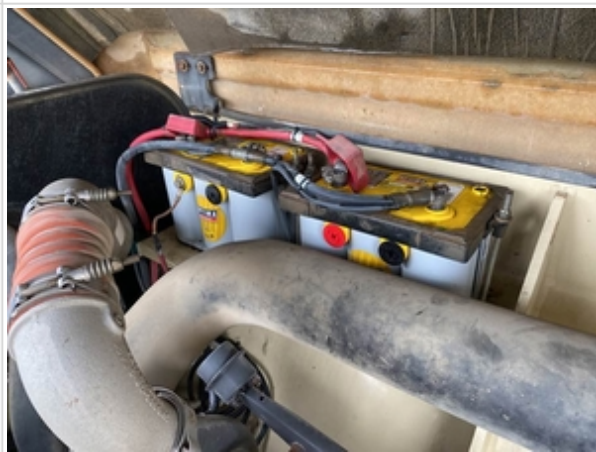
<b>Blow-by (Visual Observation Check)</b>	No
<b>Unusual Noises (Upon Start-up, Idle, Shutdown)</b>	No
<b>Unusual Noise Notes</b>	No unusual noises heard
<b>Engine Smoke (Upon Start-up, Idle, Shutdown)</b>	No
<b>Engine Smoke Notes</b>	No engine smoke issues observed
<b>Engine Exhaust Color</b>	Clear
<b>Battery</b>	3 - Normal Wear & Tear
<b>Battery Condition</b>	Like new, recently replaced, Other (see comments)
<b>Comments</b>	Batteries upgraded to Optimas

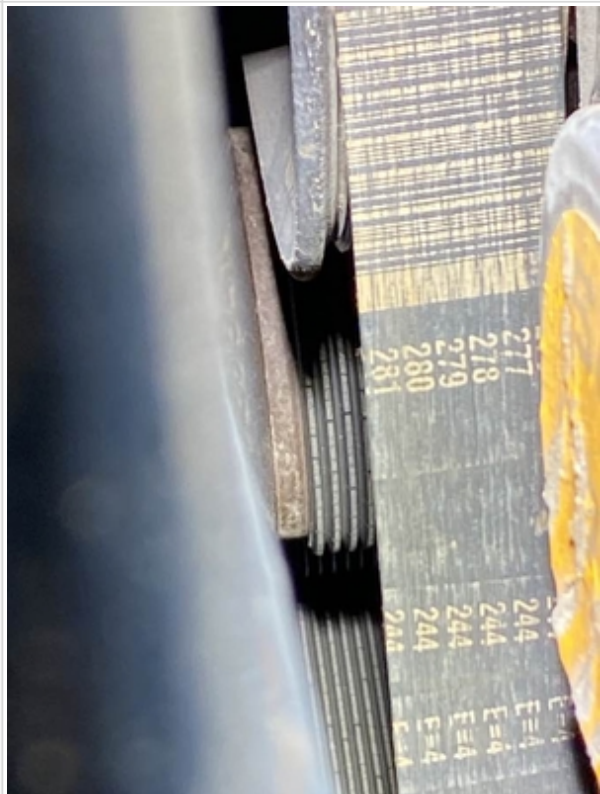
<b>Belts</b>	2 - Above Average Wear	
<b>Belt Condition</b>	Frayed belt edges observed, Other (see comments)	
<b>Comments</b>	Serpentine belt has wear cracks, should be replaced soon	
<b>Belt Photos</b>

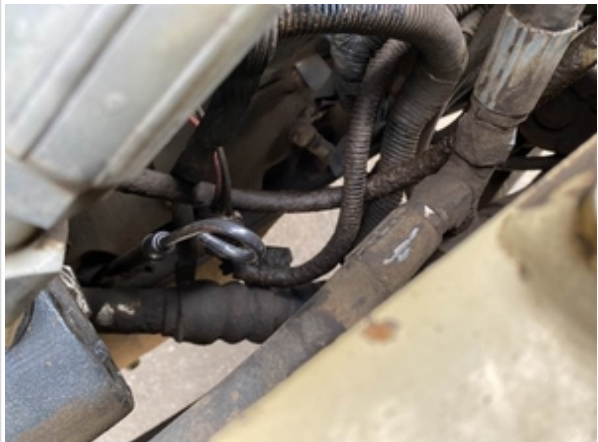
<b>Water Pump</b>	3 - Normal Wear & Tear	
<b>Water Pump Condition</b>	No unusual pump noises heard	
<b>Cooling System Leaks</b>	No	
<b>Coolant Color / Appearance</b>	3 - Normal Wear & Tear	
<b>Coolant Color/Appearance Notes</b>	Normal Translucent appearance, no visual signs of contamination	
<b>Oil Leaks</b>	No	
<b>Oil Color / Appearance</b>	3 - Normal Wear & Tear	
<b>Oil Color / Appearance Notes</b>	Clean oil appearance, no signs of cross contamination, Appropriate oil level, Other (see comments)	
<b>Comments</b>	Oil recently changed	
<b>Fuel Leaks</b>	Yes	
<b>Fuel Leak Notes</b>	Areas of accumulated dust & grime on fuel lines indicate a possible leak	
<b>Comments</b>	Seepage leaks from low pressure fuel lines and transfer pump	
<b>Fuel Leaks Photos</b>

<b>Equipped with DPF (Diesel Particulate Filter)</b>	No	
<b>Requires DEF (Diesel Exhaust Fluid)</b>	No	
<b>Overall Engine Appearance</b>	Clean & dry	
<b>Overall Engine Comments</b>	Overall engine looks & sounds healthy. Very well maintained with only a few fuel hoses that may need to be replaced. Exhaust muffler bent upwards, still works okay.

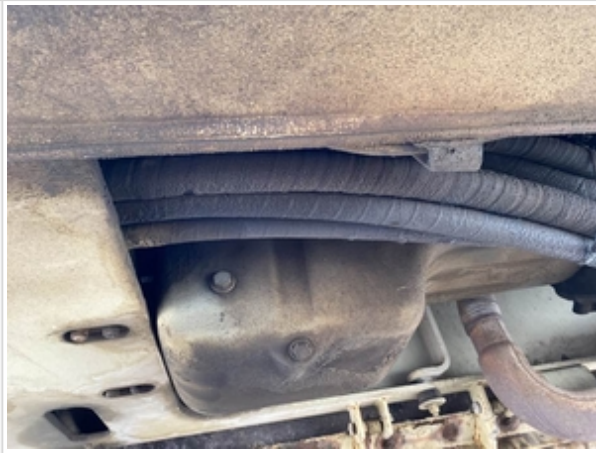
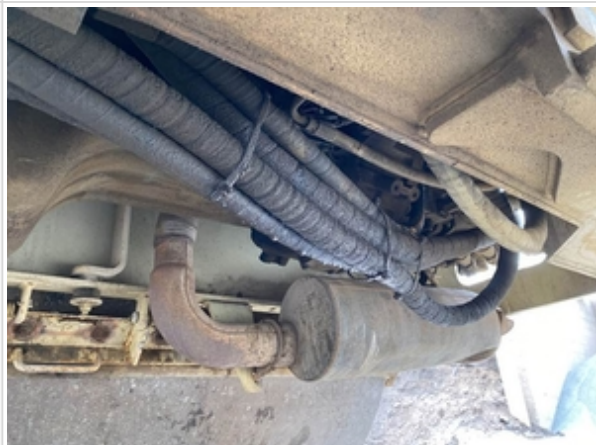
Wet or Damp Hydraulic Lines / Fittings	Yes	
Appearance of Hydraulic Lines / Fittings	3	
Hydraulic Lines / Fittings Condition	Hydraulic lines & fittings are clean and in good condition, Dried seepages observed	
Appearance of Hydraulic Lines / Fittings Photos
