## Inspection Report (Generator)

Year	2021
Make	Sutech
Model	ST-CIOOGF
Serial Number	20210202B60
Hour Meter Reading	30
Previous Application (e.g., earth moving, mining, demolition, etc)	General Construction

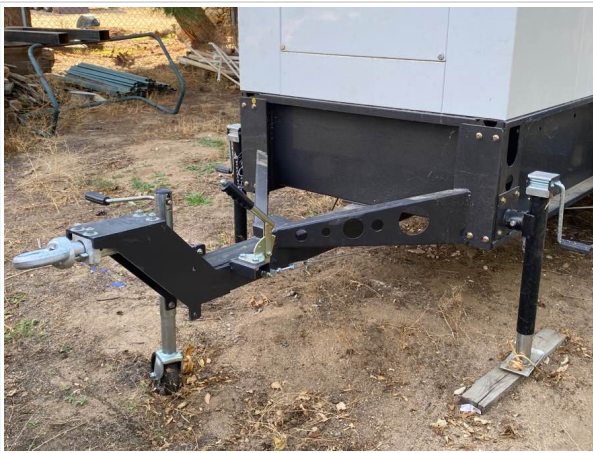
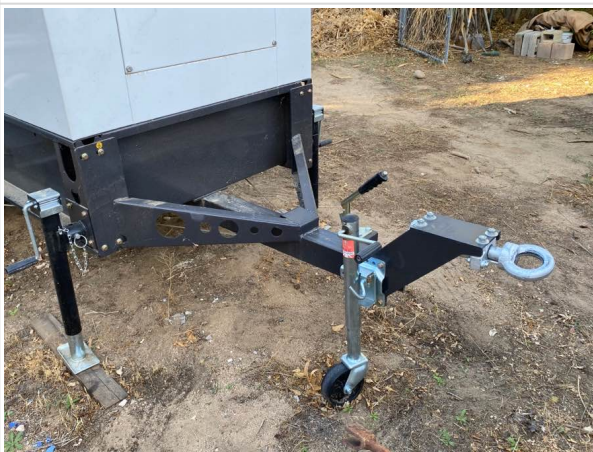
<b>Front Photos</b>

Front	4 - Like New, Recently Replaced
Front Condition	No visible damage

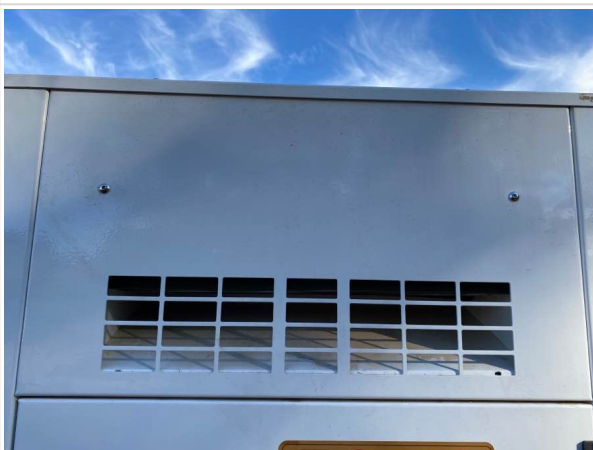
<b>Rear</b>	4 - Like New, Recently Replaced
<b>Rear Condition</b>	No visible damage
<b>Rear Photos</b>

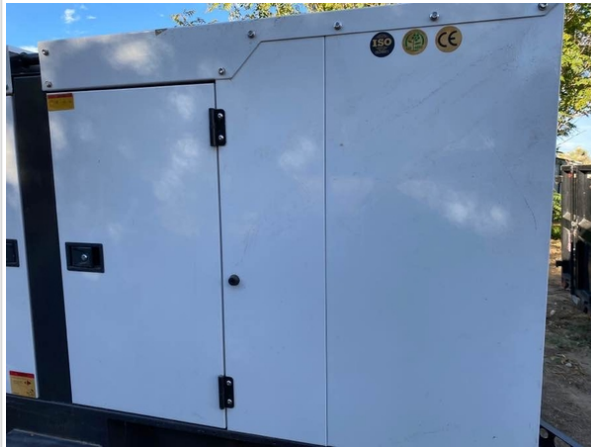
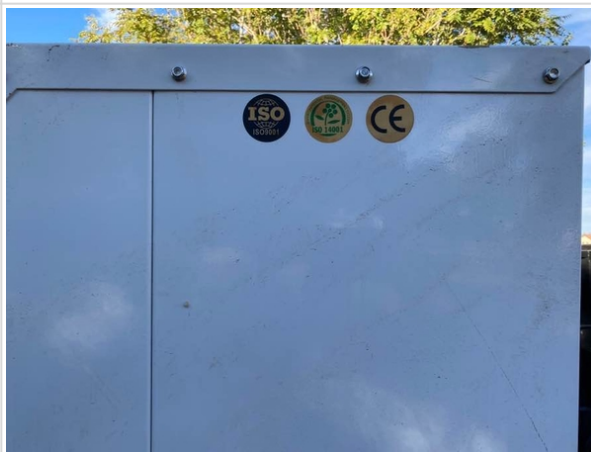
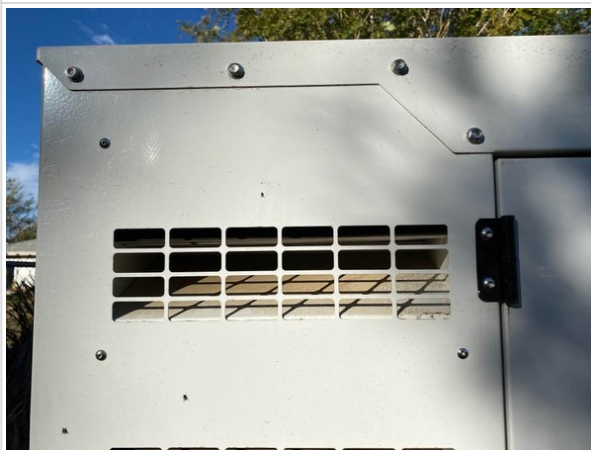
Right Photos

<b>Right</b>	4 - Like New, Recently Replaced
<b>Right Condition</b>	No visible damage

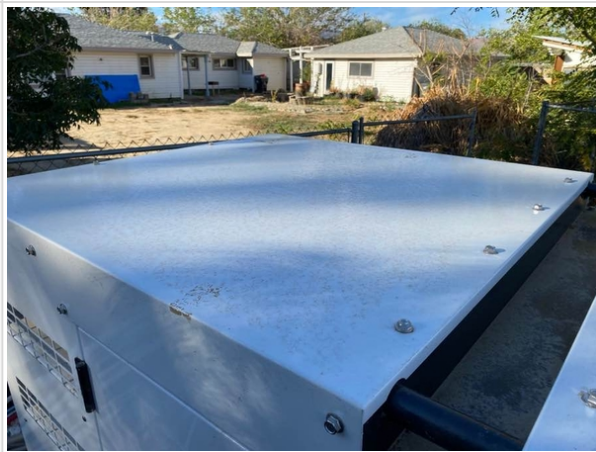
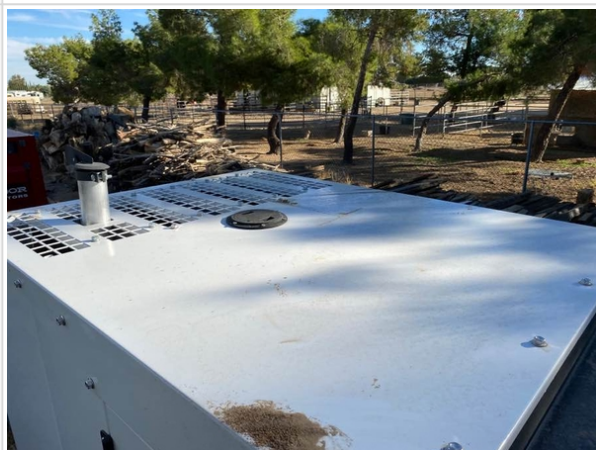
Upper	4 - Like New, Recently Replaced	
Upper Condition	No visible damage	
Upper Photos

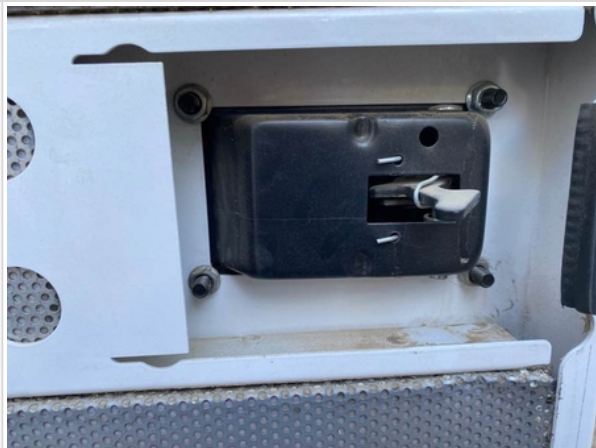
<b>Body Panels (Any Rust Damage?)</b>	4 - Like New, Recently Replaced	
<b>Doors / Canopy Latches</b>	4 - Like New, Recently Replaced	
<b>Doors / Canopy Latches Condition</b>	No visible damage	
<b>Doors / Canopy Latches Photos</b>

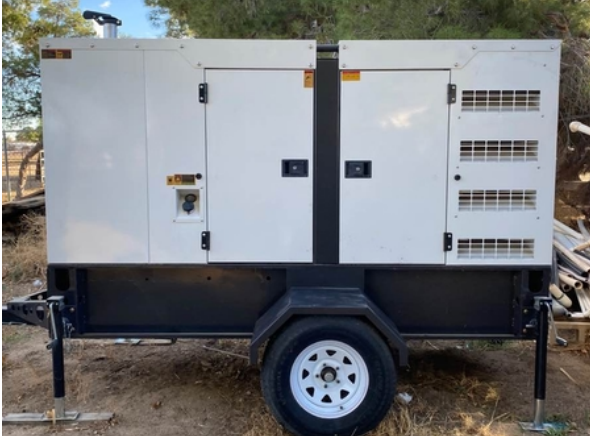
<b>Left Photos</b>

<b>Rear</b>	4 - Like New, Recently Replaced
<b>Rear Condition</b>	No visible damage
<b>Rear Photos</b>	 
<b>Left</b>	4 - Like New, Recently Replaced
<b>Left Condition</b>	No visible damage

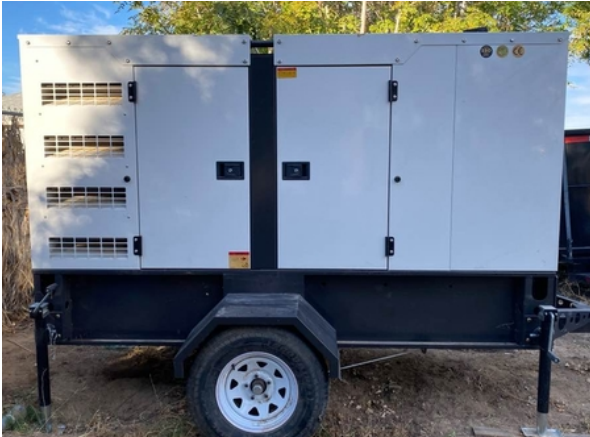
<b>Right</b>	4 - Like New, Recently Replaced	
<b>Right Condition</b>	No visible damage	
<b>Right Photos</b>

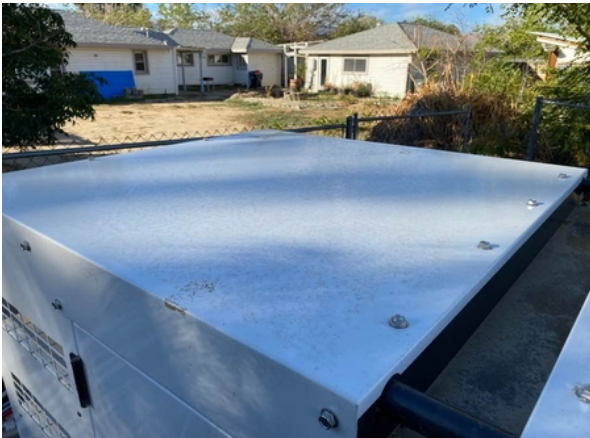
<b>Upper</b>	4 - Like New, Recently Replaced	
<b>Upper Condition</b>	No visible damage	
<b>Upper Photos</b>

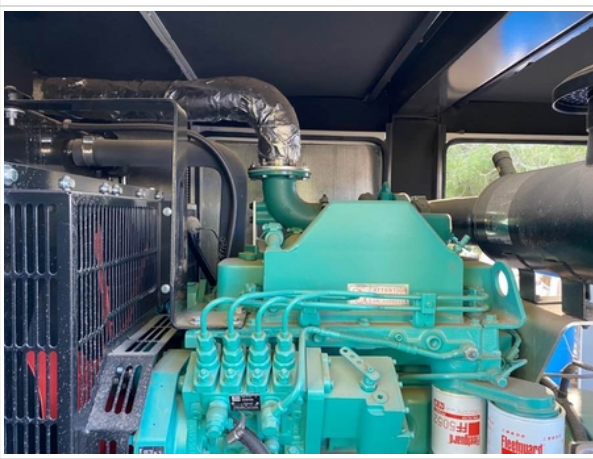
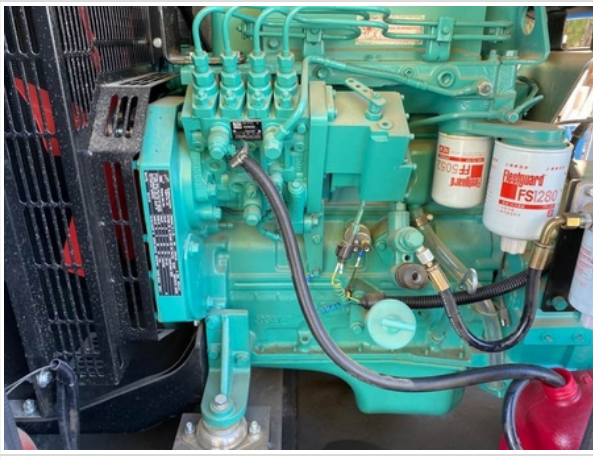
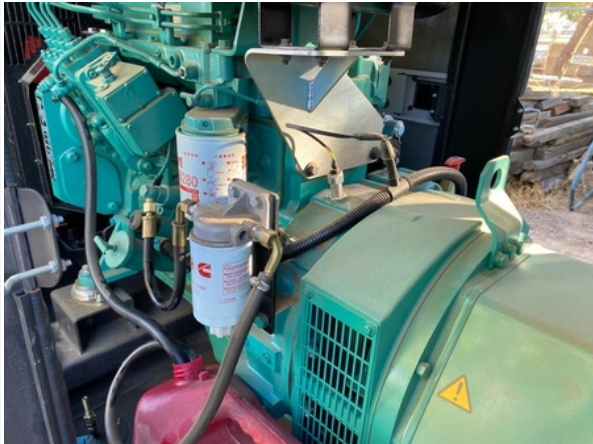
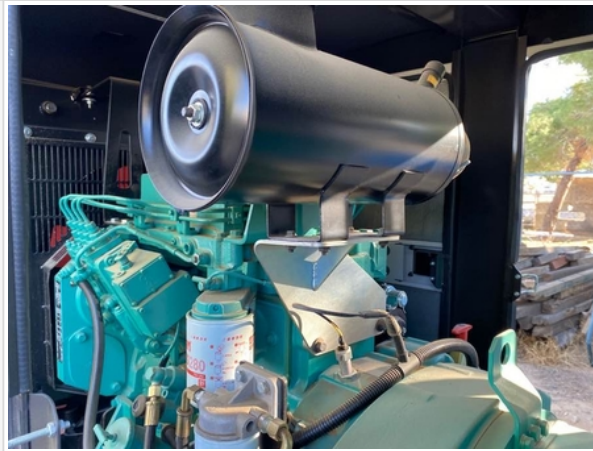
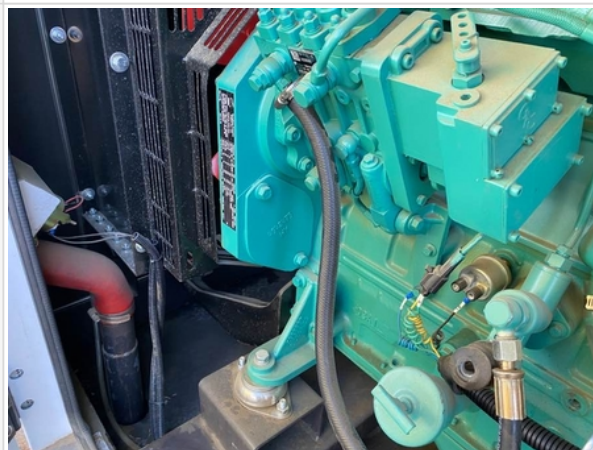
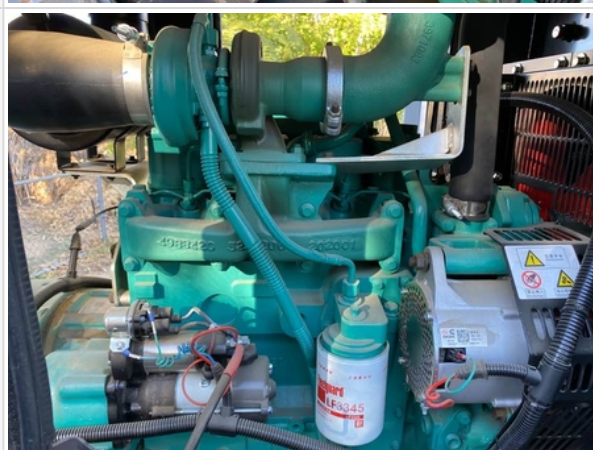
<b>Engine Type (Make, Model, Cylinders, Hp)</b>	Cummins - 4BTA-LQ-S006 - 4 CYL. - 98HP
<b>Emissions Tier</b>	Tier 4F
<b>Engine Serial Number</b>	82226297
<b>Engine Fuel Type</b>	Diesel
<b>Engine Photos</b>

Oil Color / Appearance Notes	Clean oil appearance, no signs of cross contamination, Appropriate oil level
Fuel Leaks	No
Equipped with DPF (Diesel Particulate Filter)	Yes
DPF Condition	4 - Like New, Recently Replaced
DPF Condition Notes	Filter housing is intact with no signs of damage or malfunction, DPF indicator is not illuminated
Requires DEF (Diesel Exhaust Fluid)	Yes
DEF Tank	4 - Like New, Recently Replaced
DEF Tank Condition	Area around DEF tank cap is clean, fluid is clear & appears free of contaminants
Overall Engine Appearance	Clean & dry
Overall Engine Comments	Engine in great condition. Priming pump handle broken, besides that the rest of the engine looks solid.

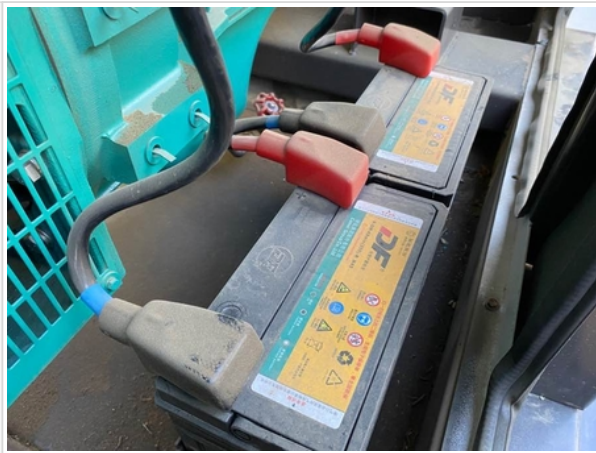
<b>Battery Condition Photos</b>

<b>Blow-by (Visual Observation Check)</b>	No
<b>Unusual Noises (Upon Start-up, Idle, Shutdown)</b>	No
<b>Unusual Noise Notes</b>	No unusual noises heard
<b>Engine Smoke (Upon Start-up, Idle, Shutdown)</b>	No
<b>Engine Smoke Notes</b>	No engine smoke issues observed
<b>Engine Exhaust Color</b>	Clear
<b>Battery</b>	4 - Like New, Recently Replaced
<b>Battery Condition</b>	Like new, recently replaced

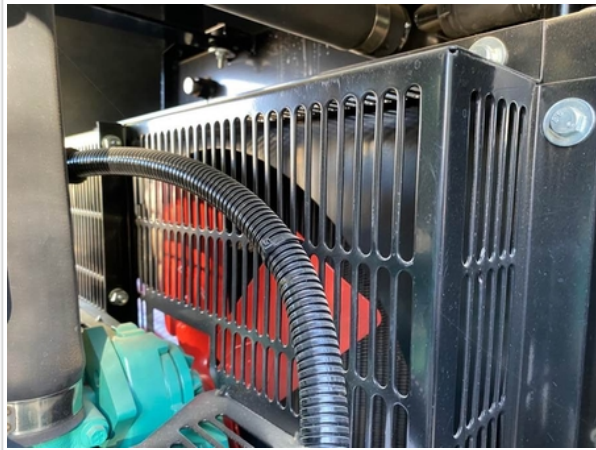
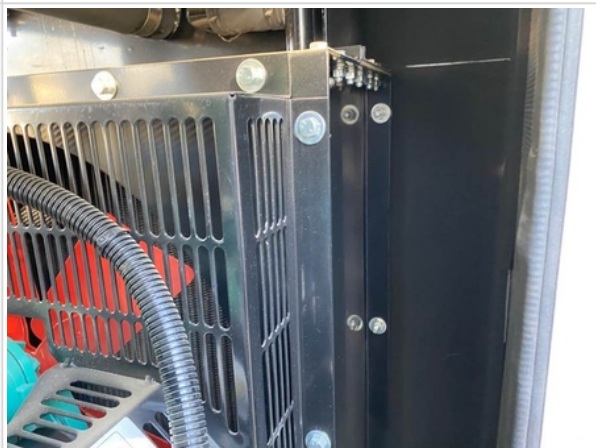
<b>Radiator</b>	4 - Like New, Recently Replaced
<b>Radiator Condition</b>	Radiator fins & components appear to be in good working order, no signs of damage or leaks
<b>Radiator Photos</b>

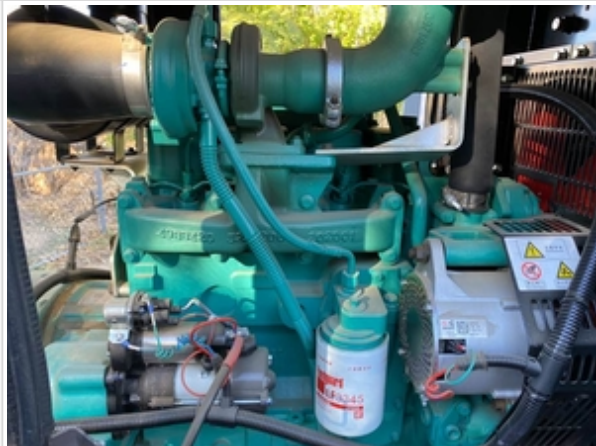
<b>Belts</b>	4 - Like New, Recently Replaced
<b>Belt Condition</b>	Belts appear in good condition & alignment with proper tension
<b>Hoses</b>	4 - Like New, Recently Replaced
<b>Hose Condition</b>	Firm, pliant hoses with no signs of wear or leaks
<b>Hose Photos</b>

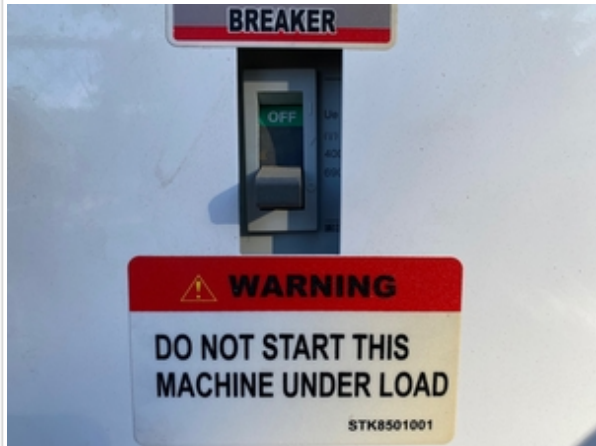
<p>Controls &amp; Switches</p>	<p>4 - Like New, Recently Replaced</p>	
<p>Controls &amp; Switches Photos</p>

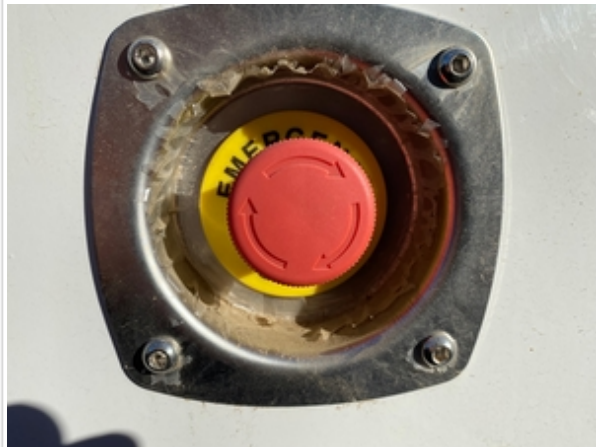
Disconnect Switch	4 - Like New, Recently Replaced
Disconnect Switch Photos

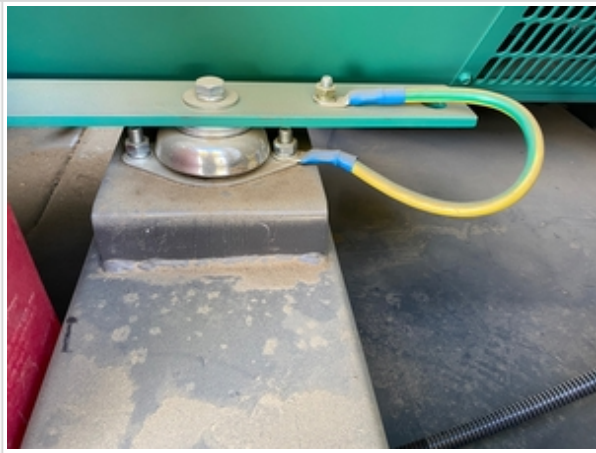
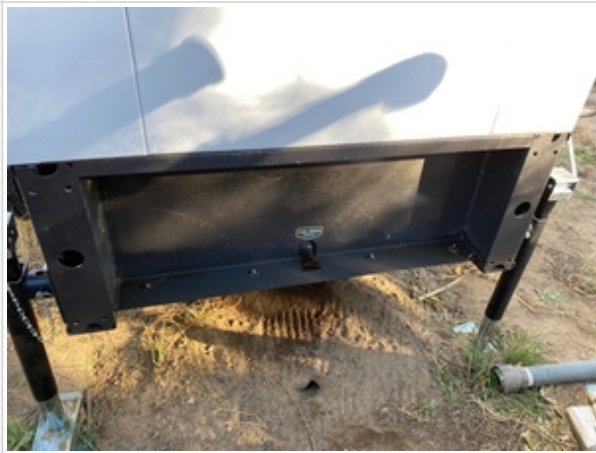
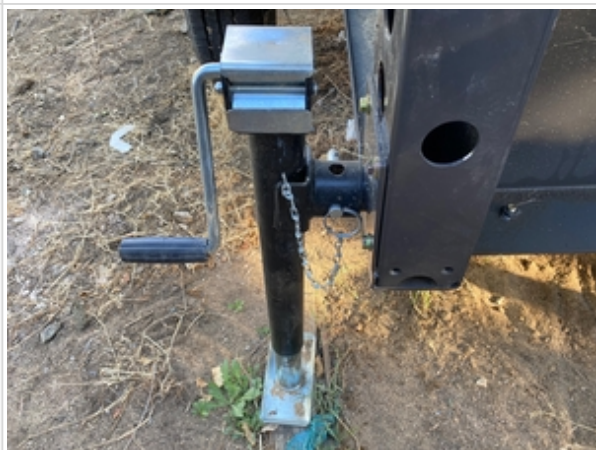
<b>Frame Condition</b>	4 - Like New, Recently Replaced
<b>Frame Photos</b>

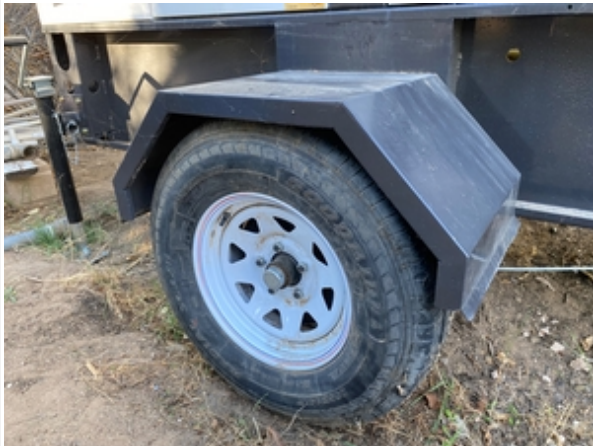
<b>Fenders</b>	4 - Like New, Recently Replaced
<b>Fender Photos</b>

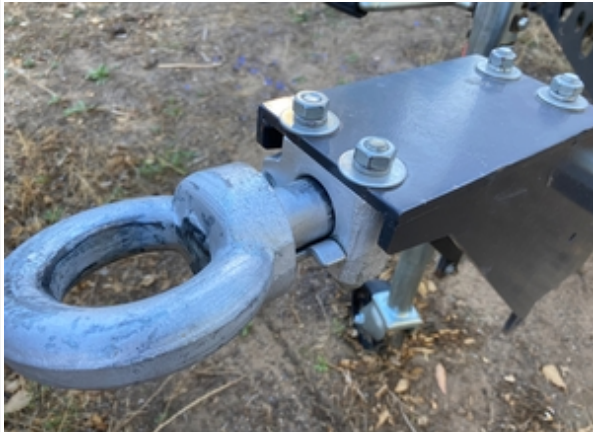
<b>Hitch Type</b>	Pintle
<b>Hitch Condition</b>	4 - Like New, Recently Replaced
<b>Hitch Photos</b>

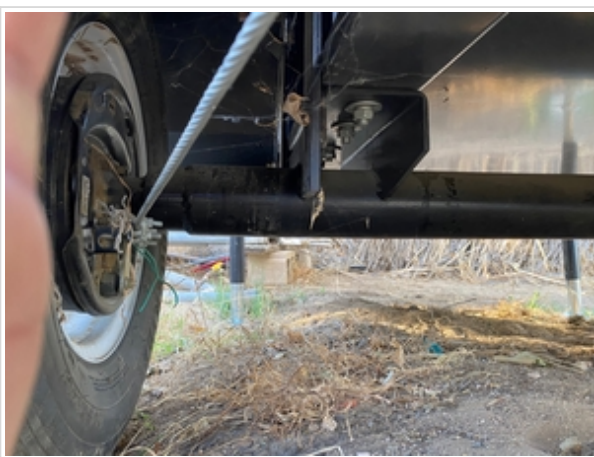
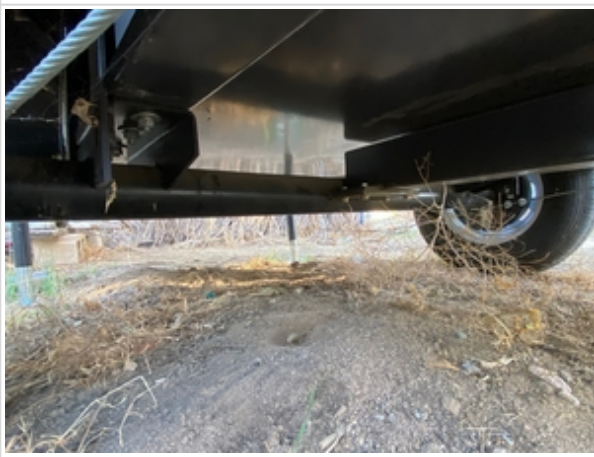
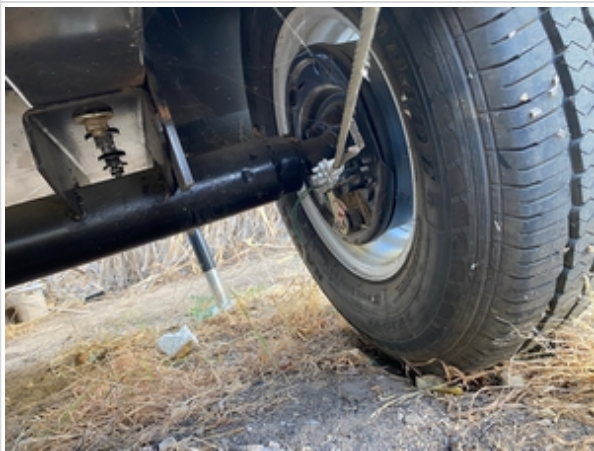
<p>Torque Arms Photos</p>

Springs	0
U-Bolts	0
Torque Arms	4

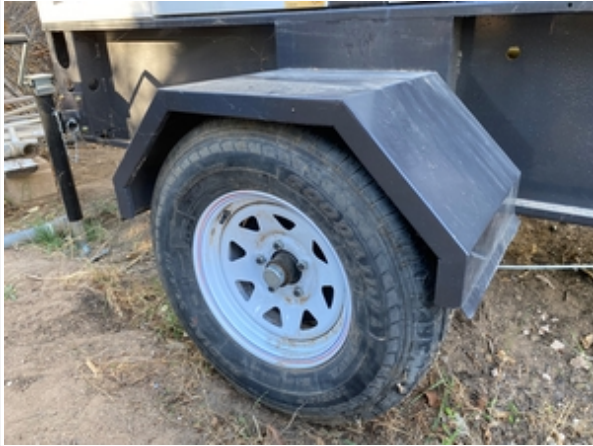
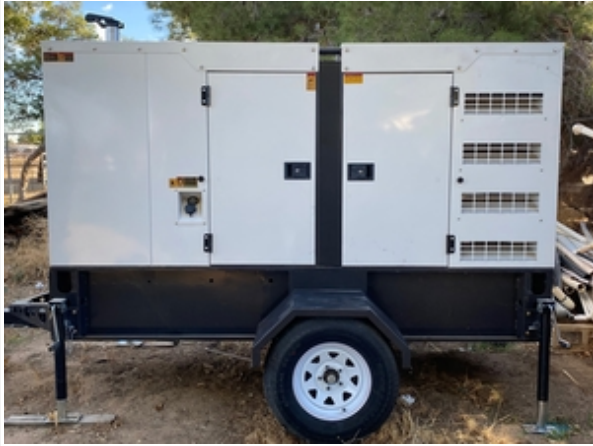
Wheels & Hub Condition	4 - Like New, Recently Replaced
Wheels & Hub Photos

Loose Lugs	No
Tire Brand	GOODRIDE
Tire Size	205R14LT
Front Left Tire - Ratio Remaining	90%
Front Right Tire - Ratio Remaining	90%

Rear Right Tire - Ratio Remaining	10%
Rear Left Tire - Ratio Remaining	10%

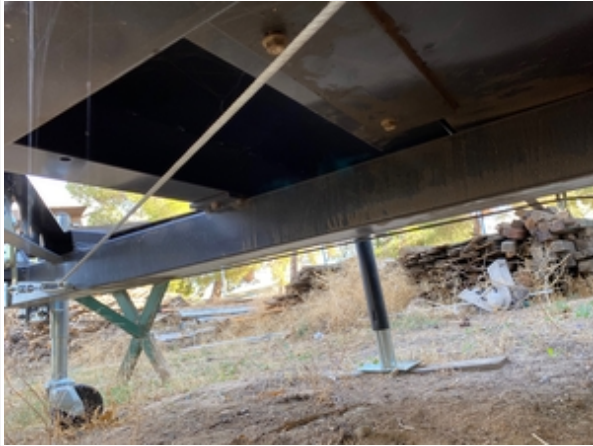
Brake Type	Other (see comments)
Comments	No harness on unit
Brake Controller	No
Brake Shoe Thickness	10%
Comments	No brakes
Emergency Brake/Break-Away	0

Overall Trailer	4 - Like New, Recently Replaced
Overall Trailer Comments	Overall trailer in great condition , no lights or brakes on unit
Overall Trailer & Undercarriage Photos

Overall Assessment	
Exterior Rating	4
Interior Rating	4
Safety Rating	3
Quality Rating	4
Functionality Rating	4
Overall Rating	4
What's Great About the Machine	Machine has hardly any use. Still has new look to it and all functions work as expected.
What Needs Work	No trailer lights or brakes so trailer needs work.
Date/Time	10-20-2022
