Inspection Report (On-Highway Dump Truck)

Year	2011
Make	Peterbilt
Model	367
Serial Number	1NPTLU0X4BD127976
Truck Odometer Reading	425,002 miles
Current Inspection / State Cert / DOT	90 day b.i.t. Inspection performed 6/20/22 @424,994
Previous Application (e.g., earth moving, mining, demolition, etc)	asphalt road work

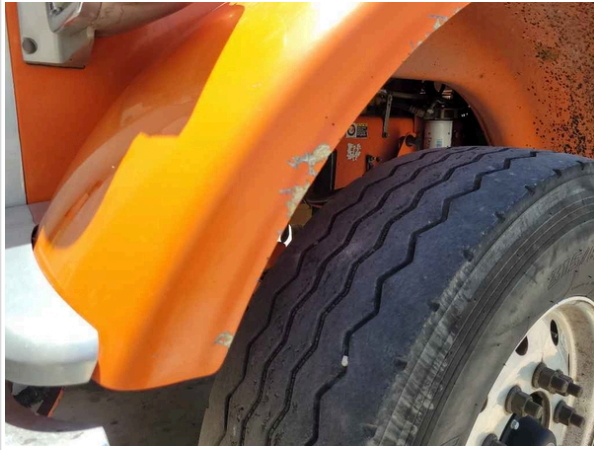
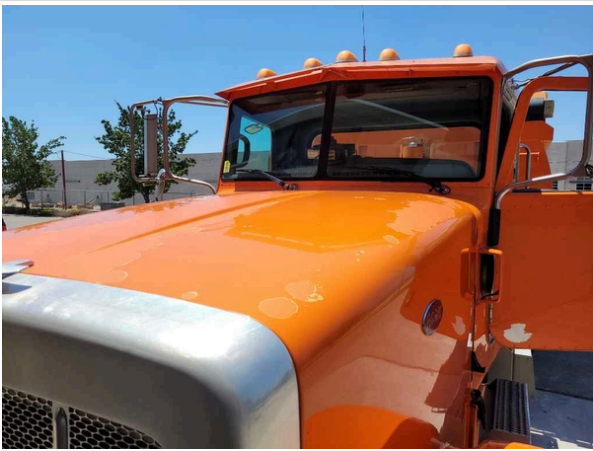
Front	3 - Normal Wear & Tear
Front Condition	No visible damage, Other (see comments)
Comments	minor fiberglass chips off fenders and clear coat peeling
Front Photos

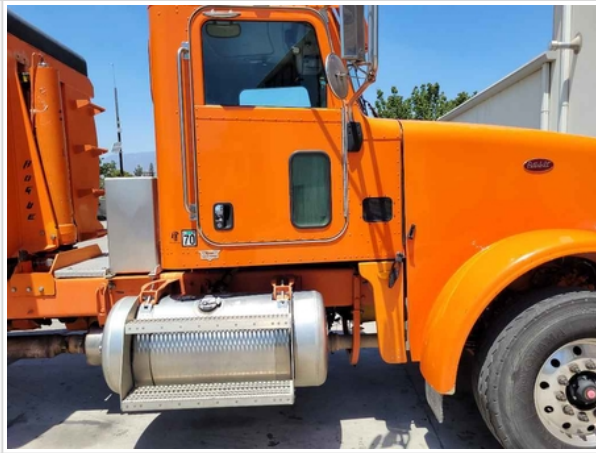
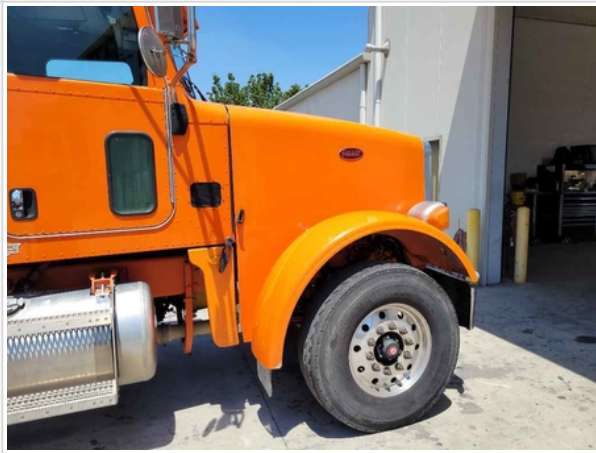
Right	3 - Normal Wear & Tear
Right Condition	No visible damage, Other (see comments)
Comments	discoloration from weld repairs

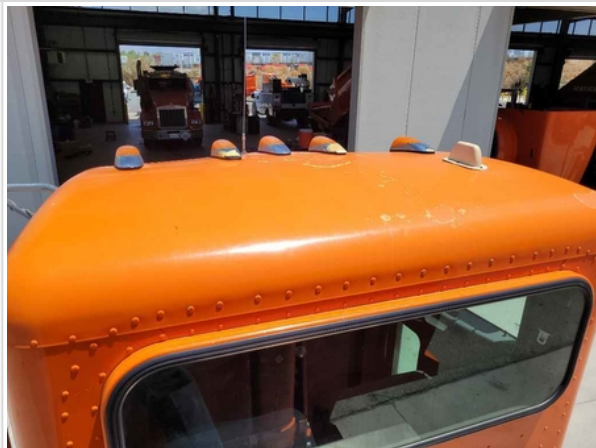
Upper	3 - Normal Wear & Tear	
Upper Condition	No visible damage, Other (see comments)	
Comments	clear coat peeling	
Upper Photos

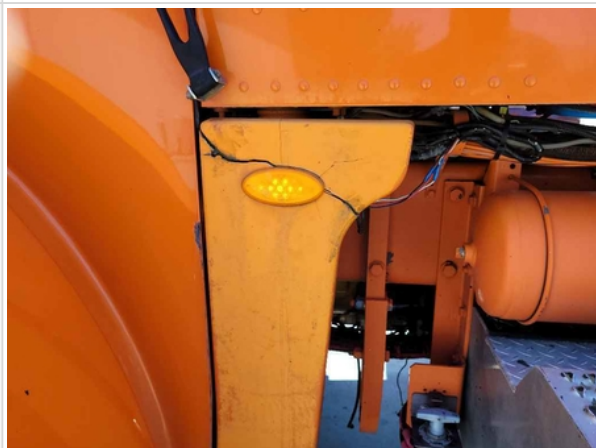
Lighting System	3 - Normal Wear & Tear	
Lighting System Condition	Other (see comments), One or more exterior lights are non-operational	
Comments	rear auxiliary work light inoperable, top cab marker lamps inop.	
Lighting System Photos

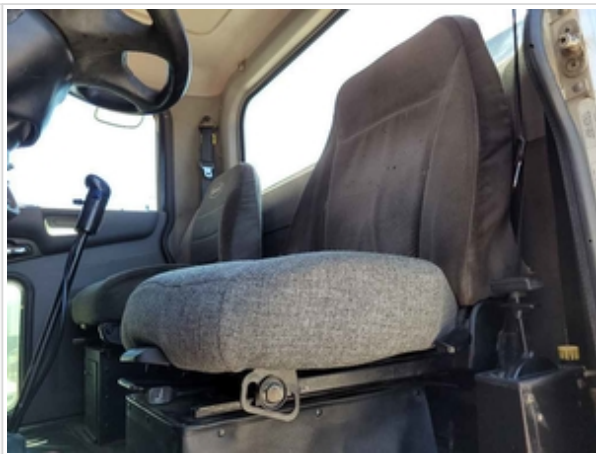
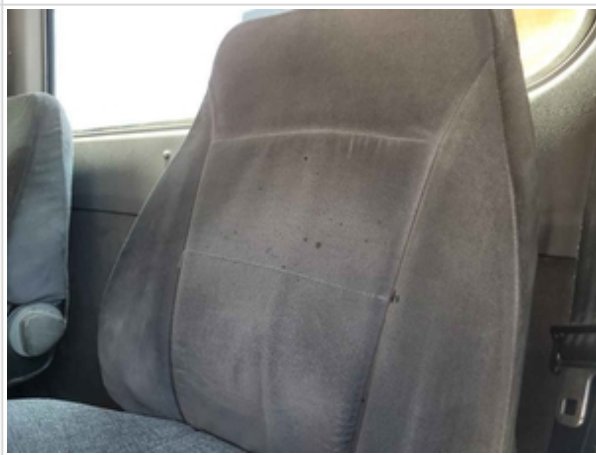
Operator Cabin	3 - Normal Wear & Tear	
Comments	normal wear, seats stained but interior pretty much intact	
Operator's Seat & Arm Rests	3 - Normal Wear & Tear	
Comments	cushion replaced, doesn't match original (cosmetic)	
Operator's Seat & Arm Rests Photos

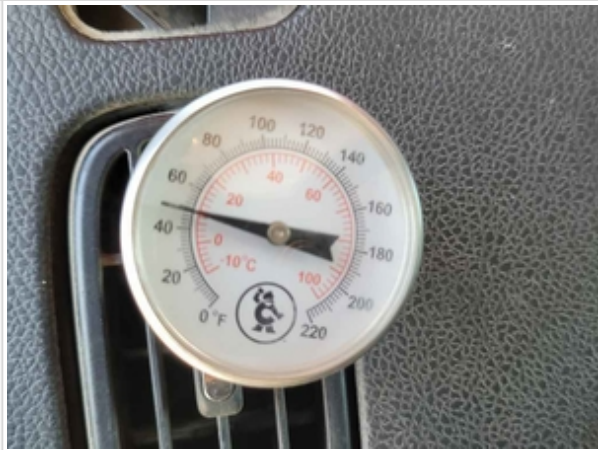
<p>Heater & A/C</p>	<p>4 - Like New, Recently Replaced</p>
<p>Comments</p>	<p>a/c temperature exceeds 30° temp drop</p>
<p>Heater & A/C Photos</p>

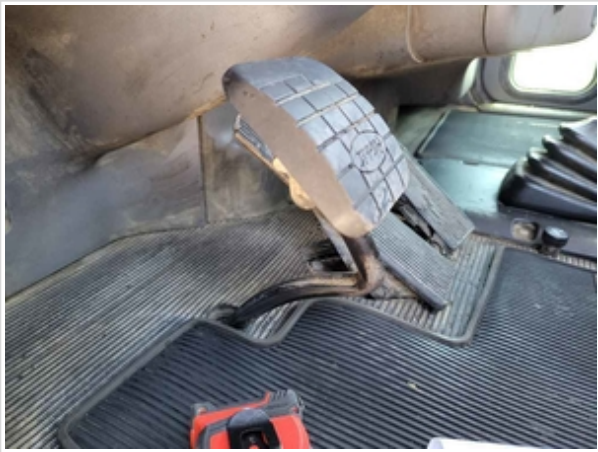
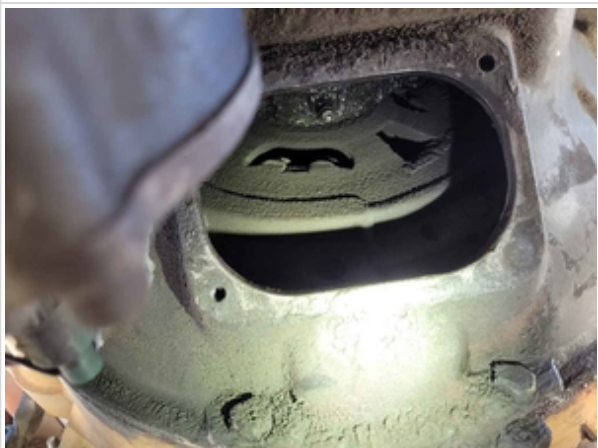
Clutch	3 - Normal Wear & Tear	
Clutch Condition	Other (see comments), Clutch is functioning as expected	
Comments	clutch pedal in need of adjustment	
Clutch Photos

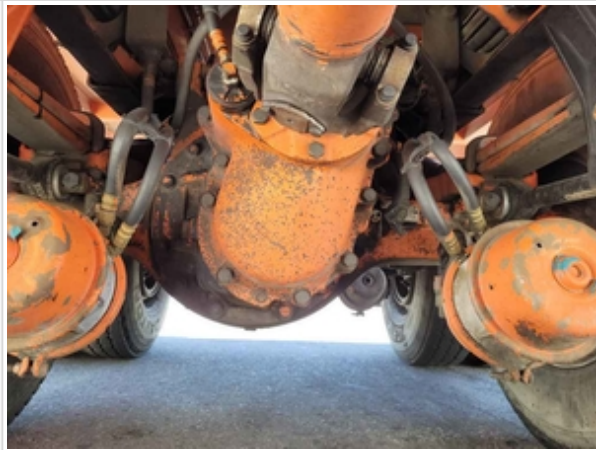
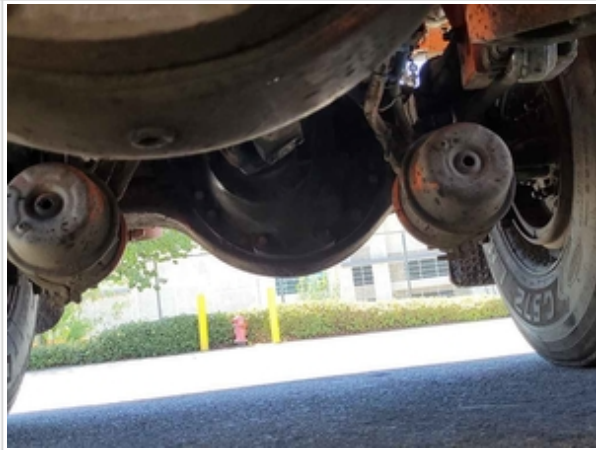
Differential	Check condition of the differential(s). Take photos and notes as relevant.
Rear Differential	3 - Normal Wear & Tear
Rear Differential Condition	Dry housing appearance, no unusual noises heard during operation, Other (see comments)
Comments	disconnected connector to 2nd axle diff sensor

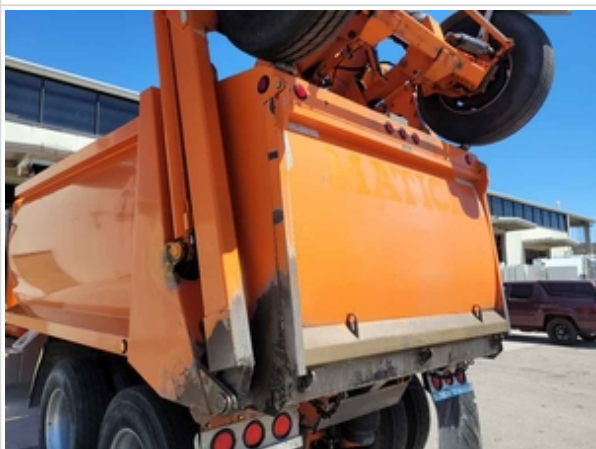
Dump Body, Tailgate, Support & Trap	Check the condition of the dump body, tailgate, support & tarp. Note any damage or wear. Take photos.	
Dump Body Make & Material	Rogue	
Dump Body Length (ft and inches)	14'	
Dump Body Height (ft and inches)	5'	
Bed Body	3	
Comments	dump body in good shape	
Bed Body Photos

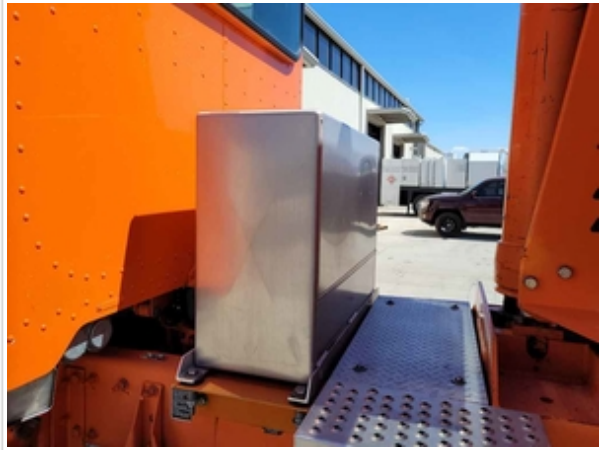
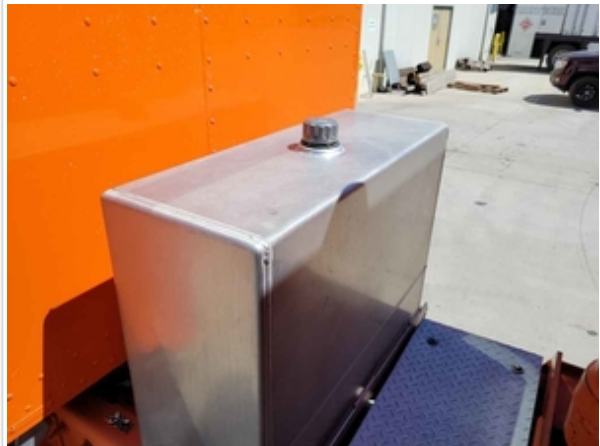
Hydraulics	Check the condition of the hydraulics. Check lines, hoses, fittings, leaks, function, etc. Note any damage or wear. Take photos.	
Hydraulic Tank	4	
Comments	have not tested tarp, tailgate, strong arm axle and dump bed actuation	
Hydraulic Tank Photos

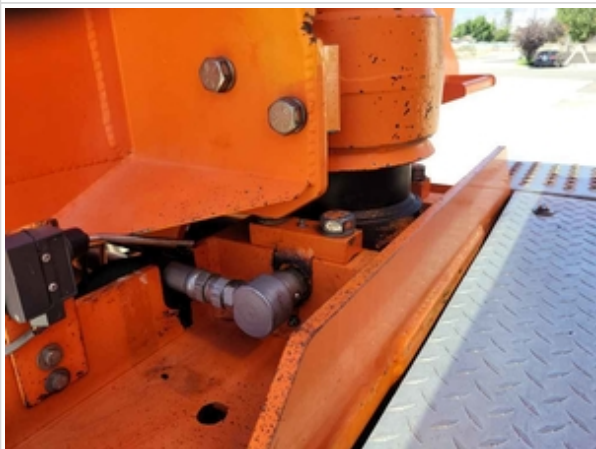
Hydraulic Cylinders	3	
Comments	hoses to strong arm axle worn (at rear)	
Hydraulic Cylinder Photos
