Inspection Report (On-Highway Flatbed Truck)

Year	2015
Make	Ford
Model	F-750
Serial Number	3FRXF7FE7FV662394
Truck Odometer Reading	219,869
Current Inspection / State Cert / DOT	Last Performed 09/2022
Previous Application (e.g., earth moving, mining, demolition, etc)	Compact Equipment Rental Hauler

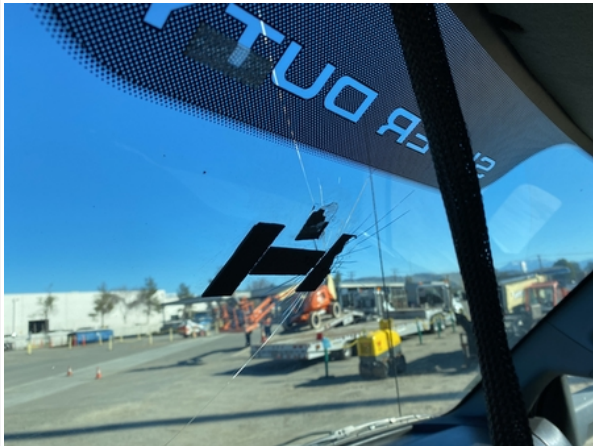
Body Panels	3 - Normal Wear & Tear
Body Panel Condition	No visible damage, good paint condition and panel fitment
Doors / Canopy Latches	3 - Normal Wear & Tear
Doors / Canopy Latches Condition	No visible damage
Steps / Ladders	3 - Normal Wear & Tear
Steps / Ladders Condition	Steps/ladders are fully intact and appear structurally sound
Handrails	3 - Normal Wear & Tear
Handrails Condition	Handrails are fully intact and appear structurally sound
Glass	2 - Above Average Wear
Glass Condition	Major chips or cracks observed, Other (see comments)
Comments	Front top center of windshield cracked
Glass Condition Photos

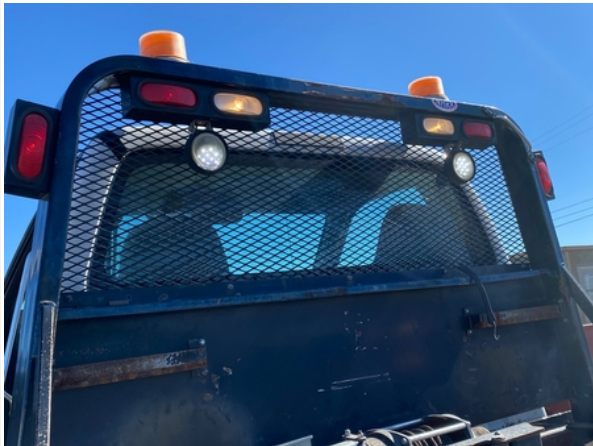
Mirrors	3 - Normal Wear & Tear
Mirror Condition	Mirrors present and intact, no visible damage
Exterior Lights	3 - Normal Wear & Tear
Exterior Lights Condition	No visible damage, lighting system is operational, Other (see comments)
Exterior Lights Photos

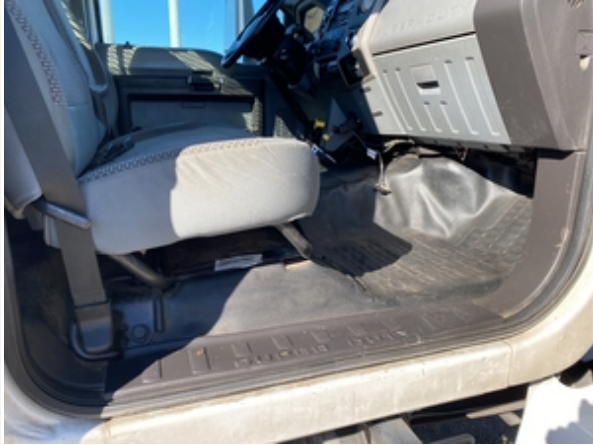
Odometer Activity	3 - Normal Wear & Tear
Odometer Condition	Odometer is working and in good condition
Controls/Switches/Gauges	3 - Normal Wear & Tear
Controls/Switches/Gauges Condition	All switches/gauges are in good condition and functioning
Brake System Type	Air Brakes
Air Brakes Build Correct Pressure	Yes
Clutch	0
Horn	3 - Normal Wear & Tear
Horn Condition	Horn is functioning as expected
Reverse Alarm / Backup Camera	2 - Above Average Wear
Reverse Alarm / Backup Camera Condition	Other (see comments)
Comments	Rear camera and wiring in place. Monitor missing. Backup alarm works well
Backup Camera Photos	 
Heater & A/C	3 - Normal Wear & Tear
Heat & A/C Condition	Only heat functionality works, Other (see comments)
Comments	A/C inoperable during the inspection

Interior Lights	3 - Normal Wear & Tear
Interior Lights Condition	All interior lights are installed and functioning
Seats/Seat Belts	3 - Normal Wear & Tear
Seats/Seat Belt Condition	Seat belt secures properly, Seat(s) have minor surface staining or small tears
Cab Interior Overall Rating	2 - Above Average Wear
Comments	Normal wear and tear and a few plastic bezels cracked driver side floor torn

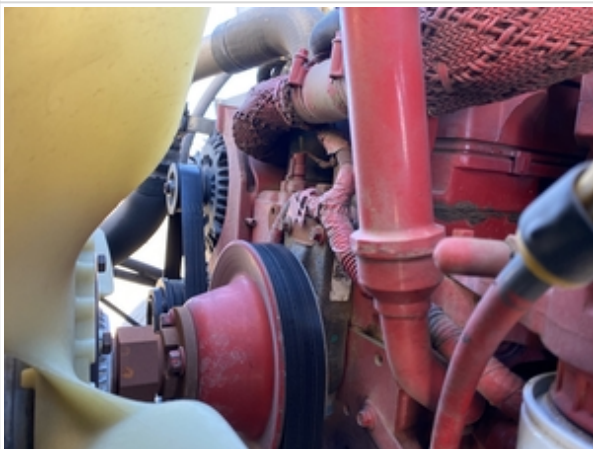
Engine Type (Make, Model, Cylinders, Hp)	Cummins - ISB6.7 289 - 6 CYL. - 280 Hp
Emissions Tier	Tier 4F
Engine Serial Number	73692358
Engine Fuel Type	Diesel
Engine Photos

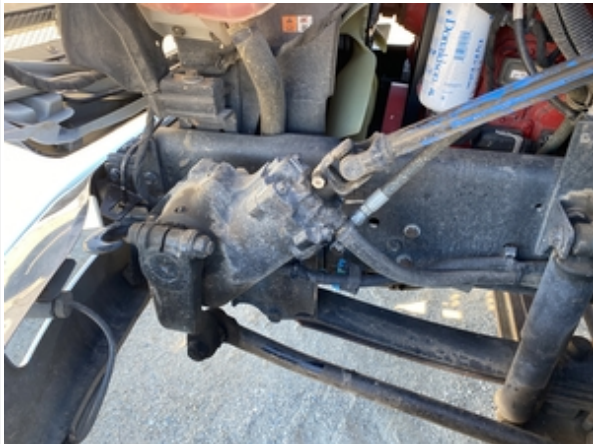
Frame	3 - Normal Wear & Tear	
Suspension	3 - Normal Wear & Tear	
Steer Axle Condition	3 - Normal Wear & Tear	
Steering Components	3 - Normal Wear & Tear	
Steering Component Photos

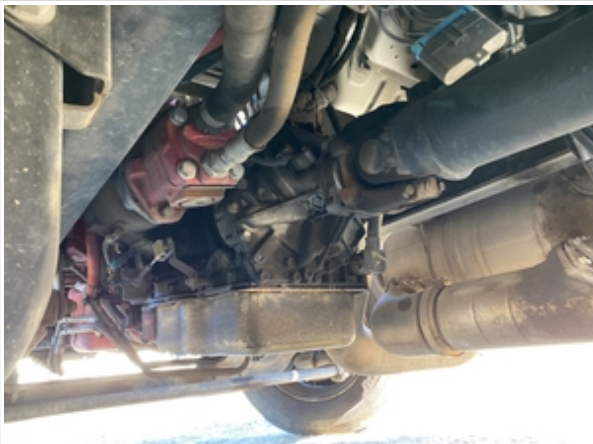
Transmission Info (Make/Model)	Allison 5 speed auto
Transmission	3 - Normal Wear & Tear
Transmission Condition	No unusual noises or vibrations, Other (see comments)
Comments	Possible leak around trans. Oil pan area
Transmission Condition Photos

Overall Drivetrain Condition	3 - Normal Wear & Tear	
Overall Drivetrain Comments	Overall drivetrain in solid shape. Minor leak at trans oil pan or around it observed.

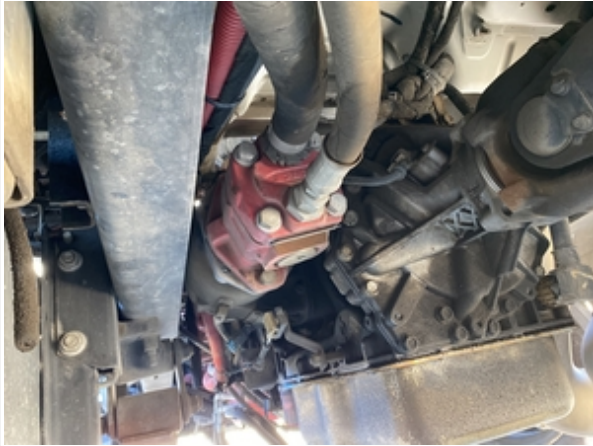
PTO	3 - Normal Wear & Tear
PTO Photos

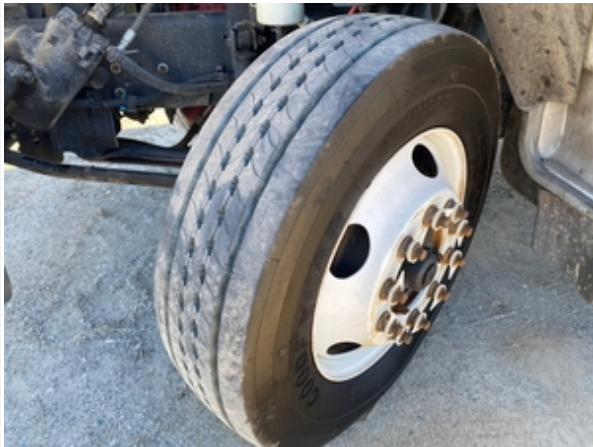
Front Left Tire Photos

Wheel Seal Leaks	No
Tire Brand	Front - Goodyear. Rear - Sumitomo
Tire Size	Front & Rear - 275/70R/22.5.
Front Left Tire - Ratio Remaining	90%

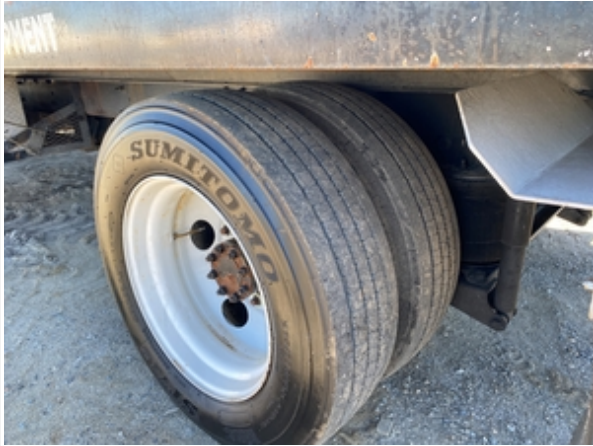
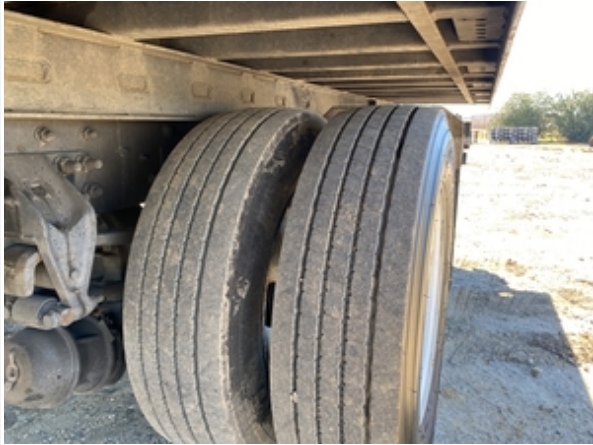
Rear Left Tire - Ratio Remaining	70%	
Rear Left Tire Photos

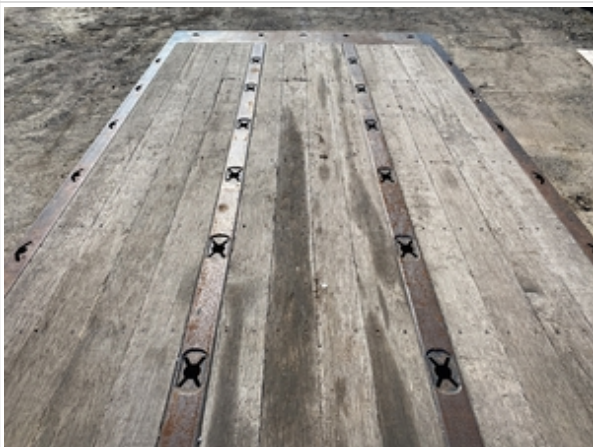
Bed Details (Deck Type, Additional Features)	Century 16,000 (Capacity)
Flatbed Length (ft and inches)	24'
Flatbed Width (ft and inches)	8'6"
Flatbed Body	3
Flatbed Body Photos
