## Inspection Report (Asphalt Trailer)

Year	2004
Make	Crafco
Model	Super Shot 250
Serial Number	N/A
Current Inspection / State Cert / DOT	N/A
Previous Application (e.g., earth moving, mining, demolition, etc)	Asphalt General Construction

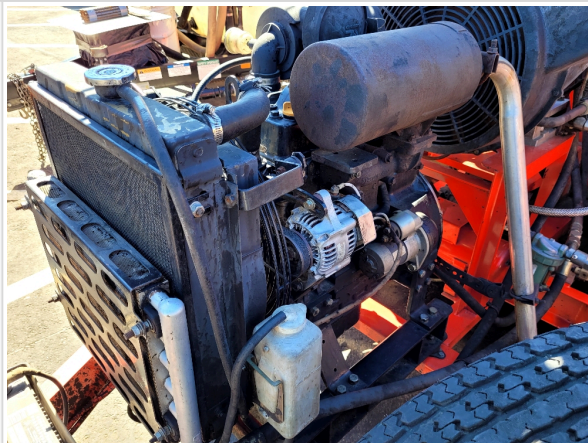
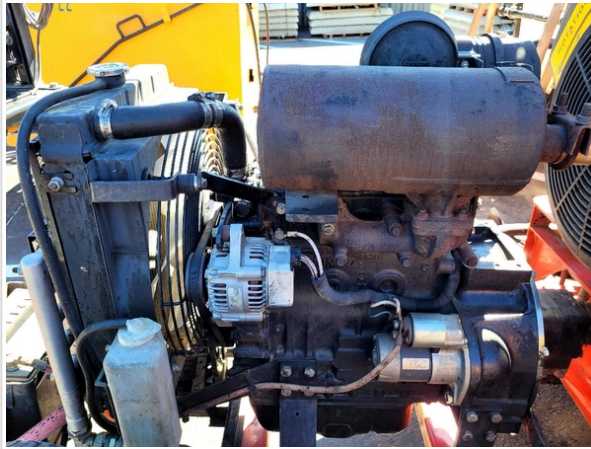
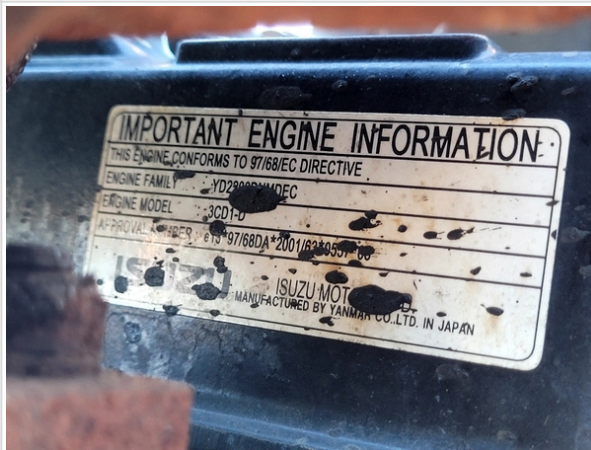
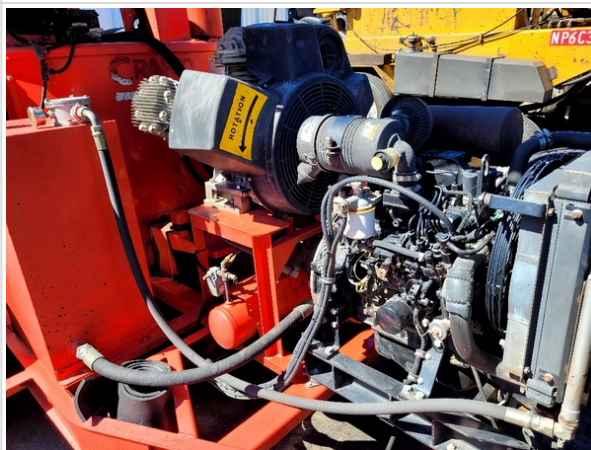
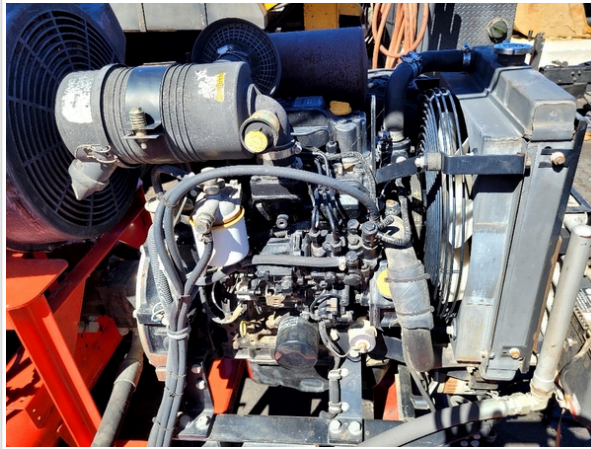
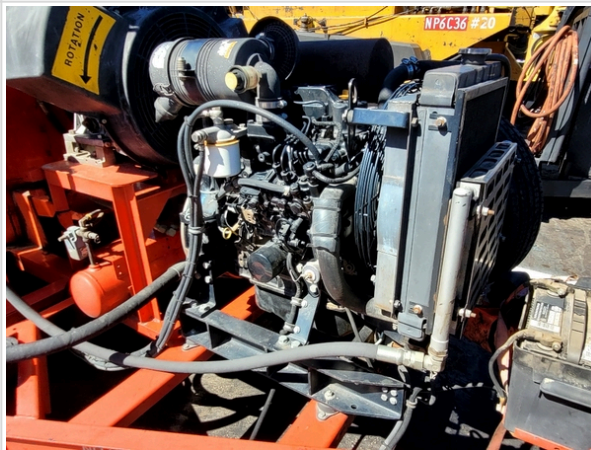
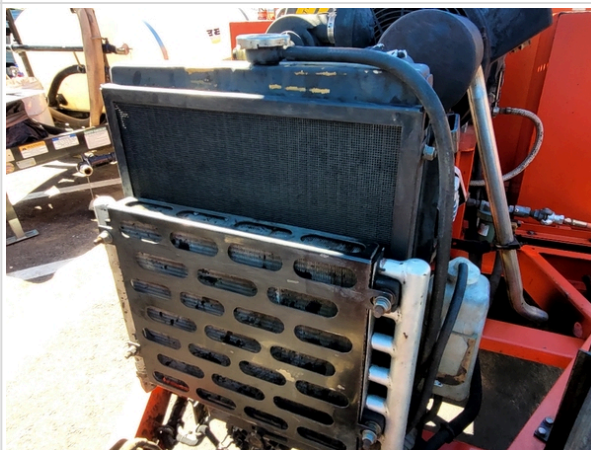
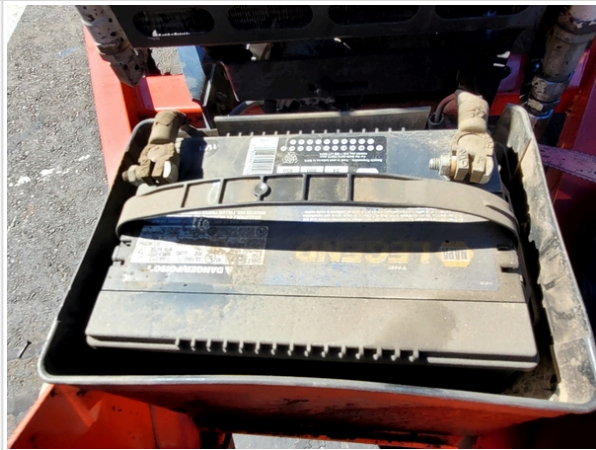
Equipped with DPF (Diesel Particulate Filter)	No
Requires DEF (Diesel Exhaust Fluid)	No
Overall Engine Appearance	Clean & dry
Overall Engine Comments	Engine has well maintained appearance and runs well. No obvious operating issues observed during the inspection.

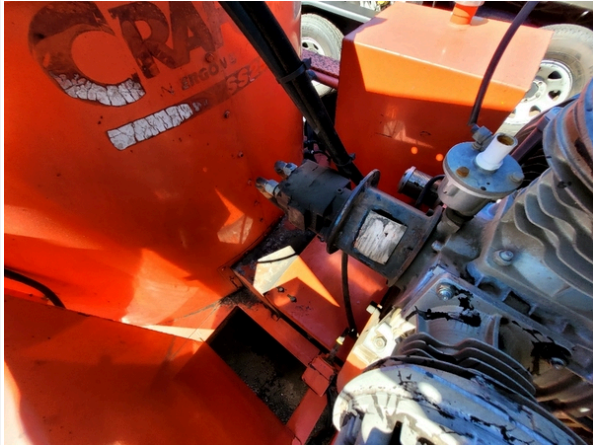
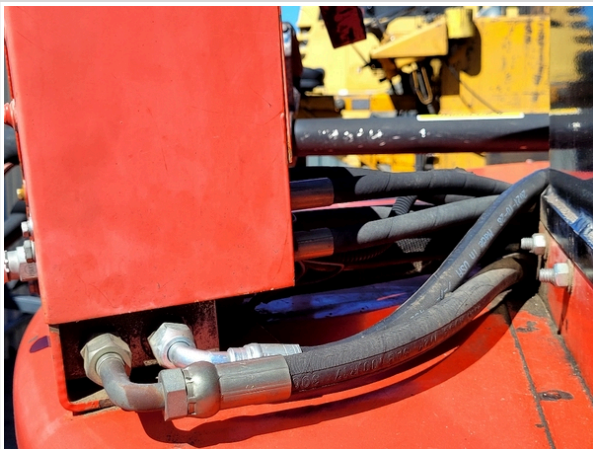
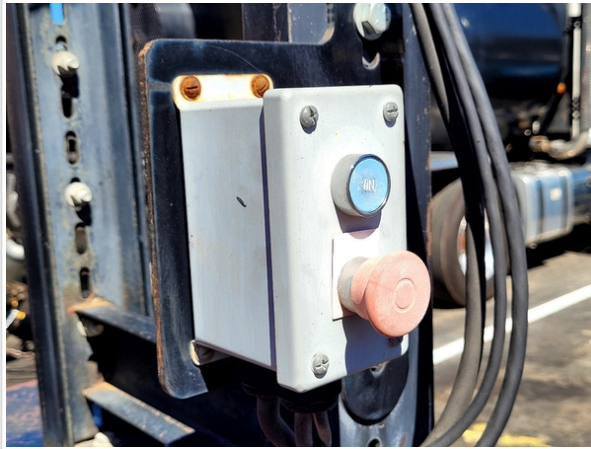
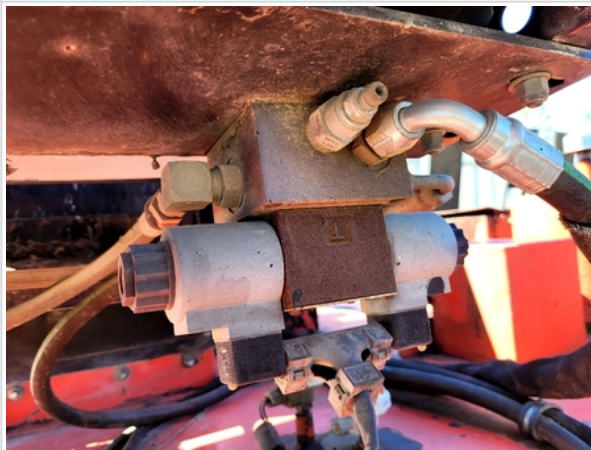
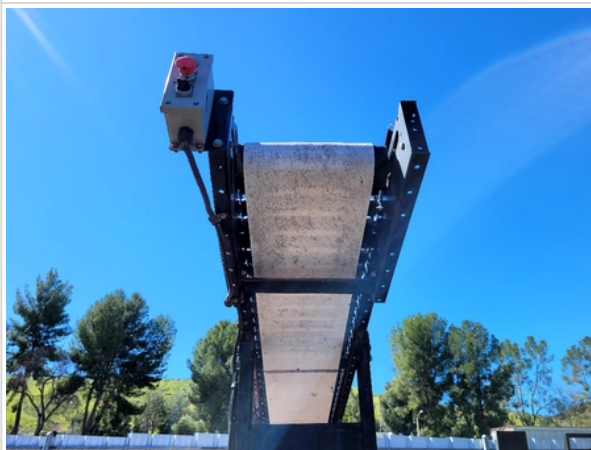
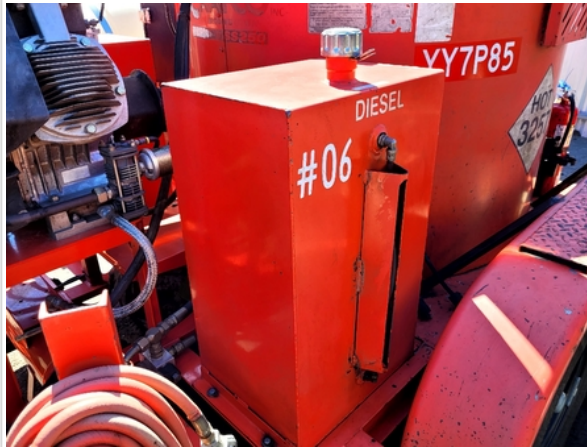
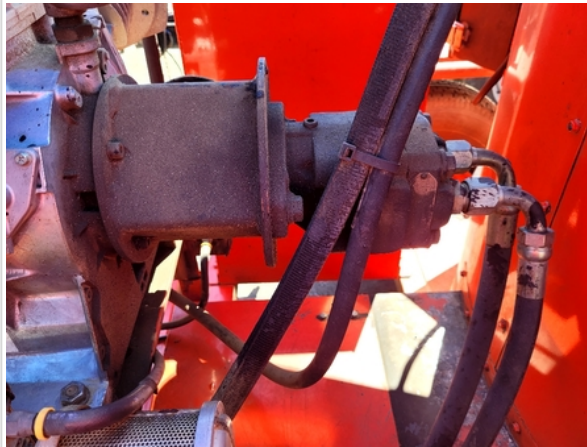
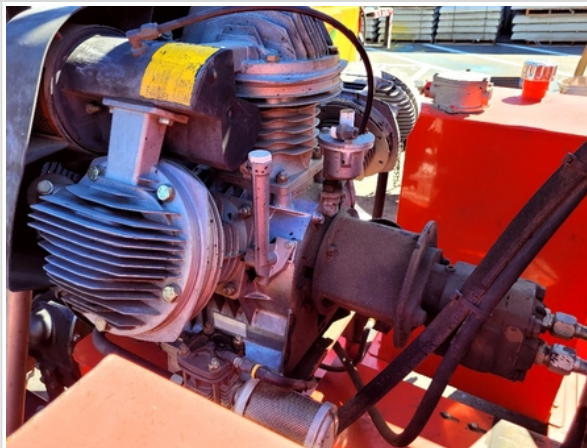
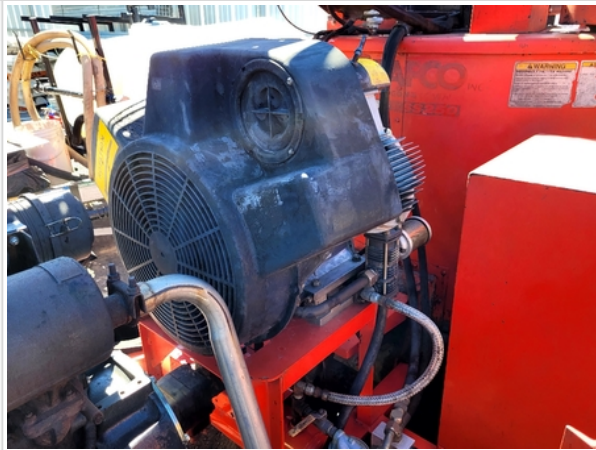
Wet or Damp Hydraulic Lines / Fittings	No
Appearance of Hydraulic Lines / Fittings	3 - Normal Wear & Tear
Hydraulic Lines / Fittings Condition	Hydraulic lines & fittings are clean and in good condition
Unusual Noises (Hydraulic Pump)	No
Hydraulic Pump Notes	No unusual noises heard during operation
Hydraulic Cylinder(s)	0
Cylinder(s): Oil Leaks	N/A

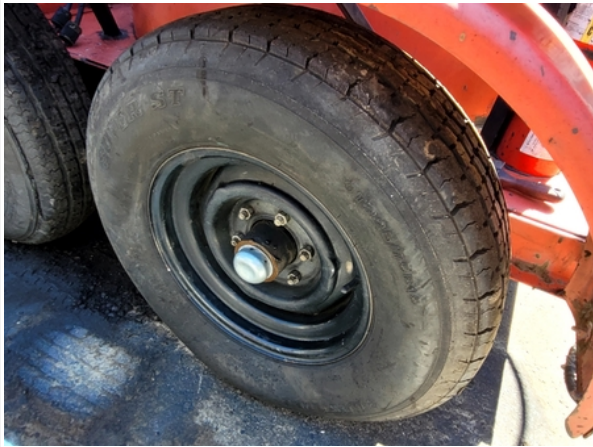
Wheels & Hub Condition	2 - Above Average Wear
Comments	Wheels in good shape, Tires need to be replaced soon
Loose Lugs	No
Tire Brand	Mastertrack
Tire Size	ST225/75/R15
Front Left Tire - Ratio Remaining	10%
Front Left Tire Photos

Exterior Rating	3 - Normal Wear & Tear
Interior Rating	0
Safety Rating	3 - Normal Wear & Tear
Quality Rating	3 - Normal Wear & Tear
Functionality Rating	3 - Normal, Operating as Expected
Overall Rating	3 - Normal Wear & Tear
What's Great About the Machine	Machine is well equipped for asphalt paving construction. The Engine, Pto and Air compressor work good and with its compact trailer setup it's easy to haul to jobsites.
What Needs Work	Most tires need to be replaced due to heat exposure and tire sidewalls cracking.
Date/Time	03-01-2023

Overall Trailer Condition	3 - Normal Wear & Tear
Overall Trailer Comments	Most Tires need to be replaced. Trailer lights and brakes were not tested during inspection. Majority of trailer in good condition.

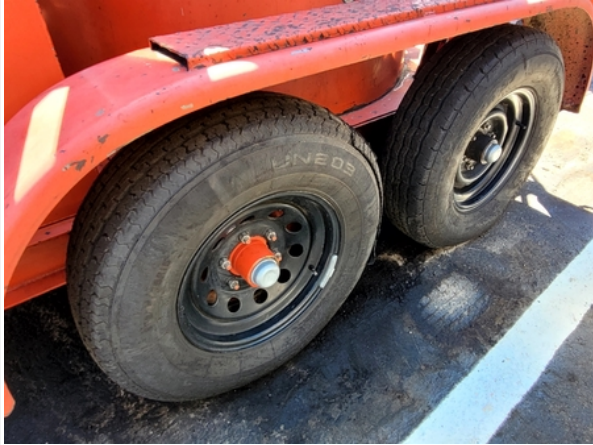
Front Right Tire Photos

Front Right Tire - Ratio Remaining	10%
