Inspection Report (On-Highway Service Truck)

Year	2015
Make	Ford
Model	F750
Serial Number	3FRXF7FK9FV639995
Truck Odometer Reading	78,711
Current Inspection / State Cert / DOT	Last Inspected 8/2022
Previous Application (e.g., earth moving, mining, demolition, etc)	Underground Utility

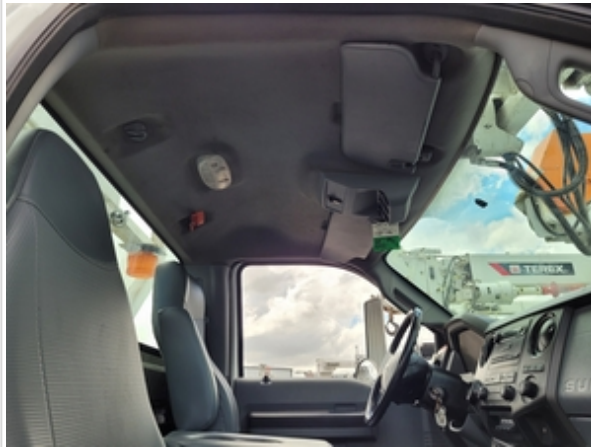
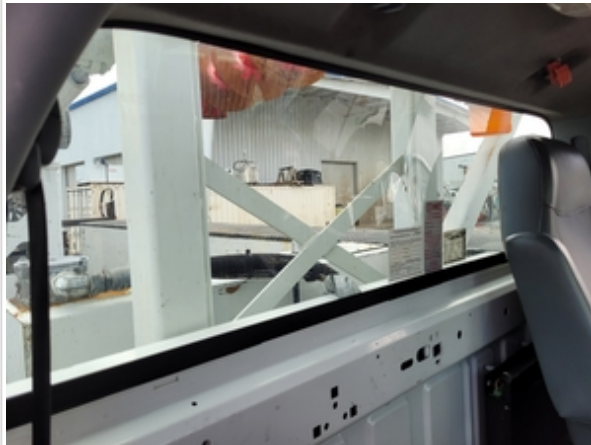
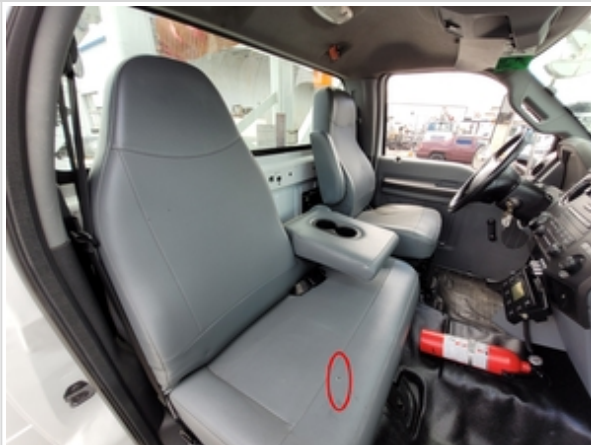
Small hole damage

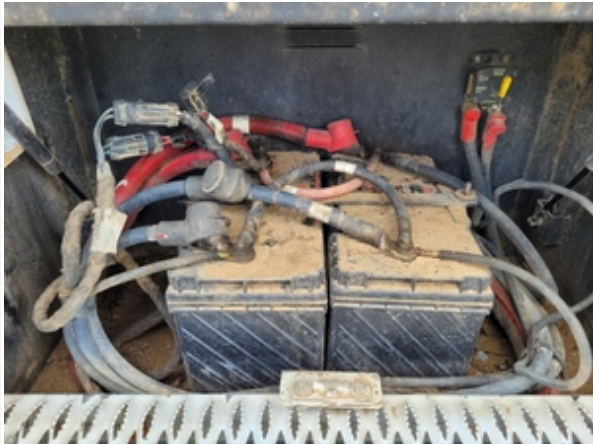
Blow-by (Visual Observation Check)	No	
Unusual Noises (Upon Start-up, Idle, Shutdown)	No	
Unusual Noise Notes	No unusual noises heard	
Engine Smoke (Upon Start-up, Idle, Shutdown)	No	
Engine Smoke Notes	No engine smoke issues observed	
Engine Exhaust Color	Clear	
Battery	3 - Normal Wear & Tear	
Battery Condition	Dusty & dirty appearance	
Battery Condition Photos

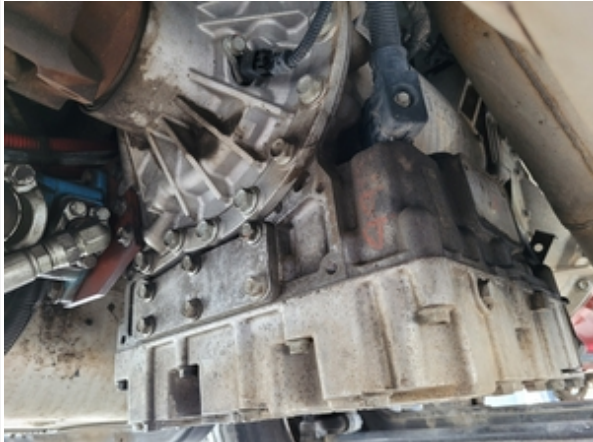
Transmission Info (Make/Model)	Allison 3000 - 5 Speed
Transmission	3 - Normal Wear & Tear
Transmission Condition	No unusual noises or vibrations
Transmission Condition Photos

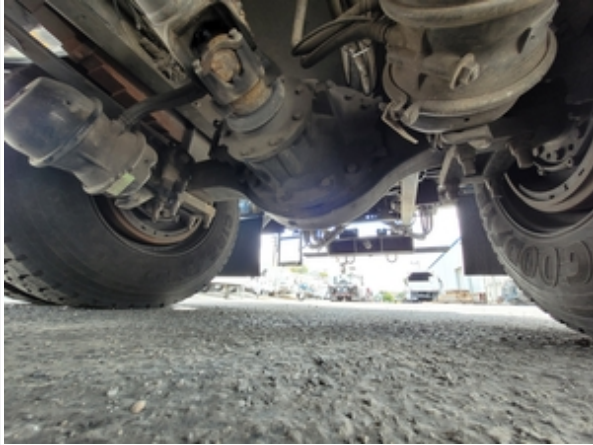
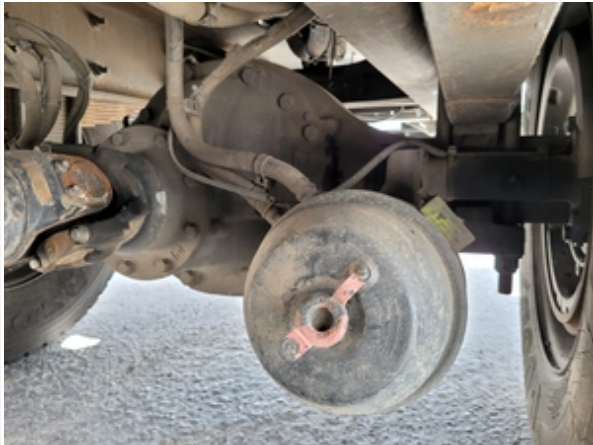
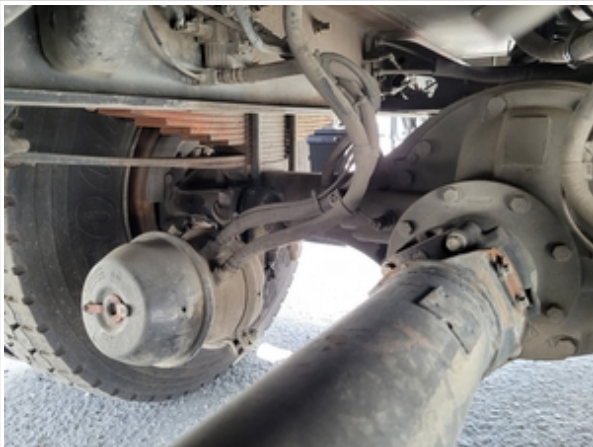
Differential	Check condition of the differential(s). Take photos and notes as relevant.
Rear Differential	3 - Normal Wear & Tear
Rear Differential Condition	Dry housing appearance, no unusual noises heard during operation

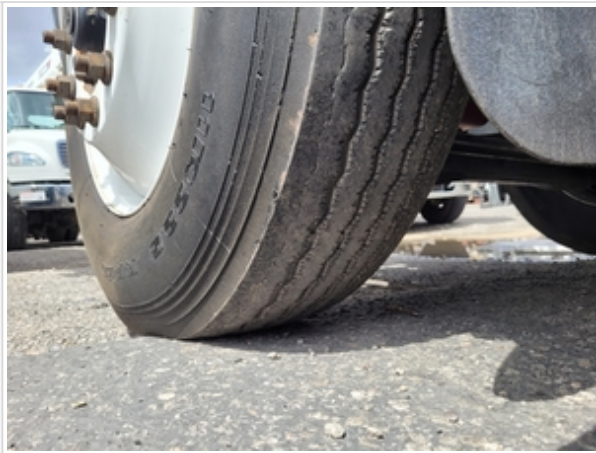
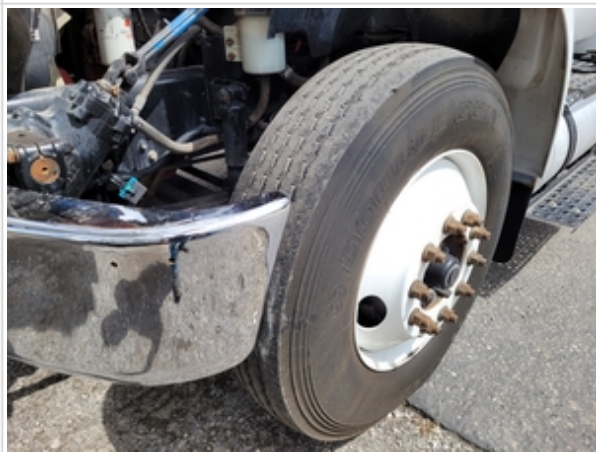
Front Left Tire Photos

Wheel Seal Leaks	No
Tire Brand	Various Brands
Tire Size	11R 22.5
Front Left Tire - Ratio Remaining	30%

Interior Rating	3 - Normal Wear & Tear
Safety Rating	3 - Normal Wear & Tear
Quality Rating	3 - Normal Wear & Tear
Functionality Rating	3 - Normal, Operating as Expected
Overall Rating	3 - Normal Wear & Tear
What's Great About the Machine	Digger Derrick Custom Truck is overall in great condition with Crane and Auger working well.
What Needs Work	Some tires getting low and may need to be replaced soon. Small tear on bench seat.
Date/Time	05-04-2023

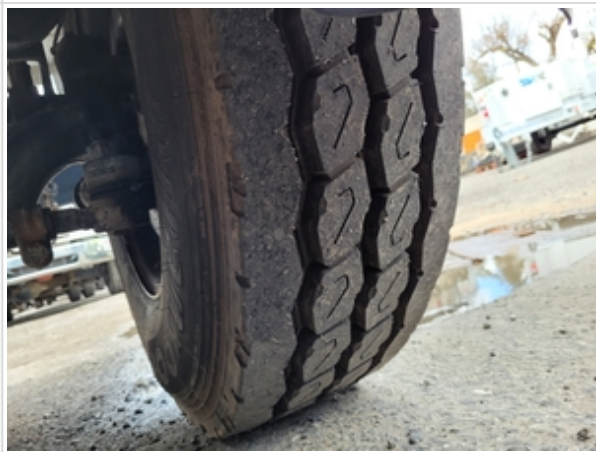
Front Right Tire - Ratio Remaining	90%
Front Right Tire Photos

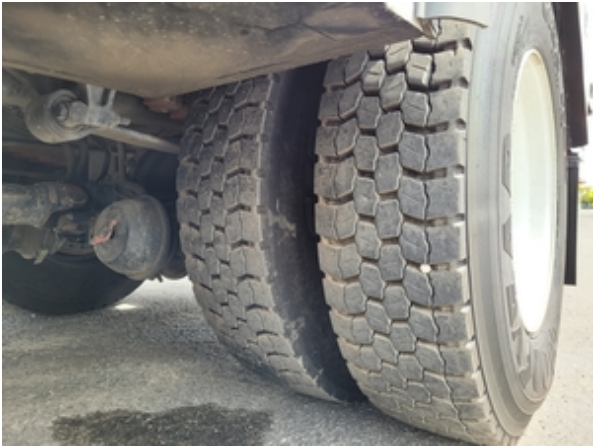
Rear Left Tire - Ratio Remaining	50%
Rear Left Tire Photos

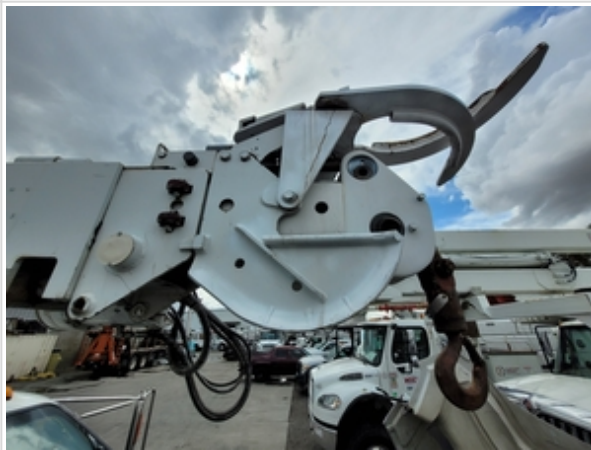
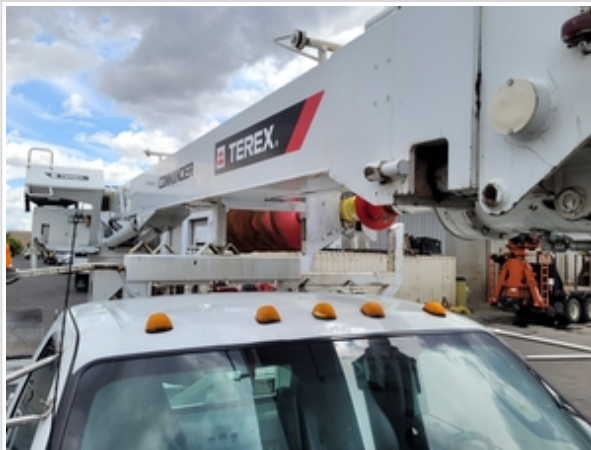
Crane Photos

Crane Condition	3 - Normal Wear & Tear
Crane Functionality	Operating as expected
