Enterprise Equipment Inspection

Category	Excavator
Travel System	Track Undercarriage
Comments	
Year	2017
Make	Takeuchi
Model	TB290
Fleet ID	10618512
Serial Number	185104456
Serial Number Plate

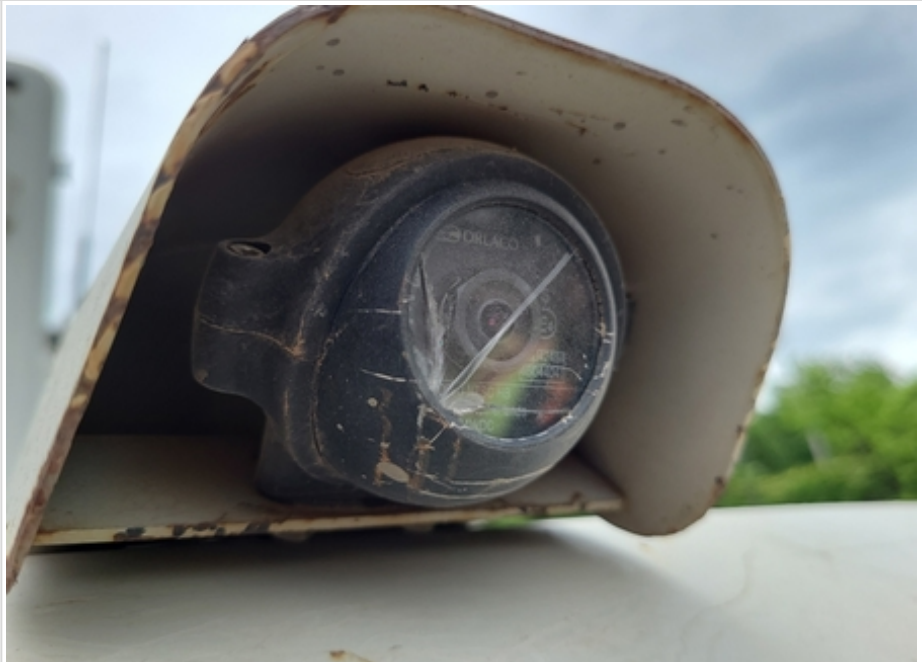
Camera screen cracked

What Needs Work	Camera cracked, fuel tank needs new cap, door and front bottom window needs replacement.	
Any Additional Info from the Seller?		
Date/Time	05-16-2023

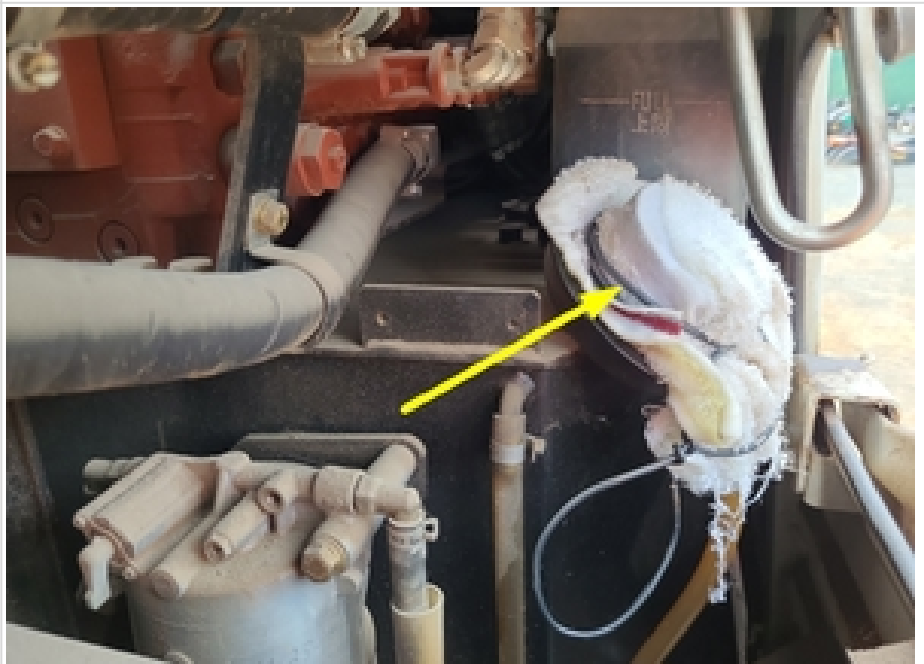
fuel cap missing

Engine Type (Make, Model, Cylinders, Hp)	Yanmar - 4Cyl. - 3.3L - 74HP
Emissions Tier	Tier 4F
Engine Rating	3 - Normal Wear & Tear
Engine Overall Comments	Engine fuel tank cap missing,

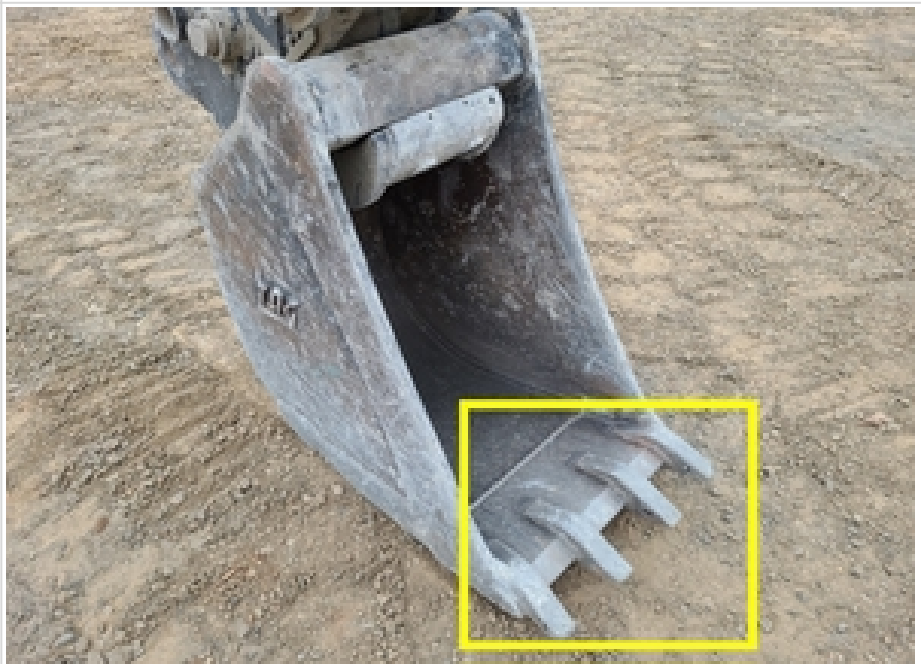
Bucket missing teeth

Attachment Rating	3 - Normal Wear & Tear
Attachment Comments	Bucket needs teeth and thumb operating okay
