General Info

| General into | | | |
|---|---|--|--|
| Make | Genie | | |
| Model | S40 | | |
| Serial Number | S4013-18140 | | |

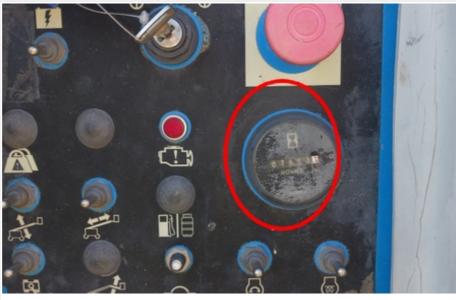
faded gauge, but it works and is readable

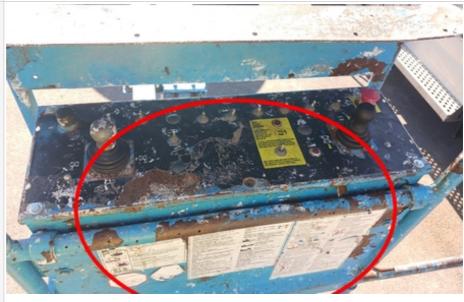
areas of rust/missing paint

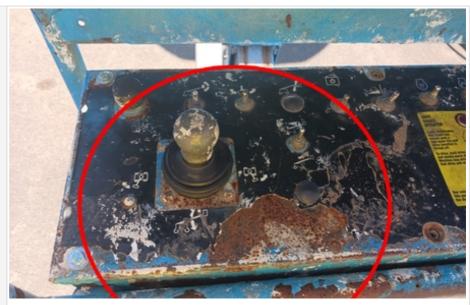
area of rust and can not see all of the instructions for the switches/controls

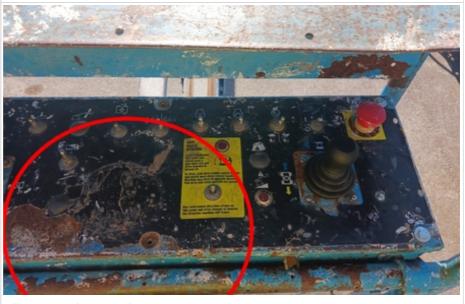
above normal wear and tear

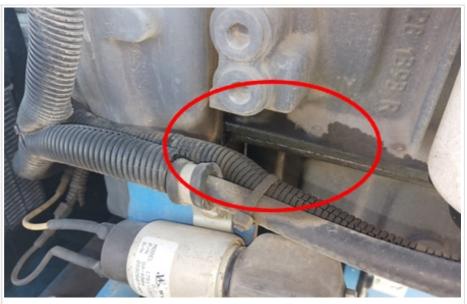
small wet spot, no dripping or pooling of fluids seen

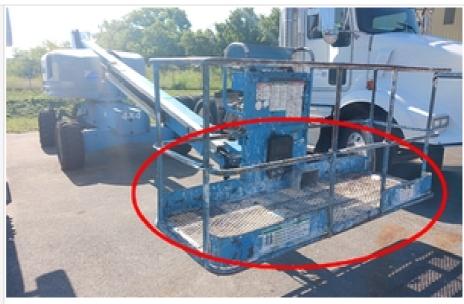
areas of rust/missing paint

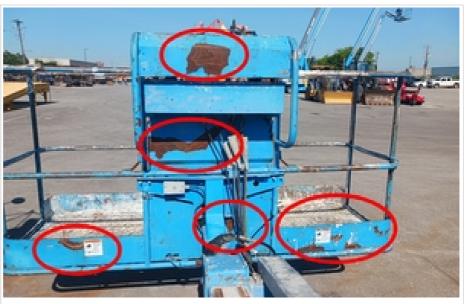
areas of rust/missing paint

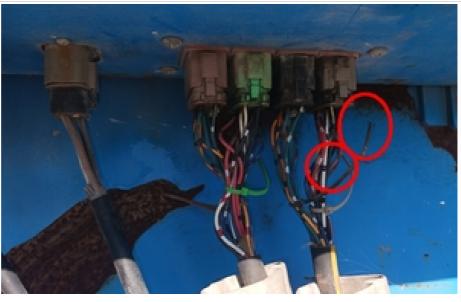
2 wires are broken

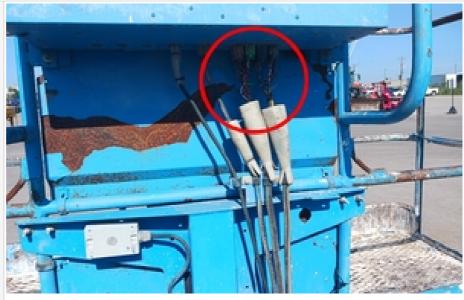
exposed wires
