Inspection Report (On-Highway Dump Truck)

B&B Stock Number	A8258812
Year	2004
Make	Volvo
Model	A25D
Serial Number	A225DV13115
Truck Odometer Reading	11507Hrs
Current Inspection / State Cert / DOT	N/A
Previous Application (e.g., earth moving, mining, demolition, etc)	unable to determine

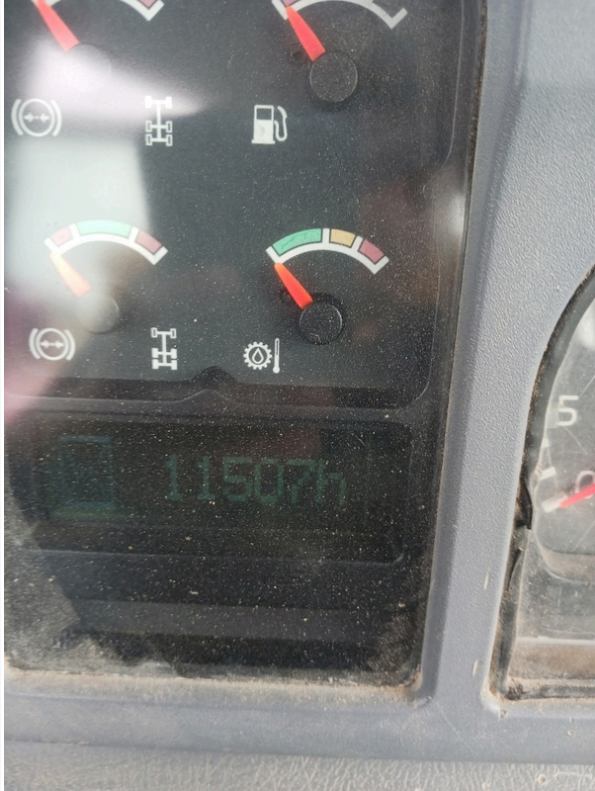
Odometer Photo

Odometer Activity	3 - Normal Wear & Tear		
Odometer Condition	Odometer is working and in good condition		
Controls/Switches/Gauges	2 - Above Average Wear & Tear		
Controls/Switches/Gauges Condition	One or more switches/gauges are inoperative or missing		
Controls/Switches/Gauges Photos

check engine light is on, indicating that there is a problem with the engine.
Brake System Type	Air Brakes		
Air Brakes Build Correct Pressure	Yes		
Clutch	0		
Horn	3 - Normal Wear & Tear		
Horn Condition	Horn is functioning as expected

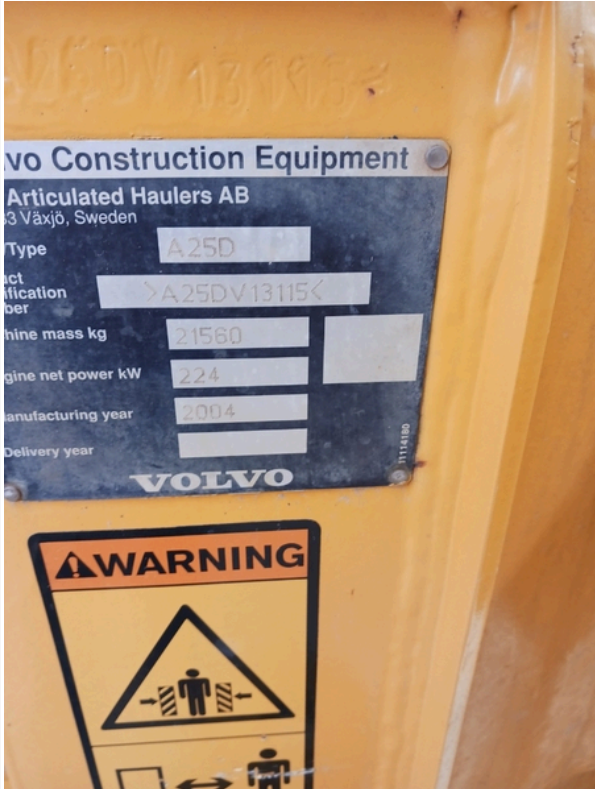
Engine Data Plate

Engine Type (Make, Model, Cylinders, Hp)	Volvo, D9AEE2, 6-Cyl, 287HP
Emissions Tier	Tier 2
Engine Serial Number	unable to verify
Engine Fuel Type	Diesel
Blow-by (Visual Observation Check)	N/A
Unusual Noises (Upon Start-up, Idle, Shutdown)	Yes
Unusual Noise Notes	Clicking noise heard during acceleration, Continuous muffled, hollow sound heard, Other (see comments)
Comments	The engine was turned on and after 5min started to make a sound like it wanted to turn off. The engine died and wouldn't start again.
Engine Smoke (Upon Start-up, Idle, Shutdown)	No
Engine Exhaust Color	Clear
Battery	3 - Normal Wear & Tear
Battery Condition	Clean & dry appearance, tight connections
Radiator	3 - Normal Wear & Tear
Radiator Condition	Radiator fins & components appear to be in good working order, no signs of damage or leaks
Belts	3 - Normal Wear & Tear
Belt Condition	Belts appear in good condition & alignment with proper tension

Equipped with DPF (Diesel Particulate Filter)	N/A
Requires DEF (Diesel Exhaust Fluid)	Yes
DEF Tank	3 - Normal Wear & Tear
DEF Tank Condition	Area around DEF tank cap is clean, fluid is clear & appears free of contaminants
Overall Engine Rating	2 - Above Average Wear & Tear
Overall Engine Appearance	Dusty & dry
Overall Engine Comments	The engine was making odd noises, and it shut off after 5 minutes of running. The engine would not turn back on after that.
