# Inspection Report

## General Appearance

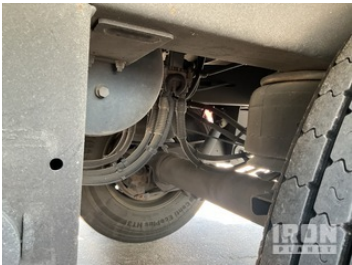
| Air System | | |
|---|---|---|
| Air Valve | Not operationally checked | |

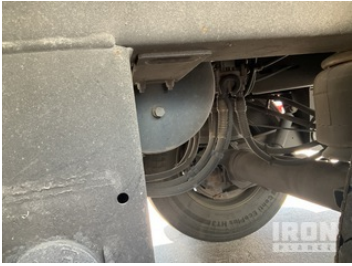
| Air System | | |
|---|---|---|
| Air Tank | Not operationally checked | |

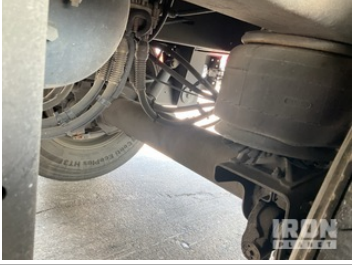
| Air System | | |
|---|---|---|
| Air Lines | Not operationally checked | |

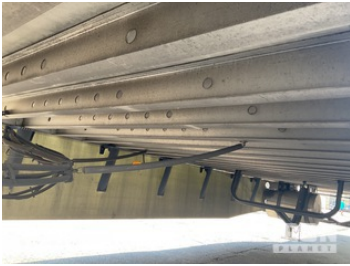
| Item | Assessment | Photo |
|---|---|---|
| Frame Rails/ Main Beams Condition | ★★★★☆<br>No visible damage | |

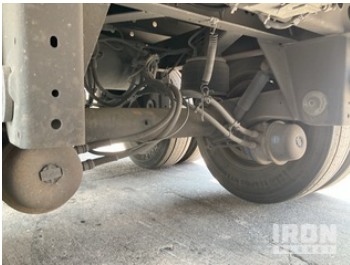
| Item | Assessment | Photo |
|---|---|---|
| Axle Condition | ★★★★☆ | |

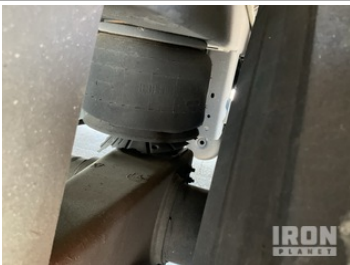
| Item | Assessment | Photo |
|---|---|---|
| Suspension Air Bags | Not operationally checked | |

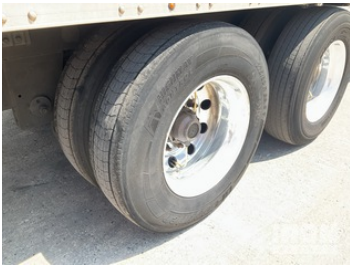
| Item | Assessment | Photo |
|---|---|---|
| Tire Condition | | |
| Tires | Left front outer: 11/32", Left front inner: 12/32", Left rear outer: 7/32", Left rear inner: 10/32", Right rear outer: 13/32", Right rear inner: 11/32", Right front outer: 12/32", Right front inner: 12/32" | |

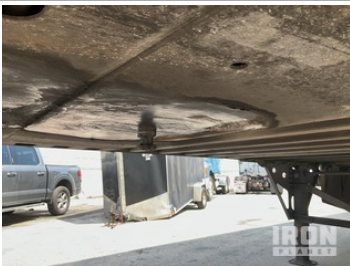
| Item | Assessment | Photo |
|---|---|---|
| Tongue/ Hitch Condition | ★★★★☆<br>No visible damage | |

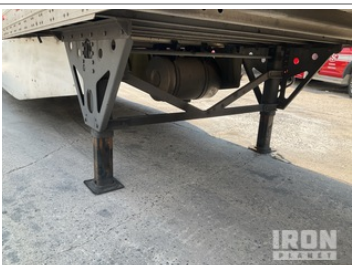
| Landing Gear / Tongue Jack | ★★★★☆ | |

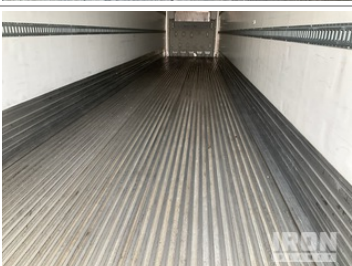
| Deck/ Floor Condition | ★★★★☆ | |
