## Hyundai Tucson blue Intro Edition 2WD

EZ 10/2016 | 4X4 | Diesel | Manual transmission | 228,644km

Fahrzeug aufgenommen am: 21.07.2026

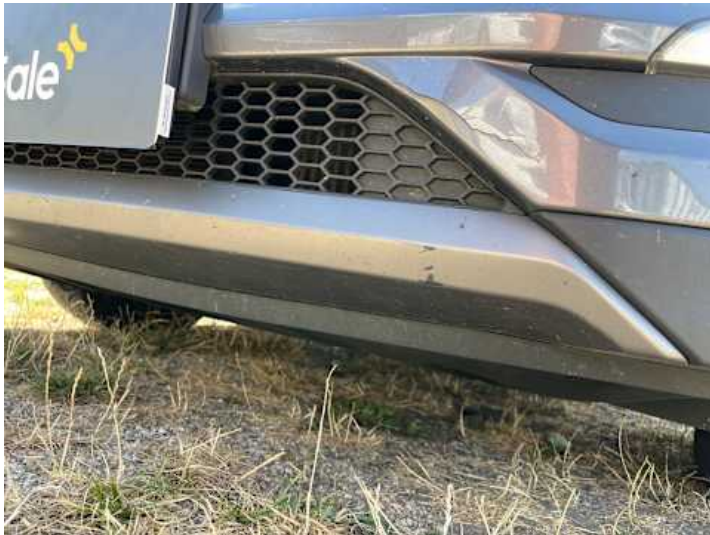
Front bumper (Scratch )

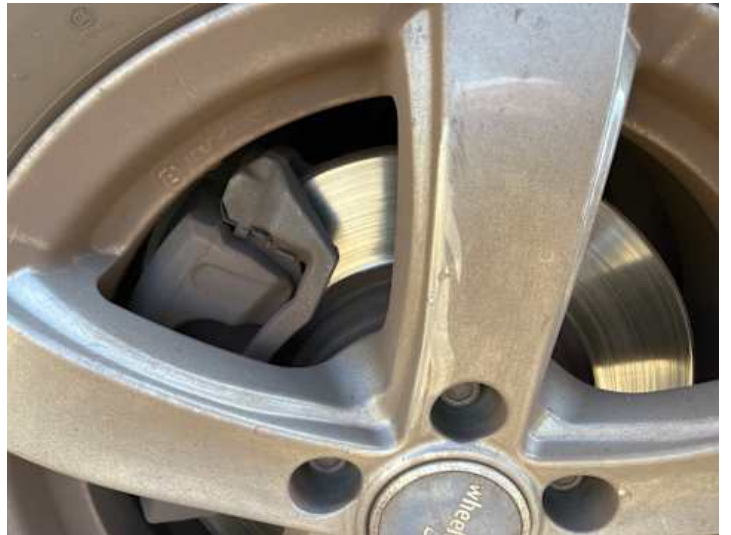
Wheel (Scratch )

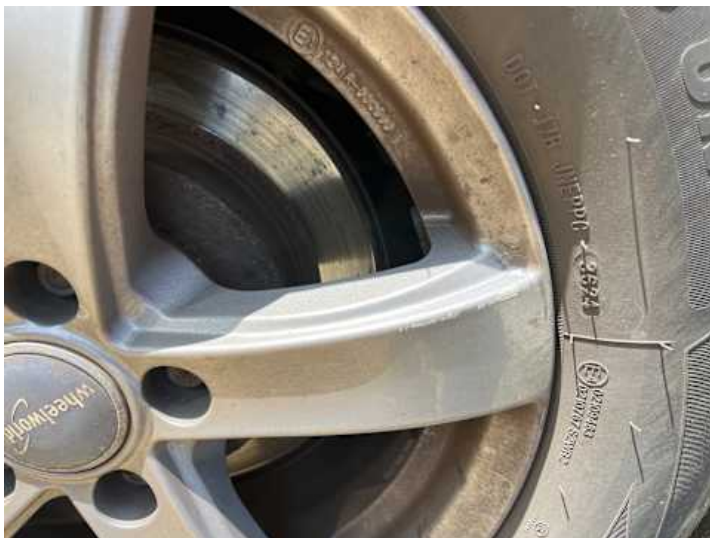
Wheel (Scratch )

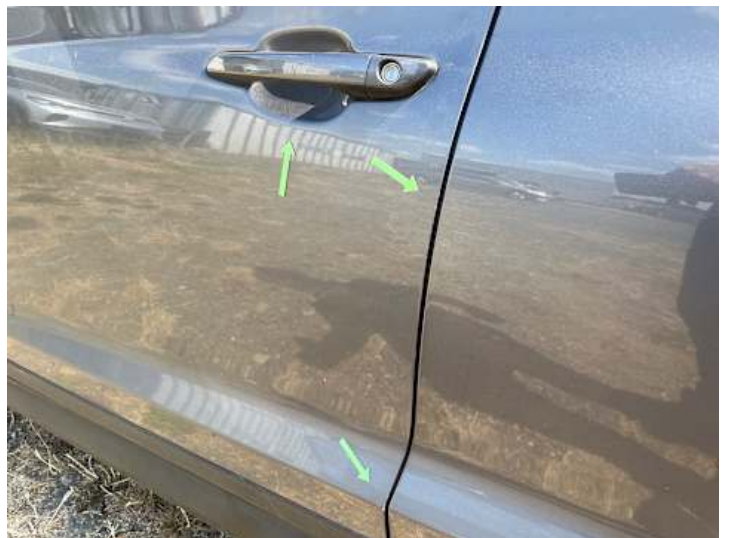
Driver door (Scratch )

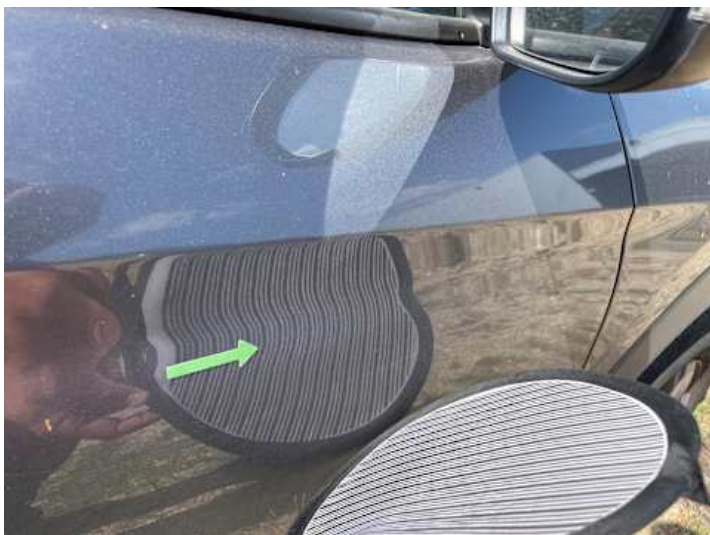
Passenger door (Delle)

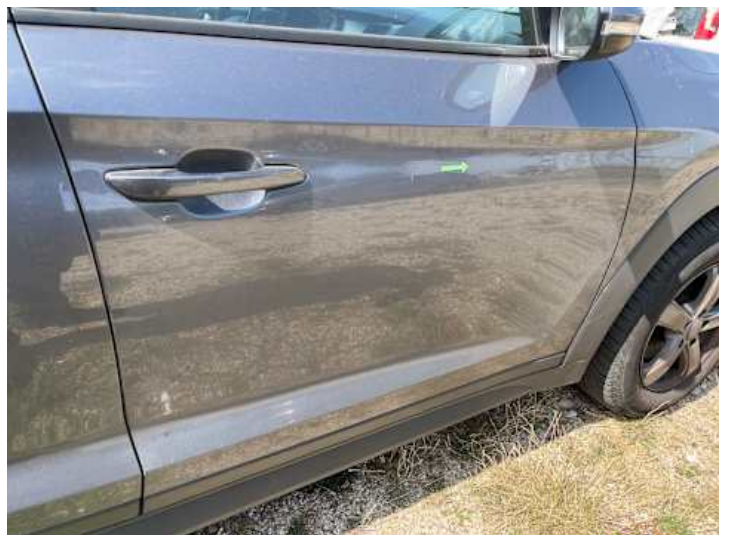
Passenger door (Delle)

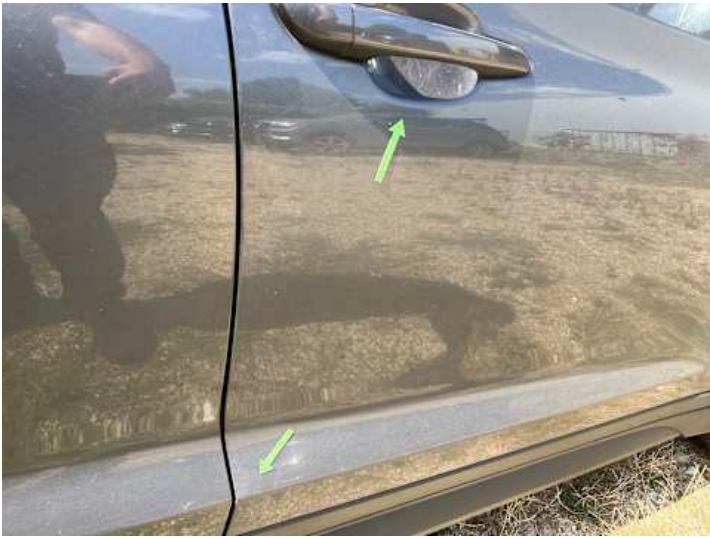
Passenger door (Scratch )

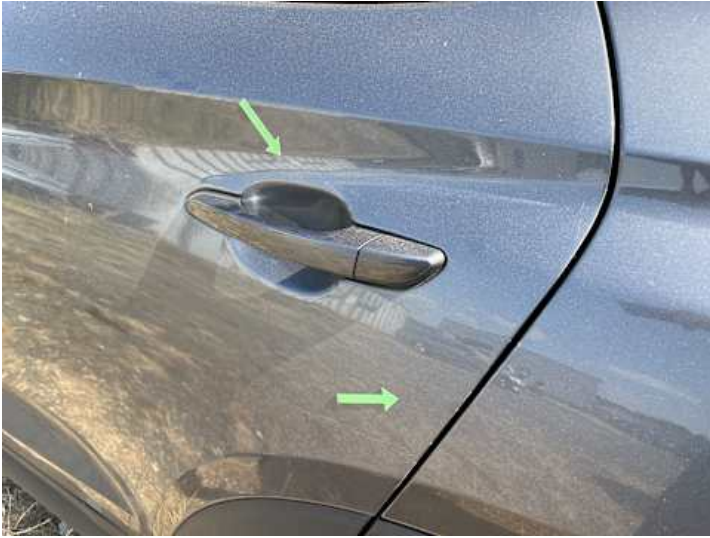
Door rear left (Scratch )

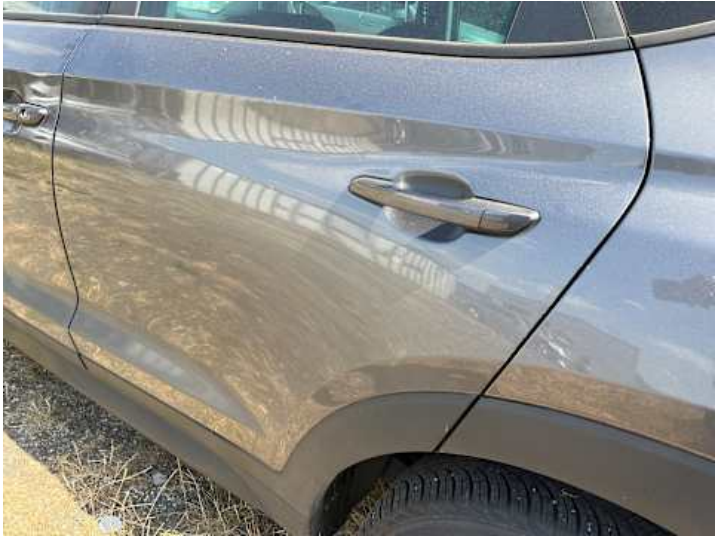
Door rear left (Other damage): It won't open.

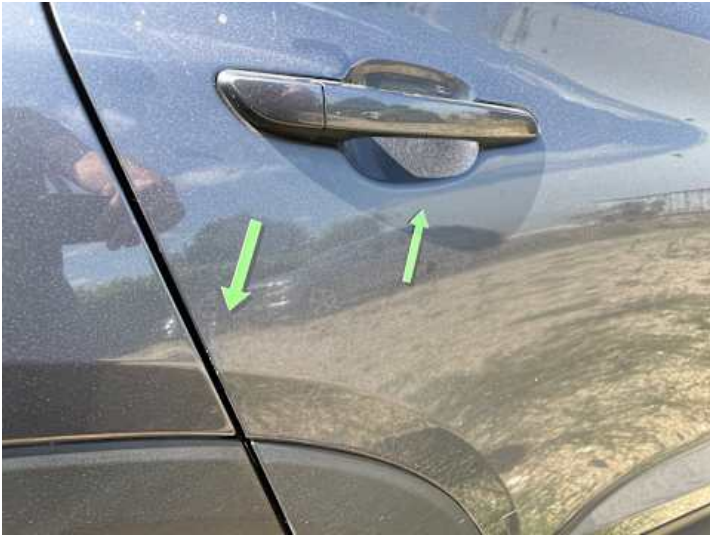
Door rear right (Scratch )

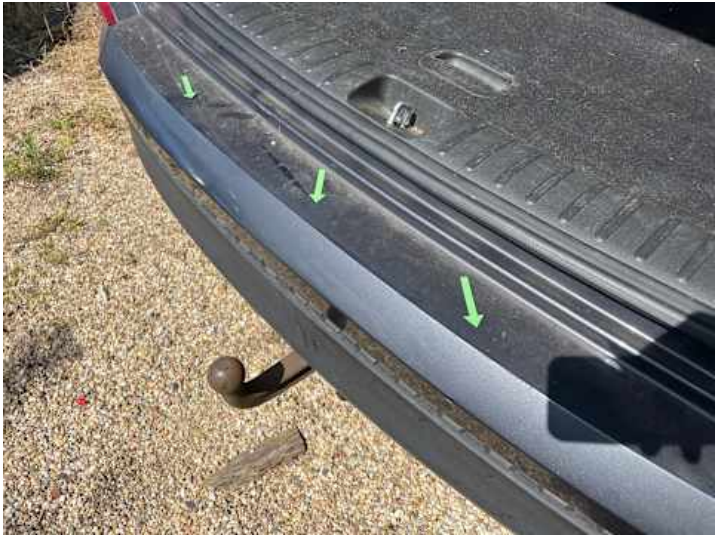
Rear bumper (Scratch )

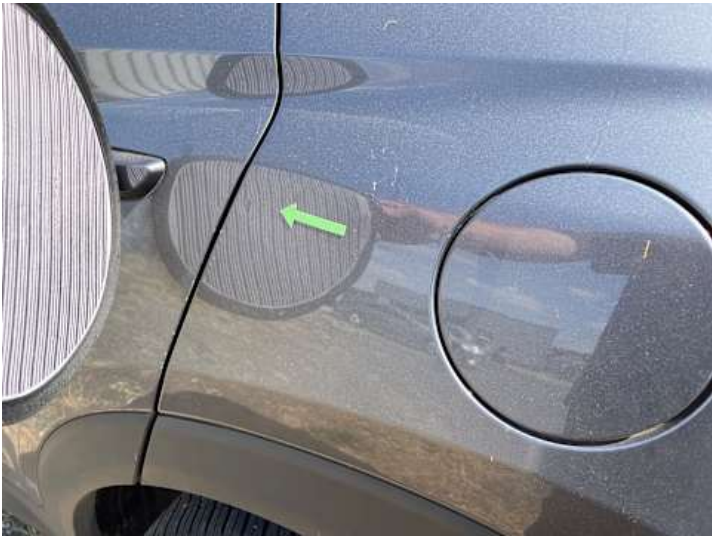
| Vehicle part | Lacquer layer thickness (in µm) | Vehicle part | Lacquer layer thickness (in µm) |
|---|---|---|---|
| Side panel rear left | 210 | Side panel rear right | 130 |

Side panel rear left (Delle)

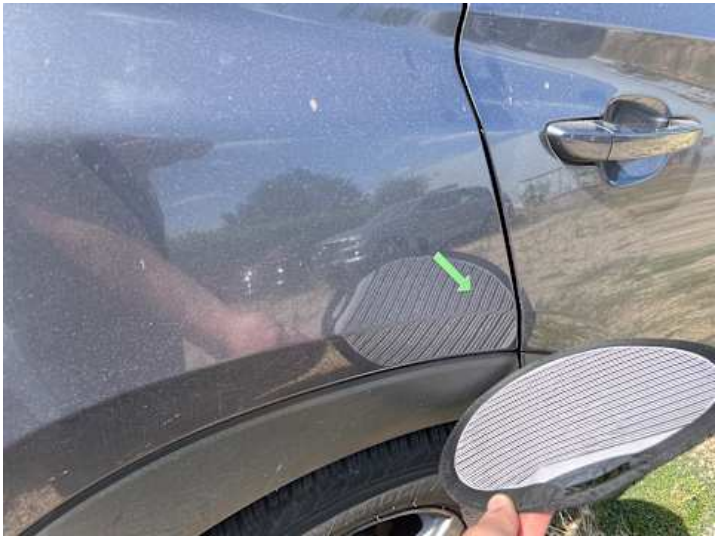
Side panel rear right (Delle)

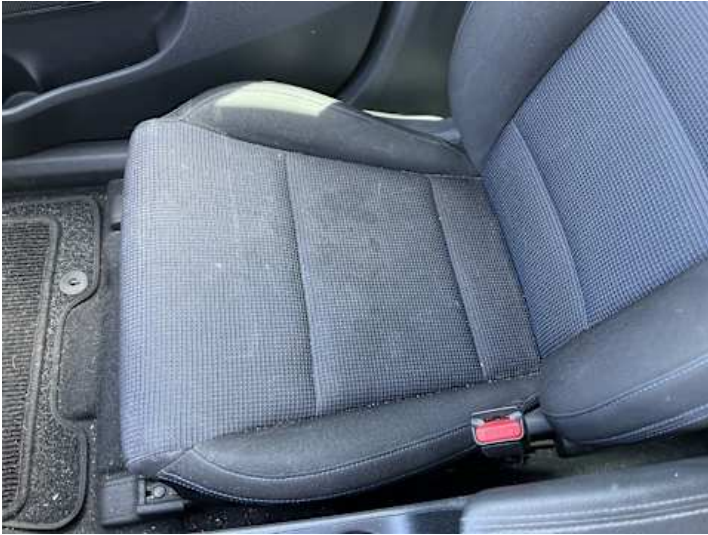
Interior (Pollution)

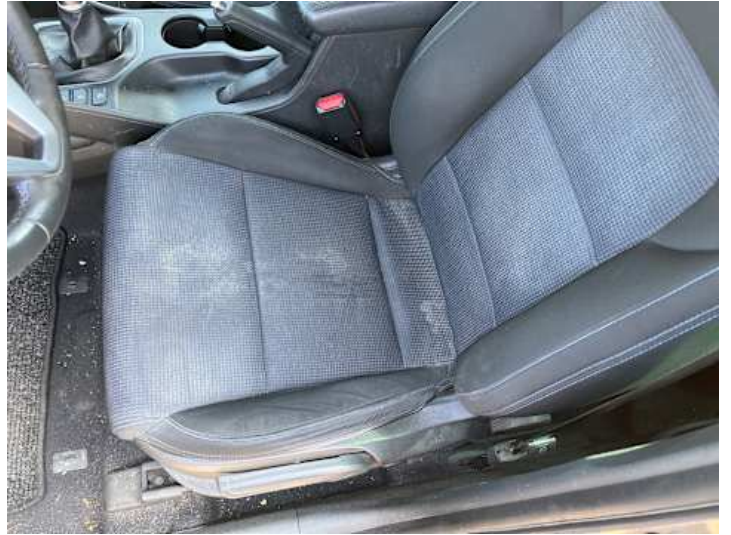
Interior (Pollution)

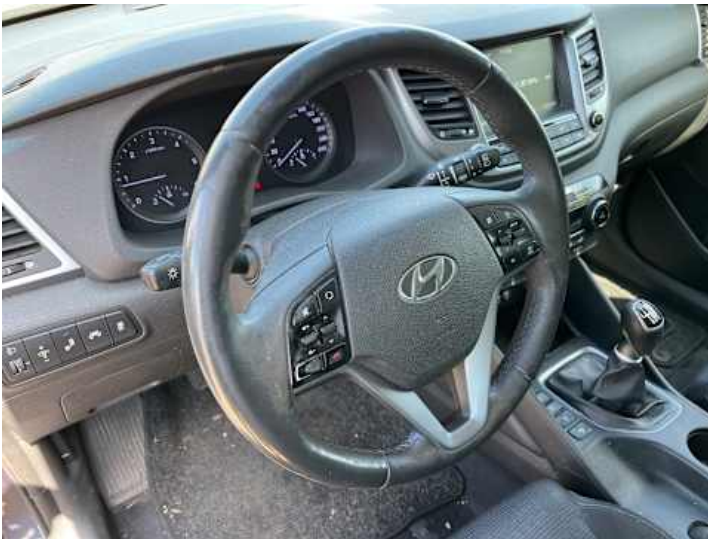
Interior (Wear)

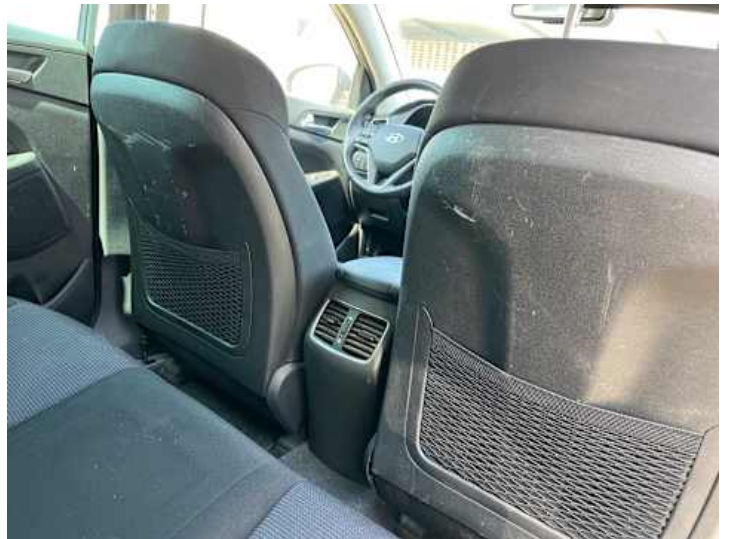
Interior (Scratch )
