Thornton Tomasetti

Building Solutions

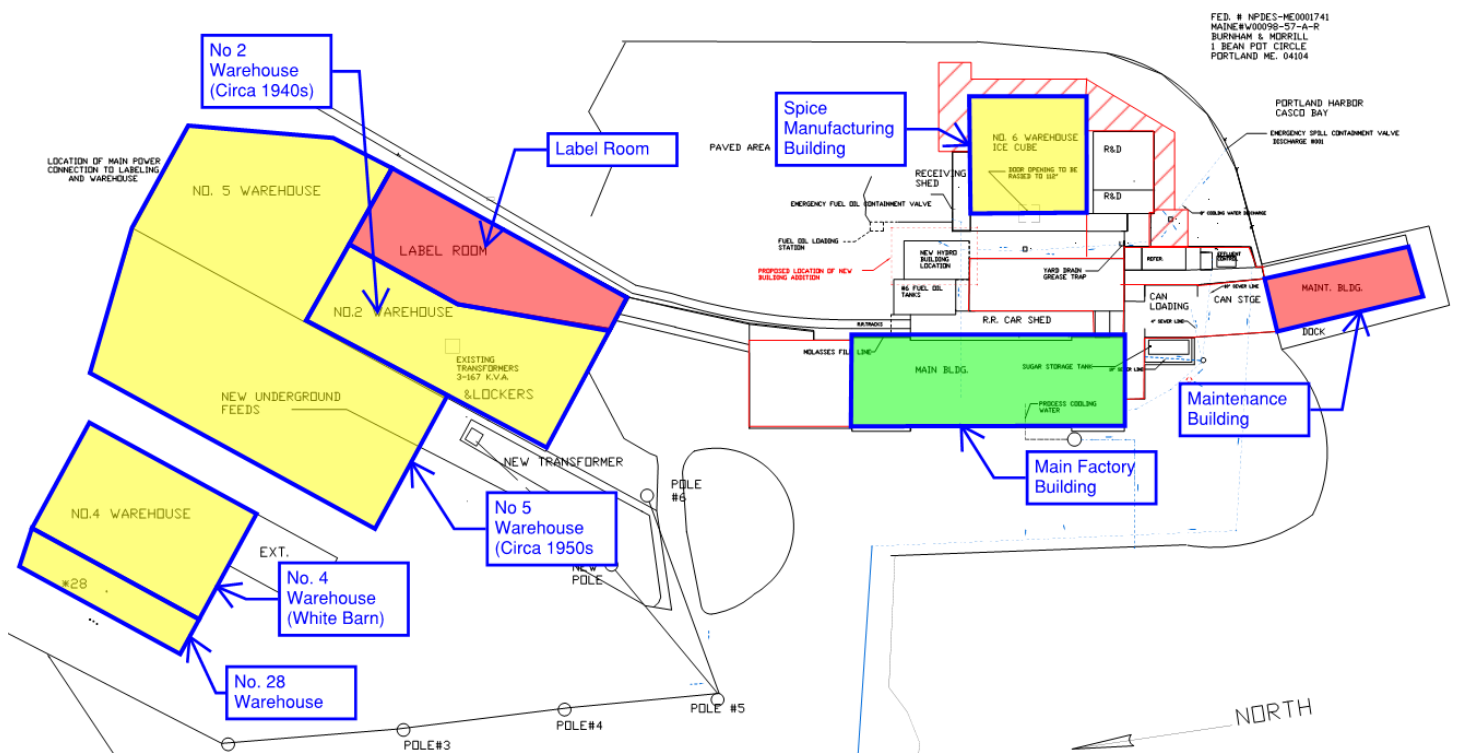
A key plan of the buildings reviewed is shown below.

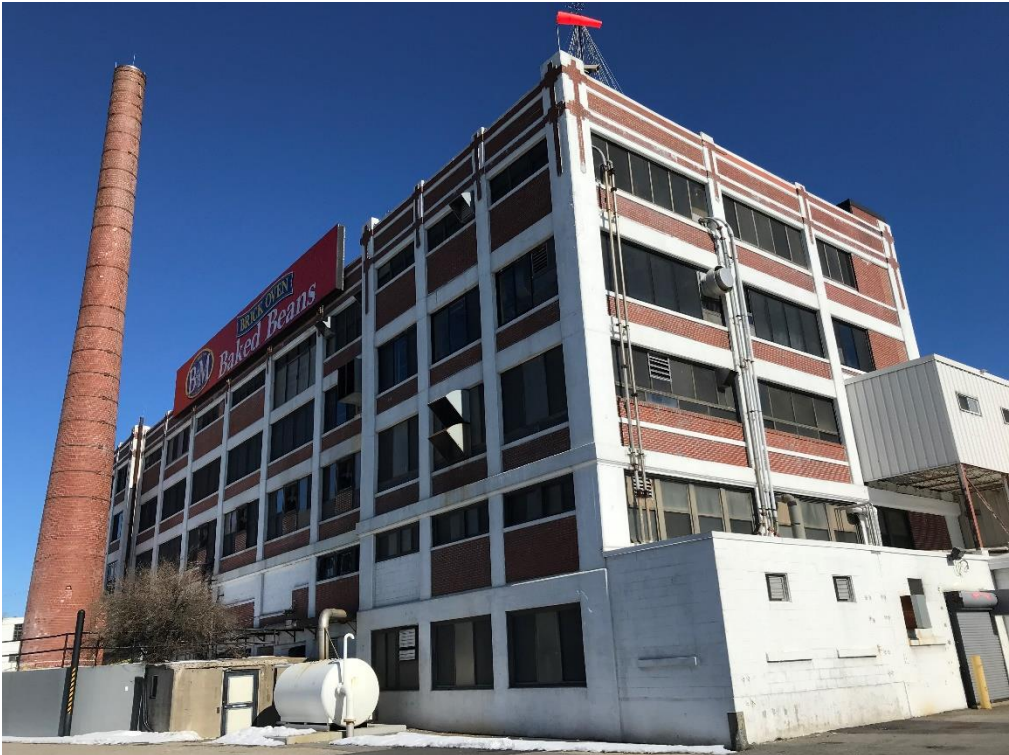
Photo 2. Main Factory Building. Exterior concrete surfaces have been recently repaired.

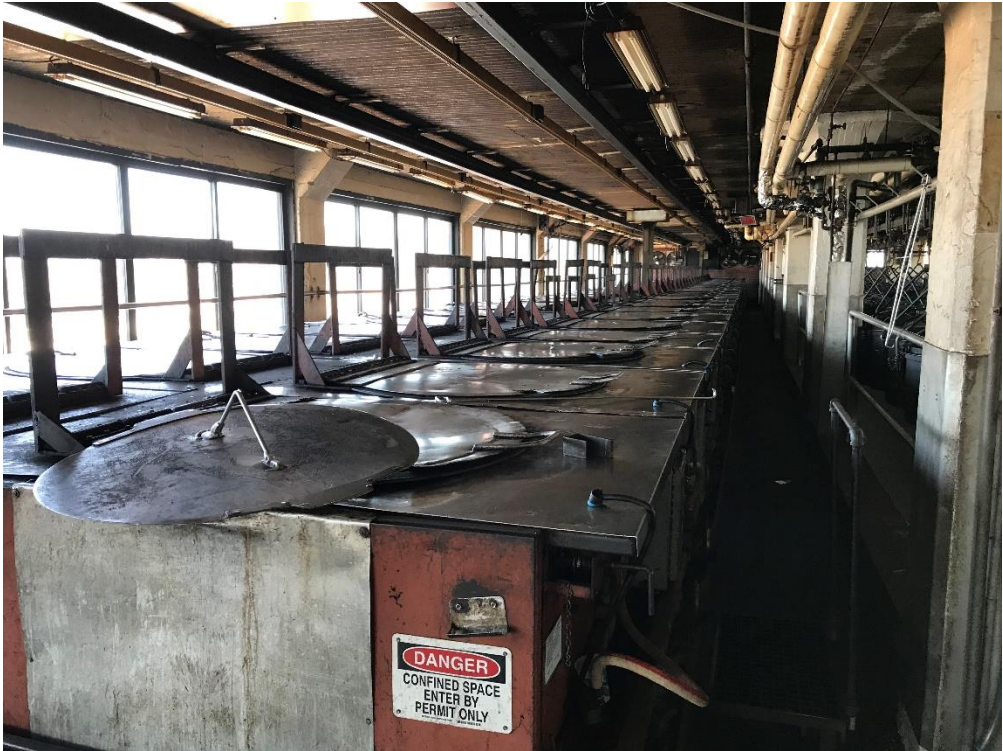
Photo 3. Main Factory Building. Heavy bean ovens located on the fourth floor.

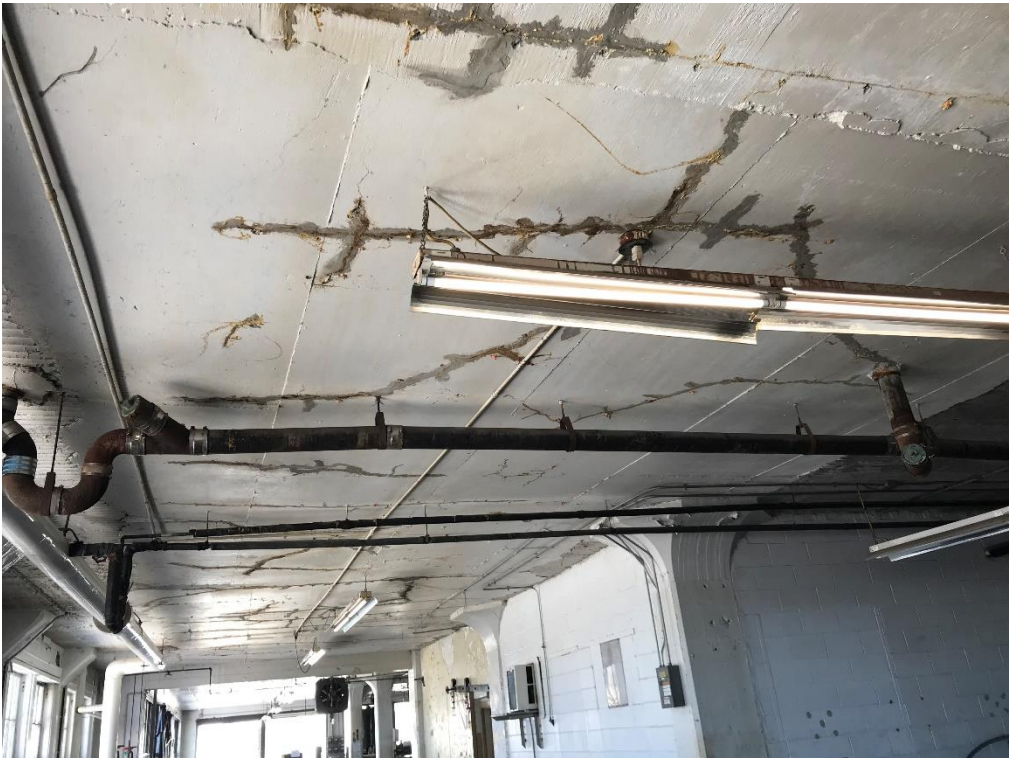
Photo 4. Main Factory Building. Epoxy injected crack repairs on the underside of the fourth floor.

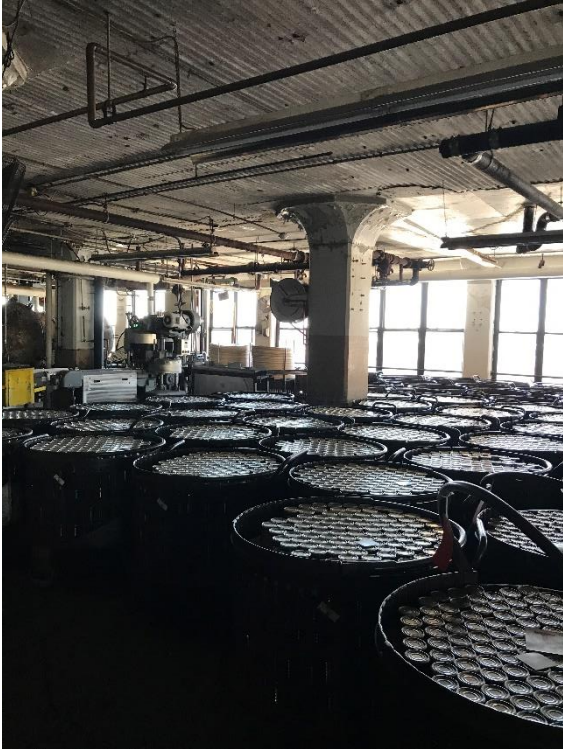
Photo 5. Main Factory Building. Reinforced concrete flat plate construction consisting of concrete columns with capitals supporting concrete slabs.

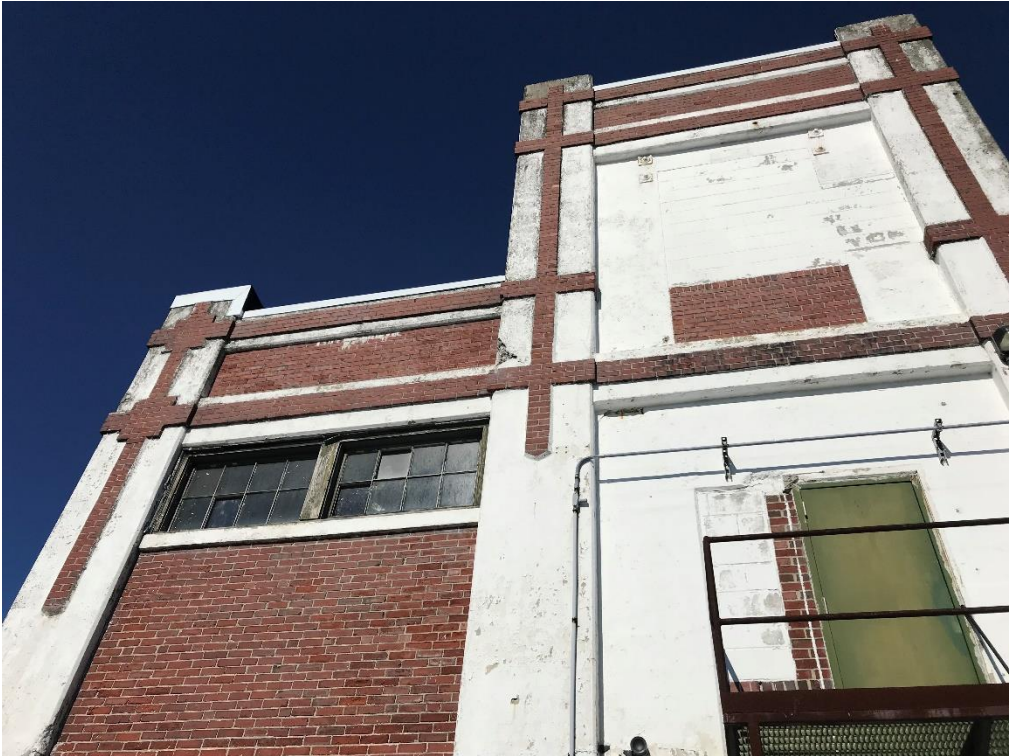
Photo 8. Maintenance Building. Exterior building condition.

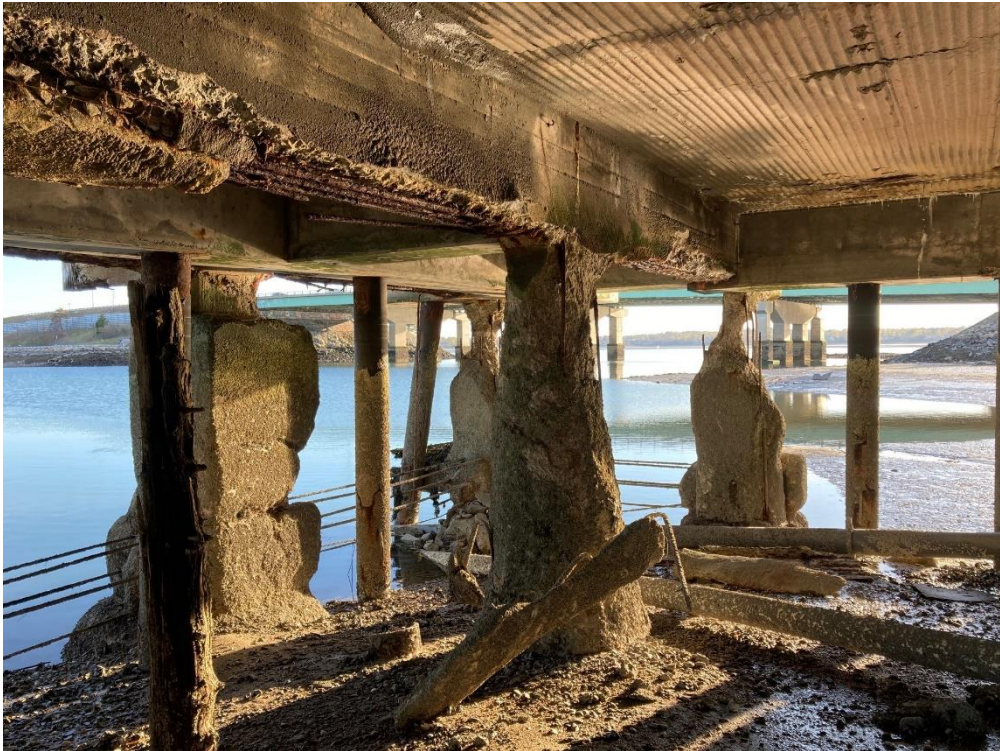
Photo 9. Maintenance Building. Deteriorated concrete girders and pier under the wharf.

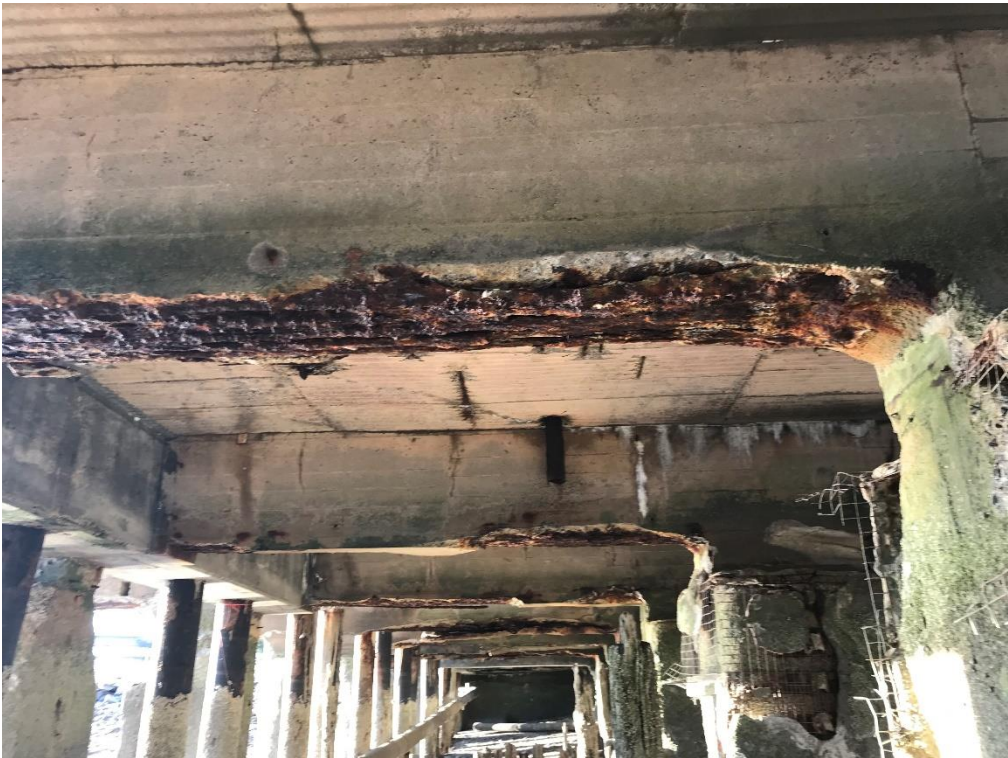
Photo 10. Maintenance Building. Concrete deterioration and reinforcing steel corrosion in the girders and piers.

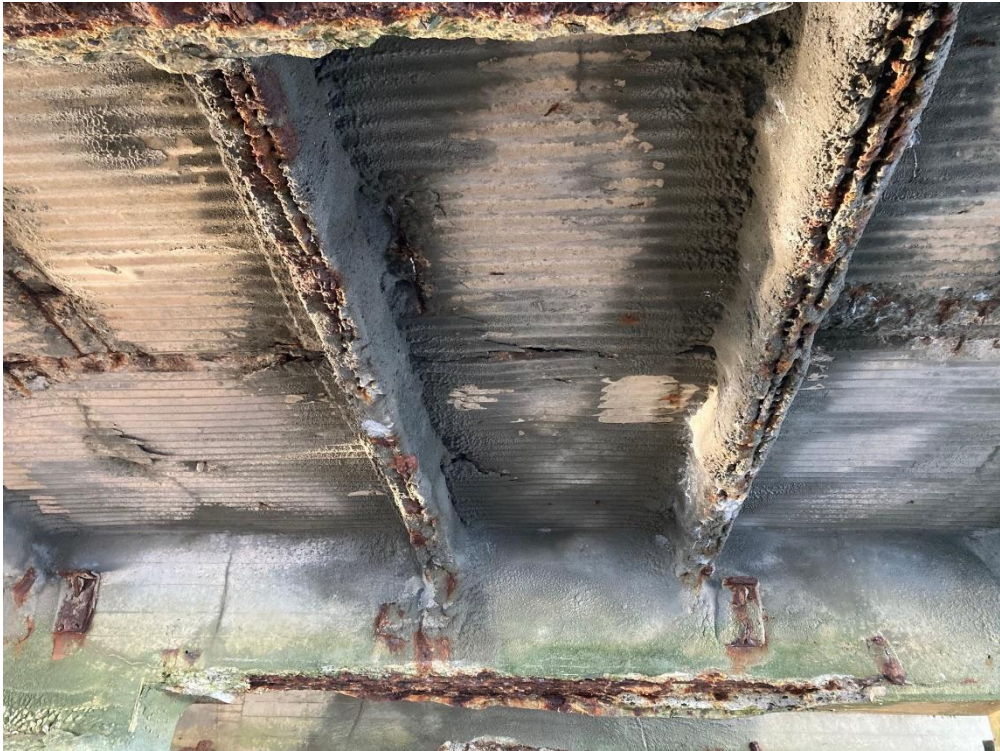
Photo 11. Maintenance Building. Deteriorated concrete floor slab and girders under the wharf.

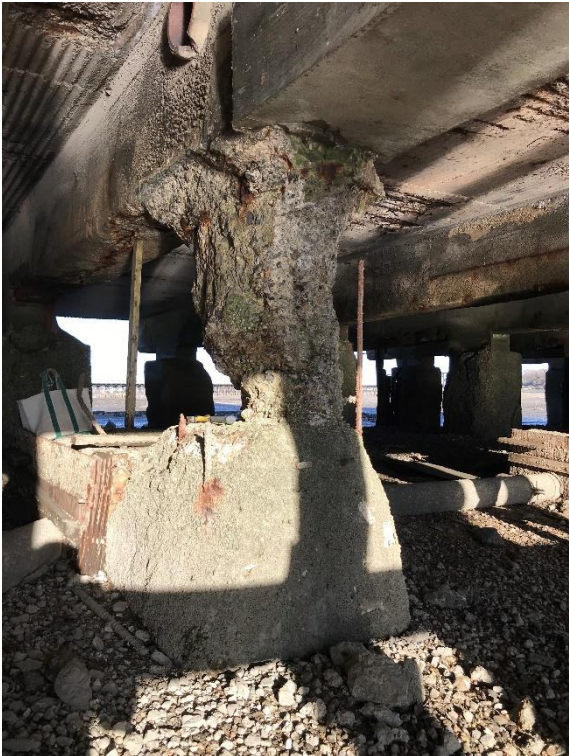
Photo 12. Maintenance Building. Deterioration has reduced the size of a concrete pier from 48" by 48" to 10" by 10". The owner was alerted of safety concerns.

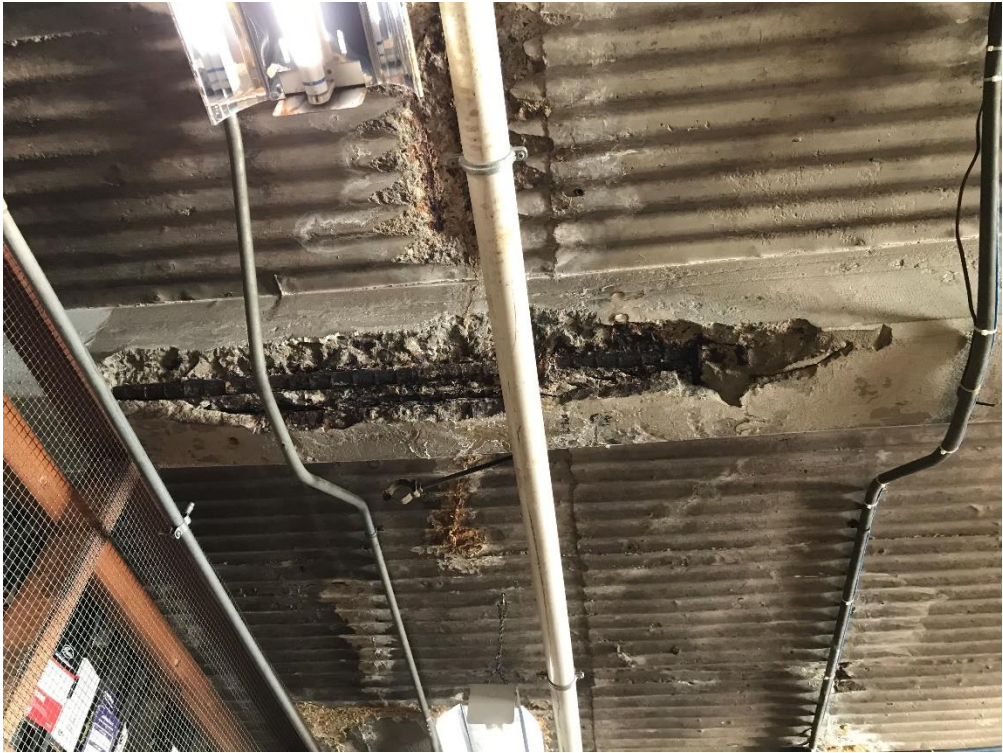
Photo 13. Maintenance Building. Concrete deterioration and reinforcing steel corrosion in roof beam.

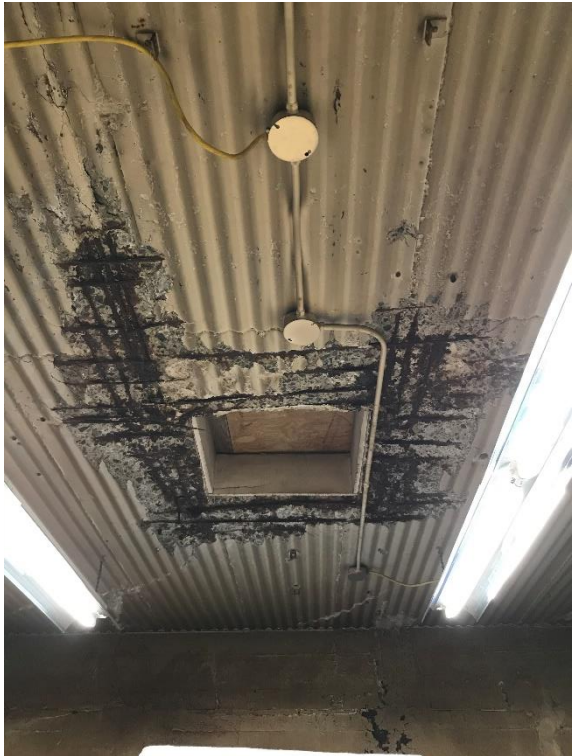
Photo 14. Maintenance Building. Concrete deterioration and reinforcing steel corrosion in roof slab.

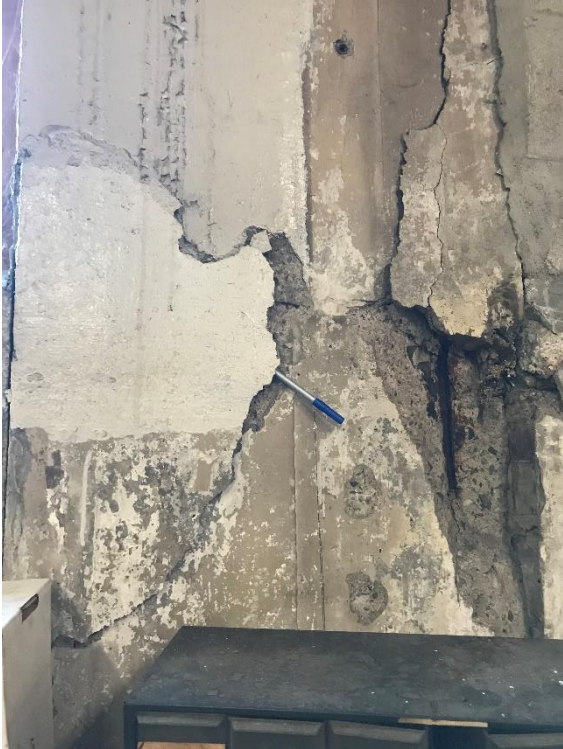
Photo 15. Maintenance Building. (Before removing spall) Concrete cracking in second floor column.

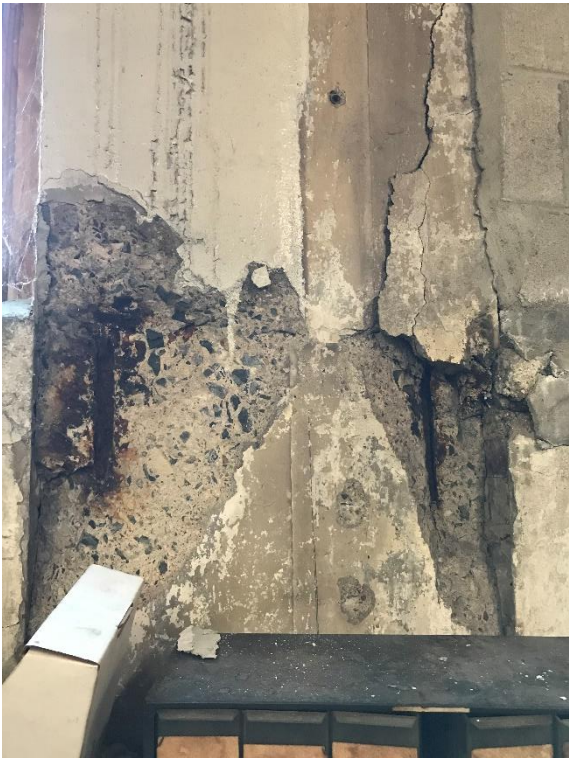
Photo 16. Maintenance Building. (After removing spall) Corroding reinforcing steel caused column spall.

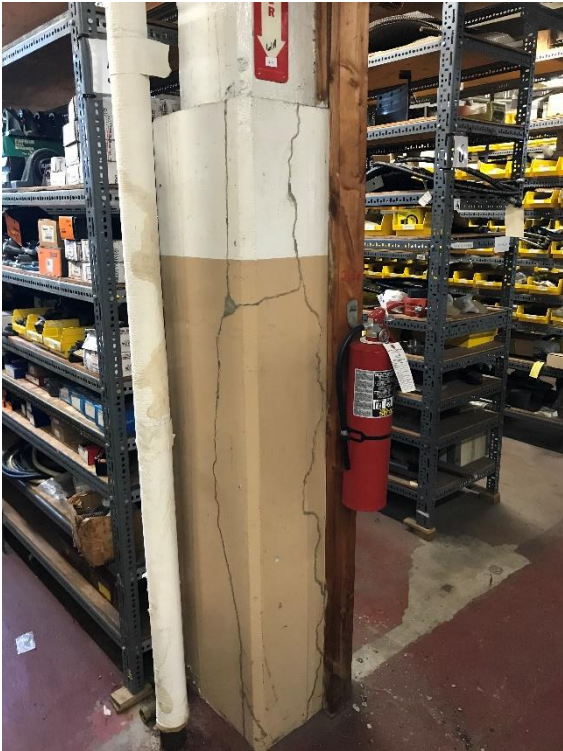
Photo 17. Maintenance Building. Concrete cracking in second floor column.

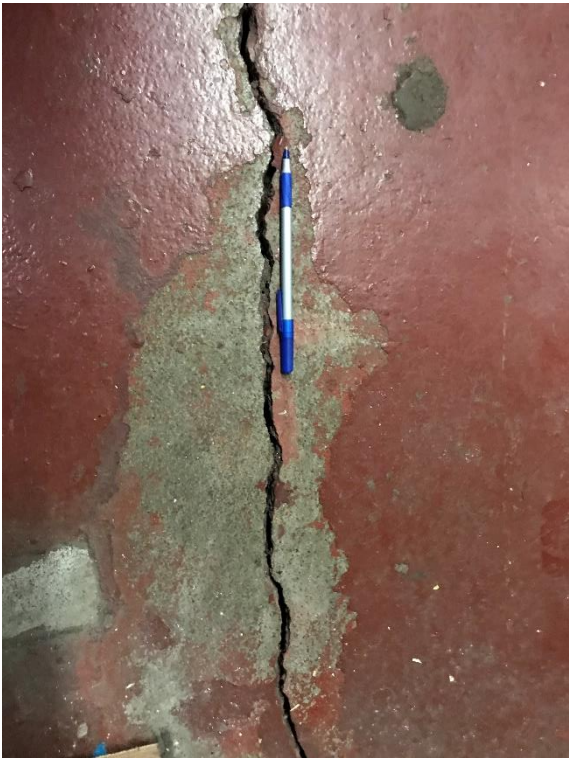
Photo 18. Maintenance Building. Concrete cracking in second floor slab.

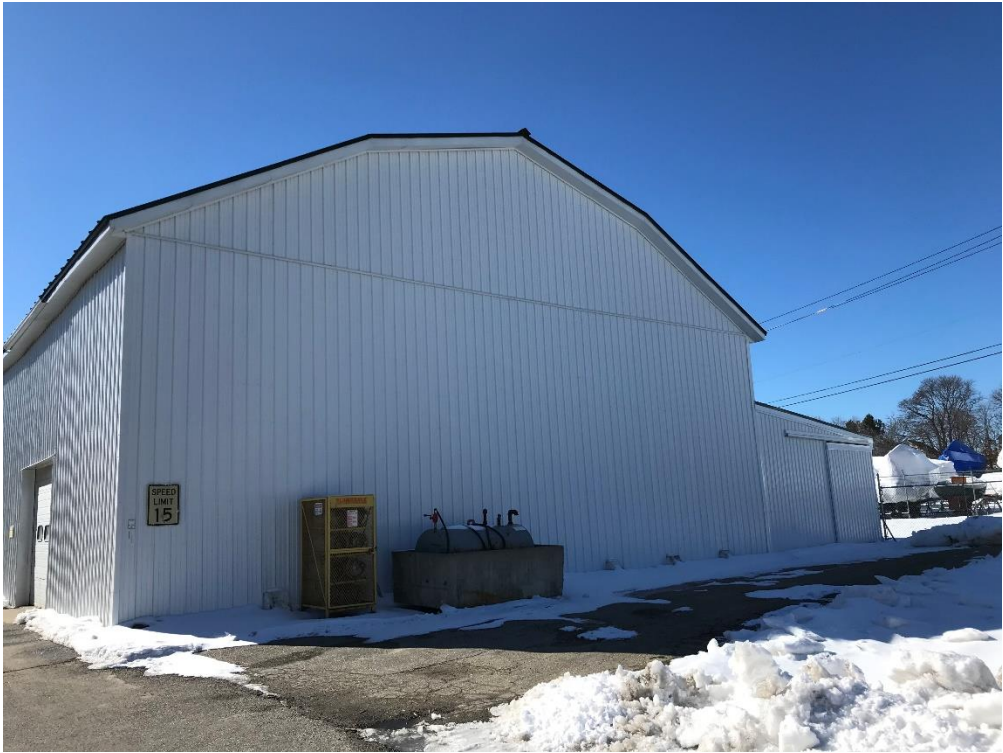
Photo 19. Warehouse No. 4 (White Barn) and Warehouse No 28 (Low bay attachment).

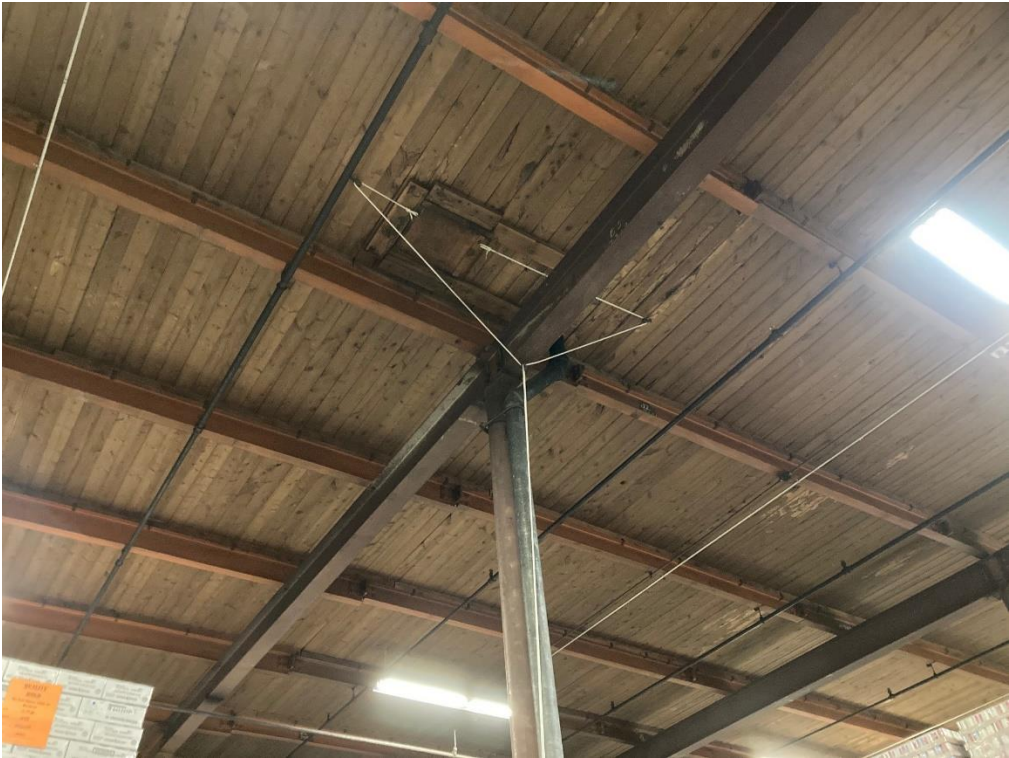
Photo 24. Warehouse No. 5. Steel framing is laid out on 24' by 25' column gird with 20' high exposed wood roof deck ceilings. The building is in excellent structural condition.

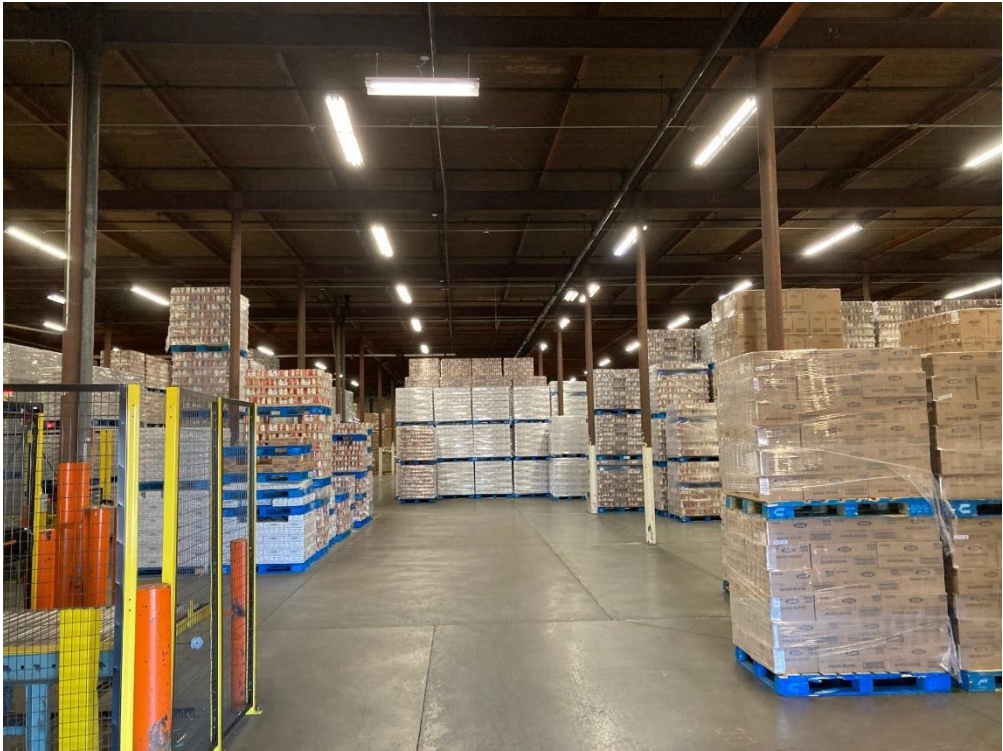
Photo 25. Warehouse No. 5. The warehouse buildings have short term value as incubator or maker space.

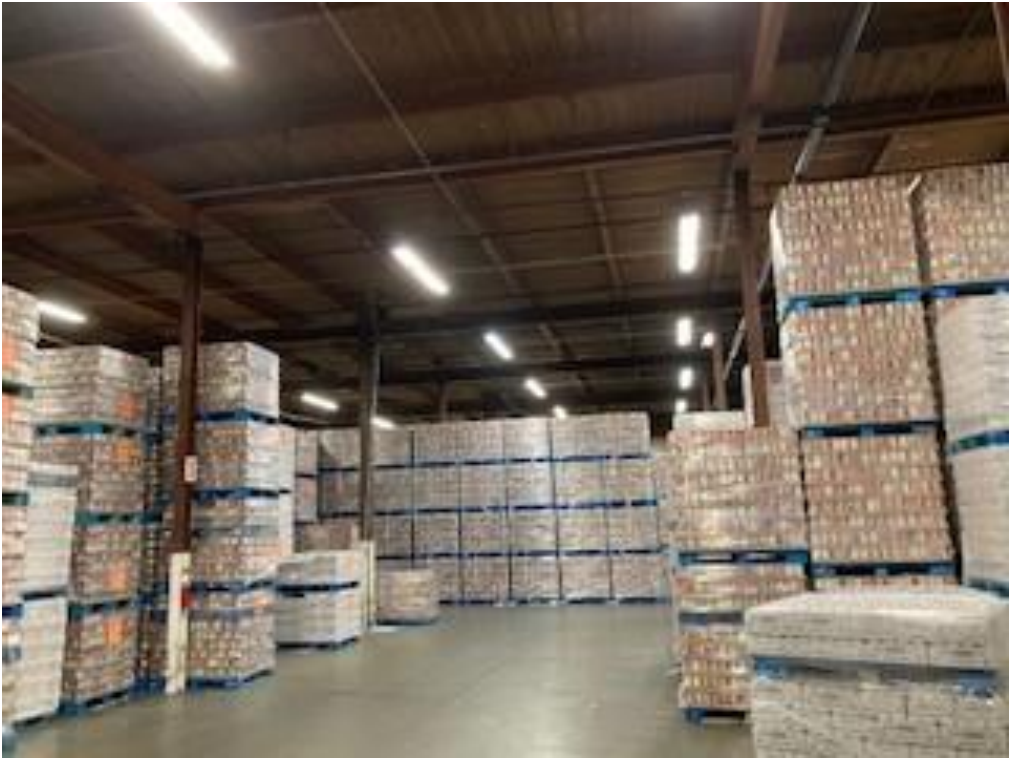
Photo 26. Warehouse No. 2. Similar to Warehouse No. 5, the one story steel framed building is in excellent structural condition with short term value as incubator or maker space.

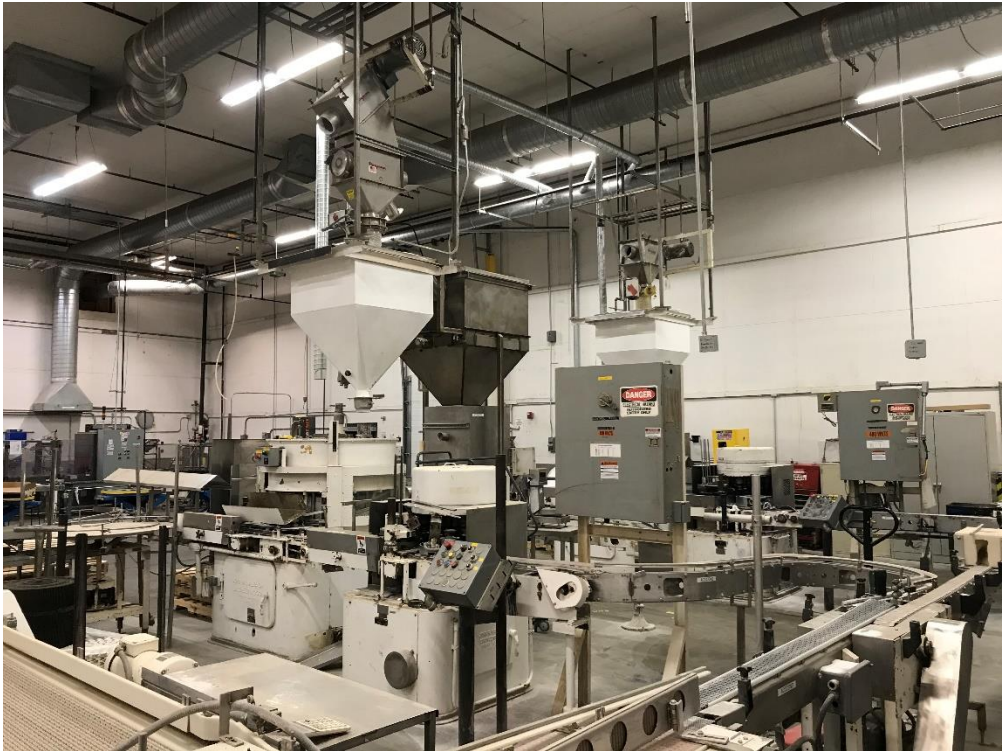
Photo 27. Spice Manufacturing Building. The circa 1980's steel framed building has large column gird and 22' high ceilings. The building is in excellent structural condition and has short term value as large meeting or incubator space.

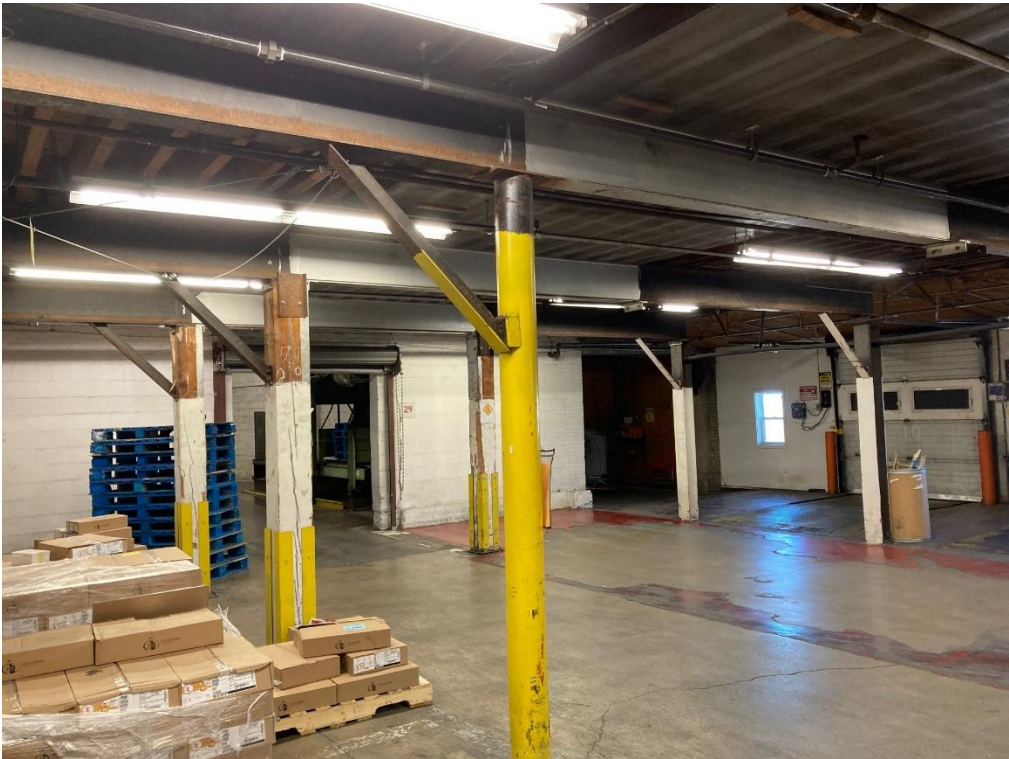
Photo 28. Label Room Building. Original warehouse and rail car unloading dock. The wood and steel framed structure has closely spaced columns that limit building reuse options.

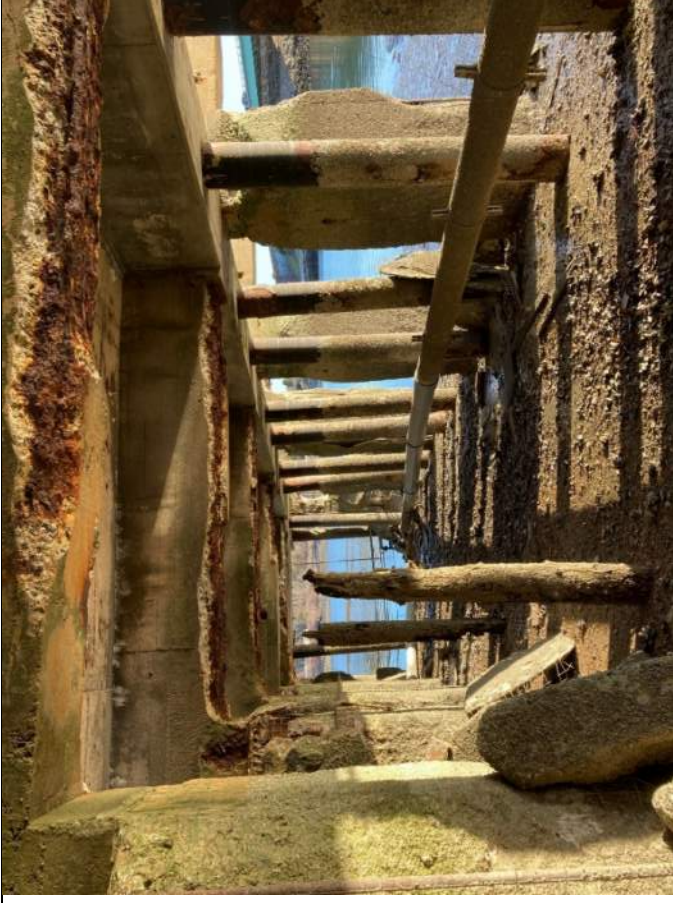
Photo 1 – First Floor Beam Corrosion Deterioration

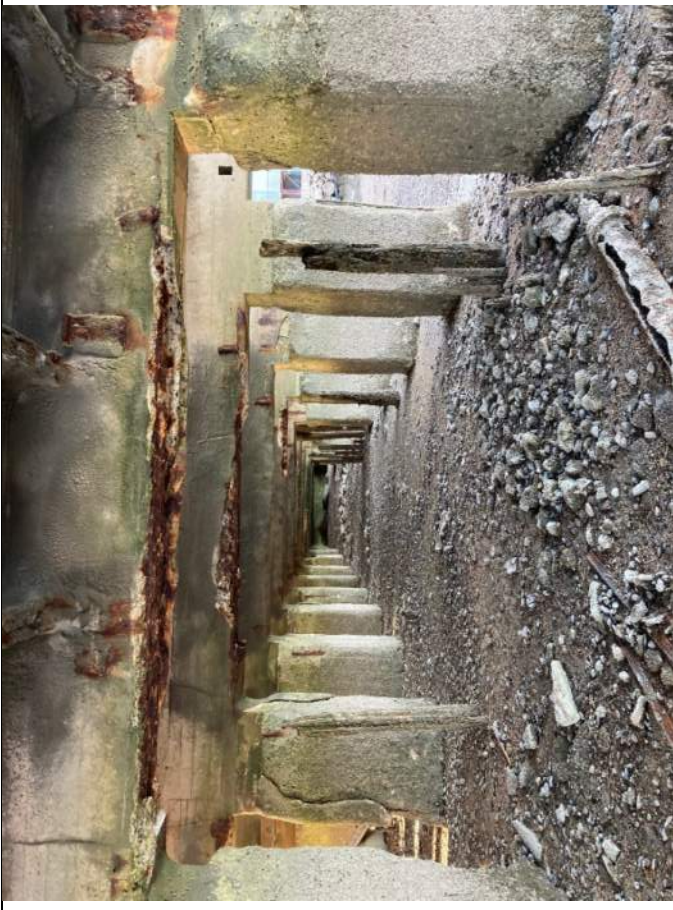
Photo 2 – First Floor Beam Corrosion Deterioration

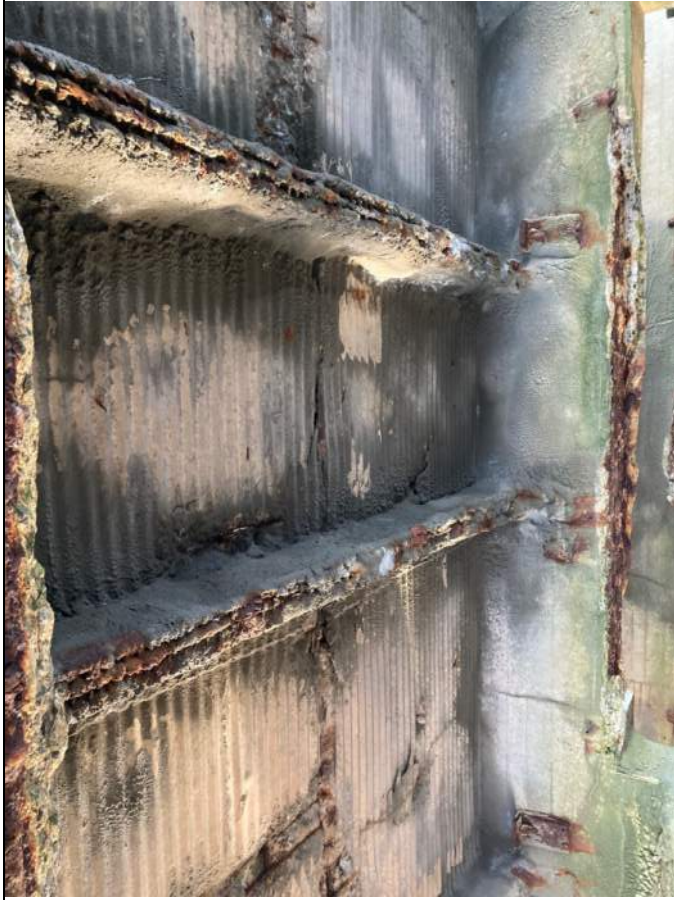
Photo 3 – First Floor Slab Corrosion Deterioration

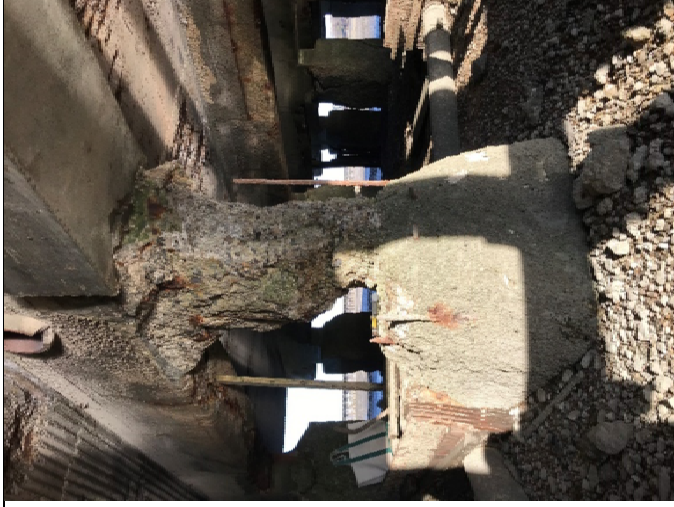
Photo 4 – First Floor Concrete Pier Deterioration

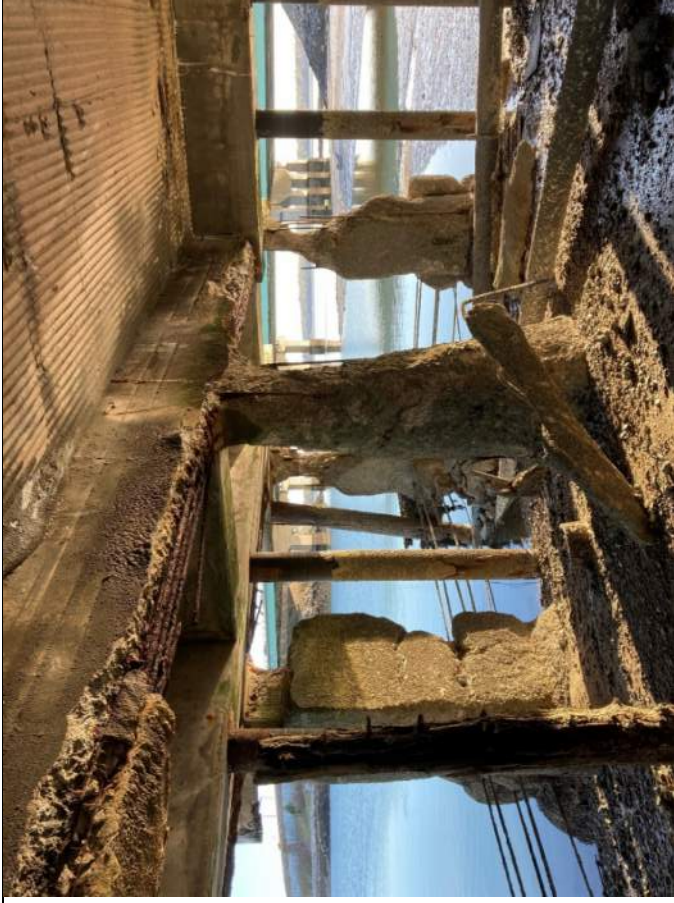
Photo 5 – First Floor Concrete Beam and Pier Corrosion Deterioration

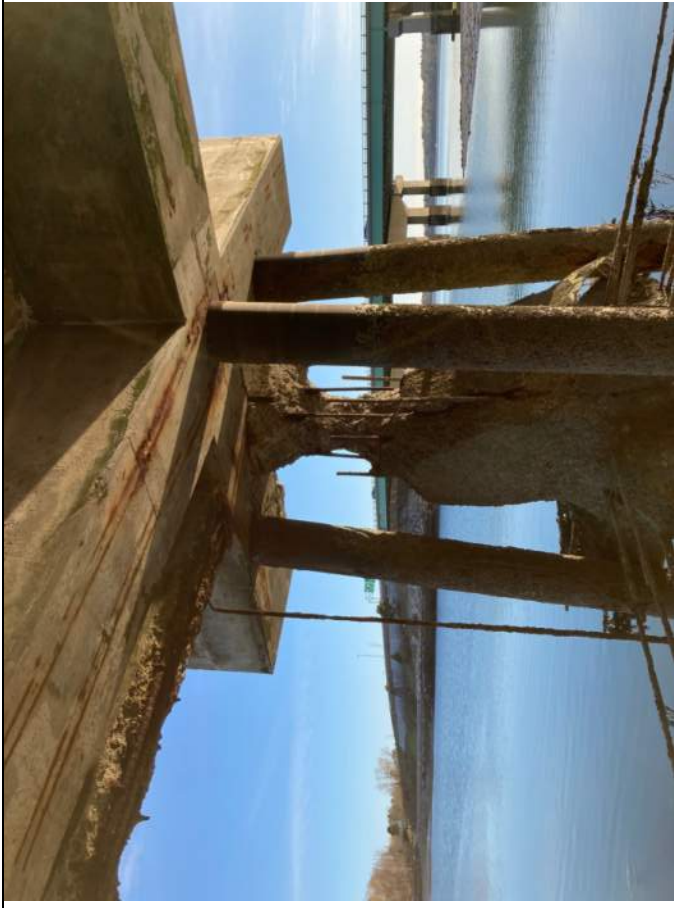
Photo 6 – Previous Repairs to On Going Deterioration are Already Rusting

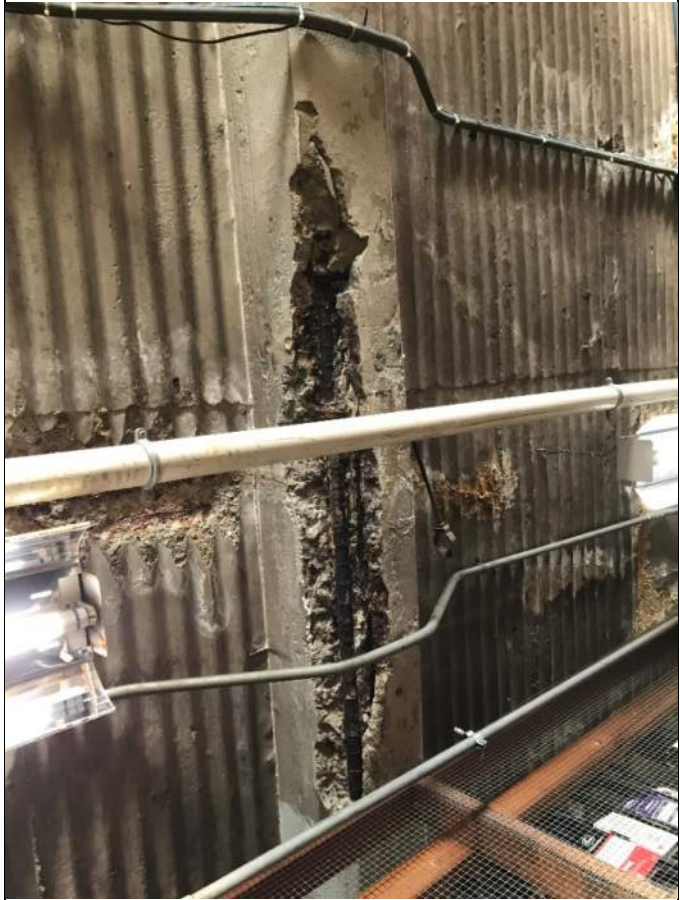
Photo 7 – Second Floor Slab and Beam Corrosion Deterioration

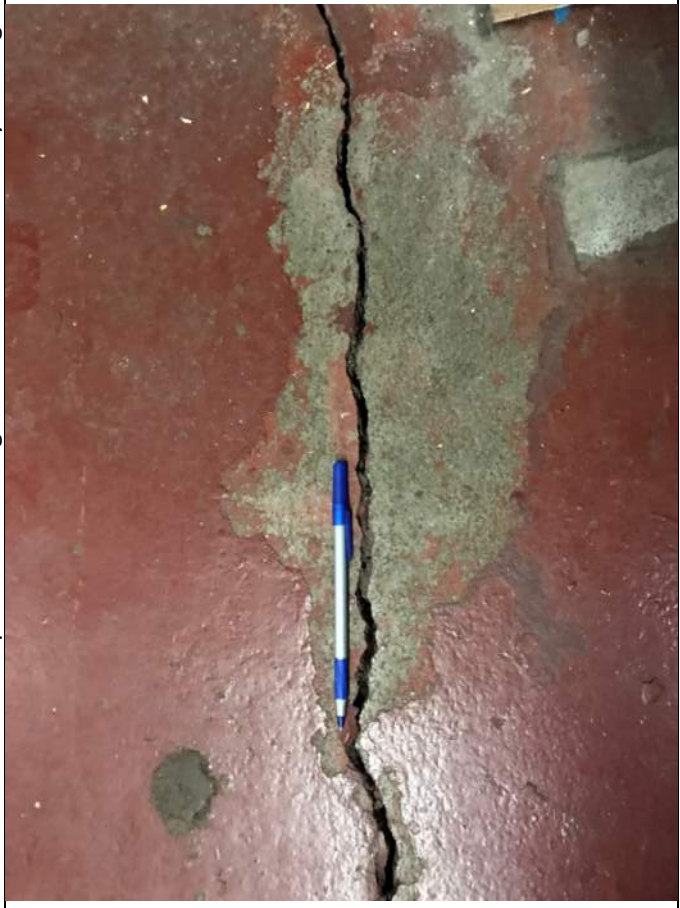
Photo 8 – Second Floor Slab Cracking

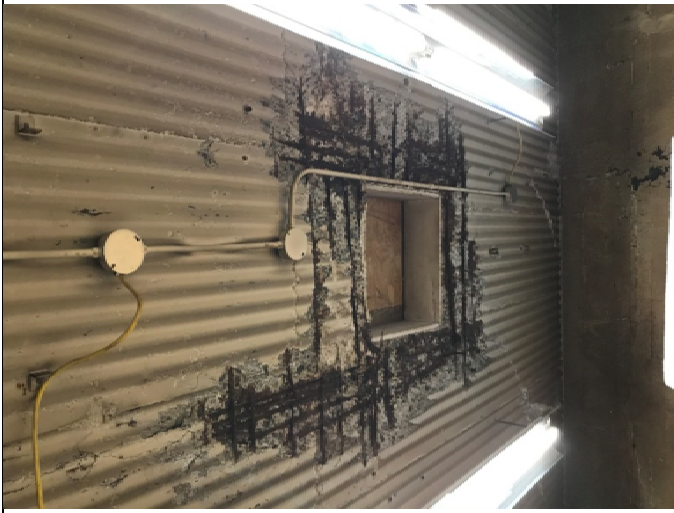
Photo 9 – Roof Slab Corrosion Deterioration

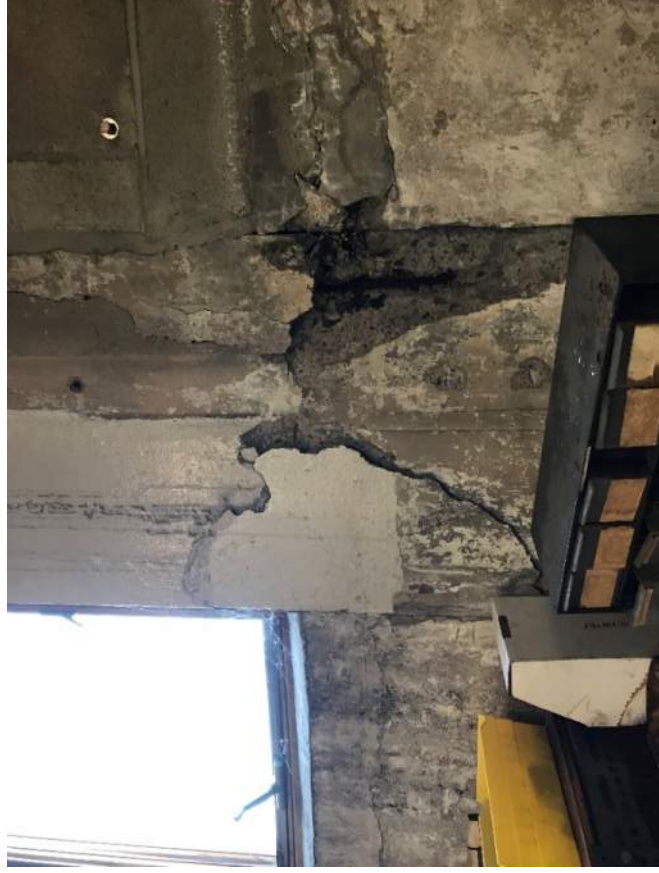
Photo 10 – Exterior Roof Column Corrosion Deterioration

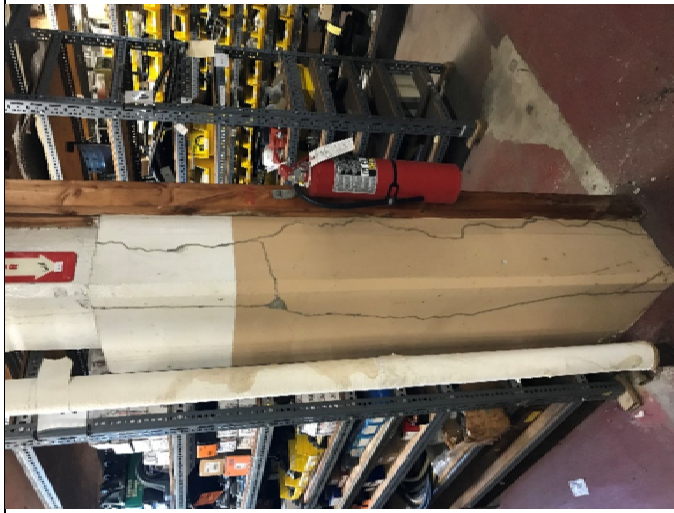
Photo 11 – Interior Roof Column Cracking

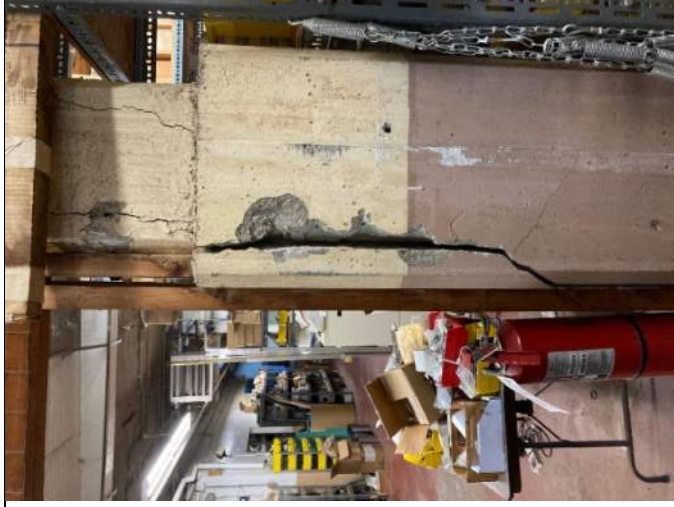
Photo 12 –Interior Roof Column Cracking
