### Technical Service Bulletin

Subject: Firmware Update V4.21h

Affected Models: MSX1234, MSX134 and MSX3030

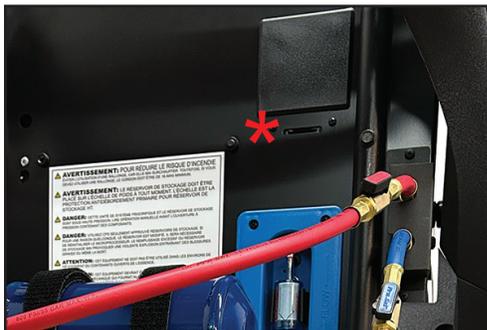
**\*SD card slot located in upper right corner on backside of MSX unit (above Refrigerant Identifier on MSX1234 & MSX3030 models)**
