TECHNICAL SERVICE BULLETIN

TSB C-GN-PT-0097

Date: July 1, 2026
To: All Service and Parts Managers
From: Technical Services Department
Subject: EEM Blower Motor Dropping Out

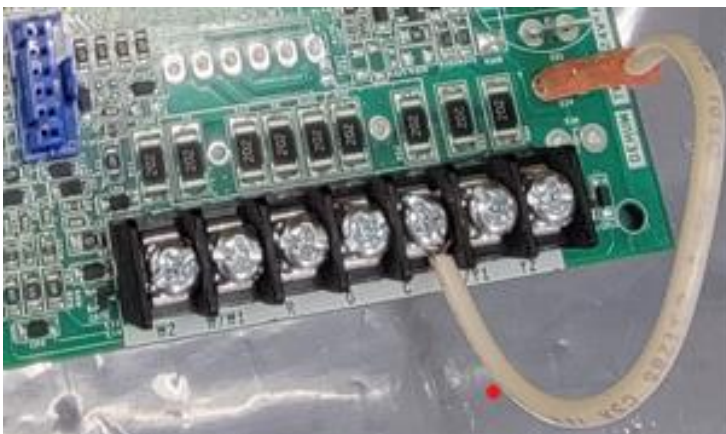
Figure 1

This is an important Technical Service Bulletin to be carried out by trained and certified service technicians. The intent of this bulletin is to inform our customers of an intermittent issue with circulator blower operation on our non-communicating multi-speed furnaces. On a limited number of non-communicating furnaces, the control board might momentarily change the blower speed before reverting to its original speed.

When this occurs, the blower motor might slow down as it changes to the new blower speed and then operate the same as it reverts to the original blower speed. This occurrence has been described as the blower motor dropping out for a short time and restarting, or the fan speed changing on the control board display (Example: F01 to F02). If the furnace is operating in gas heat mode, this occurrence might also cause the gas heat to turn off and restart once the original blower speed has returned.

A firmware update is planned for the non-communicating control boards that will resolve this issue and provide additional improvements to the non-communicating control boards. In the meantime, a field solution has been developed. Per **Figure 1** below, connect an 18-24awg jumper wire from the unused 3/16" QC TWIN connection on the control board to the "C" terminal on the Thermostat connections.

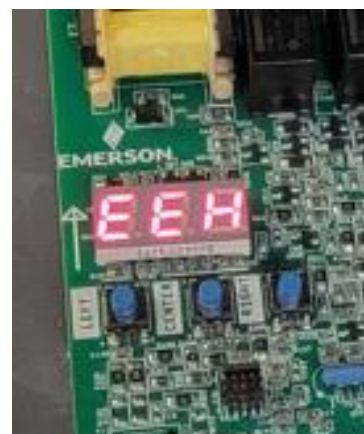
Figure 2

When using this field solution, the control board will display the “EEH” error code (Twinning Error) shown in **Figure 2** in the Status loop. The EEH error code will not affect system operations and should be ignored. The twinning function of the control board becomes unavailable when this field solution is applied.
