Bartlett Regional Hospital

CONDITION SURVEY

FAMILY PRACTICE BUILDING

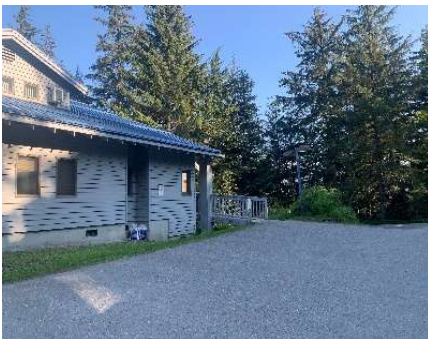
Parking: No striping is provided at parking area. It is estimated that 38 spaces are available on the site. Signage for 3 accessible parking stalls is provided, as well as signage for Ambulance parking. No van accessible stall parking signage is provided.

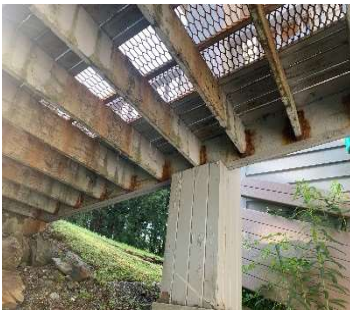
Exterior Decks/Ramps: Overall, the wood is in good condition. Construction of the ramps is comprised of joists hanging off a ledger with Simpson hangers. The ramp structure on the Southwest corner is in poor condition. The wood appears acceptable, but the Simpson hangers are rusted and should be replaced. The ramp also needs handrail extensions on both ends/both sides.

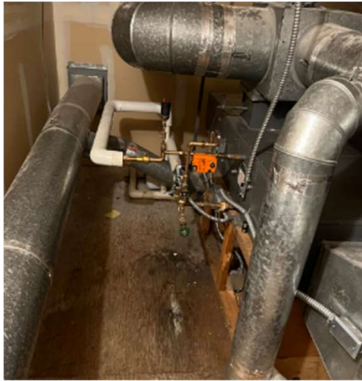
Ventilation system: The building is ventilated by a combination of forced air and operable windows. The upper floor is ventilated by five different single fan units, four are located in the upper floor, and one located in the lower floor fan room. Forced air ventilation is provided through taped metal uninsulated ductwork. The ductwork is typically in fair to good condition. The four upper floor-based fan units provide outside air through four separate louvers located on the corners of the building. Ventilation air is circulated to the outer offices through ceiling-based supply and return grilles. The central nurses station on the upper floor is supplied air from Ventilation Unit-“P” via various floor grilles. The lower floor Ventilation Unit-“P” has an oversized dedicated OSA duct that terminates in a louver on the south wall. All the fan units are original to the building. There is evidence that there has been hydronic repair work at several of the fan unit heating coils.

The lower floor occupied spaces are ventilated by a combination of operable windows and exhaust fans. The exterior rooms generally have no mechanical ventilation and rely on operable windows to meet code ventilation requirements. Interior rooms currently have no supply ventilation air and rely on inline exhaust fans tied to operable room switches. Typically, the exhaust fans are working, but are in poor condition.

The lower floor had a noticeably humid smell. The dank smell is likely from infiltration from the dirt floor crawlspaces below since there is no make-up air path on the lower floor space, especially if the exterior windows are closed. Most likely there is inadequate fresh air being pulled into the lower floor. The lower floor fan room original design called for additional fan units to serve future tenant spaces. This area may still be utilized to provide additional positive ventilation air to the lower floor.

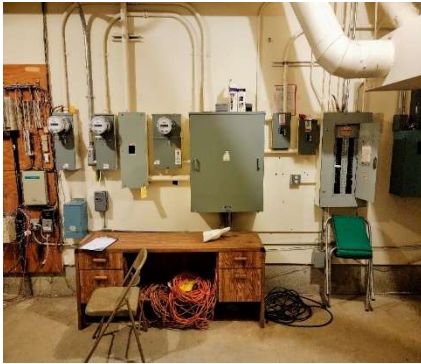
Electrical Service and Distribution: A 400 ampere, 208Y/120 volt utility service is routed underground into the lower floor to a current transformer enclosure with two 2 inch steel conduits enclosing single conductors. From the line (utility) side of the current transformers, feeders are routed to two smaller meters and main disconnects serving the two medical clinics in the lower floor. From the load (customer) side of the current transformers, three individual feeders are routed through separately enclosed circuit breakers to appliance panels in the lower floor, on the main floor, and on the second floor in the laboratory area. The three noted appliance panels are metered by the utility using a single meter connected to the current transformers.

There is a total of five service disconnects which is allowable by the National Electrical Code (NEC) and complies with the CBJ Title 19. Several of the disconnects are not clearly identified as service disconnects as required by code, and the disconnects are located well inside the building which is no longer allowed by code. This situation might be “grandfathered”, but any major building modifications will probably require this to be upgraded to current code. At the very least, a placard should be posted on the building’s exterior, identifying the service disconnects’ location.

All the appliance panels are panelboard style with dead front covers over the circuit terminations on the circuit breakers. The panels are in good condition, but the circuit breakers have reached their service life and should be replaced.

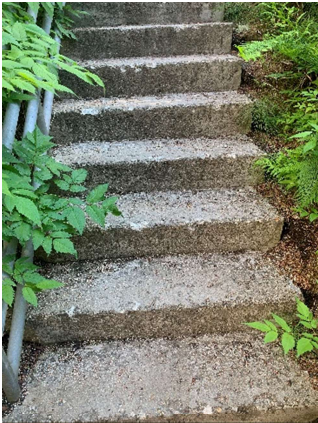
Exterior Stairs: The South concrete stairs have a good amount of ice melt surface damage although still in fair condition.

South end exterior stairs

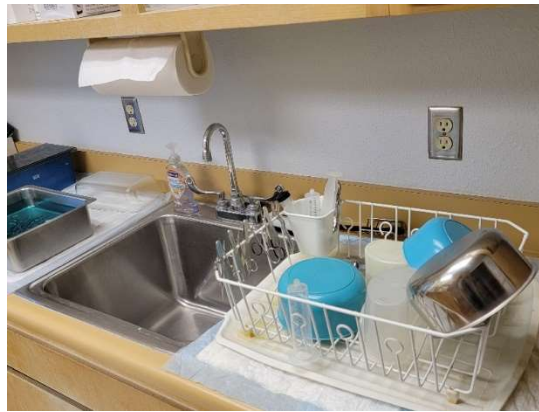
None of the receptacles within proximity to exam room or laboratory sinks are GFCI protected as required by the present codes. This was not required at the time the building was constructed. However, they should be replaced accordingly.

Outlets near sink

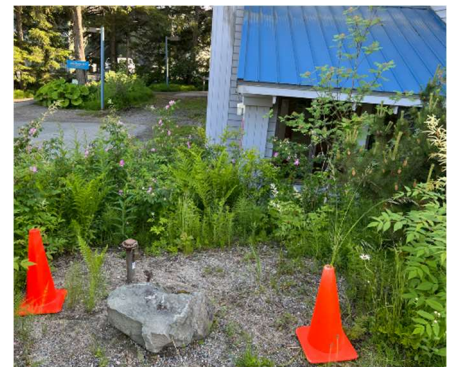
The underground oil tank is likely nearing the end of its service life and should be replaced with an aboveground double walled tank in the future.

Underground storage tank location

- Replaced underground tank with an aboveground double walled tank in the future.
- First floor ventilation should be examined for a solution to the lack of fresh make-up air.

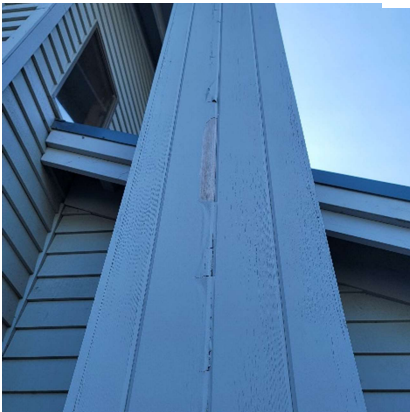
Paint at Column

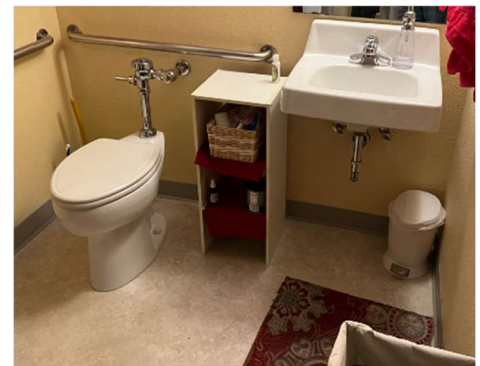
Bathroom Fixtures

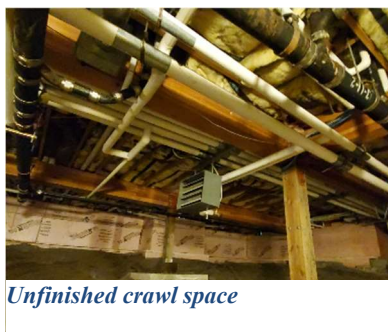
Unfinished crawl space

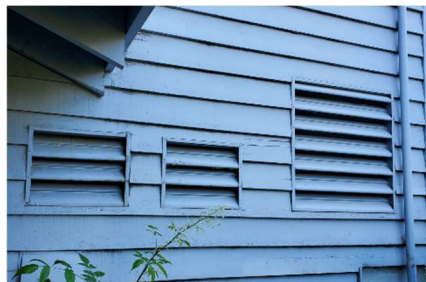
Boiler room relief and outside air louver

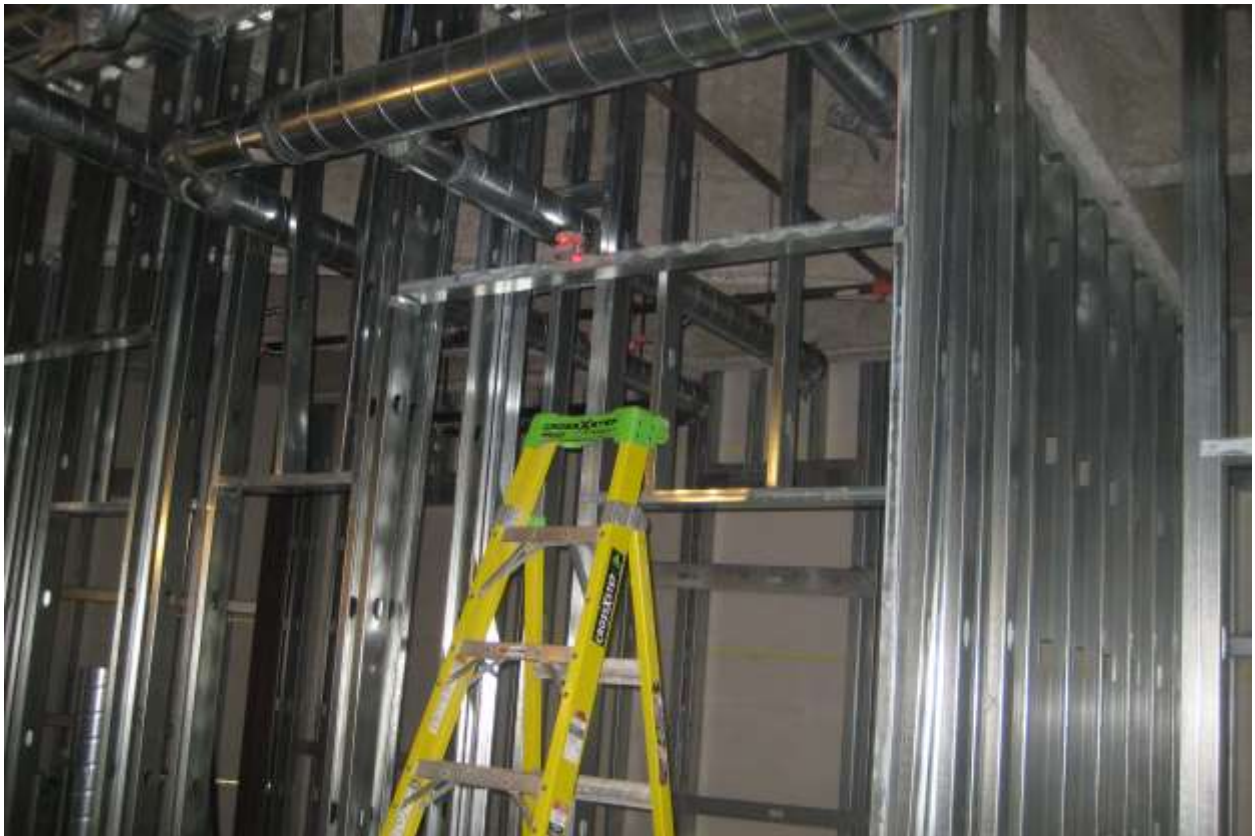
Photo 2382 – View of missing metal stud framing at the third floor. To be repaired by DC worker, Trevor.
