CONDITION SURVEY

FAMILY PRACTICE BUILDING

Family Practice Building 2022

EXECUTIVE SUMMARY

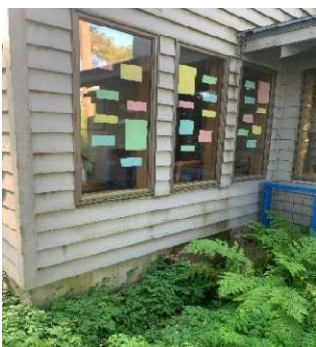
Windows: The windows are aluminum clad with a combination of casement operation and fixed that appear to be original from the 1984 building construction. The windows are in fair condition with some minor watermarks on wood window sills. The seal between panes did not appear broken in any of the windows, although the rubber seals on some of the operable windows were dry and brittle. A couple of the windows needed new operable window hardware but were still usable. Note that not all casement window operation was tested.

Exterior Doors: Exterior wood doors are worn and weathered. Although still functional, they are reaching the end of their useful life.

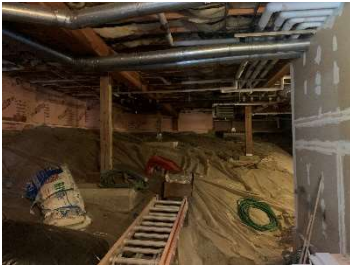
Foundations: Foundations are the original to the building and no improvements have been made since original construction. The structural wood members and concrete foundation walls in the crawlspace look to be in good condition, the metal brackets that connect the columns to the beams are rusted but appear to be surface rust only.

Siding: The building was last painted in 2010. Paint looks to be in fair condition but is reaching the end of its life. Mildew is showing on the Southeast side of the building where the Main Floor meets the exterior wall. See above for recommendations.

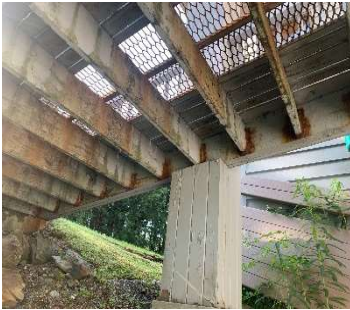
Exterior Decks/Ramps: Overall, the wood is in good condition. Construction of the ramps is comprised of joists hanging off a ledger with Simpson hangers. The ramp structure on the Southwest corner is in poor condition. The wood appears acceptable, but the Simpson hangers are rusted and should be replaced. The ramp also needs handrail extensions on both ends/both sides.

Exterior Stairs: The South concrete stairs have a good amount of ice melt surface damage although still in fair condition.

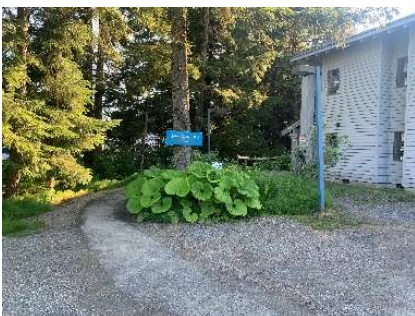
Exterior parking: Based on the estimated available parking, 2 accessible parking stalls are required with one being signed as 'van accessible'. Signage is provided for 3 accessible parking areas on the North, West, and East sides of the building. No striping is provided to designate accessible parking stalls and access aisles. Signage at the East side of the building is difficult to see within the vegetation that has overgrown the sign. Recommend moving the sign or trimming vegetation so sign is visible. At the north side of the building, the slope at the accessible stall exceeds allowable limits – accessible parking cannot be located in this area. Recommend removing sign for accessible parking. At the West side of the building, recommend

adding "Van Accessible" signage below existing accessible signage to meet van accessible requirement. Provide parking striping at accessible parking areas to show parking stalls and accessible aisles per code requirements.

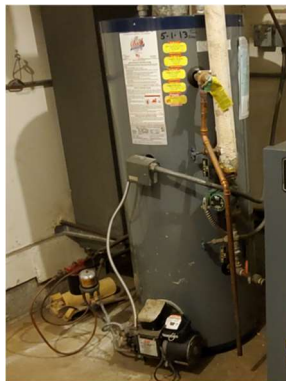
Plumbing System: The domestic water piping is copper and is largely insulated. The domestic waste piping is typically cast iron with some ABS likely added in later tenant improvements. A water service and meter are located in the unimproved crawlspace outside the boiler room. There is a reduced pressure backflow preventer (RPBP) segregating the entire domestic system from the city service. There does not appear to be an RPBP segregating the upper floor lab domestic water from the rest of the domestic system. The plumbing fixtures appear mostly original to the building with some replacements and tenant improvement modifications since the building was constructed. There are no hot water tempering or anti scald devices located at the lavatories or showers. Heated domestic hot water is provided by a single oil-fired hot water tank. The domestic water system is circulated by a single hot water recirculation pump located in the boiler room. Overall, the plumbing system is in good condition.

- **Oil Fired Hot Water Heater:** Model- Bock 51E, Heating is provided by an oil-fired burner. Volume capacity: 50 gallons. Heating capacity: 161GPH @ 90F. The hot water heater is in good condition and has a likely service life of 5-15 years.

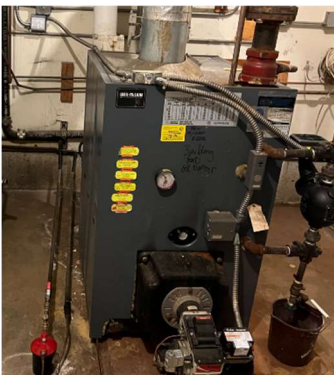
Heating System: The building is heated by a single oil-fired hydronic boiler located in the lower floor boiler room. The hydronic piping is copper and mostly original. The piping is generally in fair condition. Heating water is distributed via perimeter fin-tubes, unit heaters, and fan unit heating coils. Individual zones and rooms are controlled by local thermostats. There is evidence of repaired hydronic leakage especially around several ventilation units. There is no current evidence of piping leaks. Terminal unit heaters, baseboards and heating coils appears to be original and are in fair condition. The hot water heater and boiler share a common double wall chimney which terminates at the roof. There is evidence of previous water leakage down the chimney stack. There was no evidence of ongoing water damage on the chimney stack. The chimney breeching that is visible in the mechanical room is in fair condition.

- **Boiler:** Model- Weil McLain Commercial 580. Installed in 2015. Net capacity: 448MBH. The boiler is in good condition and should have a service life of 10-20 years.
- **Zone Pumps:** P-1, P-2 and P-3. P-1 was replaced in recently replaced in 2019 and is in very good condition. P-2 and P-3 are older but are in fairly good condition.

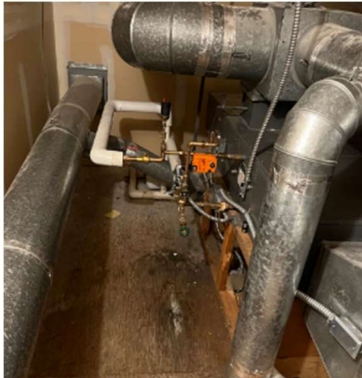
Fuel Oil System: Fuel oil is used to produce building heat and hot water from the domestic water heater. An existing underground oil storage tank (UST) supplies oil to the basement appliances via a copper supply and return pipe. Since the UST is original it is presumed to be single wall. The majority of the oil supply and return piping appears to be original. Portions of the oil supply and return have been modified at the hot water heater and boiler appliances.

In 2021, there was a reported failure in the fuel oil system. The underground tank was reportedly tested for water and contaminate leaks and was determined to be leak free. The exterior fuel lines were also excavated and reportedly were in good condition, but are single wall, direct buried. The failure of the fuel system was fixed by replacing the fuel filter and firomatic valve assembly.

The underground oil tank is likely nearing the end of its service life and should be replaced with an aboveground double walled tank in the future.

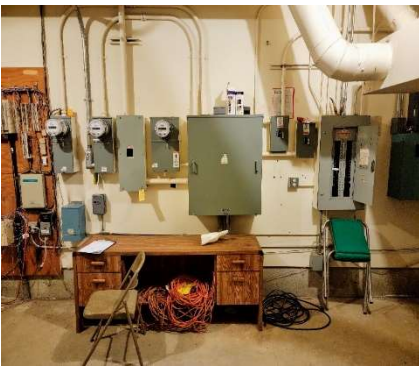
Electrical Service and Distribution: A 400 ampere, 208Y/120 volt utility service is routed underground into the lower floor to a current transformer enclosure with two 2 inch steel conduits enclosing single conductors. From the line (utility) side of the current transformers, feeders are routed to two smaller meters and main disconnects serving the two medical clinics in the lower floor. From the load (customer) side of the current transformers, three individual feeders are routed through separately enclosed circuit breakers to appliance panels in the lower floor, on the main floor, and on the second floor in the laboratory area. The three noted appliance panels are metered by the utility using a single meter connected to the current transformers.

There is a total of five service disconnects which is allowable by the National Electrical Code (NEC) and complies with the CBJ Title 19. Several of the disconnects are not clearly identified as service disconnects as required by code, and the disconnects are located well inside the building which is no longer allowed by code. This situation might be “grandfathered”, but any major building modifications will probably require this to be upgraded to current code. At the very least, a placard should be posted on the building’s exterior, identifying the service disconnects’ location.

All the appliance panels are panelboard style with dead front covers over the circuit terminations on the circuit breakers. The panels are in good condition, but the circuit breakers have reached their service life and should be replaced.

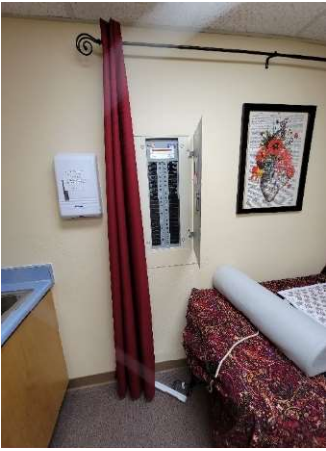
Branch Circuits and Receptacles: All the branch circuits for lighting, receptacles and appliances appear to use single conductors in conduit. All appear to conform to codes and are in good condition.

Convenience receptacles are distributed throughout the building as individual devices and as multi-outlet strips. The receptacles in the toilet rooms include ground fault circuit interrupters (GFCI). Most, if not all, receptacles appear to have been installed with the original construction and have exceeded their service life.

None of the receptacles within proximity to exam room or laboratory sinks are GFCI protected as required by the present codes. This was not required at the time the building was constructed. However, they should be replaced accordingly.

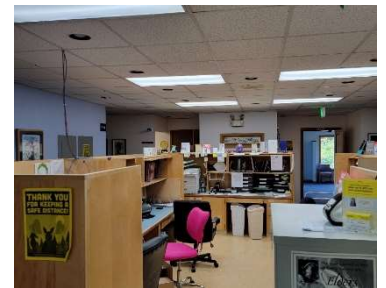
Lighting and Lighting Controls: Most of the interior illumination is accomplished using 2ft x 4ft troffers in the suspended ceiling. All utilize fluorescent lamps. There are some recessed cylinders in the public areas and the main nurse’s station, fitted for incandescent type lamps (some might be using LED lamps now). All the fixtures have exceeded their service life.

All the interior lighting is controlled with manually operated switches strategically located to control specific rooms. All the switches have exceeded their service life and should be replaced.

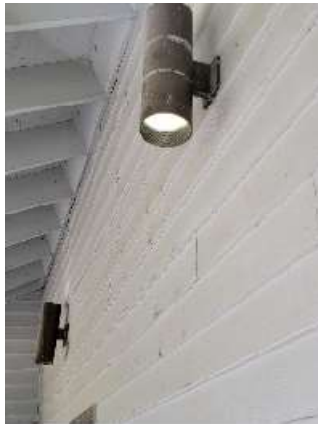
The exterior lighting includes wall mounted fixtures at all the entries, except the lower back door to Suite #100. Post mounted fixtures are distributed throughout the parking and driveway areas. The luminaires are now fitted with LED type lamps. All of the fixtures have exceeded their service life.

The exterior lighting is controlled by a mechanical timer located in the lower floor with the electrical service equipment.

Emergency light fixtures and electrically illuminated exit signs are in most of the egress routes. There are some exits that lack signs and proper emergency lights as required by the present codes. The emergency lights and exit sign lights on the lower level do not operate and should be repaired or replaced.

There is no emergency lighting for the exterior egress pathways. It is recommended for this type of facility even though it might not be strictly required by the present codes.

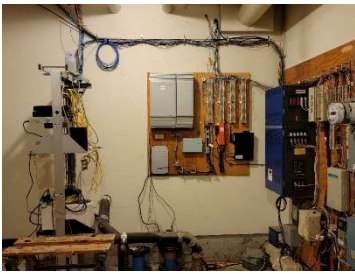
Data & Communications: The building was originally constructed with basic telephone service. With the advent of data networks and their general development over time since the original construction, data circuits have been routed throughout the building. The main distribution frame (MDF) is in the lower floor in the same room as the electrical service equipment. The circuits disperse from there to workstation and telephone terminals throughout the building. All the cables appear to be routed in an open manner, mostly concealed above suspended ceilings and within walls. Some circuits drop from the ceiling over the main nurse's station. The circuits and MDF are in fair condition.

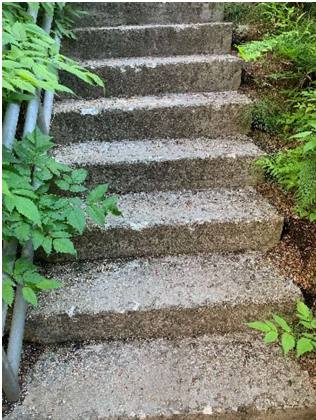
South end exterior stairs

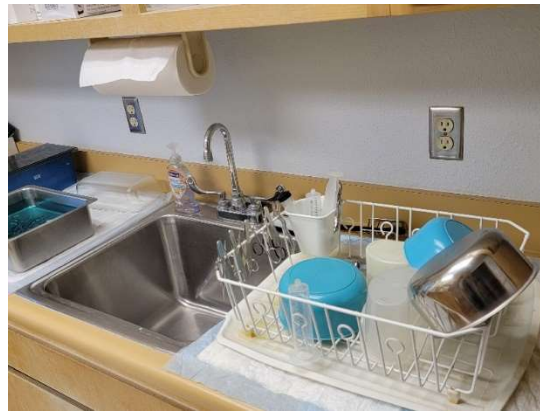
Outlets near sink

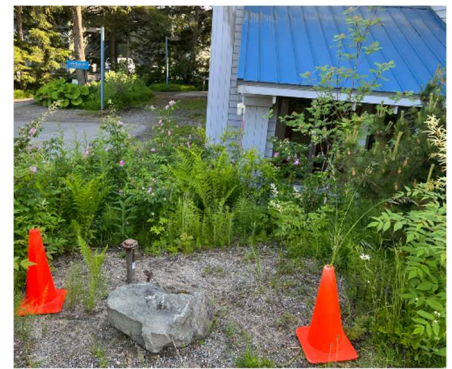
Underground storage tank location

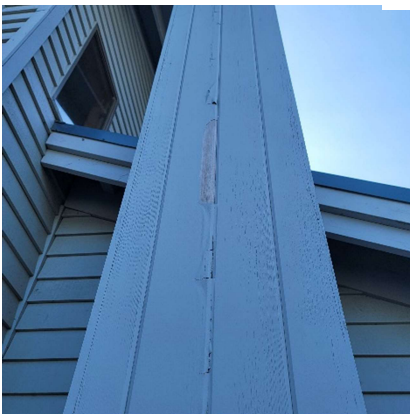
Paint at Column

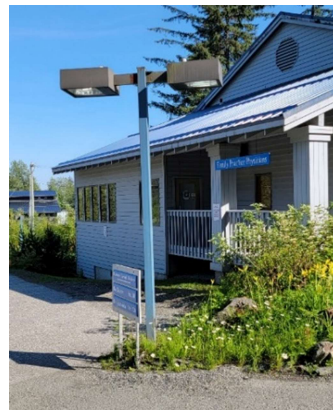
Main floor entry

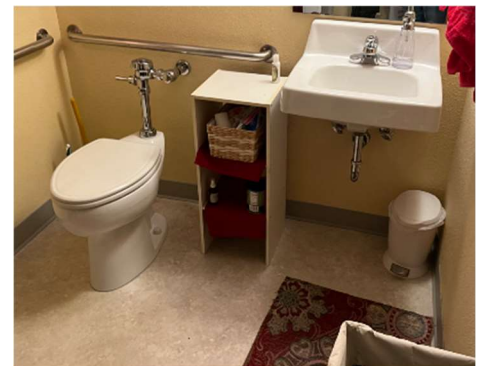
Specialties: Toilet accessories appear to be in good working condition. They are older models so an upgrade would be good but not necessary at this time.

Bathroom Fixtures

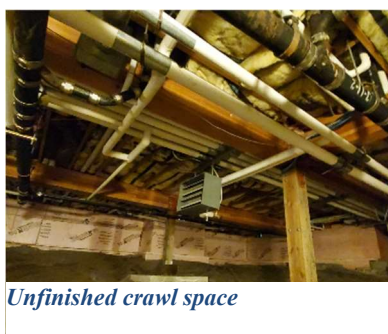
The lower floor had a noticeably humid smell. The dank smell is likely from infiltration from the dirt floor crawlspaces below since there is no make-up air path on the lower floor space, especially if the exterior windows are closed. Most likely there is inadequate fresh air being pulled into the lower floor. The lower floor fan room original design called for additional fan units to serve future tenant spaces. This area may still be utilized to provide additional positive ventilation air to the lower floor.

Unfinished crawl space

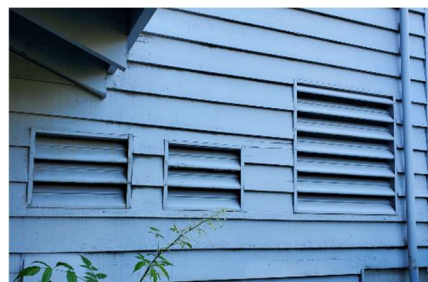
Boiler room relief and outside air louver
