# Home Inspection Report

3225 Hospital Drive, Juneau , AK 99801

**Inspection Date:**

Thursday, January 21, 2021

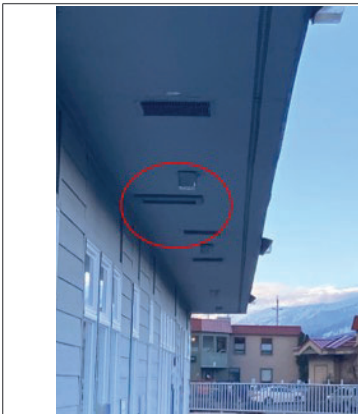
Small access hatch to mansard roof eave framing. Plywood sheer sheeting is installed on the rafter and soffit framing approximately every 20' that restricts access to the southeast sides of building. Consider installing additional access for inspection/maintenance.

Small access hatch to mansard roof eave framing. Plywood sheer sheeting is installed on the rafter and soffit framing approximately every 20' that restricts access to the southeast sides of building. Consider installing additional access for inspection/maintenance.

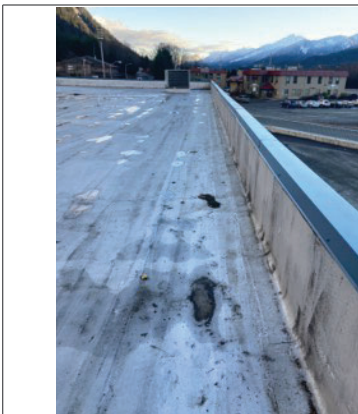
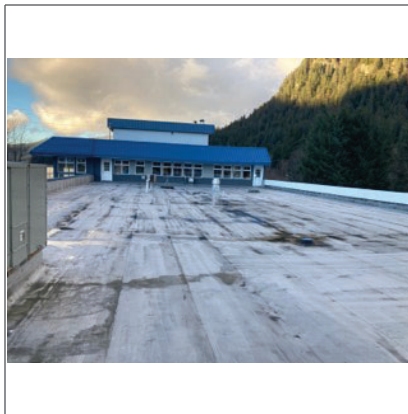
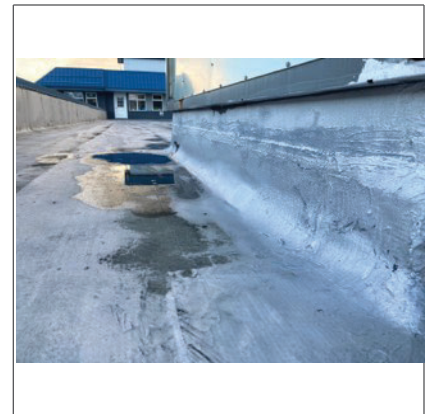
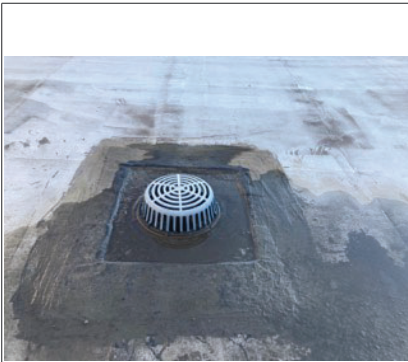
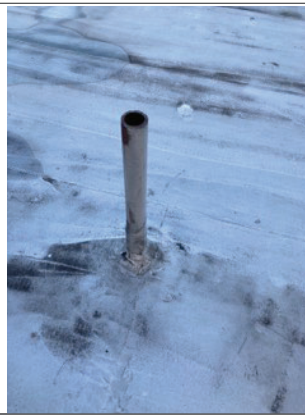
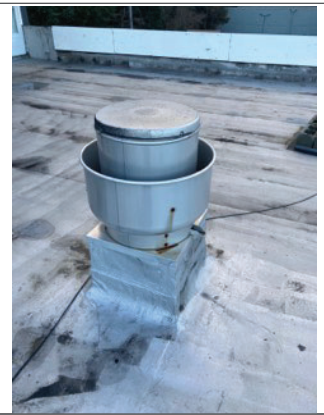
Roofing appears to be overall functional though appears to be nearing the end of its useful life. The estimated average life expectancy of Modified Bitumen ( torch down asphalt membrane) is +/- 20 years. Many factors such as installation, geographical location and maintenance may affect serviceable life. Recommend anticipating some maintenance related repairs and sealing of areas noted and replacement of the low slope roof system in the near future.

Water pools along side the penthouse wall, ventilation hood is cut low into the roof to wall coving. This area may be susceptible to water intrusion.

Several areas of patching and sealing present on roof. Recommend qualified roofing contractor evaluate and monitor/repair as needed to ensure proper protection and anticipate replacement of low slope roofing systems in the near future.

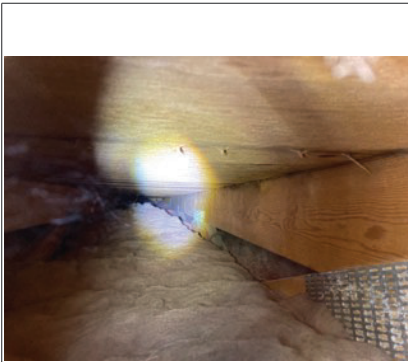
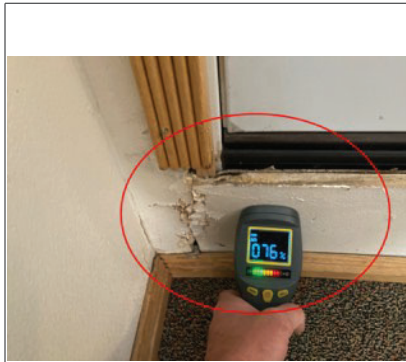
Water intrusion at the roof access door. Elevated moisture readings noted at interior wall assembly. Recommend qualified contractor evaluate extent of damage and properly seal door threshold/roof transition to prevent further damage.

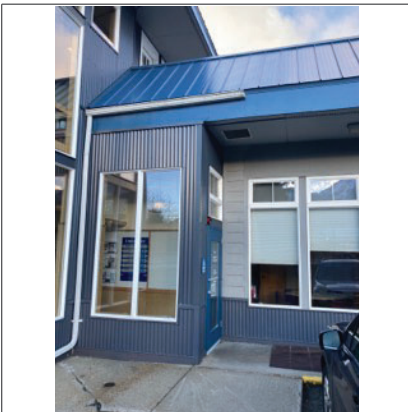
**Gutters & downspouts** Metal gutters and downspouts are only present on the exterior tower eaves and a small section protecting the main tower entry wall that does not have extended eaves. The gutters installed appear properly sloped and secure. Remaining eaves over original structure and southeast tower eaves over flat/low sloped roof do not have gutters. Missing gutters cause excessive backsplash on wall components that may cause accelerated deterioration. The lower walls have been recently clad with a metal siding Wainscot to replace the damaged fiber cement siding. Areas of pooling water and corrosion near exterior door frames as well as elevated moisture readings to interior wall board in these areas may be in part due to the lack consider installing gutters and downspouts where missing to improve drainage away from building.

Consider installing gutters and downspouts to all eaves where missing to aid in directing excessive water away from lower wall cladding and doors.

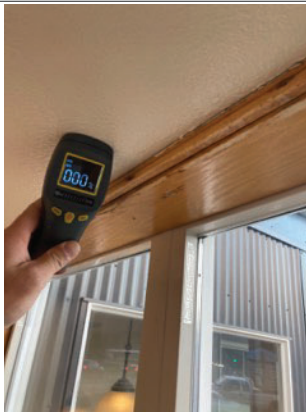
Is few areas of moisture stains at interior window trims and wall cladding though no elevated moisture readings noted at time of inspection other then near doors as noted.

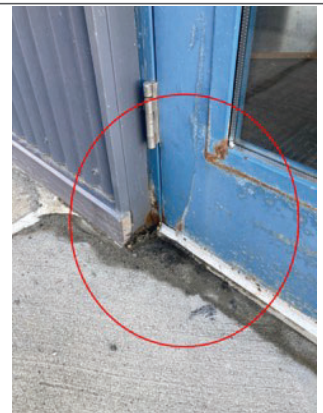
Many of the exterior doors are significantly weathered and are nearing the end of their serviceable life. Recommend Anticipating exterior door replacement throughout.

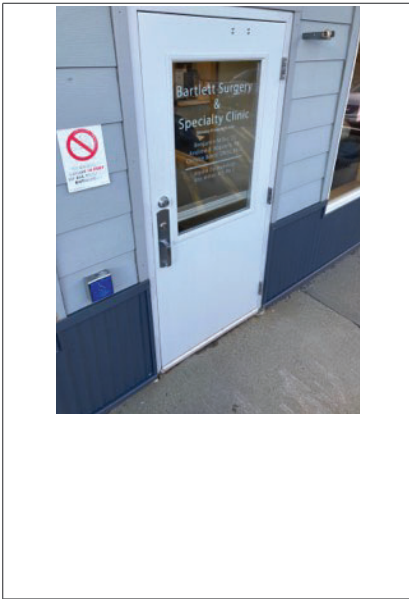
Damaged door and frames due to water pooling.

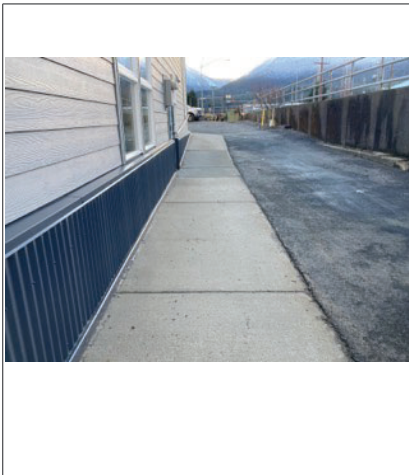
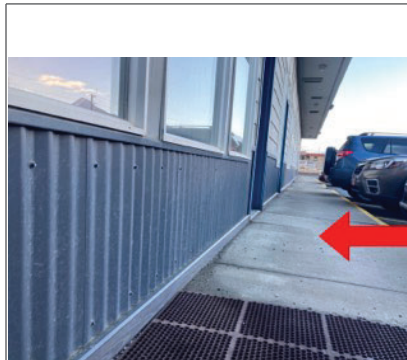
A few areas of the concrete side walks appear to slope towards the building. Sidewalks are flush with floor slabs and water intrusion under door thresholds visible on a few of the exterior doors has contributed to corrosion of door frames and water damage to floor coverings. Areas of elevated moisture readings on drywall where moisture appears to be wicking up. Recommend anticipating replacement and re sloping of portions of walkways to direct water away from structure.

Water pools against building in a few areas. Recommend repair

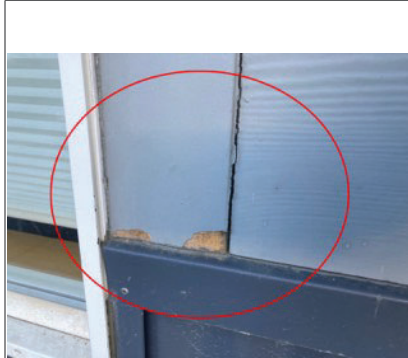
Areas of typical exterior weathering consistent with age. Recommend repair and repaint fiber cement sidings and trims as needed.

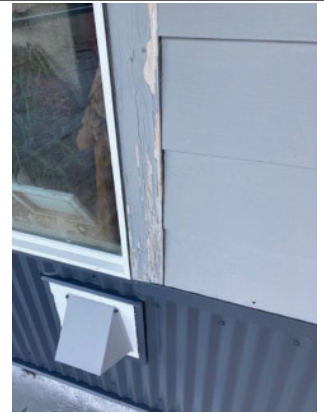
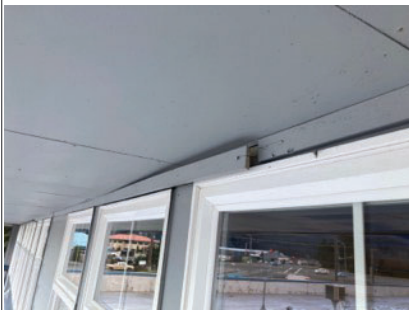
Typical cracks at siding / trim details. Areas of spalling and de laminations visible at exterior fiberboard trims. This type of material is susceptible to accelerated deterioration when subjected to moisture. Recommend anticipating repainting and sealing of all non metallic exterior claddings.

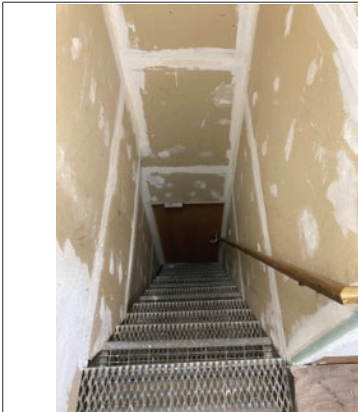
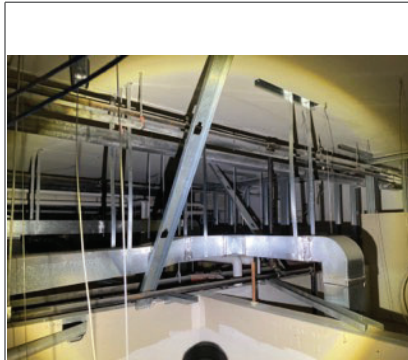
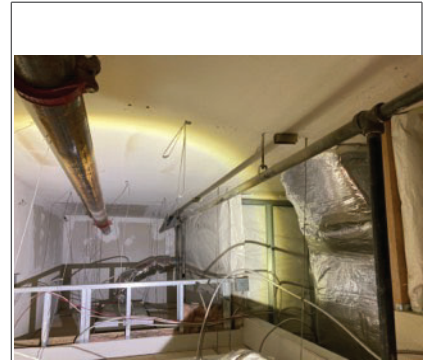
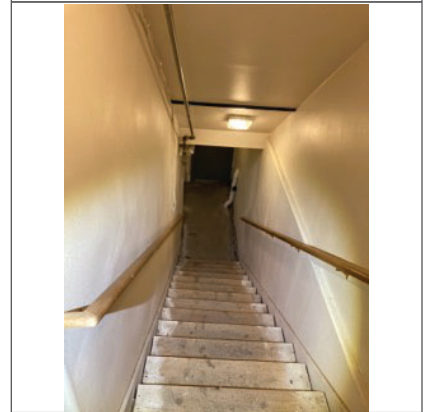
A few areas with diagonal cracks through wallboard visible on each floor Adjacent to elevator shaft suggests minor settling of structural supports however a full structural assessment was not performed. Further evaluation by licensed structural engineer is recommended if cracking worsens or shows signs of movement.

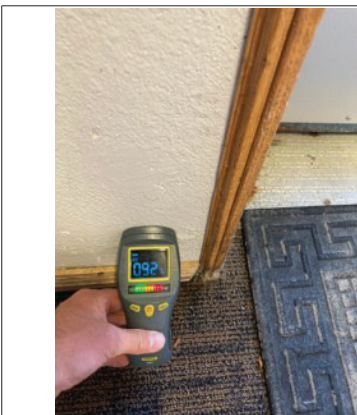
A few areas of wet drywall on ground level exterior doors appear to be from improperly sloped walkways and failing door seals/frame.

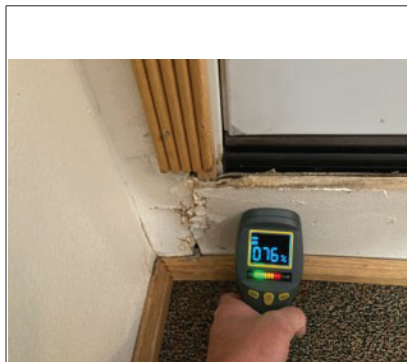
Water intrusion noted at exterior door at roof access. Recommend further evaluation and repair as needed to restore weather protection and prevent further damage.

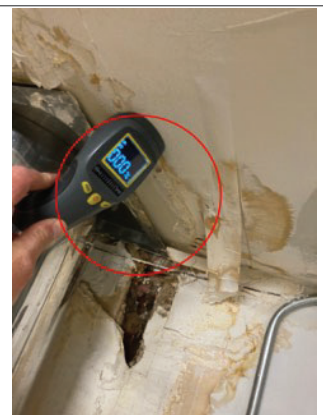
Areas of water damage visible in boiler room appear to be from previous roof leaks at chimney penetration. No elevated moisture readings present. Condition of framing/sheeting is unknown.

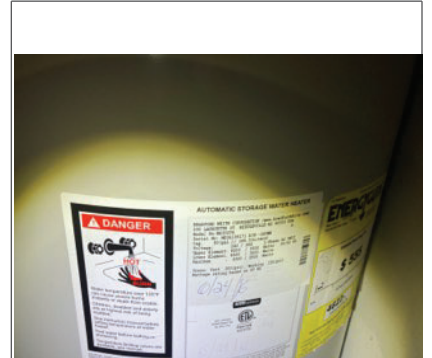
All water heaters are required to be installed with seismic straps. Recommend installing seismic straps to all water heaters.

Recommend installing seismic straps on all water heaters as required.
