SAFETY ALERT - #03-2006

INCIDENT WITH MISMATCHED HAMMER UNIONS

RELEASE DATE: DECEMBER 22, 2005

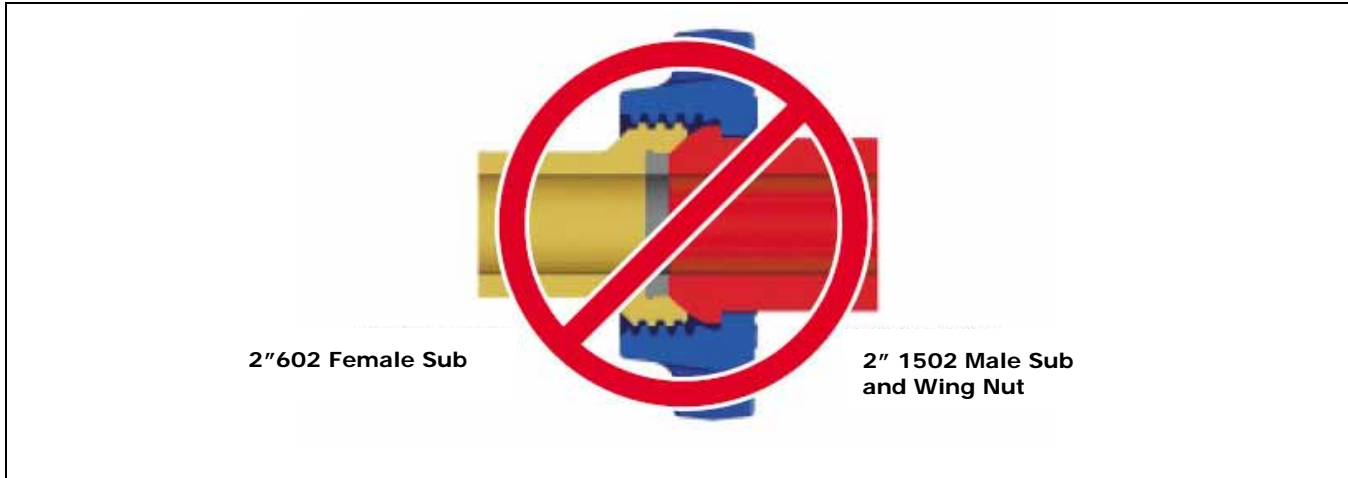
Illustration:

Mismatched hammer unions - A 1502 wing half was connected to a 602 thread half.

1. There was an improper identification process for changeovers.
2. There was no formal written policy for colour coding of equipment (i.e., changeovers).
3. There was no formal communication to supervisors and employees regarding the colour coding of equipment
4. Not all crew members were familiar with identifying different pressure ratings and sizes of hammer unions.

1. Review and revise the identification process for hammer union changeovers. Develop a formal policy for identification. Communicate this policy and standard to operations managers, field supervisors, and operators, and train and educate them in the policy and standard, too.
2. Update the pre-flow checklist to include more details regarding the high-pressure flowline (i.e., hammer-union size confirmation, changeover identification, etc.).
3. Raise this mismatched hammer union issue through PSAC, as this has been an industry issue for many years.
