**ANNUAL INSPECTION REPORT FOR COAL COMBUSTION RESIDUALS (CCR) UNITS  
SAN MIGUEL ELECTRIC COOPERATIVE POWER PLANT**

January 10, 2020

Wood Project No.: 6706160039

Appendix A    November 21, 2019 Inspection Summary

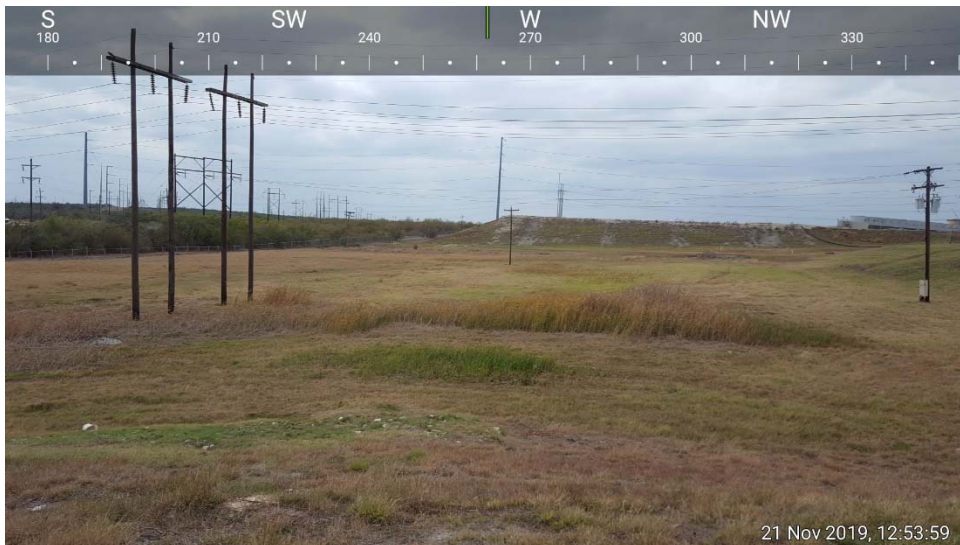
**PHOTO 2**

The wet area between the Equalization Pond and the Ash Ponds A and B. The water seepage in this area is thought to be due to leakage from the concrete water pipe that brings fresh water from a water well located to the east of the Equalization Pond to the Raw Water Pond.

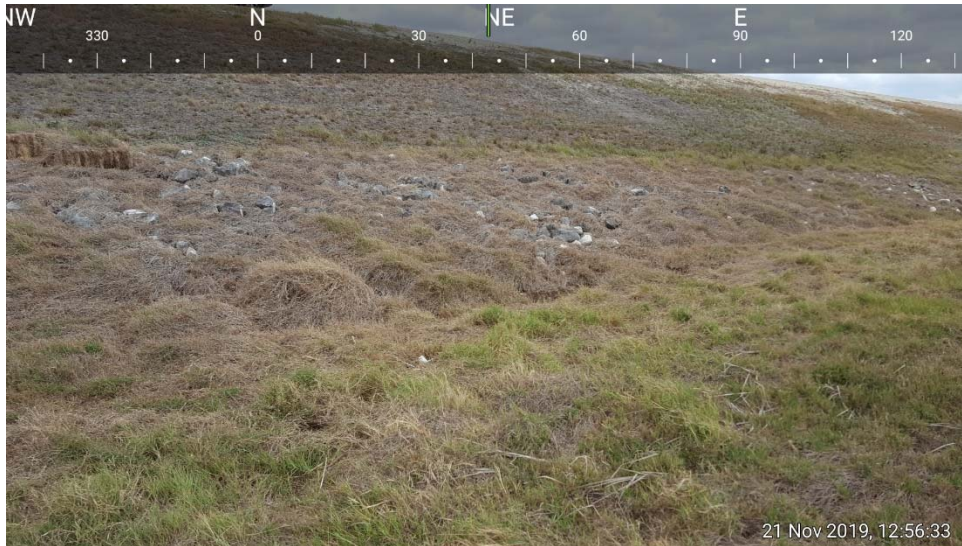
**PHOTO 3**

A view of the riprap located along the toe of the Equalization Pond. The riprap extends up the slope approximately 10 feet.

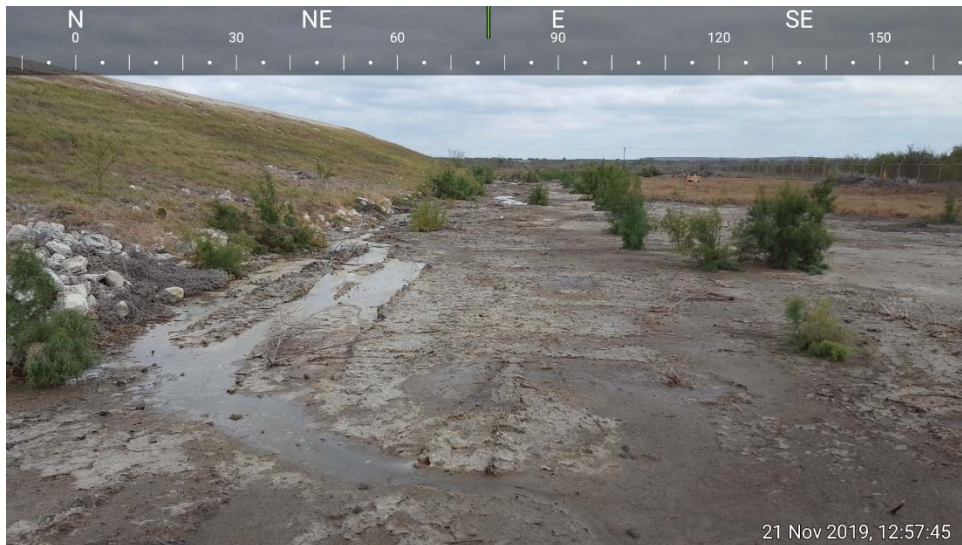
**PHOTO 4**

Looking to the east along the toe of the southern side of the Equalization Pond. This area is the channel for a natural drainageway that flows around the Equalization Pond. Surface grading upstream is recommended so as to redirect the natural flow some distance away from the toe of the Pond.

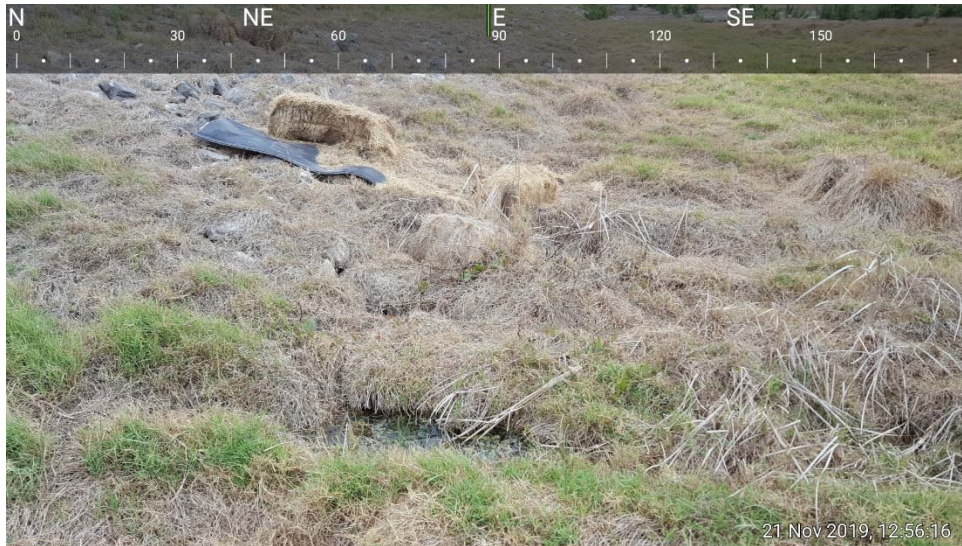
**PHOTO 5**

A pooled area along the natural drainage feature near the southwest corner of the Equalization Pond. line. The water is pooled in a tractor tire rut.

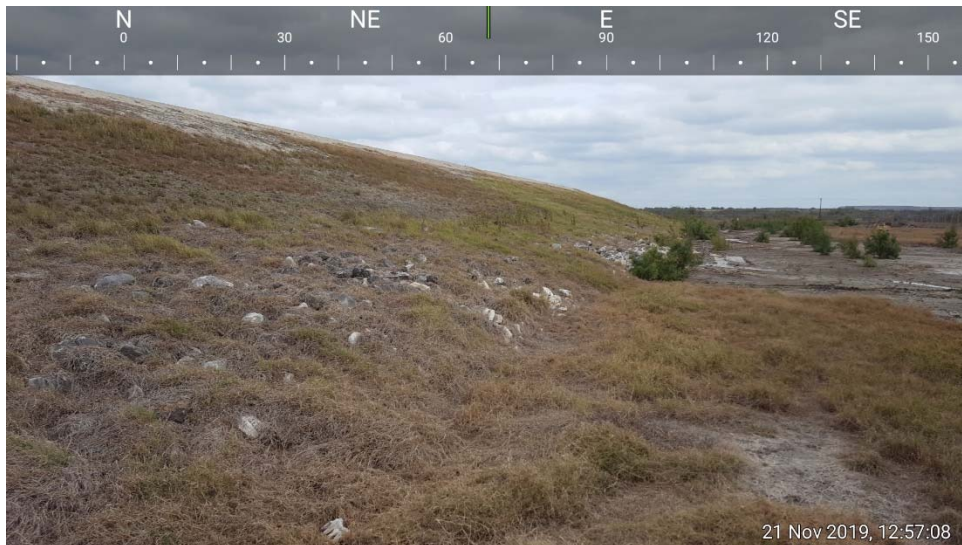
**PHOTO 6**

Looking to the east along the toe of the southern side of the Equalization Pond. Vegetation removal should be conducted in the coming year.

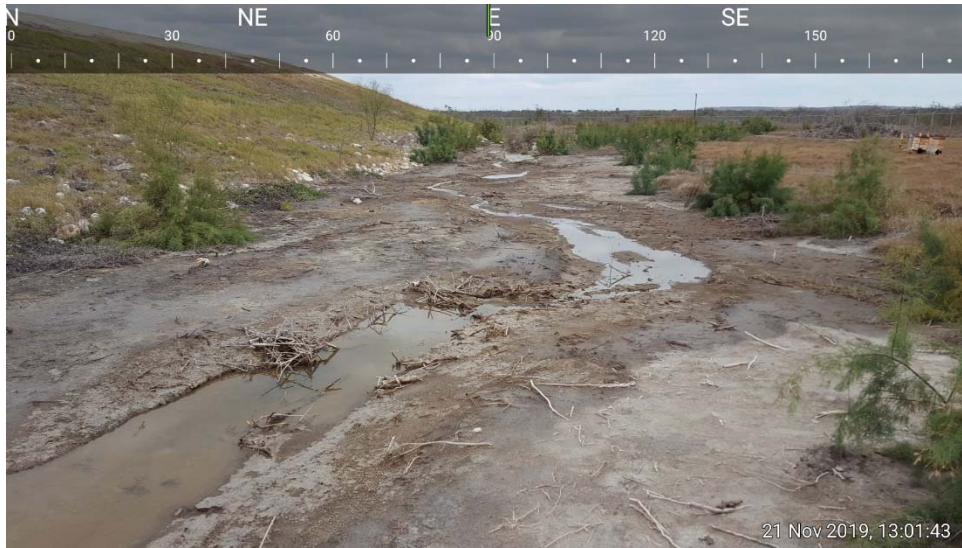
**PHOTO 7**

Looking to the east along the drainageway on the southern side of the Equalization Pond. Woody vegetation is growing again in this area and should be removed. SMECI personnel during daily observations have observed this area to be dry during periods of low rainfall.

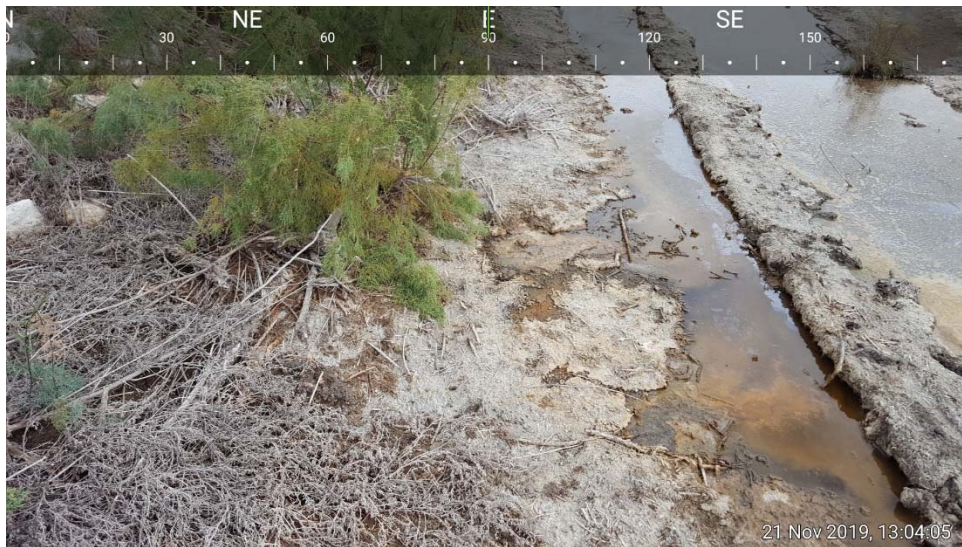
**PHOTO 8**

Water ponded in ruts within the natural drainage feature, along the southern toe of the Equalization Pond near the base of the riprap.

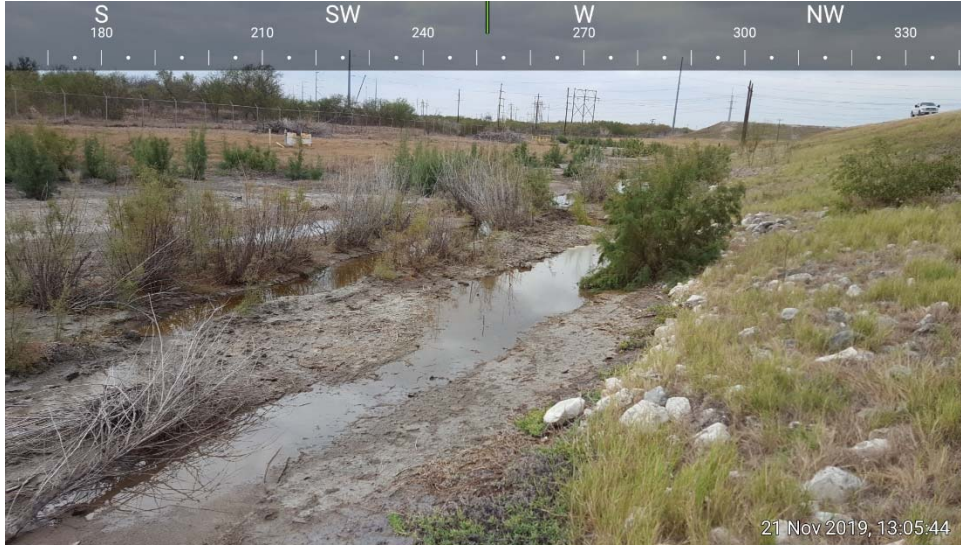
**PHOTO 9**

Looking to the west along an area of ponded water within the stream channel near the toe of the Equalization Pond.

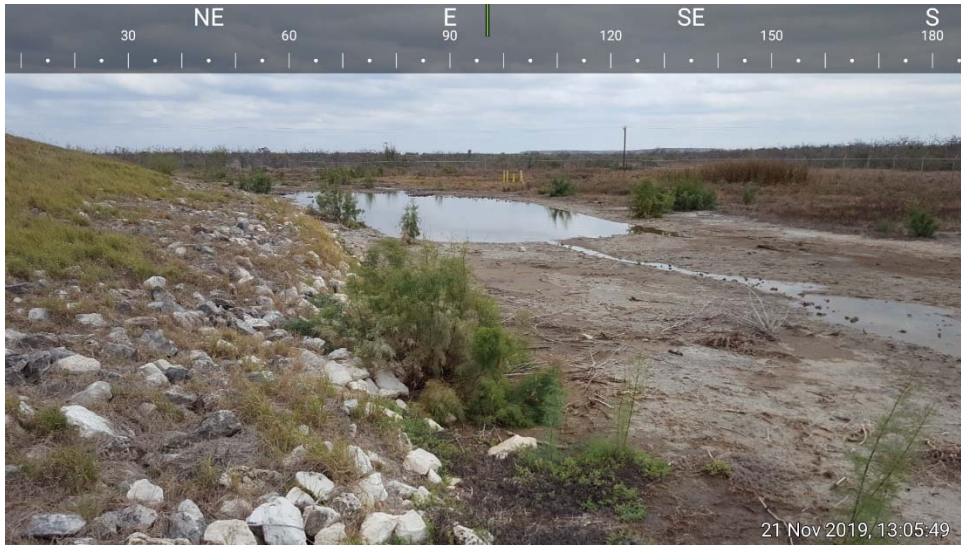
**PHOTO 10**

The largest area of ponded water is near the southeastern corner of the Equalization Pond. In addition to the natural stream channel, on-site personnel indicated that a concrete water line is buried in this area. It is possible that this water line is leaking and contributing to the surface water observed in this area. It should be determined if raw water line is leaking and if so, the line should be repaired.

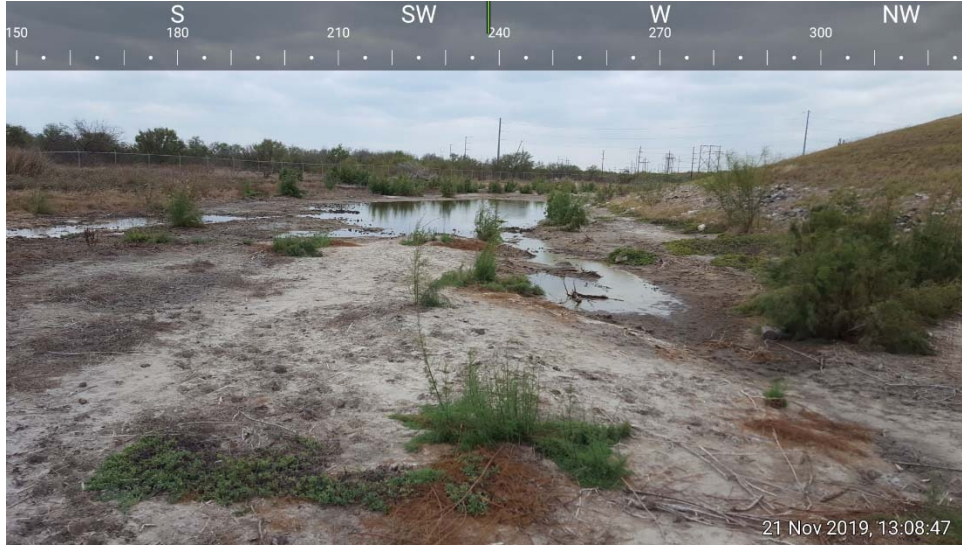
**PHOTO 11**

Looking to the southwest across the southeastern corner of the Equalization Pond embankment.

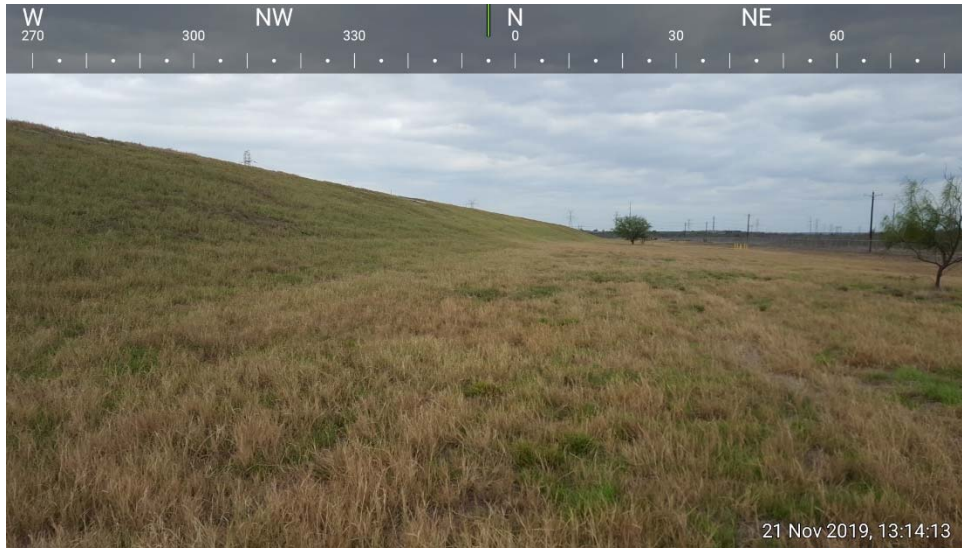
**PHOTO 15**

The grass covered slopes and the area around the toe of the embankment on the eastern side of the Equalization Pond.

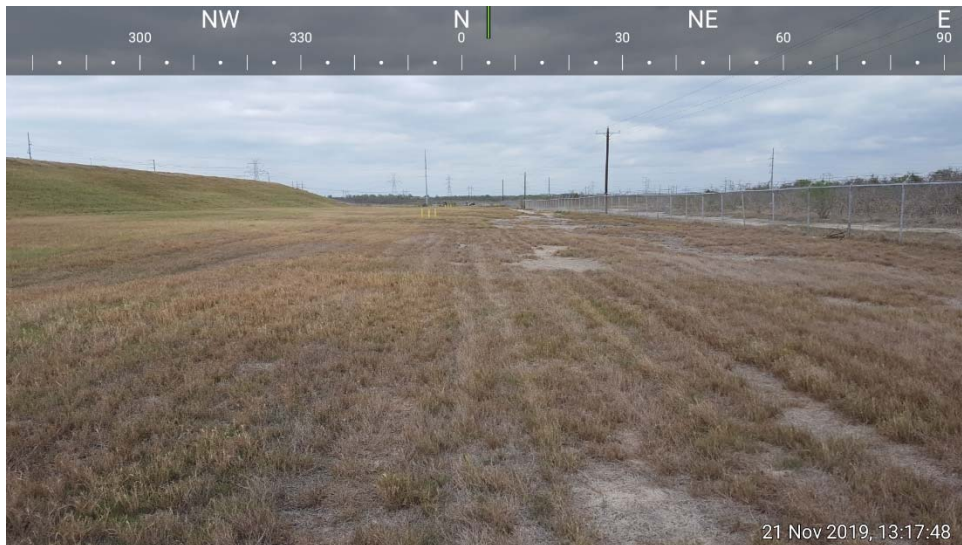
**PHOTO 16**

The northern portion of the area located to the east of the Equalization Pond.

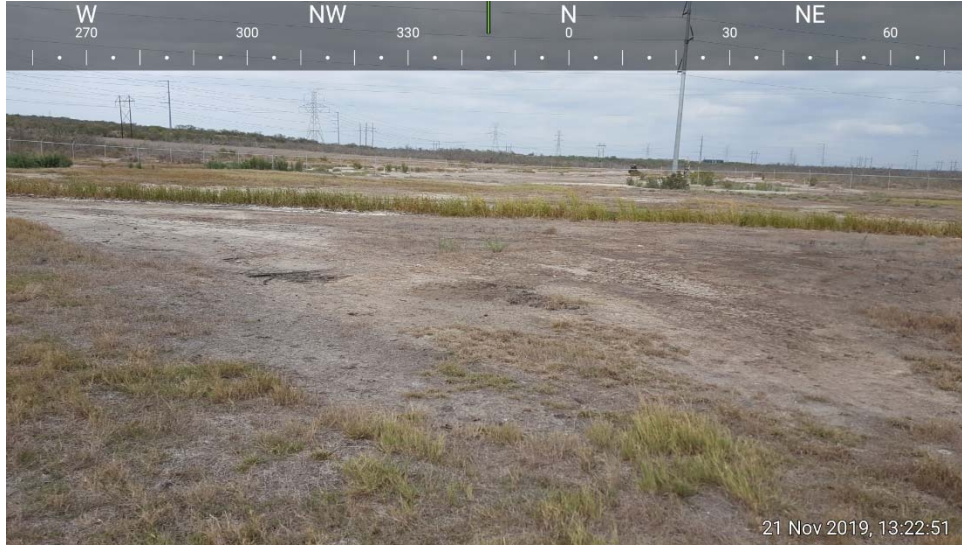
**PHOTO 17**

The eastern extent of the drainageway located on the northern side of the Equalization Pond. A barren area was located at the northeastern corner of the Equalization Pond embankment.

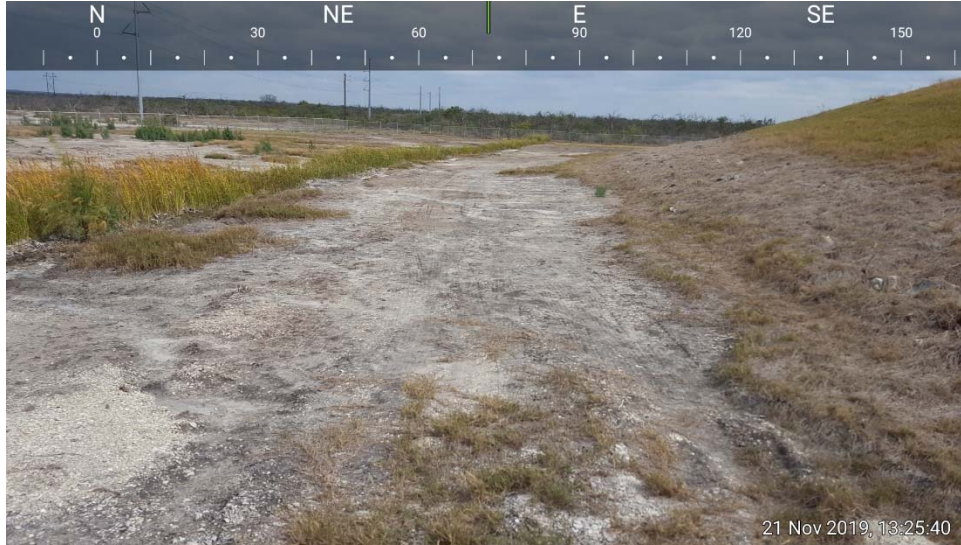
**PHOTO 19**

No seepage was observed along the area at the northern toe of the Equalization Pond embankment to the east of the culvert along the northern drainageway.

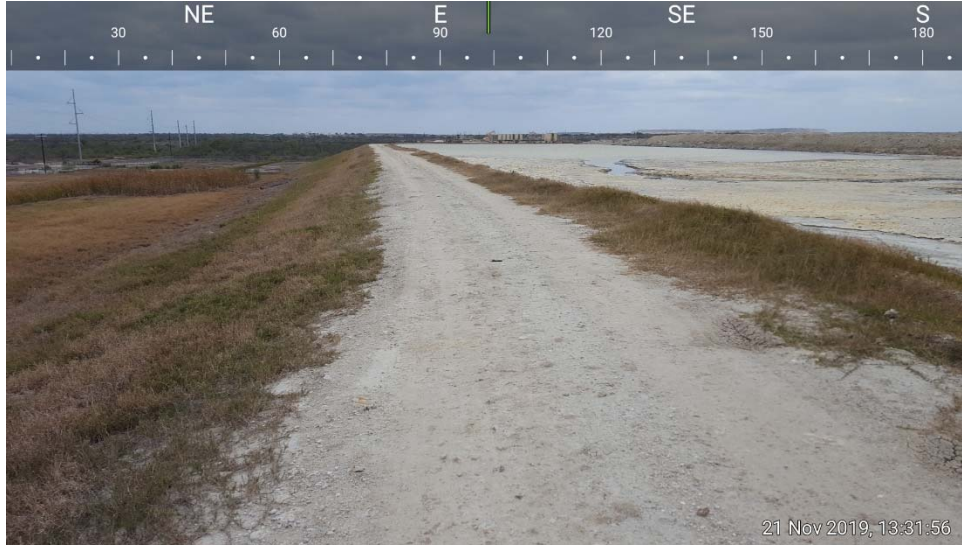
**PHOTO 21**

No rutting or woody vegetation is present along the northern portion of the interior or exterior portions of the Equalization Pond berm.

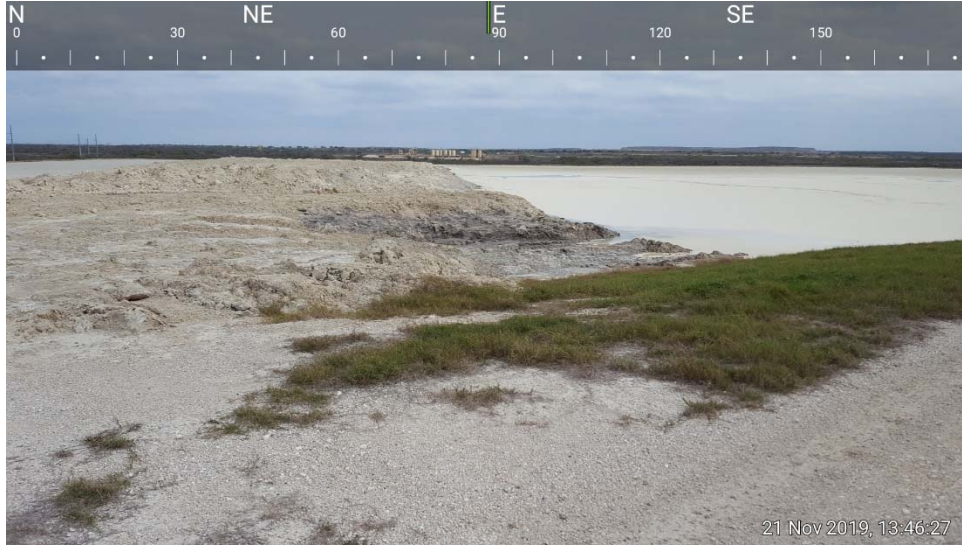
**PHOTO 23**

The stockpiled ash within the Equalization Pond that was dredged from the pond prior to 2018.

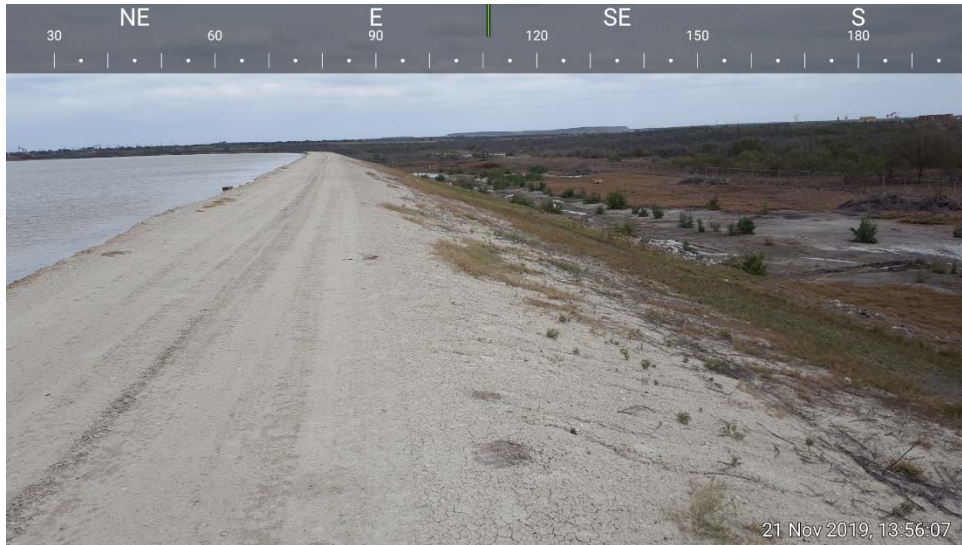
**PHOTO 24**

The berm of the Equalization Pond looking to the east along the southern portion of the berm. No rutting or woody vegetation was observed in this area.

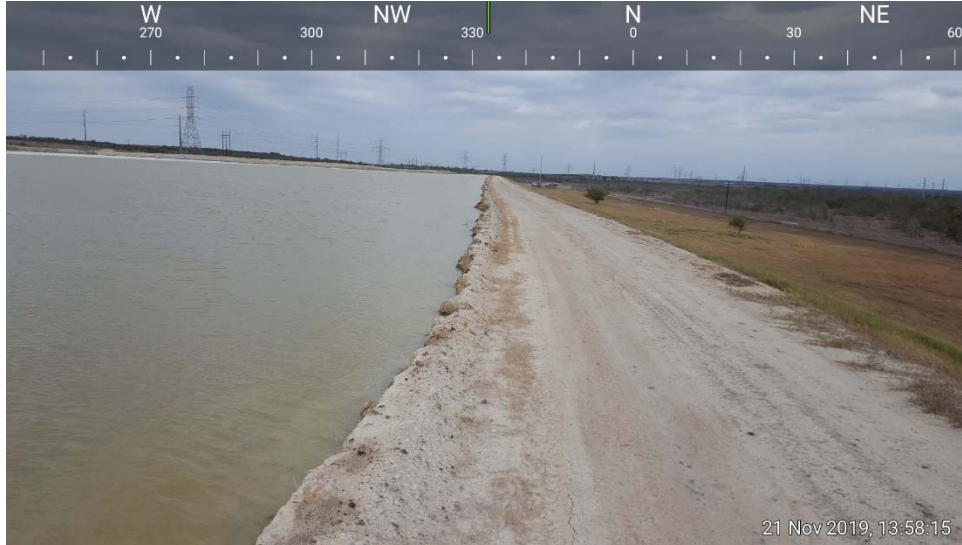
**PHOTO 25**

Looking to the north along the eastern crest of the Equalization Pond berm. No rutting or woody vegetation was observed in this area.

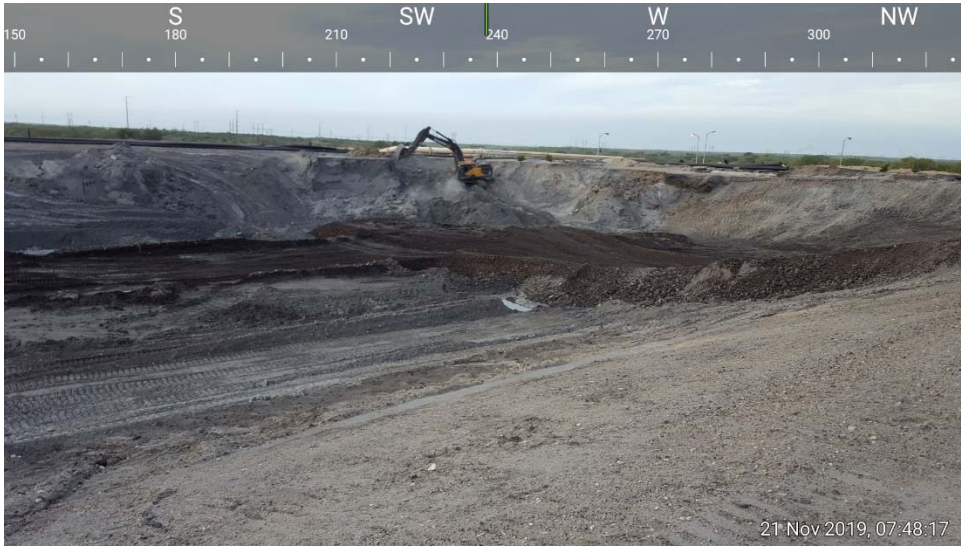
**PHOTO 1**

Looking to the southwest at the track hoe that is excavating ash material from the western extent of the dewatered Ash Pond A.

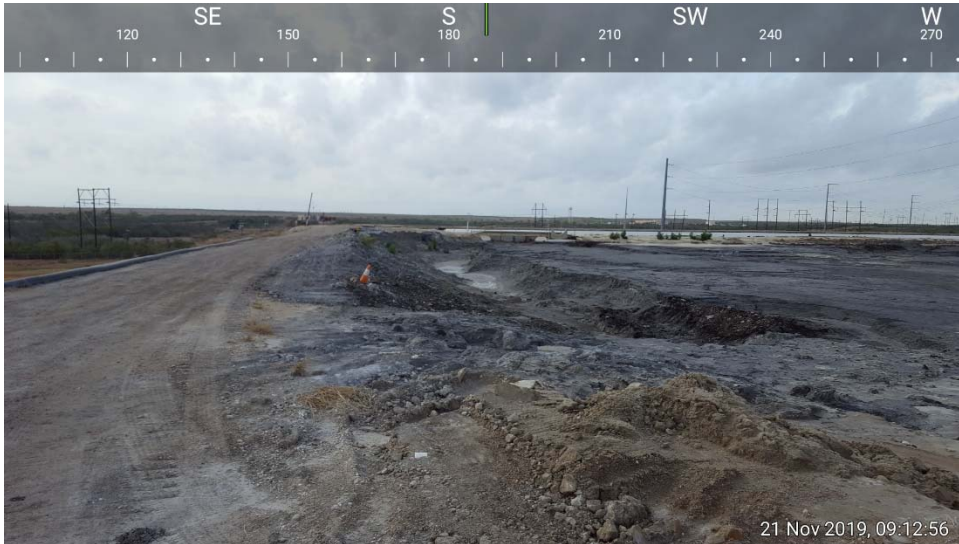
PHOTO 4

Looking to the south along the eastern slope of the Ash Ponds A and B. No woody vegetation was observed in this area.

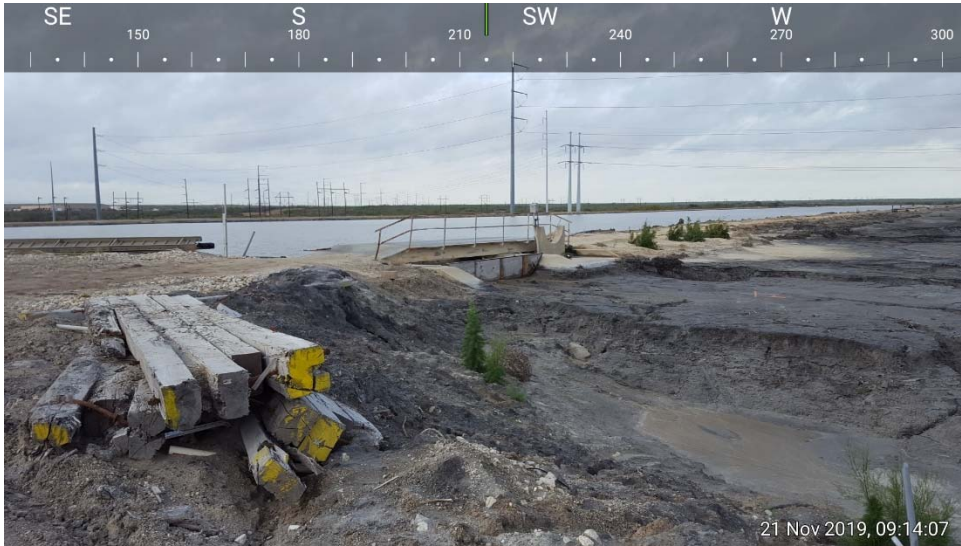
**PHOTO 5**

The weir that formerly connected Ash Pond A to Ash Pond B is now blocked to allow dewatering of Ash Pond A.

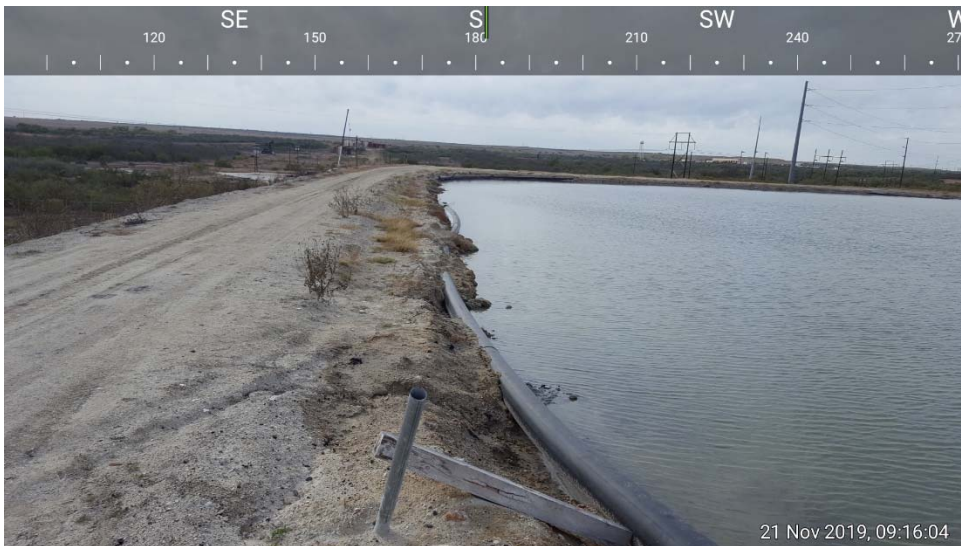
**PHOTO 8**

Looking to the south along the crest of the eastern end of Ash Pond B. No rutting or cracks were observed along the crest of the embankment. Minor amounts of vegetation were observed along the interior of the embankment.

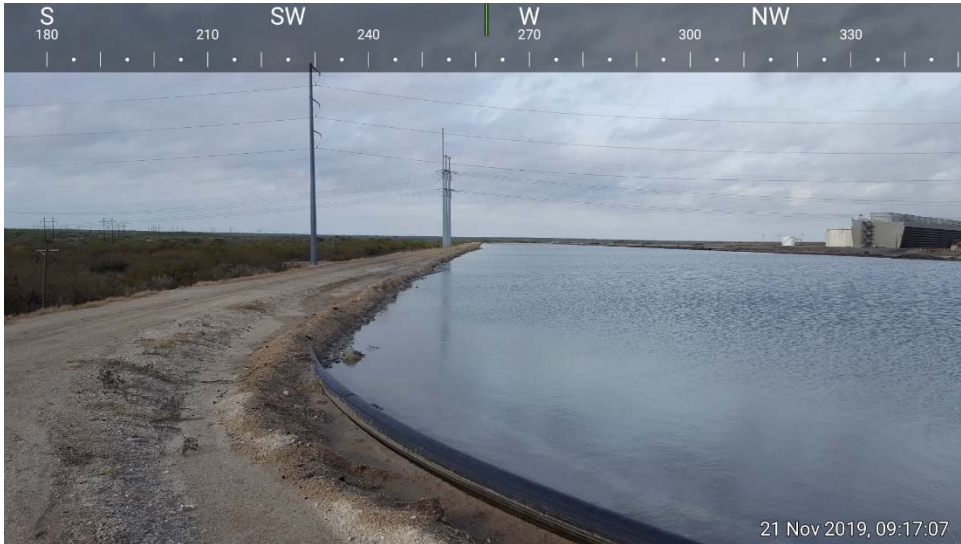
PHOTO 10

Looking to the west along the crest of the embankment on the southern side of Ash Pond B. Grass covers the exterior slope of the embankment.

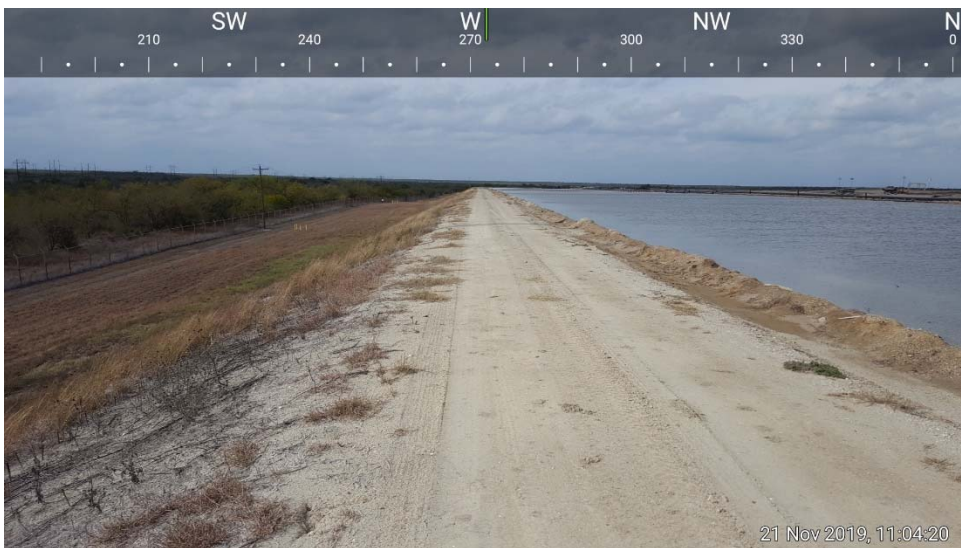
**PHOTO 18**

Looking to the west along the crest of the impoundment along the southern side of Ash pond B. The crest of the embankment was in good condition with no observed cracking or rutting. No vegetation was observed along the interior slope of the embankment.

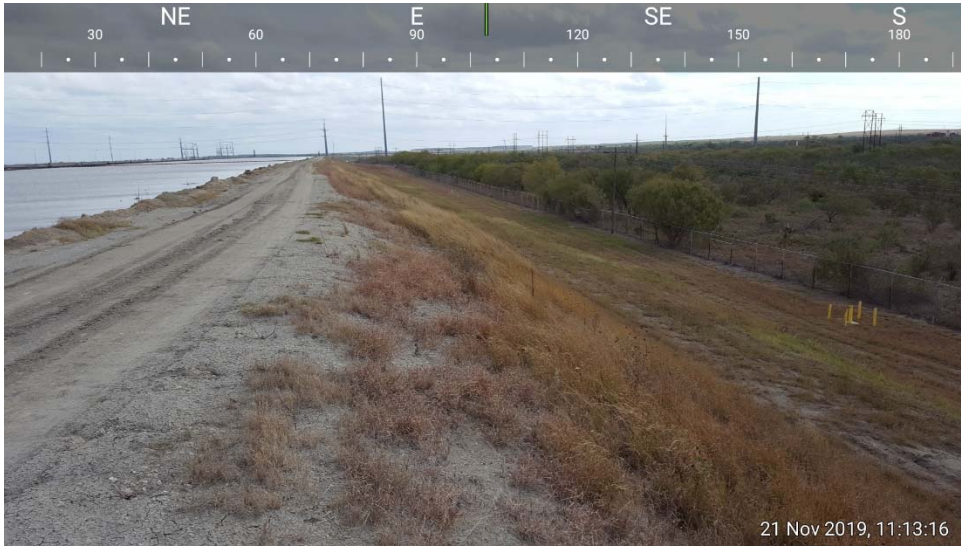
**PHOTO 21**

Looking to the east along the southern side of the Ash Pond B embankment. A few isolated areas near the crest were sparsely vegetated.

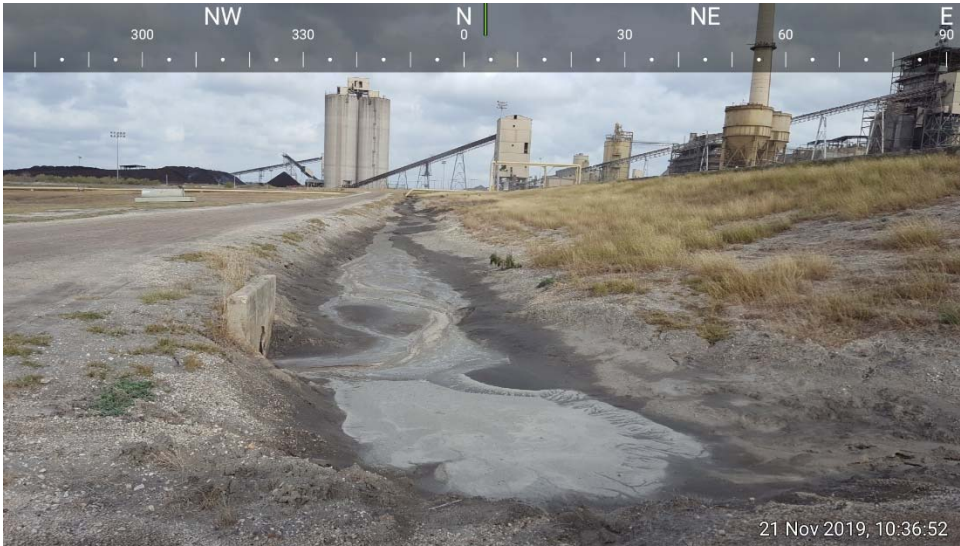
**PHOTO 24**

A barren slope near the electrical building located to the north of the toe drain. This area had washed-in soils removed in 2019.

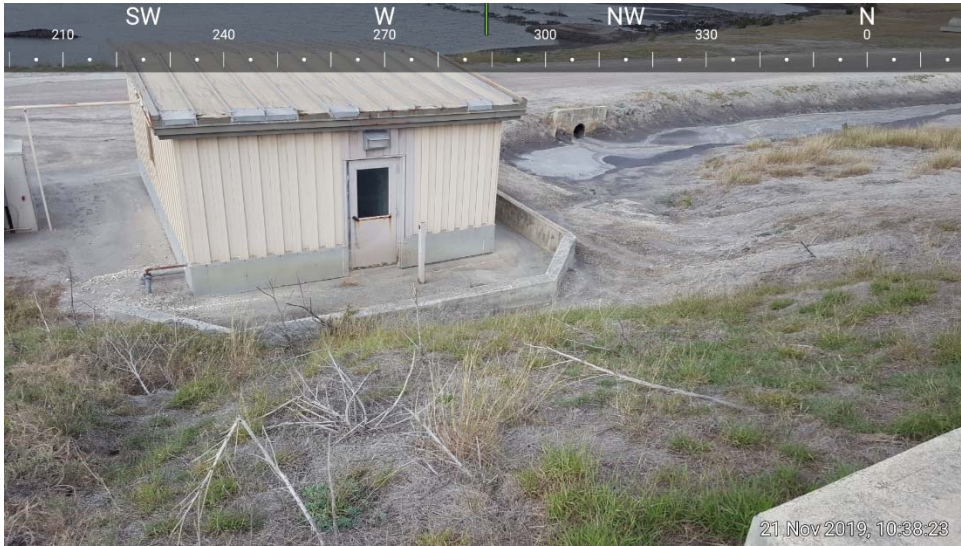
**PHOTO 25**

Looking to the west at the area in the previous photograph. Soils were removed from around the retaining wall.

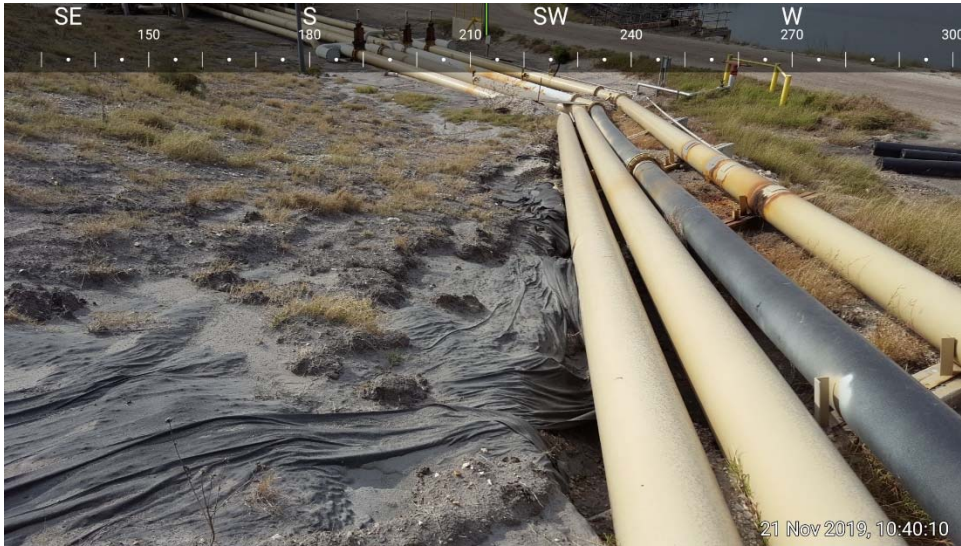
**PHOTO 27**

Erosion has reoccurred along the northern edge of the area where the toe drain was installed, and a portion of the liner is exposed. This area should be repaired.

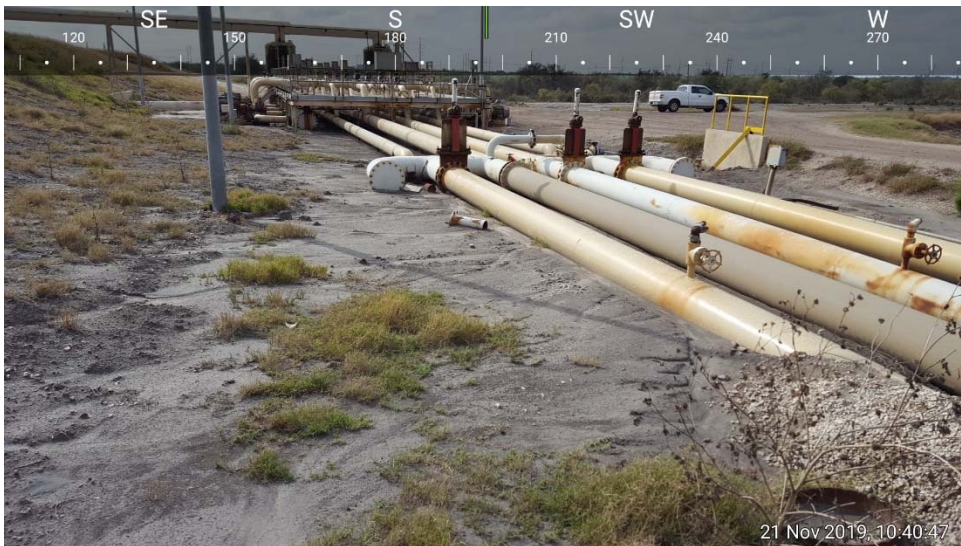
**PHOTO 28**

The area downslope of the toe drain on the western side of the Ash Ponds. Some sediment transported to this area was observed.

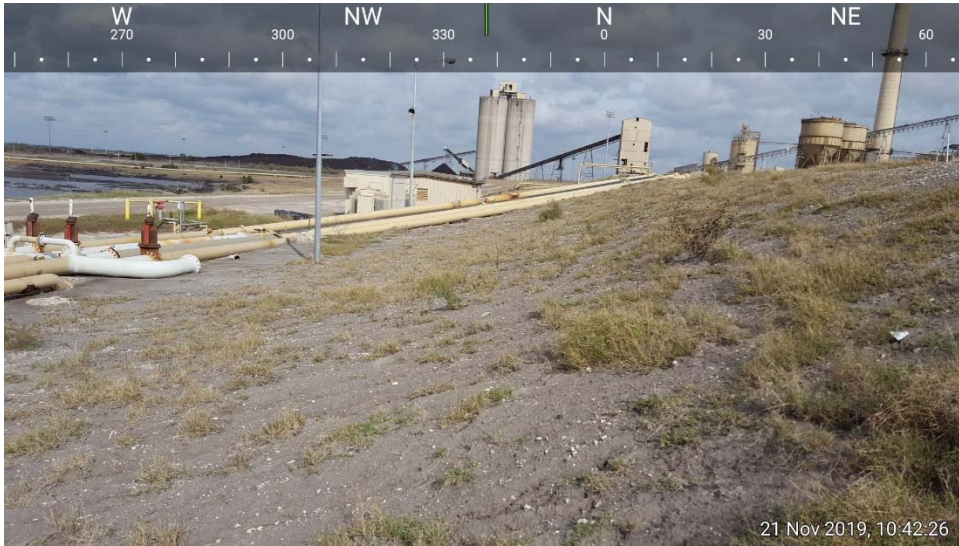
**PHOTO 29**

Looking to the north along the toe drain installed in 2018. Some erosion has occurred along the slope due to the sparse vegetation. The area has been reseeded. No soft areas or seepage was observed in this area.

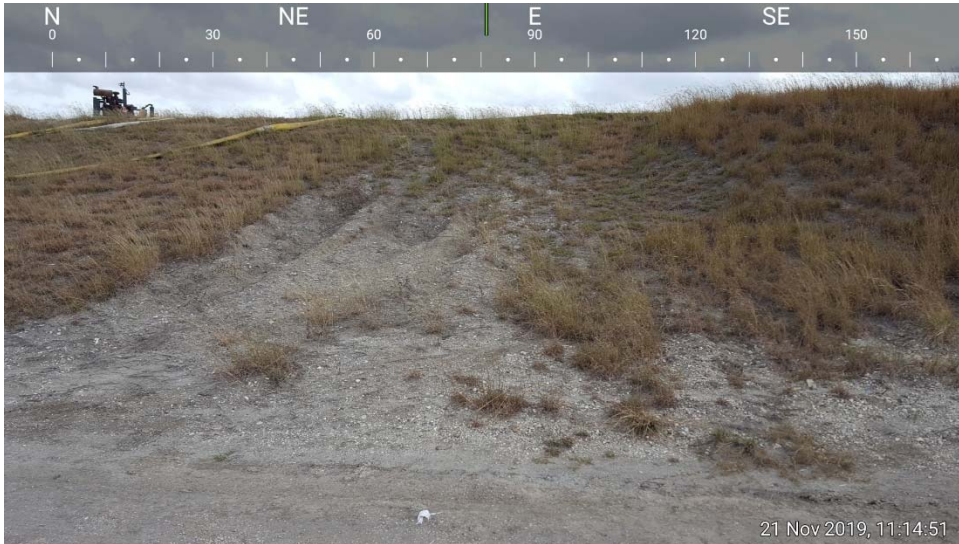
**PHOTO 31**

An area along the western slope of the Ash Pond B embankment that showed erosion due to vehicle traffic. This area should be repaired and reseeded. Vehicular traffic should be limited to the nearby roadway.

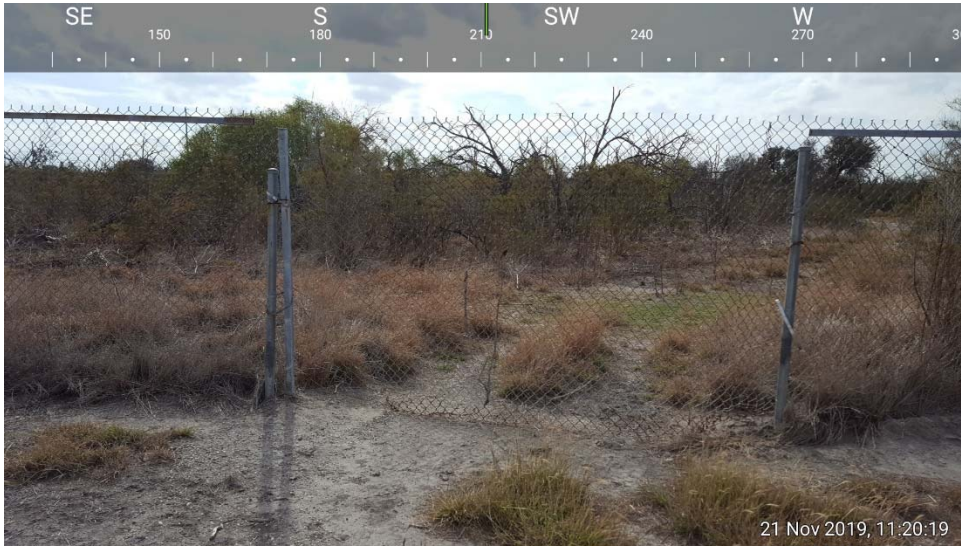
**PHOTO 33**

There was extensive fence damage to the south of the Ash Ponds due to recent high storm winds. The fence was repaired.

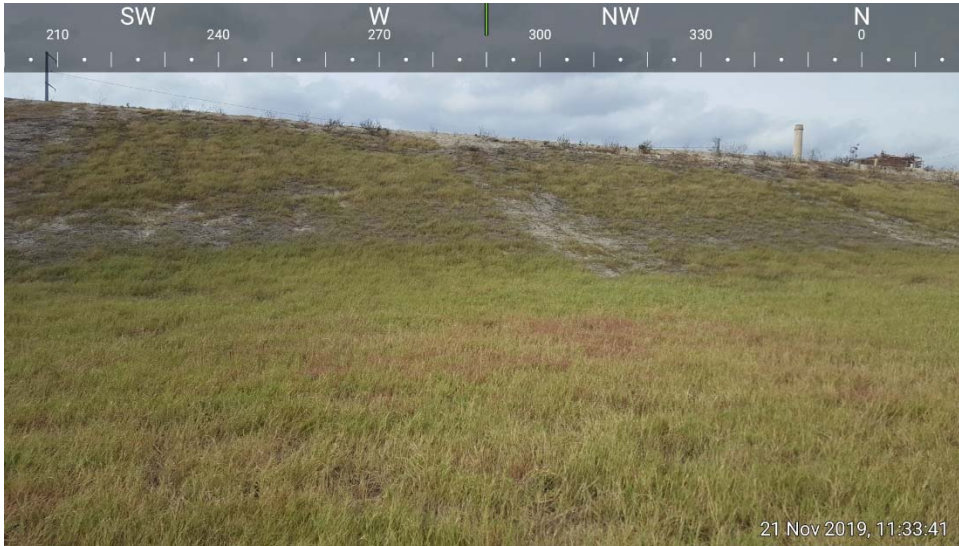
**PHOTO 38**

Another view of the northern portion of the slope realignment area. Two areas are less vegetated than the adjacent areas.

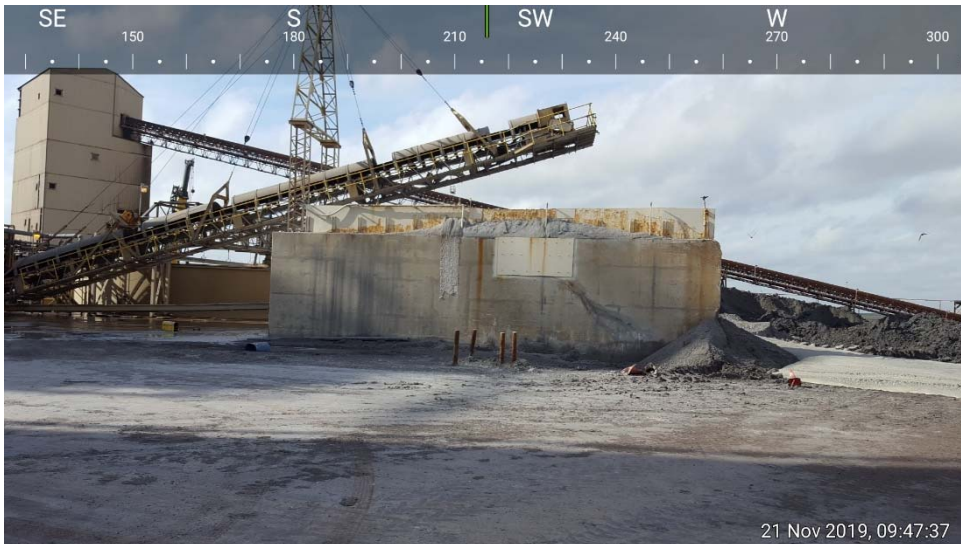
**PHOTO 1**

Looking to the southwest at the northeastern wall of the Ash Pile containment structure. The repairs completed in 2018 are visible and operating as designed.
