ANNUAL CCR UNITS INSPECTION

SAN MIGUEL ELECTRIC COOPERATIVE, INC.

January 8, 2021

BBA Project No. 20379

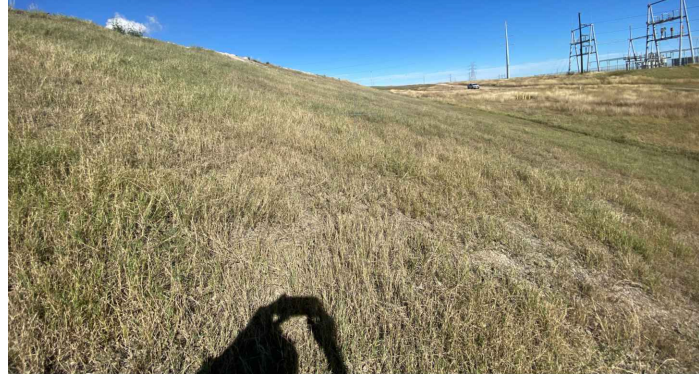
2677 - Facing North. A/B Ponds Exterior Slope.

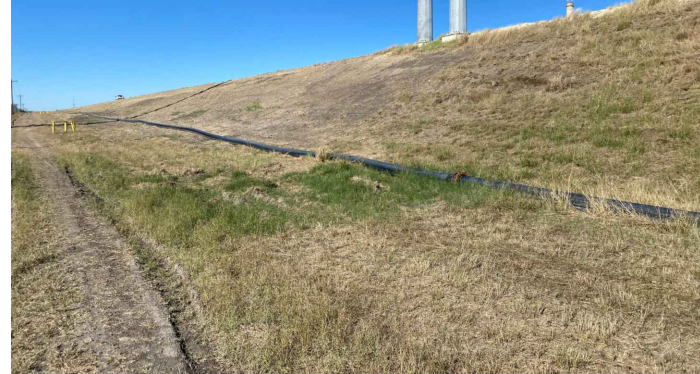
2699 - Facing Northwest. Ash Pond B, Exterior Slope.

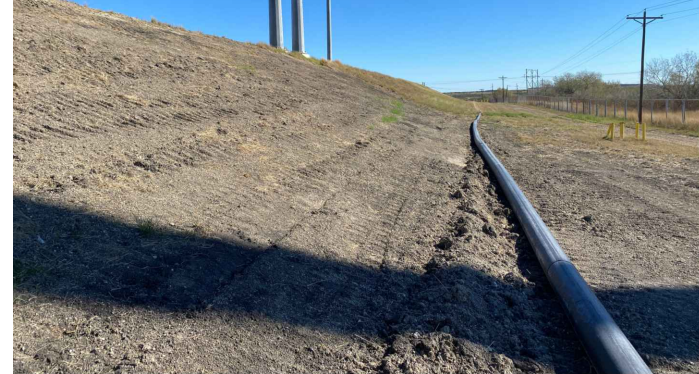
2702 - Facing East. Ash Pond B, Exterior Slope.

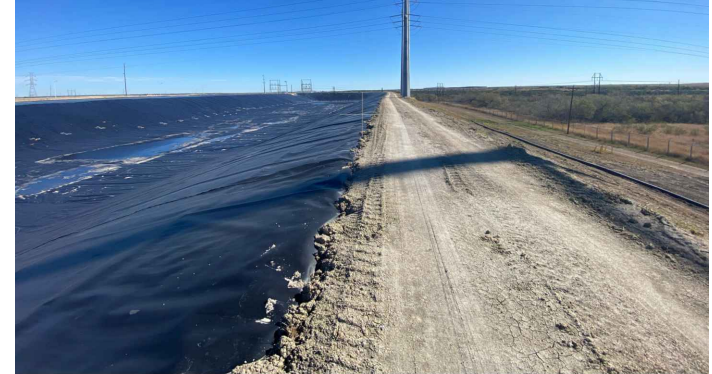
2705 - Facing East. Ash Pond B, Interior Slope and Dike Crest.

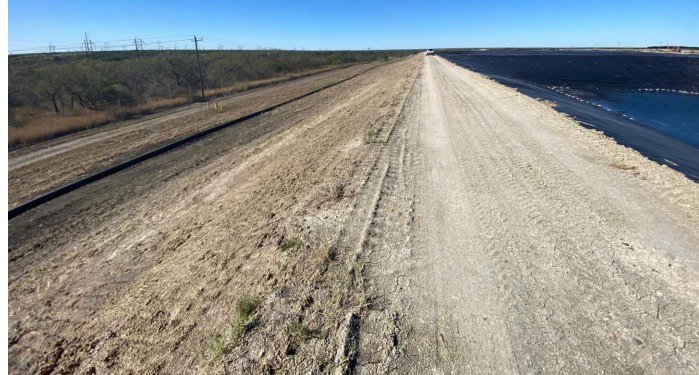
2706 - Facing West. Ash Pond B Exterior Slope and Dike Crest.

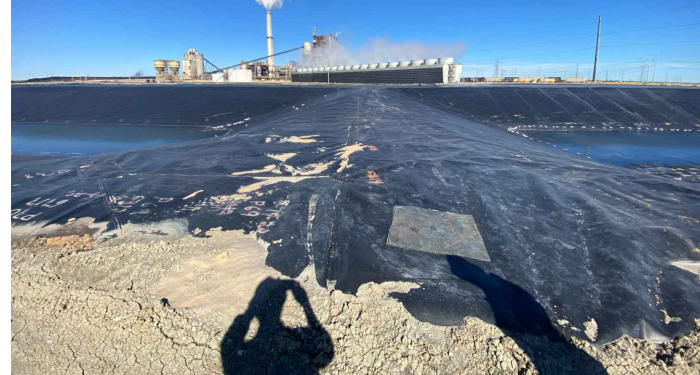
2709 - Facing North. Ash Pond B and South Equalization Basin Splitter Dike.

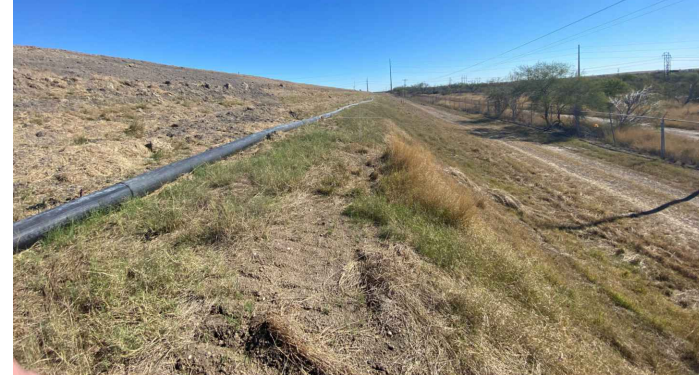
2717 - Facing East. South Equalization Basin Exterior Slope.

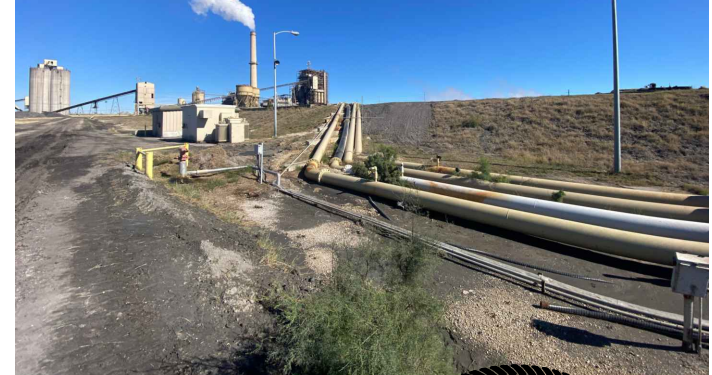
2730 - Facing Northeast. Ash Pond A, West Exterior Slope

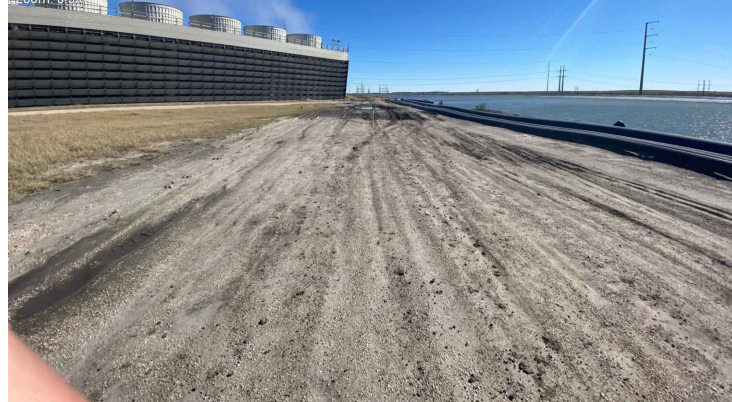
2773 - Facing East. Ash Pond A Dike Crest.

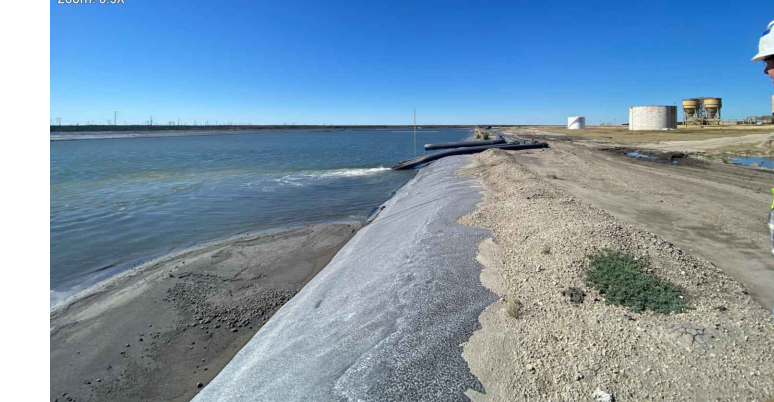
2775 - Facing West. Ash Pond A Dike Crest and Interior Slope.

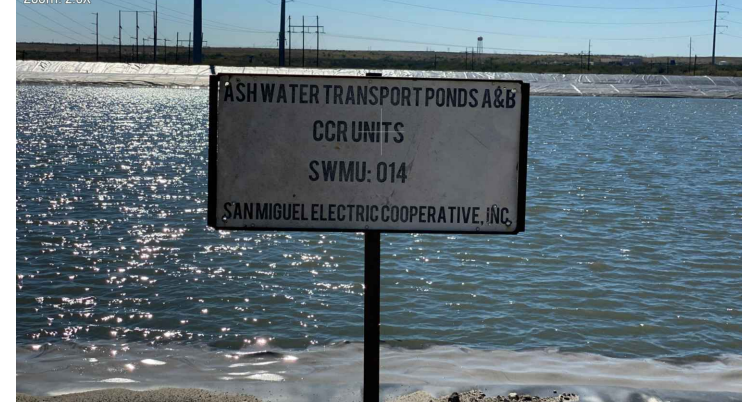
2778 - Facing South. Ash Pond A and Signage.

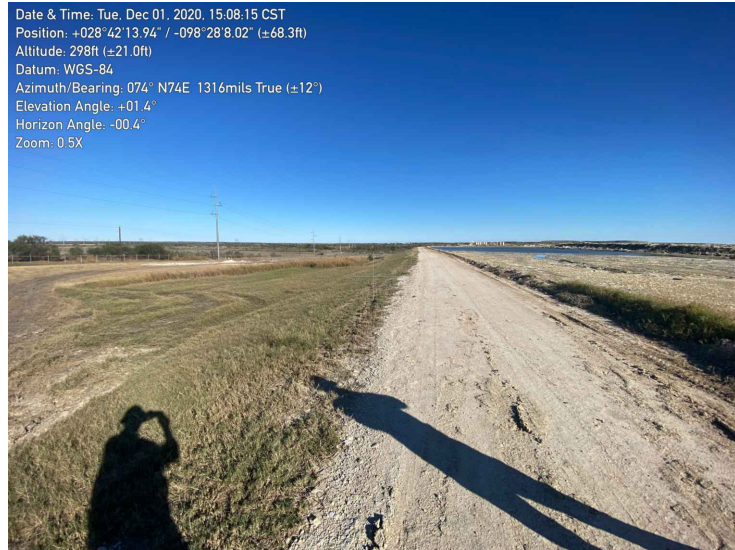
2893 - Facing East. Northwest Corner, Exterior Slope and Dike Crest.

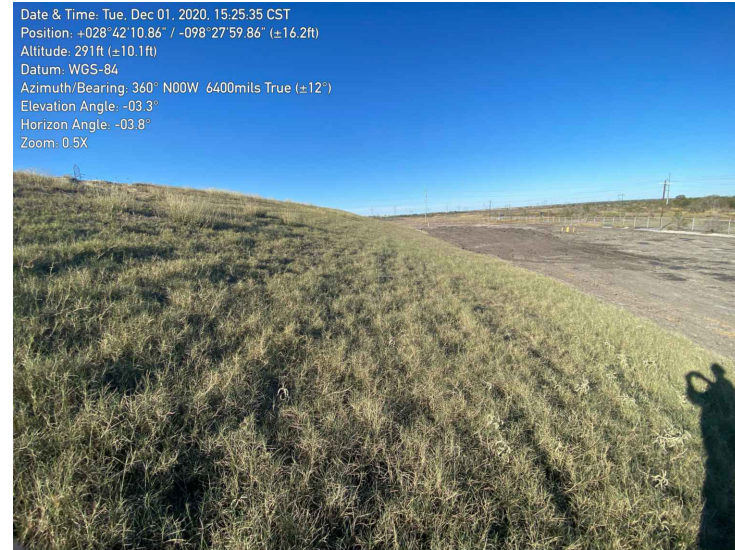
2908 - Facing North. East Exterior Slope, Interceptor Trench Construction in Background - Right Side.

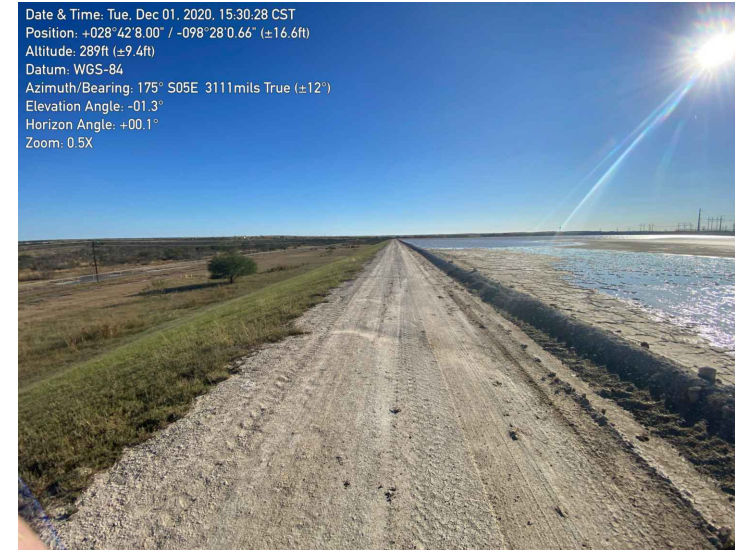
2914 - Facing South. East Dike Crest.

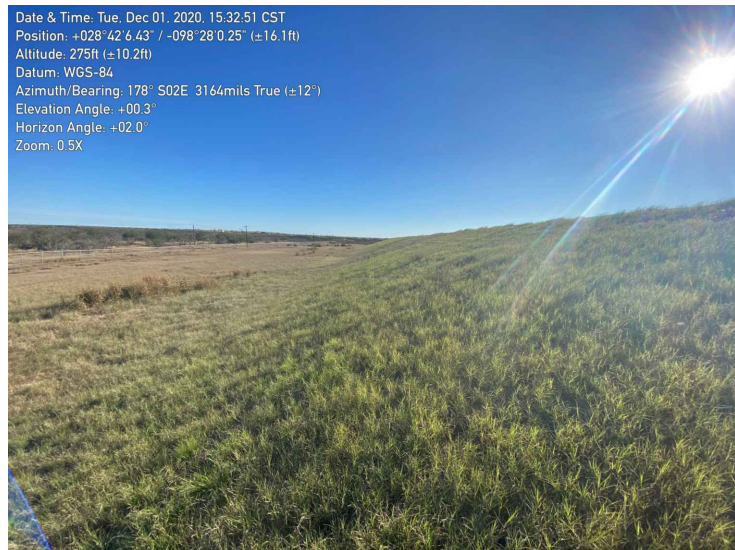
2916 - Facing South. Southeast Exterior Slope.

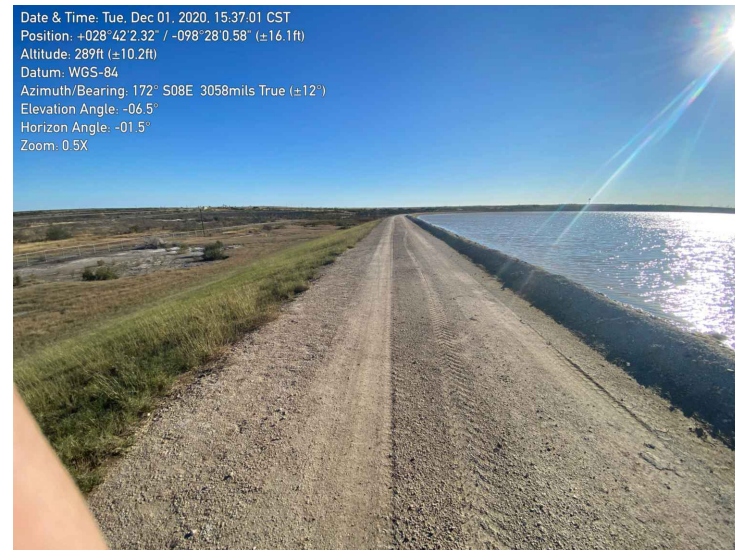
2935 - Facing South. Southeast Dike Crest.

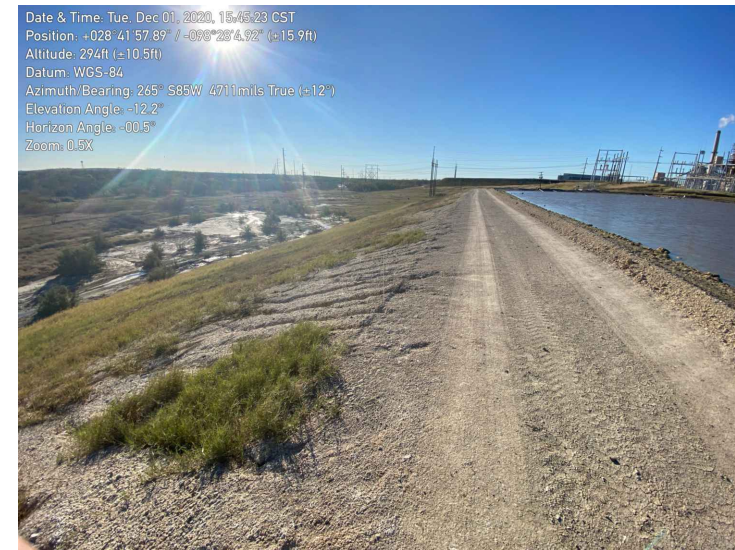
2953 - Facing West. South Dike Crest and Exterior Slope.

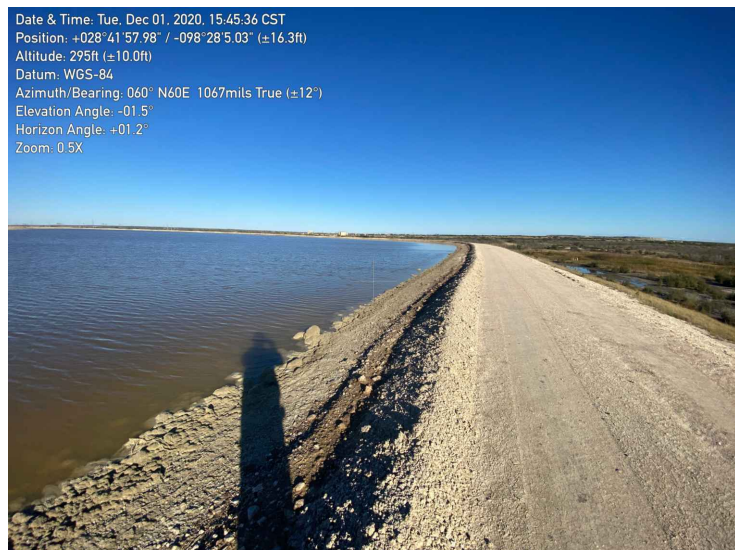
2955 - Facing East. South Dike Crest and Interior.

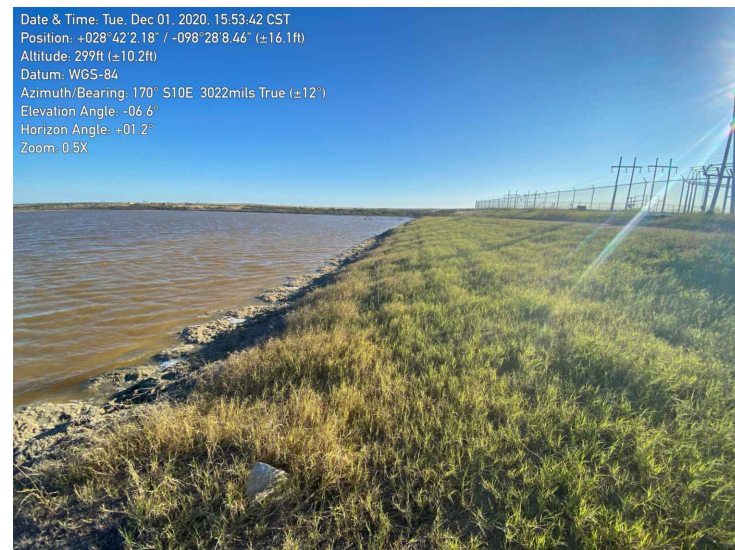
2981 - Facing South. Southwest Interior Slope.

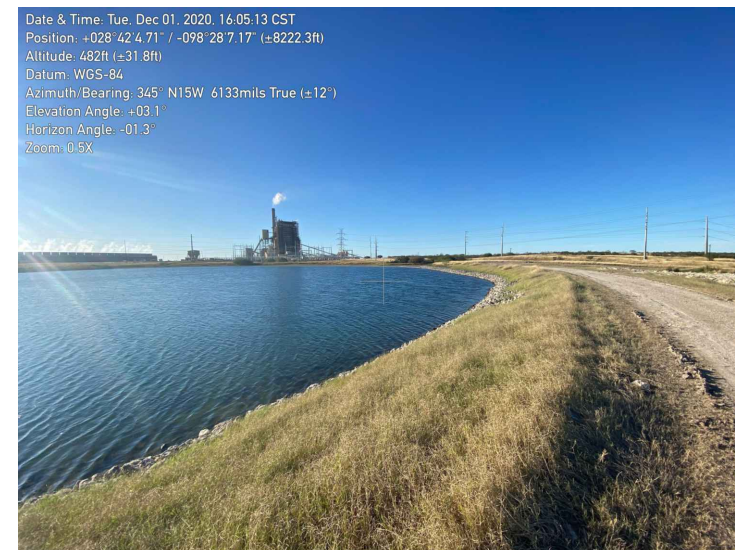
2993 - Facing North. West Dike Crest, Raw Water Pond on Left.

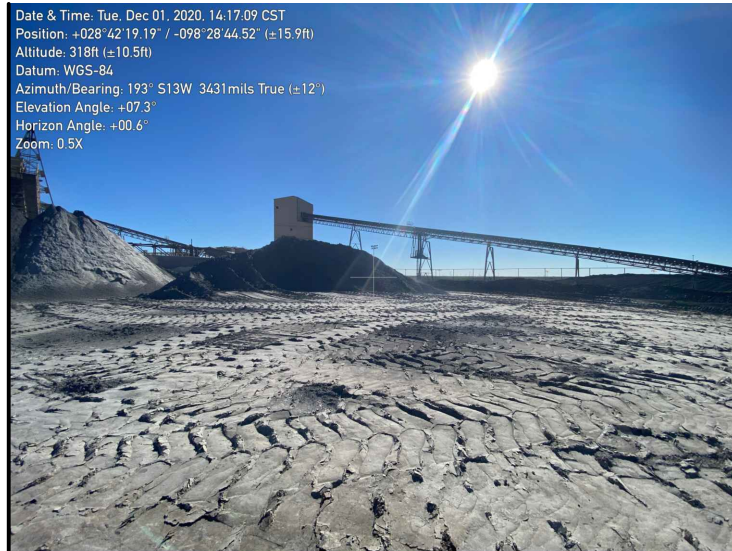
2866 - Facing Southwest. Ash Pile.

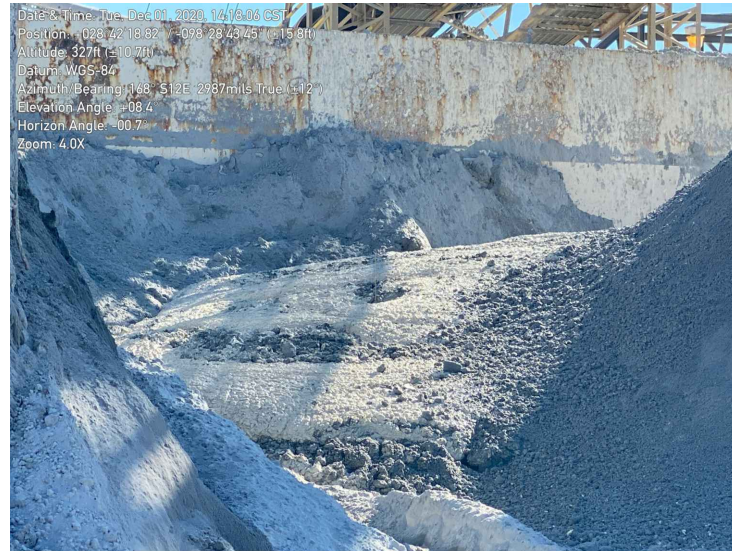
2869 - Facing South. Ash Pile and Wall.

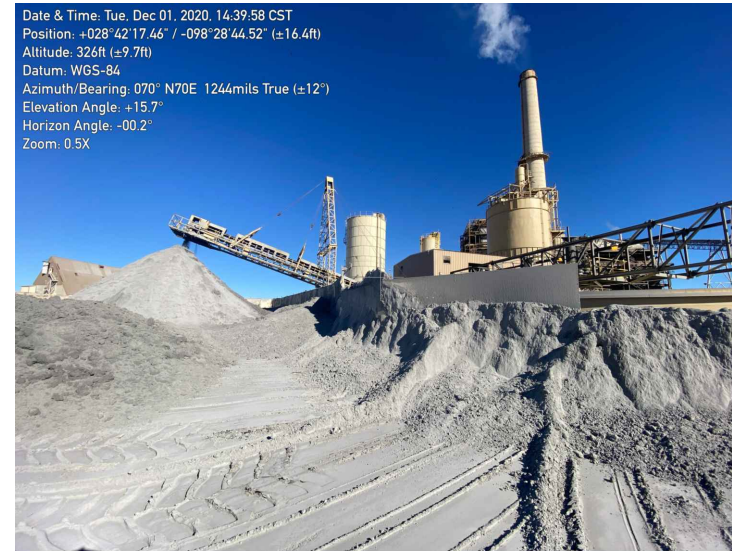
2883 - Facing Northeast. Ash Pile and Wall.

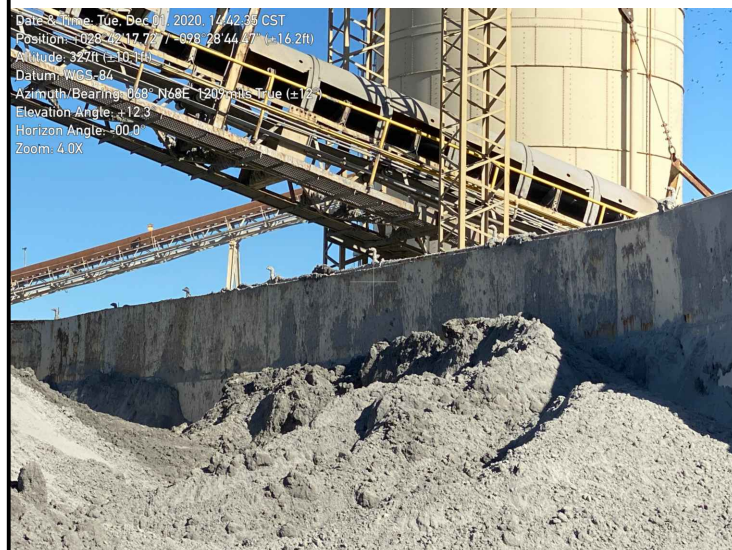
2889 - Facing Northeast. Ash Pile and Wall.
