**ANNUAL CCR UNITS INSPECTION**

**SAN MIGUEL ELECTRIC COOPERATIVE, INC.**

October 12, 2022

BBA Project No. 21447

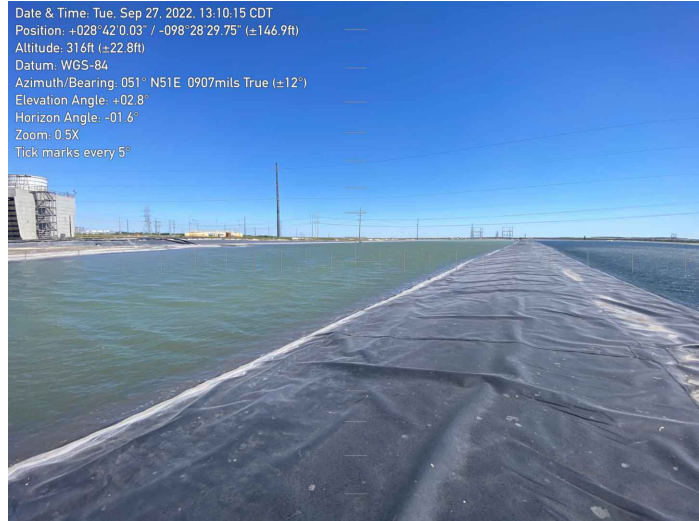
7284 - Facing East. Ash Pond A and South Equalization Basin Interior Dike.

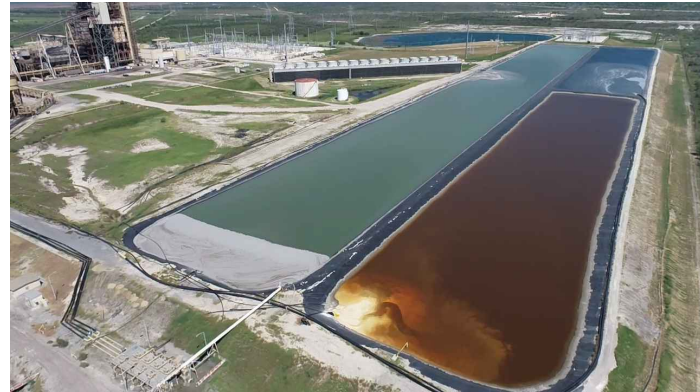
7285 - Facing Northeast. Aerial view of ponds.

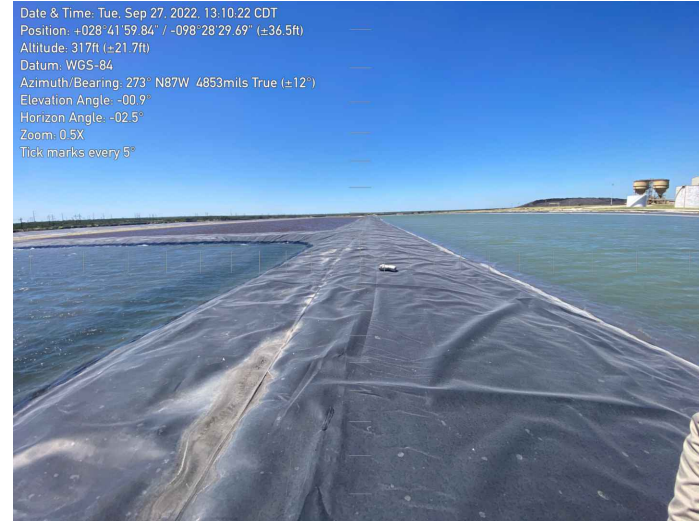
7292 - Facing West. Ash Pond A and Ash Pond B, Interior Dike.

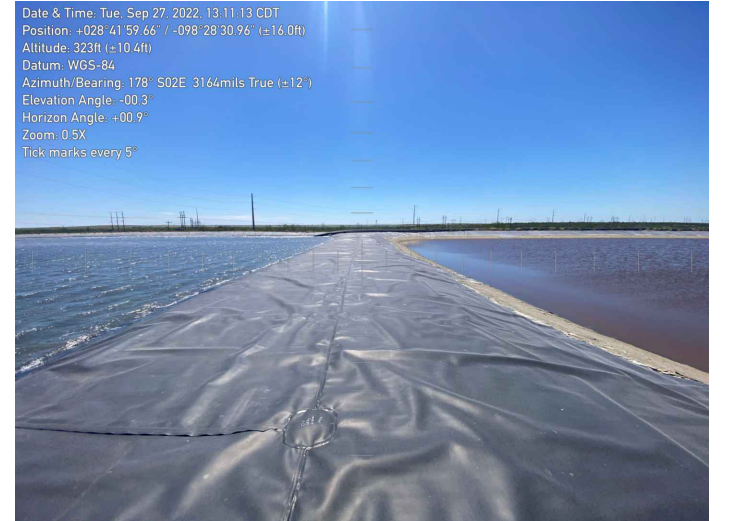
7296 - Facing South. Ash Pond B and South Equalization Basin Splitter Dike.

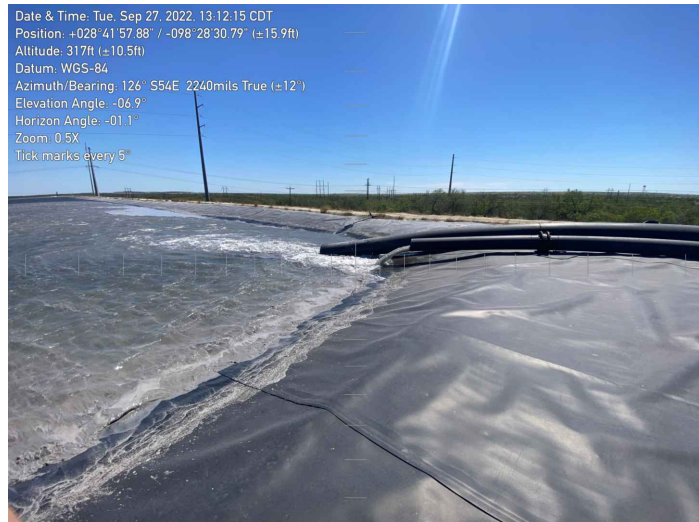
7302 - Facing Southeast. Ash Pond B Splitter Dike.

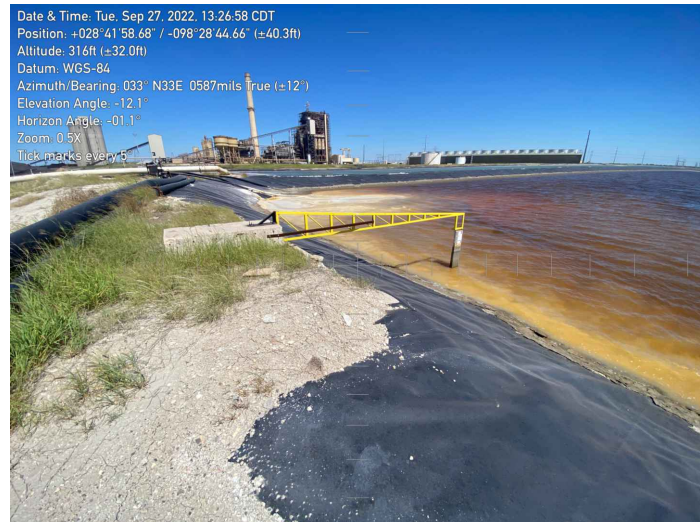
7323 - Facing North. South Equalization Basin Water Level Gauge.

- Clean the staff gauges (both locations) of solids build-up to facilitate water surface readings.
- Address minor erosion rills observed at various locations on the exterior dikes of the ash ponds and equalization ponds.
- Address minor rutting observed on the perimeter access roads.
- Address any localized areas with sparse vegetation due to dry conditions.
- Continue vegetation control program.
- Continue removal of ant beds when observed.

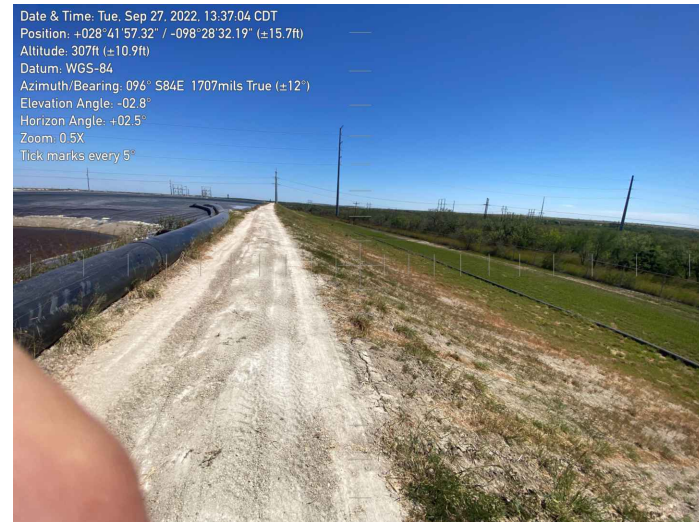
7330 - Facing East. South Equalization Basin Exterior Slope.

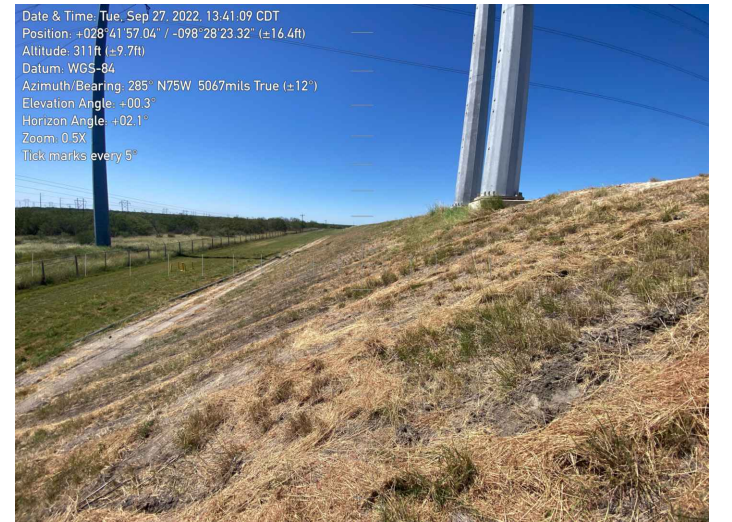
7338 - Facing West. Ash Pond B, South Exterior Slope.

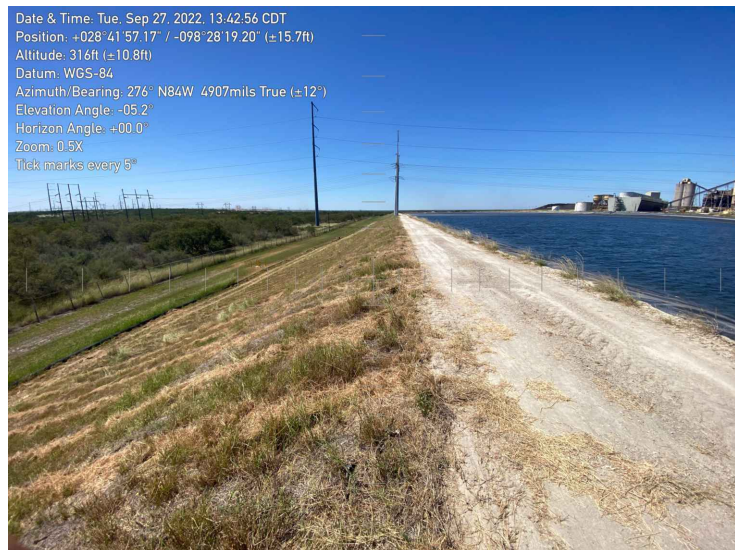
7341 - Facing West. Ash Pond B Dike Crest.

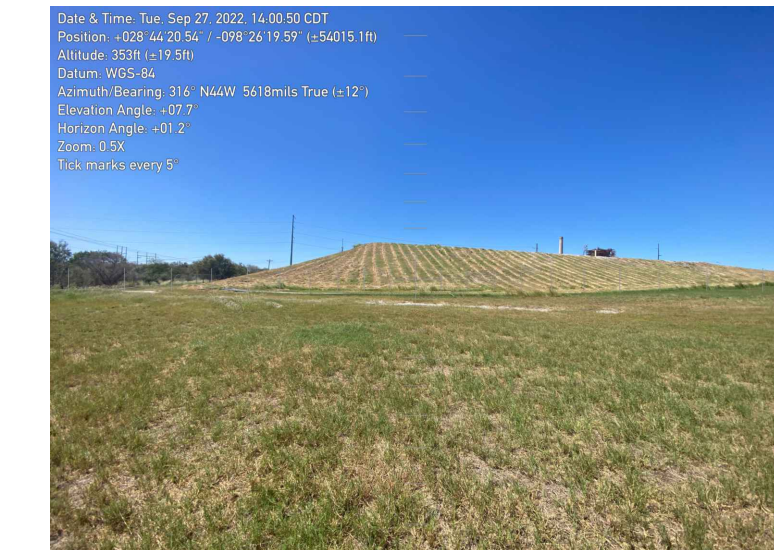
7348 - Facing West. Ash Pond B Exterior.

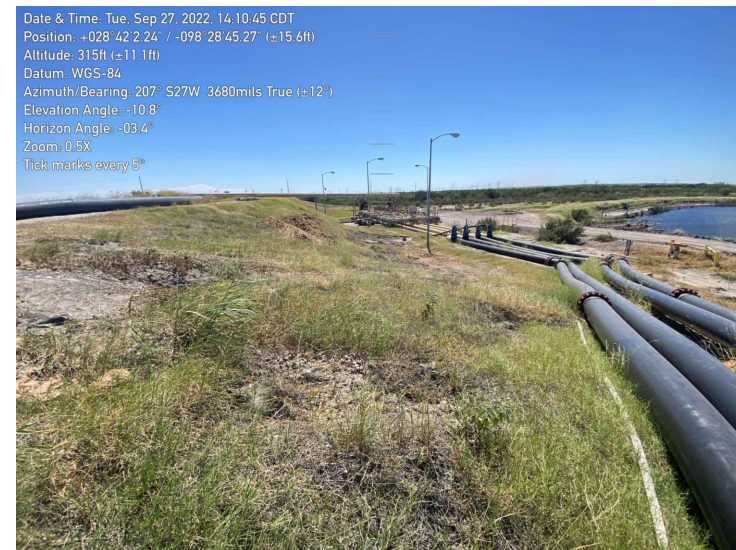
7360 - Facing South. Ash Pond A, West Exterior Slope.

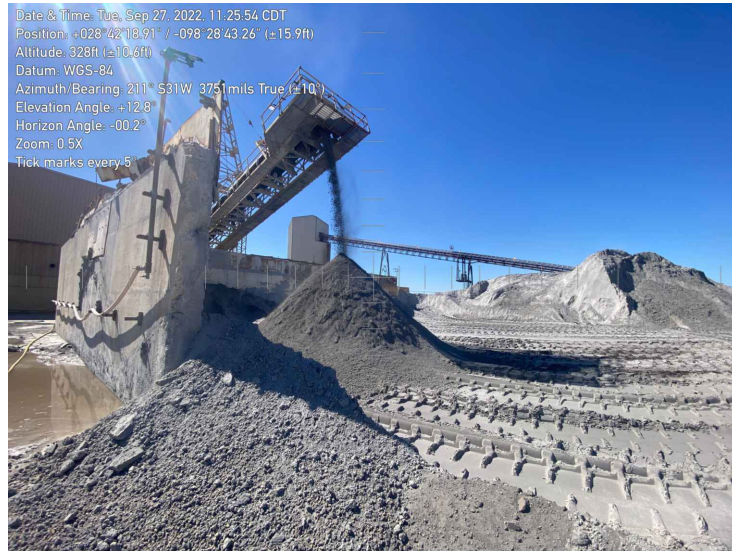
7200 - Facing Southwest. Ash Pile and Wall.

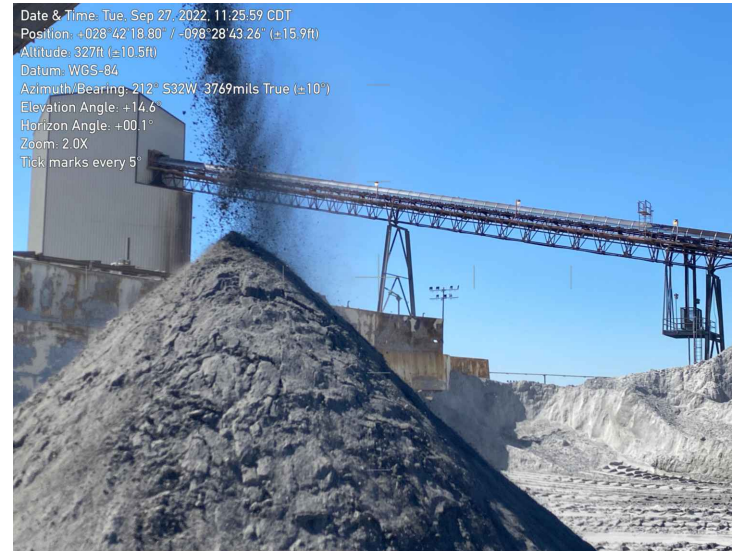
7201 - Facing Southwest. Ash Pile.

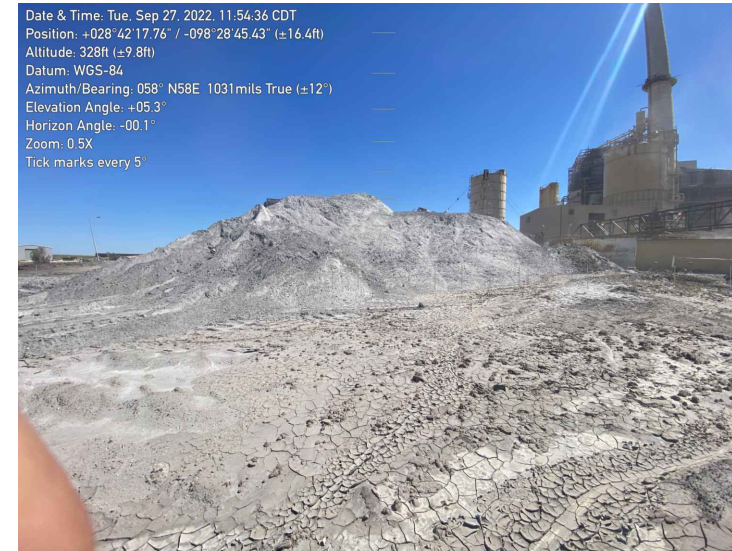
7246 - Facing Northeast. Ash Pile.

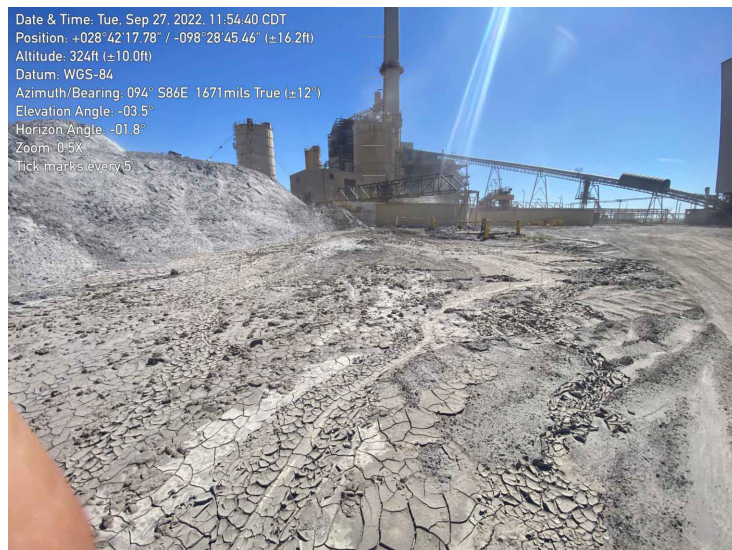
7250 - Facing East. Ash Pile and Wall.

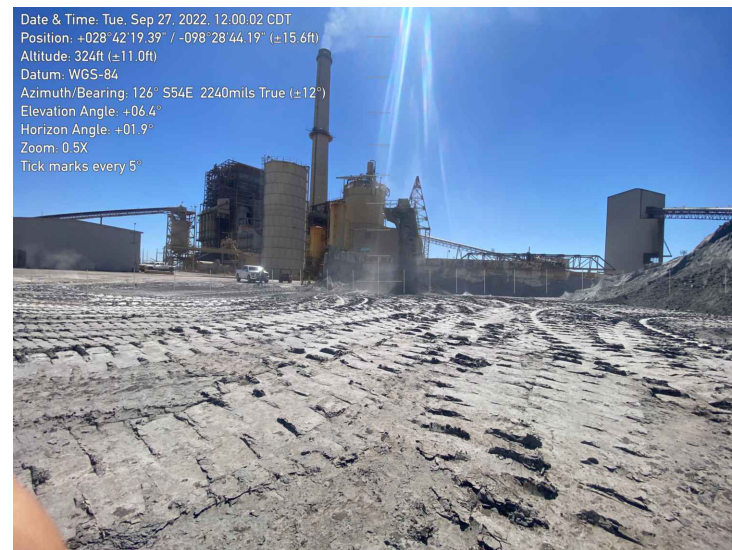
7259 - Facing Southeast. Ash Pile and Wall.

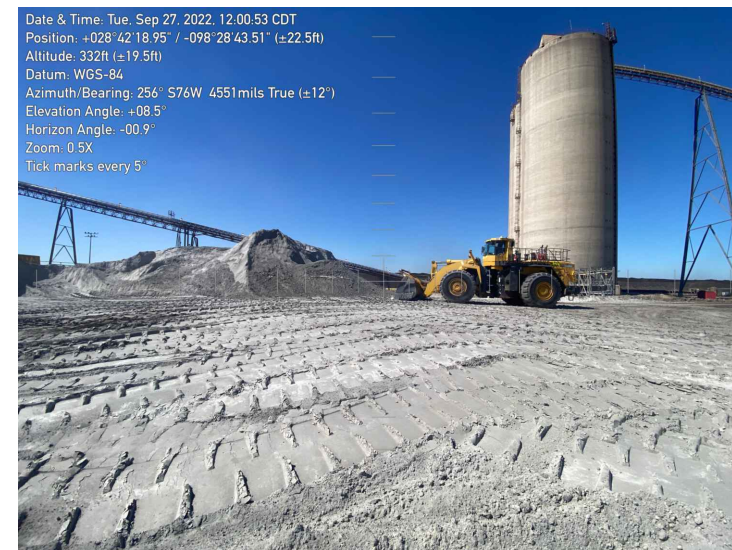
7267 - Facing West. Ash Pile.

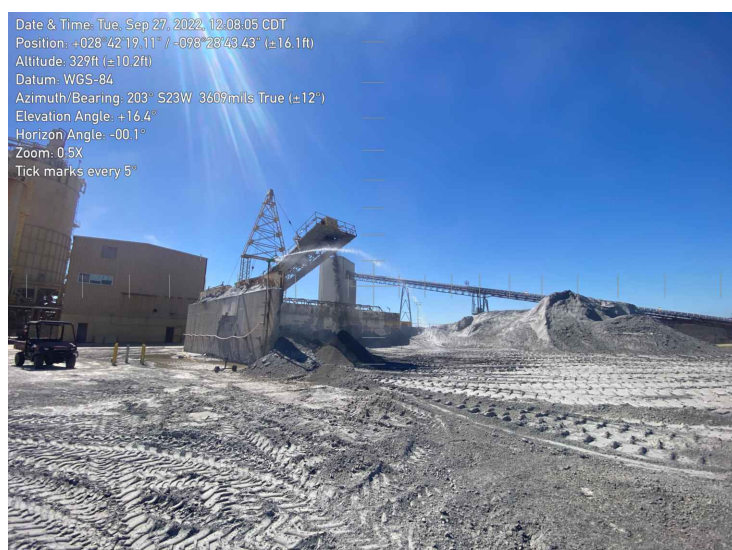
7273 - Facing West. Ash Pile and Sprinklers.
