ANNUAL CCR UNITS INSPECTION

SAN MIGUEL ELECTRIC COOPERATIVE, INC.

October 12, 2023

BBA Project No. 23673

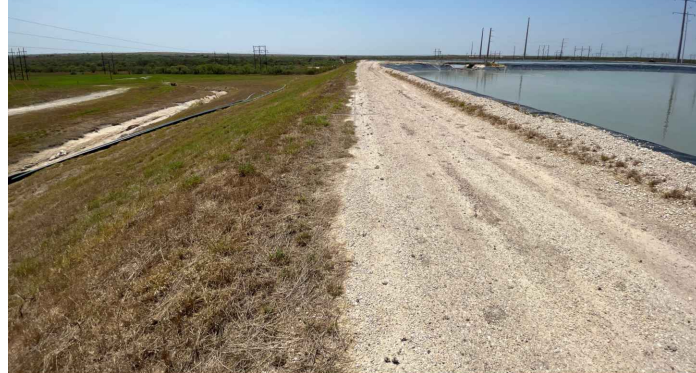
9120 - Facing South. Ash Pond A and Ash Pond B Dike Crest.

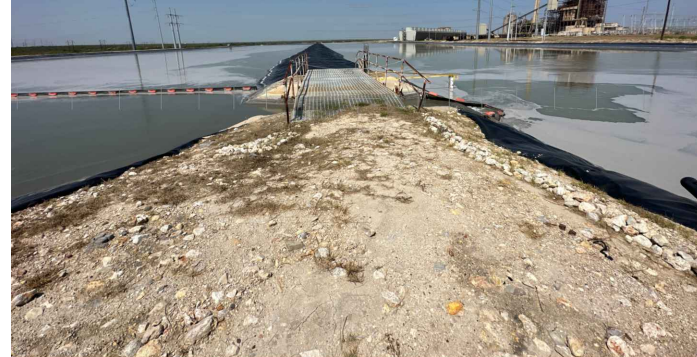
9123 - Facing West. Ash Pond A and Ash Pond B Dike Crest.

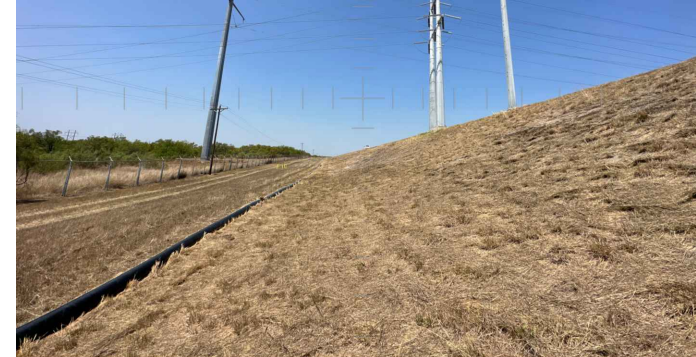
9150 - Facing West. Ash Pond A, South Exterior Slope.

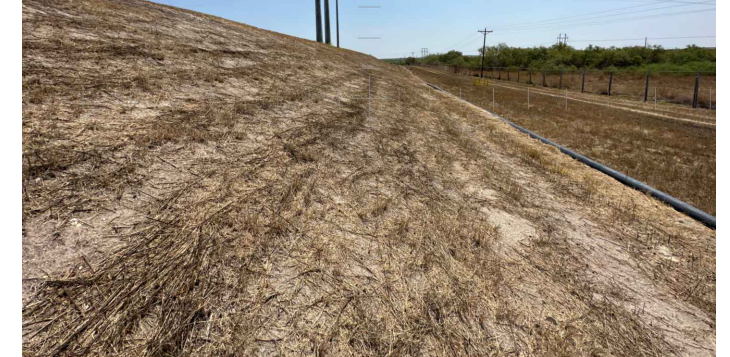
9151 - Facing East. Ash Pond A, South Exterior Slope.

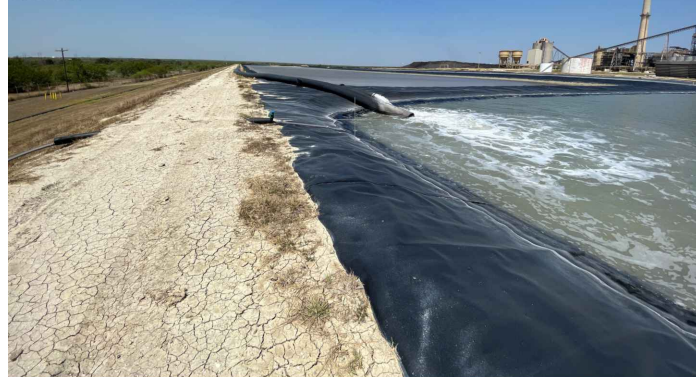
9160 - Facing West. Ash Pond B Splitter Dike.

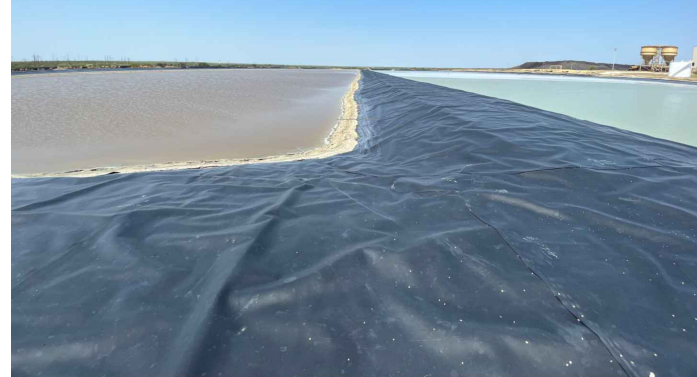
9165 - Facing West. South Equalization Basin, Splitter Dike.

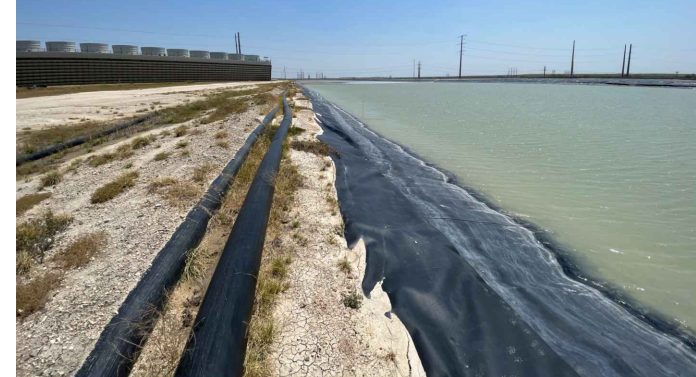
9170 - Facing East. Ash Pond A, Dike Crest.

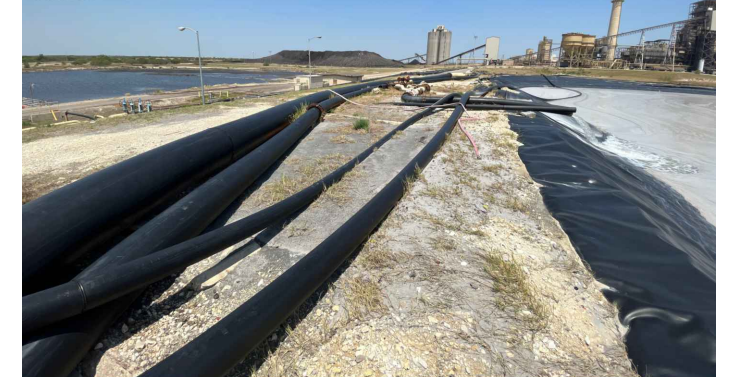
9175 - Facing North. Ash Pond A, Dike Crest.

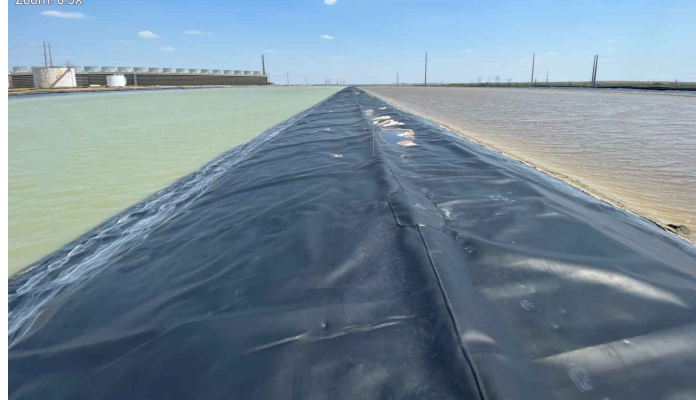
9180 - Facing East. Ash Pond A and South Equalization Basin, Splitter Dike.

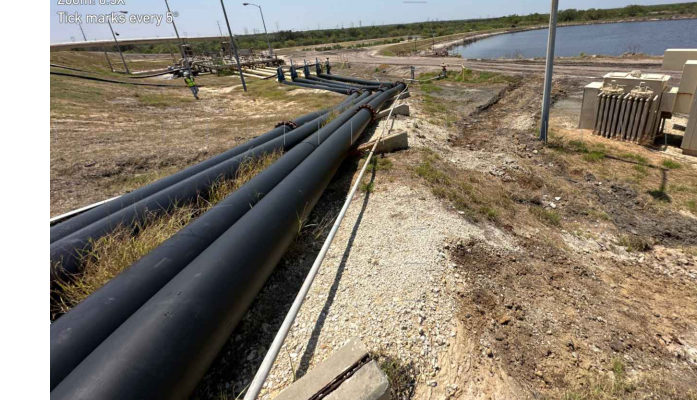
9213 - Facing Southwest. Ash Pond A, Exterior Slope.

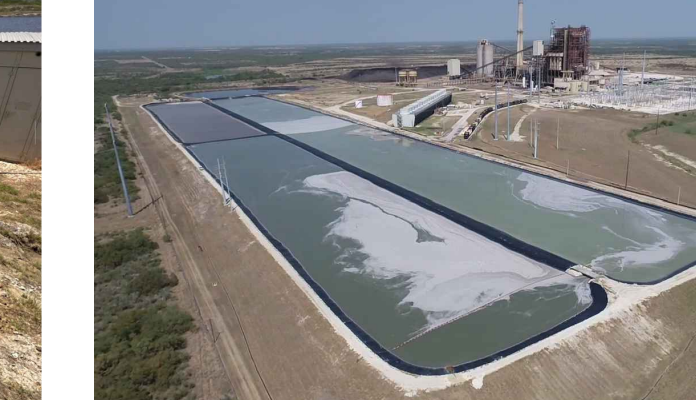
9220 - Facing Northwest. Aerial view of ponds.

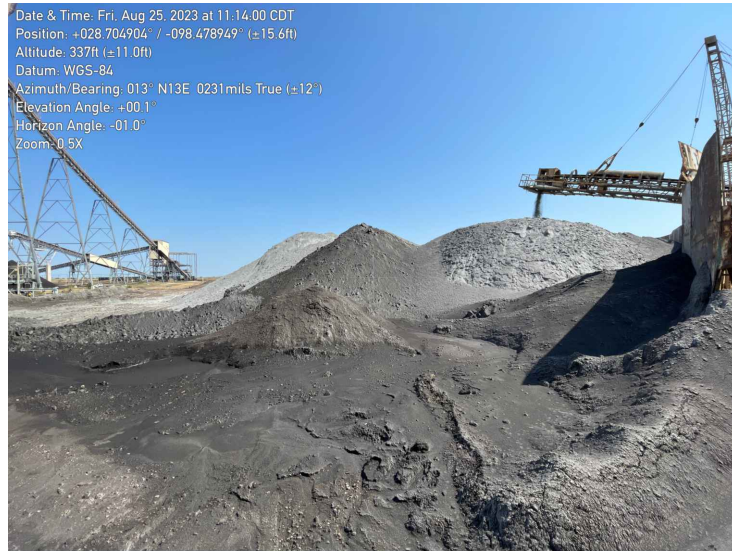
9041 - Facing Northeast. Ash Pile and Wall.

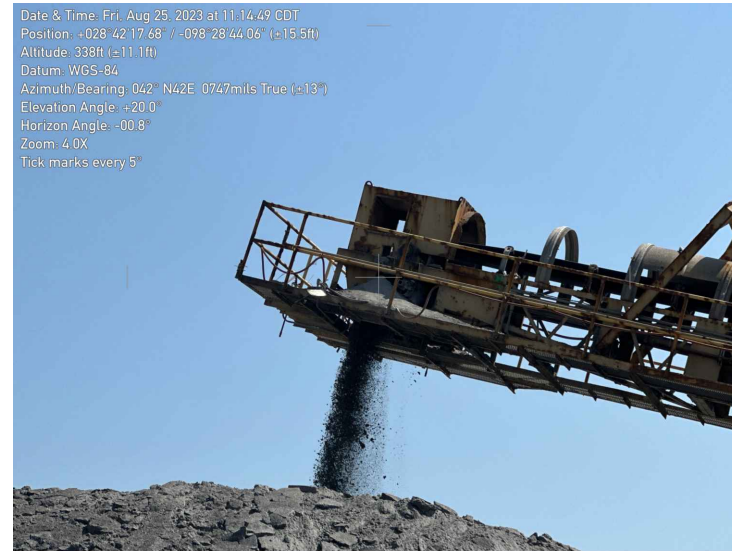
9042 - Facing Northeast. Ash Pile.

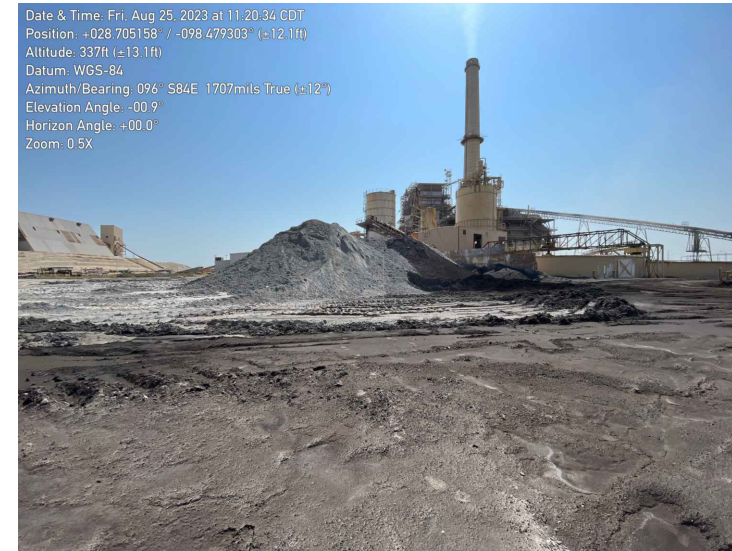
9045 - Facing East. Ash Pile.

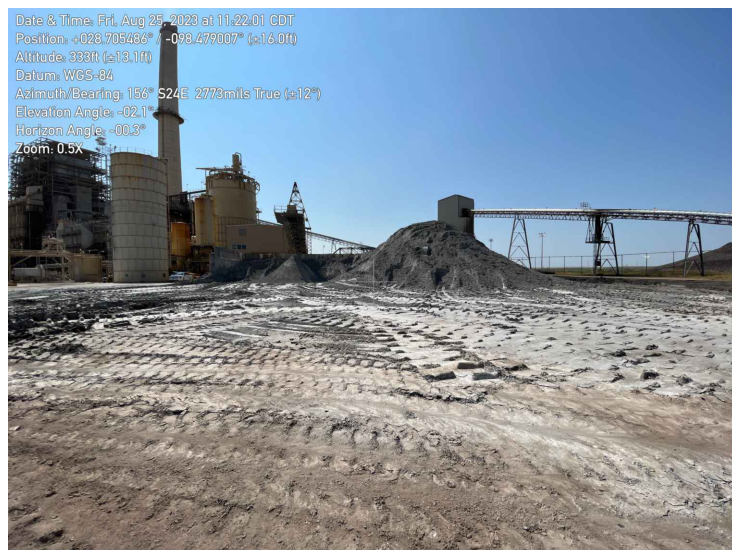
9050 - Facing Southeast. Ash Pile and Wall.

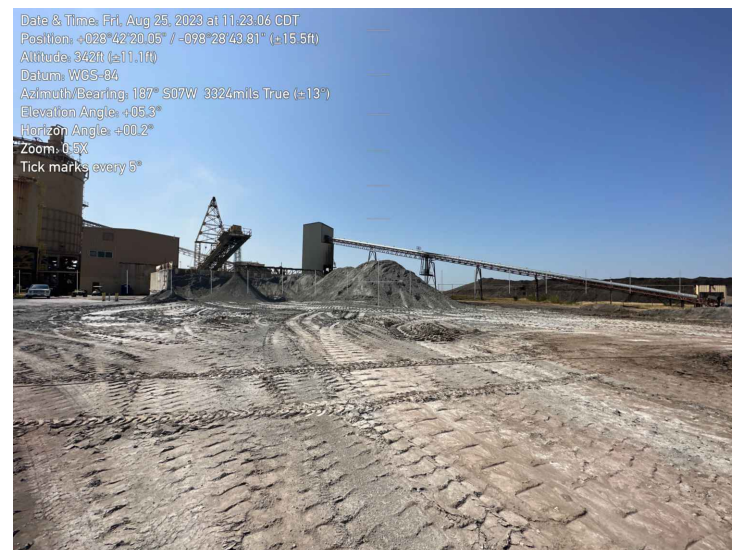
9055 - Facing South. Ash Pile and Wall.

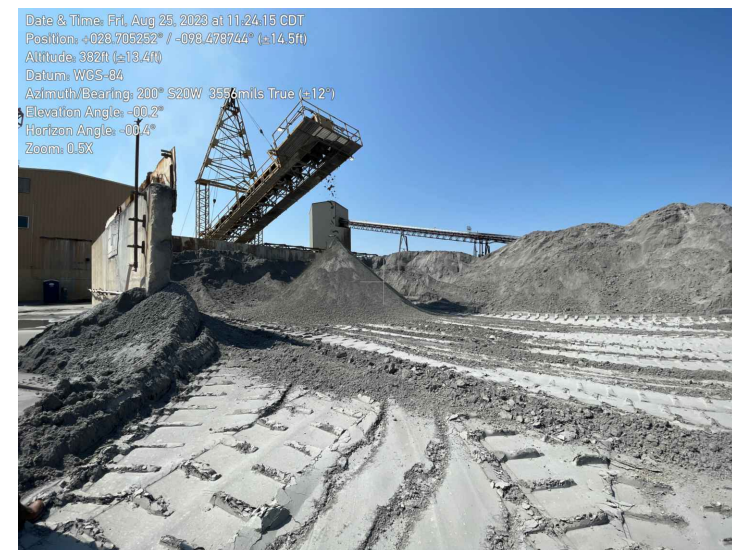
9060 - Facing Southwest. Ash Pile and Wall.
