ANNUAL CCR UNITS INSPECTION

SAN MIGUEL ELECTRIC COOPERATIVE, INC.

October 11, 2024

BBA Project No. 24792

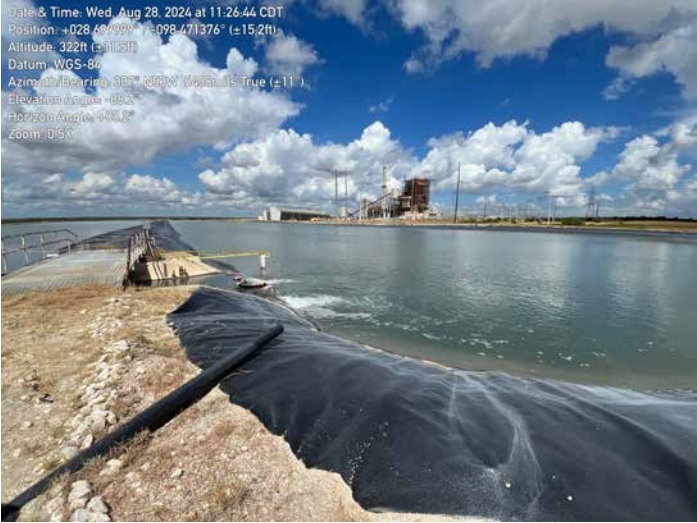
1801 - Facing Northwest. Ash Pond A and Ash Pond B DiKE Crest.

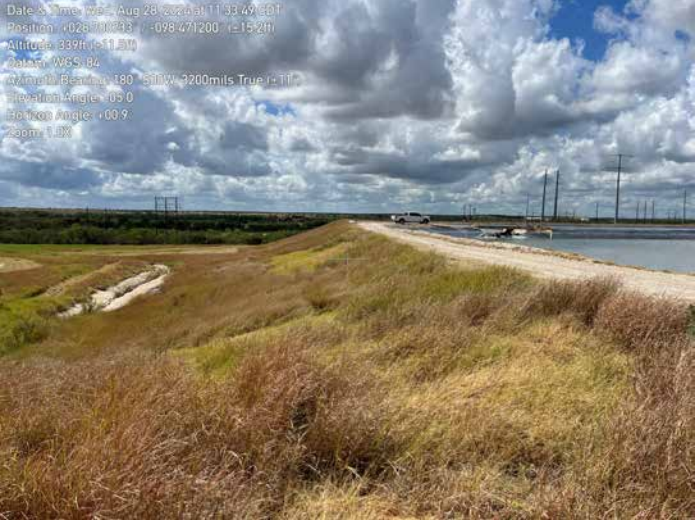
1807 - Facing South. Ash Pond A and Ash Pond B Exterior Slope.

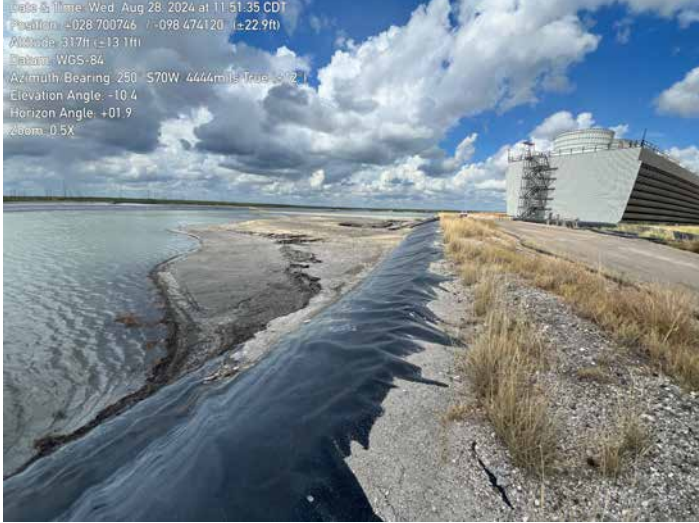
1815 - Facing Southwest. Ash Pond A Interior Slope (left) and Exterior Slope (right).

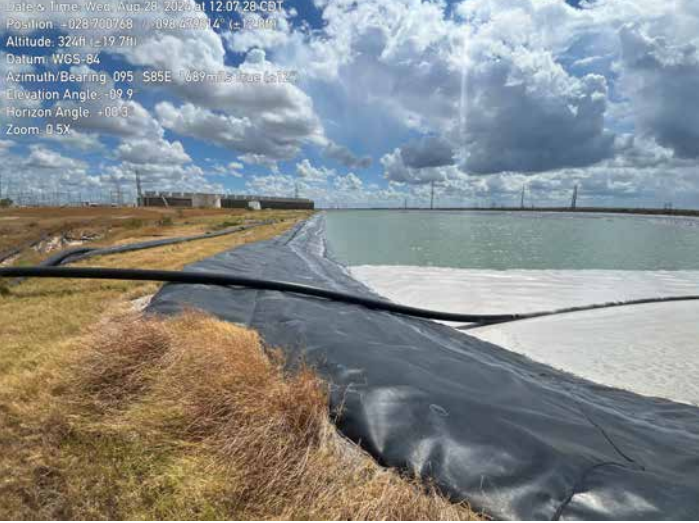
1823 - Facing East. Ash Pond A, Northwest Corner.

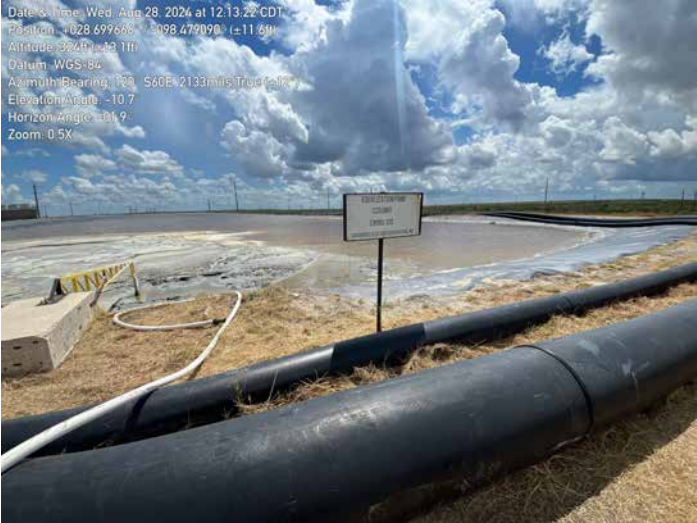
1831 - Facing Southeast. South Equalization Basin, West DiKE and Signage.

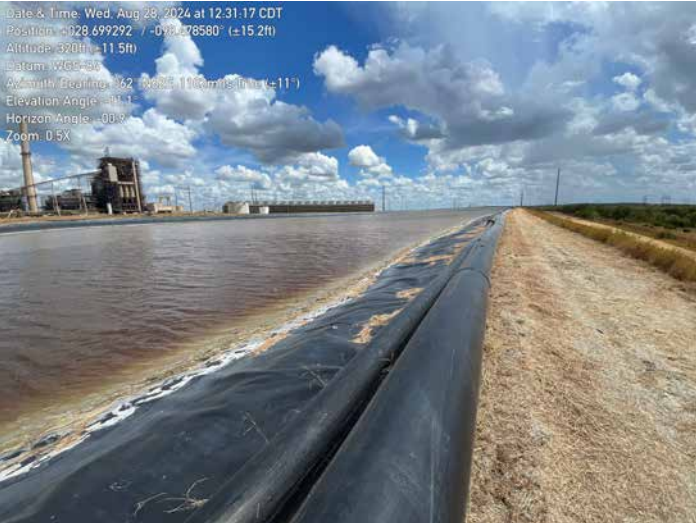
1837 - Facing East. South Equalization Basin, South DiKE.

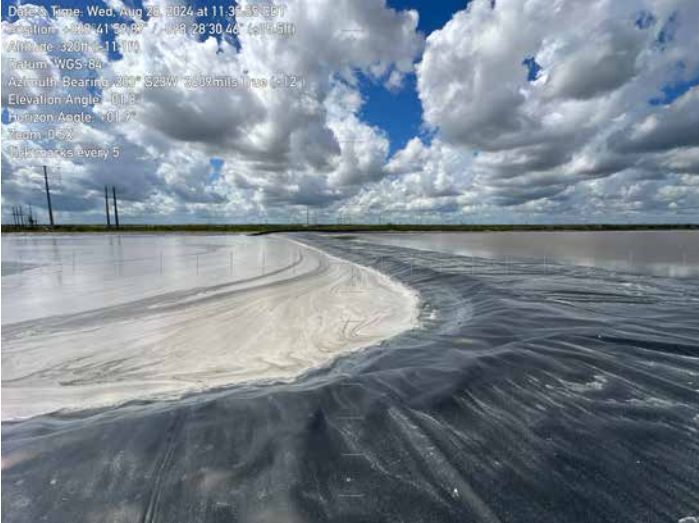
1850 - Facing Southwest. Ash Pond B and SEB Splitter DiKE Crest.

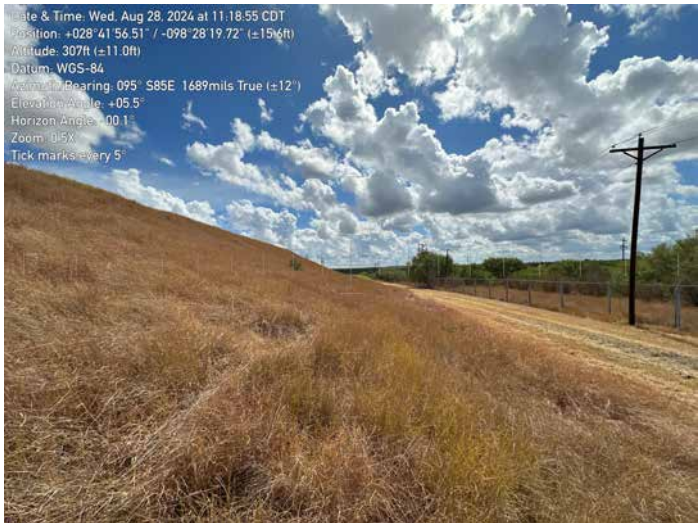
1893 - Facing East. Ash Pond A, Exterior Slope.

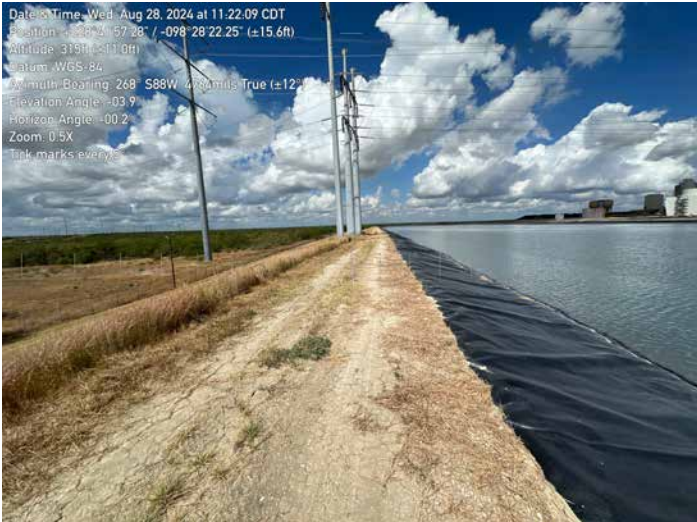
1903 - Facing West. Ash Pond B, DiKE Crest.

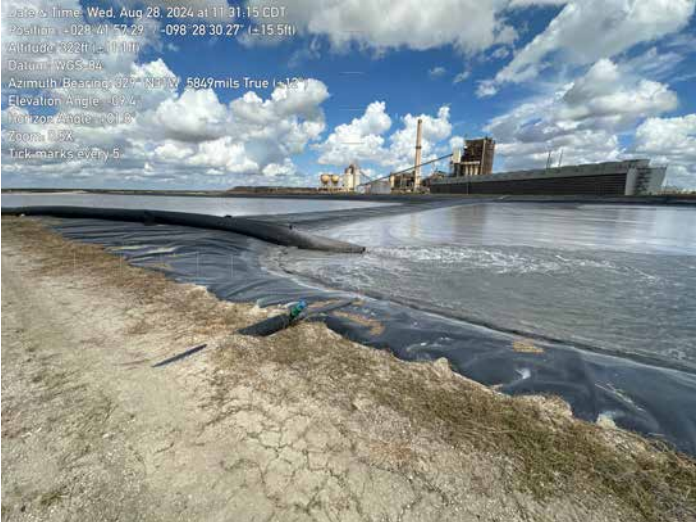
1927 - Facing Northwest. Ash Pond A and SEB Splitter DiKE.

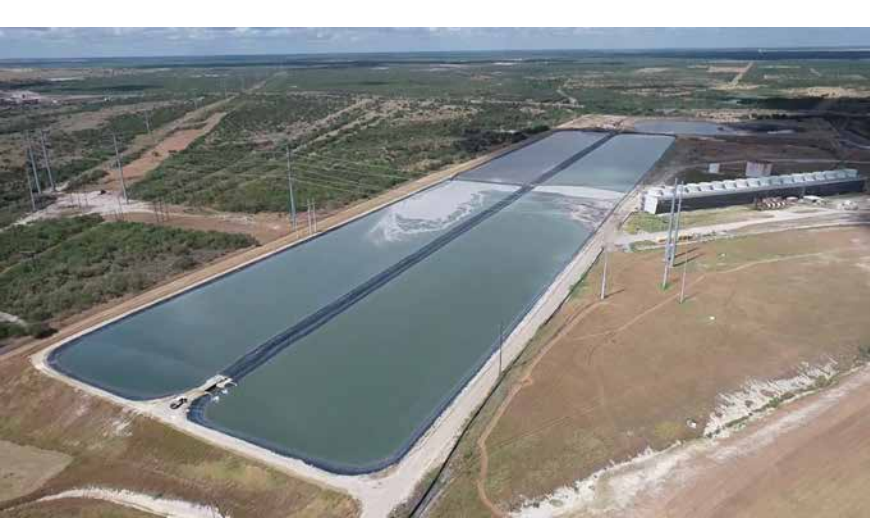
1950 - Facing Southwest. Ash Ponds and SEB, Aerial Overview

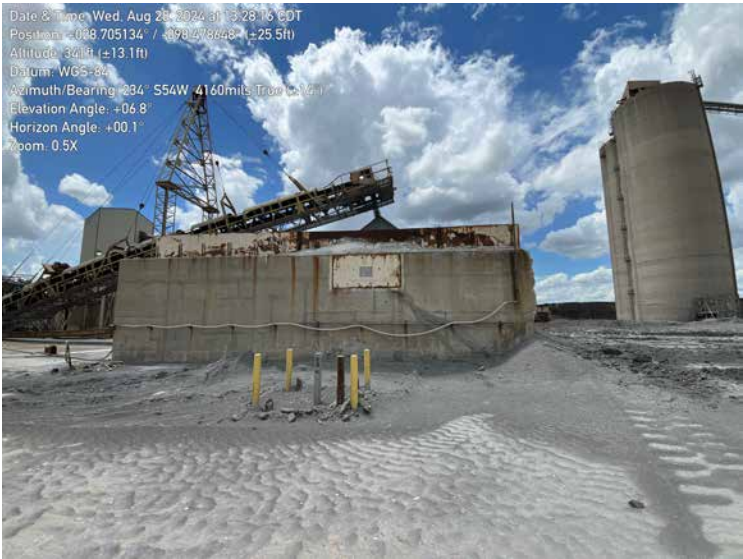
1701 - Facing Southwest. Ash Pile and Wall.

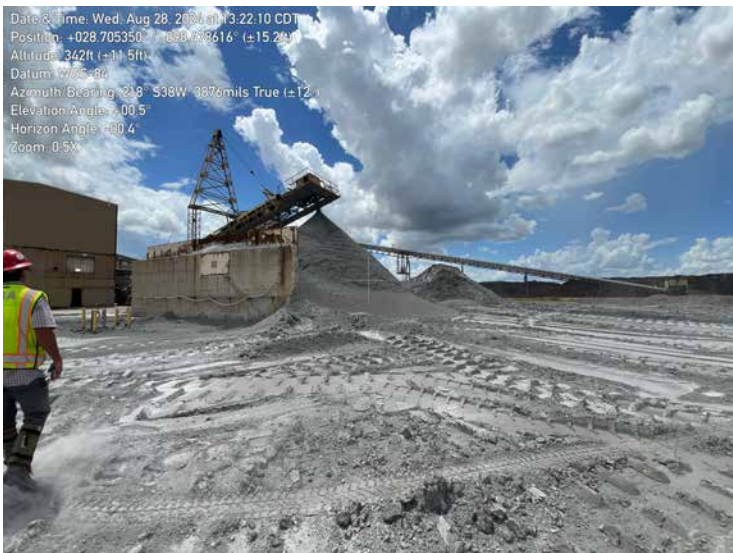
1709 - Facing Southwest. Ash Pile.

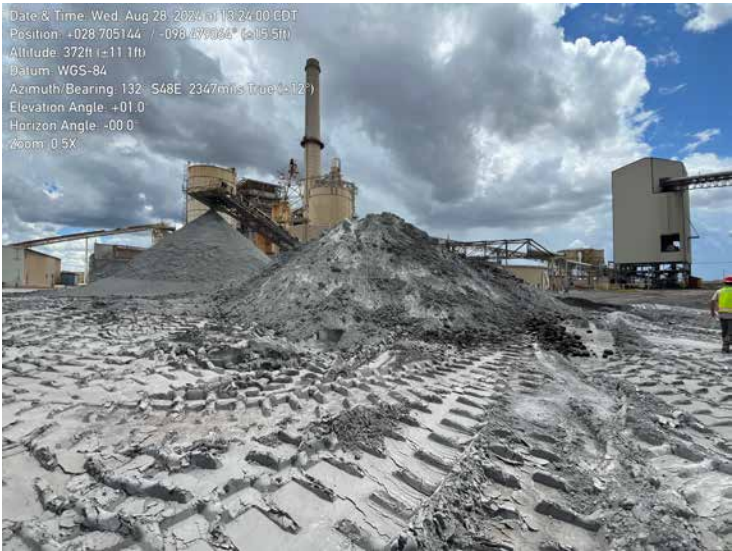
1715 - Facing Southeast. Ash Pile.

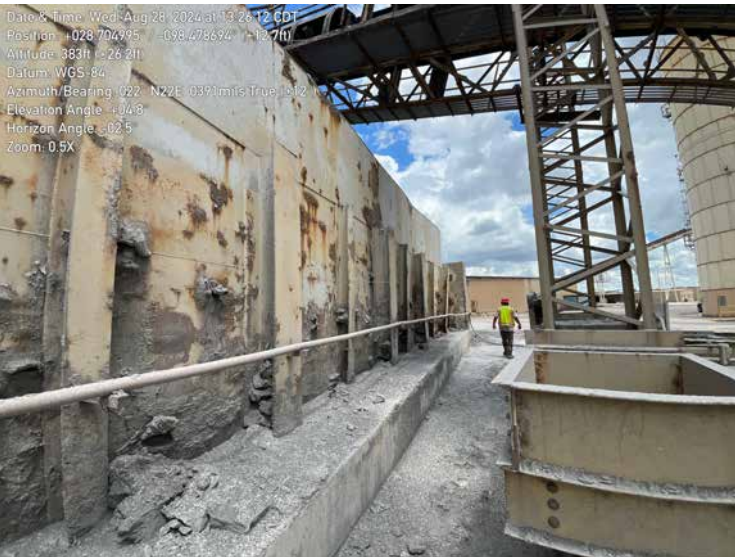
1725 - Facing Northeast. Ash Pile Wall.
