**ANNUAL CCR UNITS INSPECTION**

**SAN MIGUEL ELECTRIC COOPERATIVE, INC.**

October 13, 2025

BBA Project No. 25931

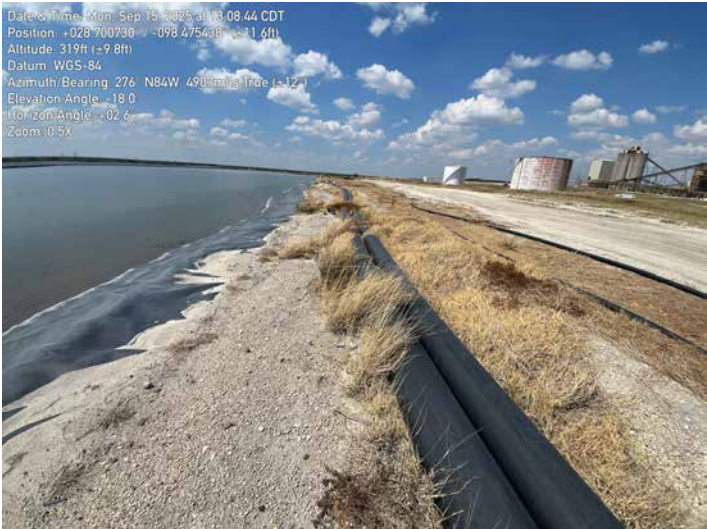
1603 - Facing West. Ash Pond A Northern Dike.

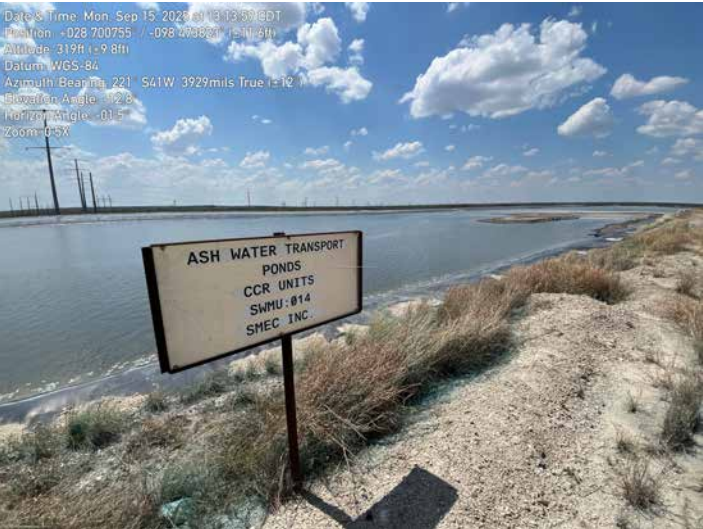
1609 - Facing Southwest. Ash Pond A Exterior Slope and Typical Signage.

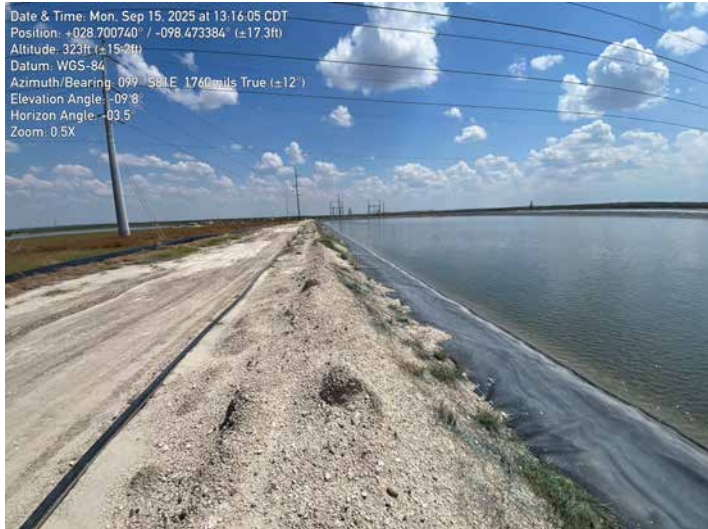
1615 - Facing Southeast. Ash Pond A Interior Slope (right) and Exterior Slope (left).

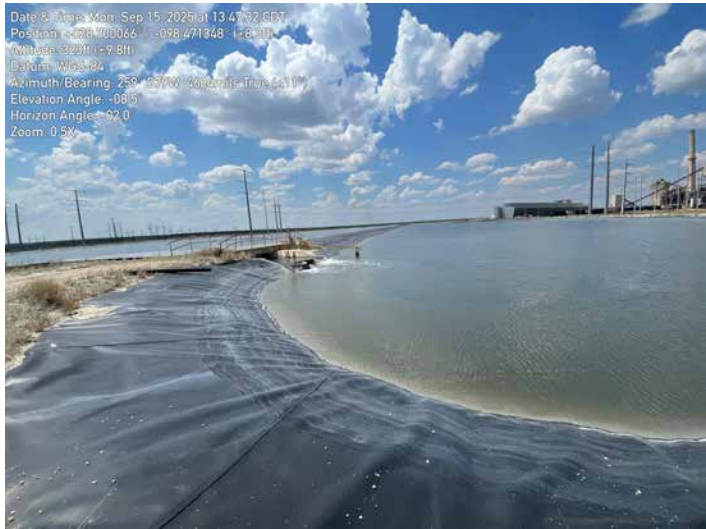
1619 - Facing Southwest. Ash Pond B Outlet Location to Ash Pond A

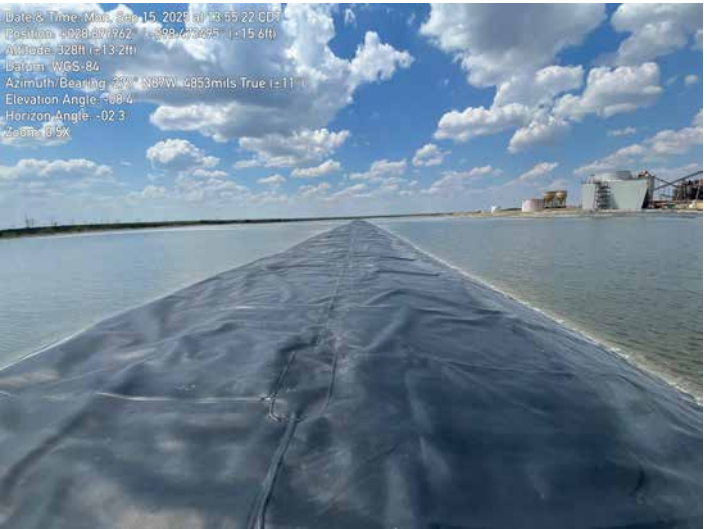
1629 - Facing West. Splitter Dike Crest Between Ash Pond A (right) and Ash Pond B (left)

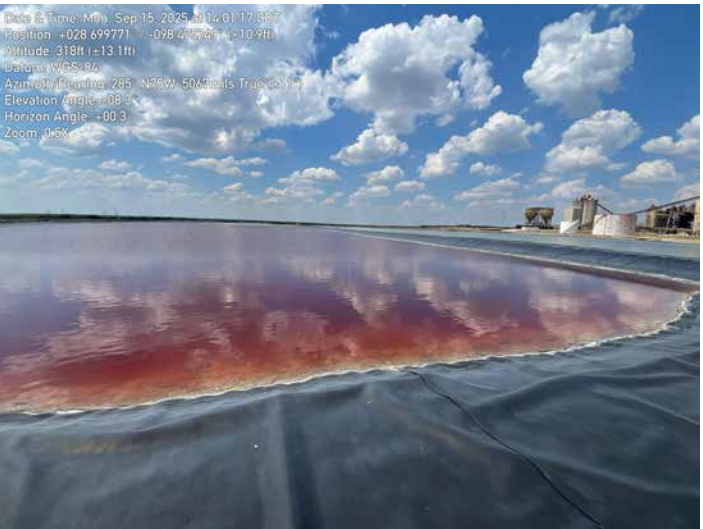
1633 - Facing Northwest. South Equalization Basin, South and North Dike.

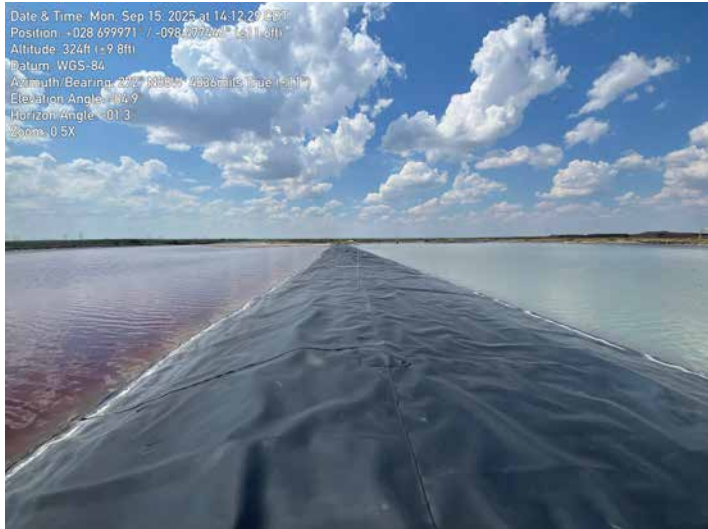
1637 - Facing West. Ash Pond B and SEB Splitter Dike Crest.

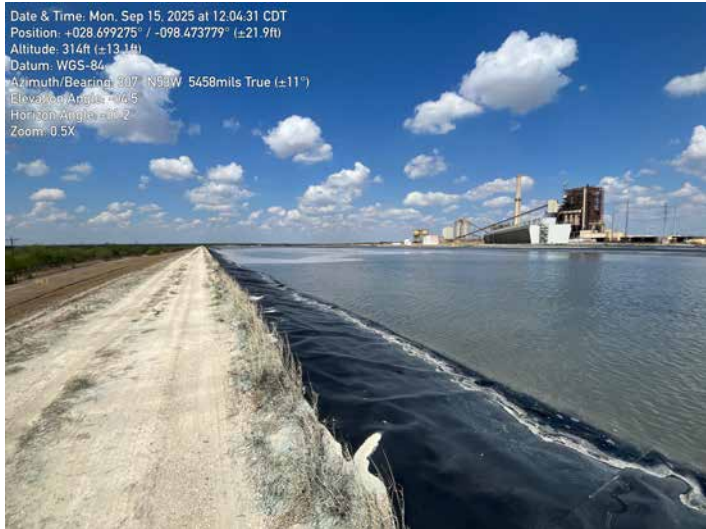
1641 - Facing Northwest. Ash Pond B, Interior Slope (right) and Exterior Slope (left)

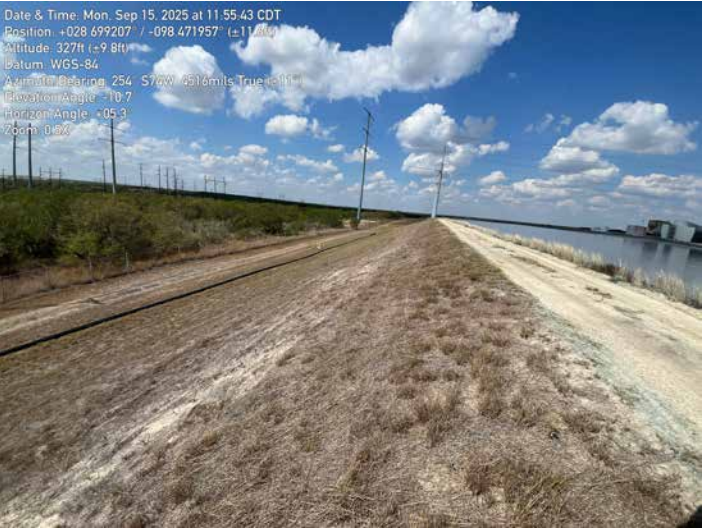
1647 - Facing Southwest. Ash Pond B, Dike Crest and Exterior Slope.

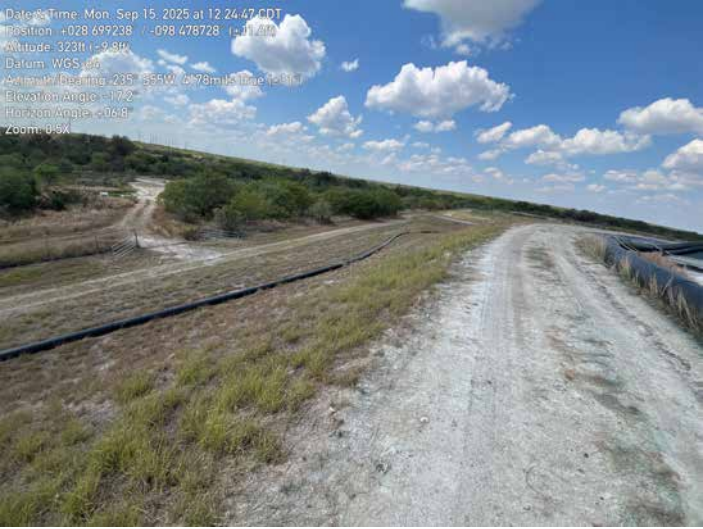
1653 - Facing Southwest. SEB Dike Crest and Exterior Slope

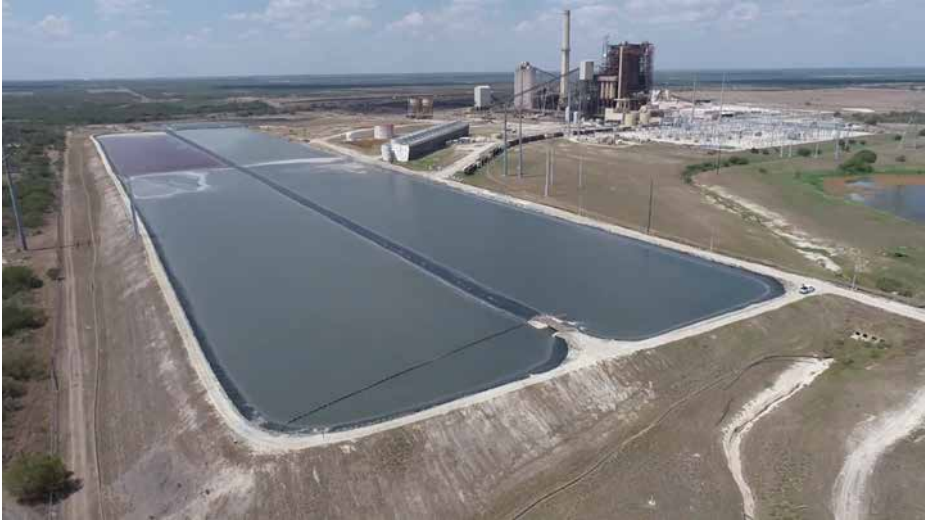
1701 - Facing Northwest. Ash Ponds and SEB, Aerial Overview

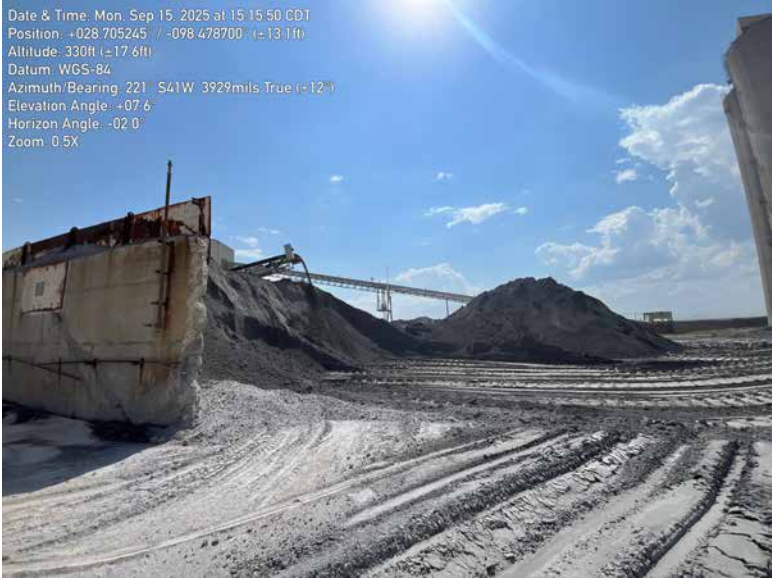
1801 - Facing Southwest. Ash Pile and Wall.

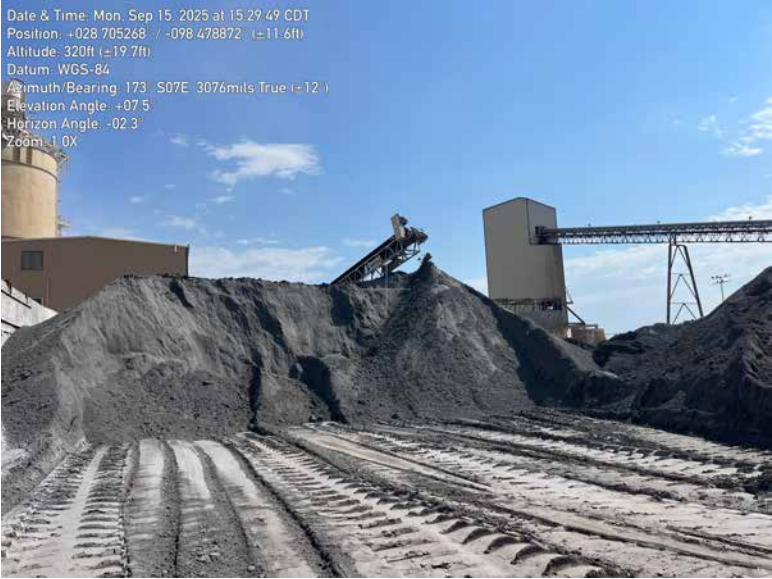
1803 - Facing Southeast. Ash Pile.

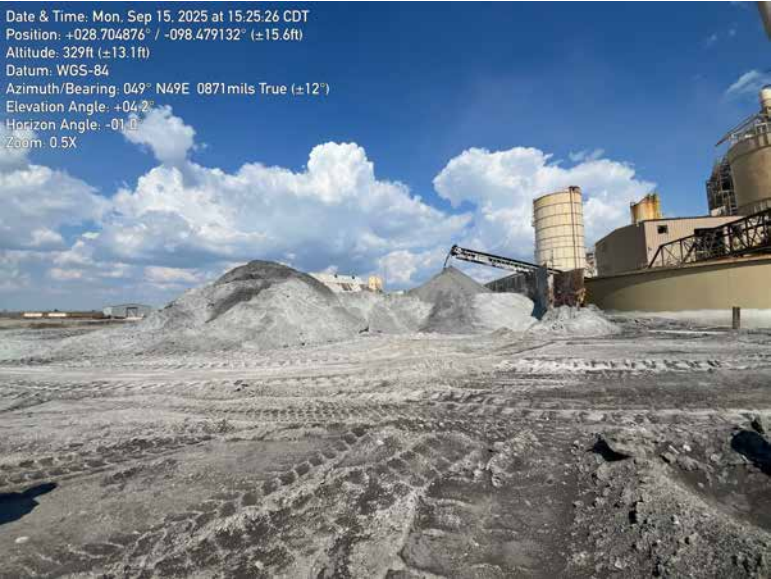
1805 - Facing Southeast. Ash Pile.

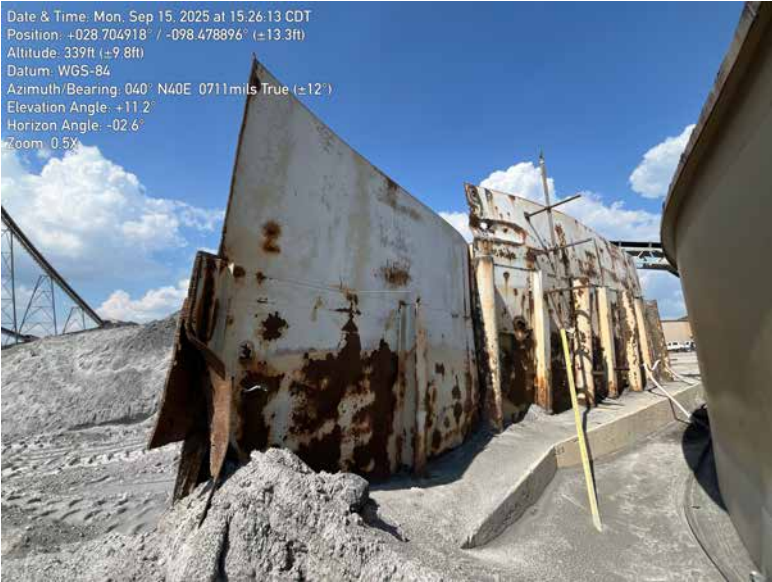
1809 - Facing Northeast. Ash Pile Wall.

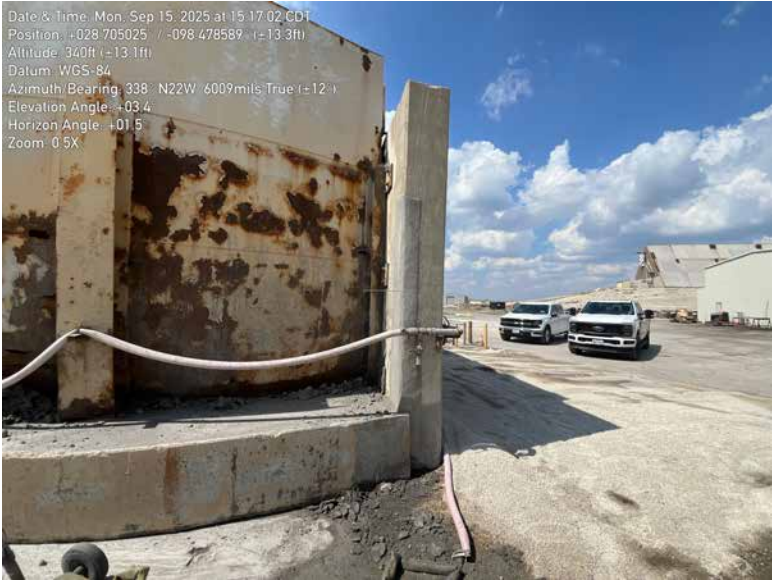
1811 - Facing Southeast. Ash Pile Wall.
