Digital Ink Lines on a SMART Board™ 600 Series Interactive Whiteboard Appear Jagged When a SMART USB Audio System is Attached

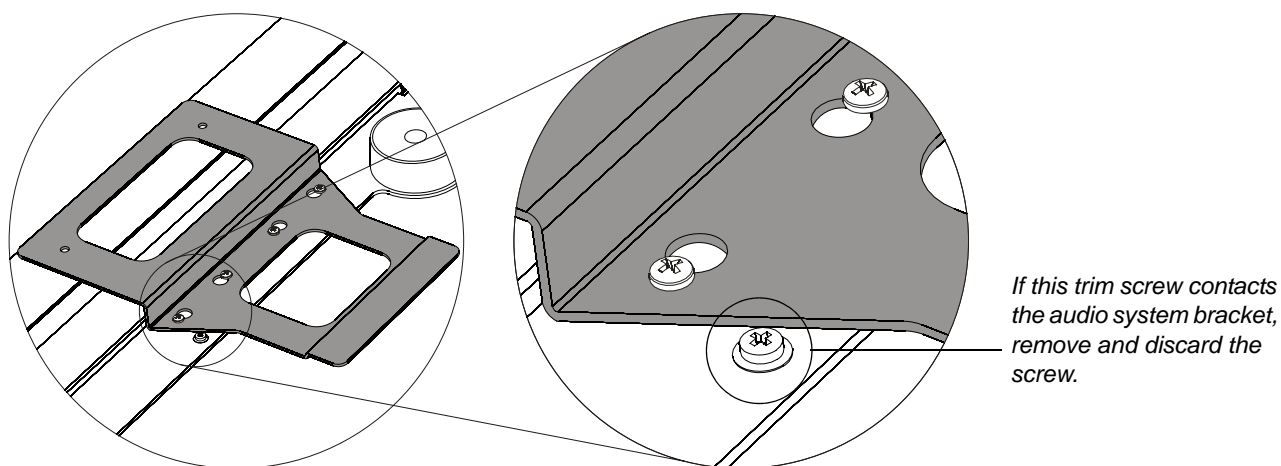
Digital ink written on a SMART Board 600 series interactive whiteboard may appear jagged. This can be the result of electrical interference caused by the metal brackets used to mount the SMART USB Audio System to the rear of the interactive whiteboard.

If the brackets contact a trim screw on the rear of the interactive whiteboard, electrical interference can occur.

If the trim screw on either side of the interactive whiteboard contacts the audio system mounting bracket, remove and discard the trim screw. These two trim screws aren't necessary for the interactive whiteboard's reliable and safe performance.
