Vendor's building survey report
**The Plaza, Elms Road,
Wokingham RG40 2AA**

Prepared for: Aviva Life & Pensions UK Limited
Prepared by: Shaun Miller BSc (Hons) MRICS
Mark Hannan
Issue date: 11 June 2024
Report stage: Final
Reference: 124359-100/MAS/SPM

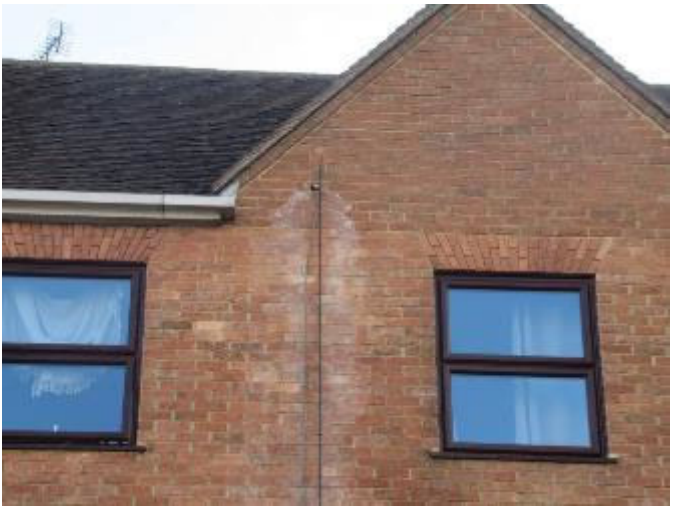
<p>2.</p>	<p>Example of isolated sections of staining to brickwork throughout The Plaza exterior.</p>

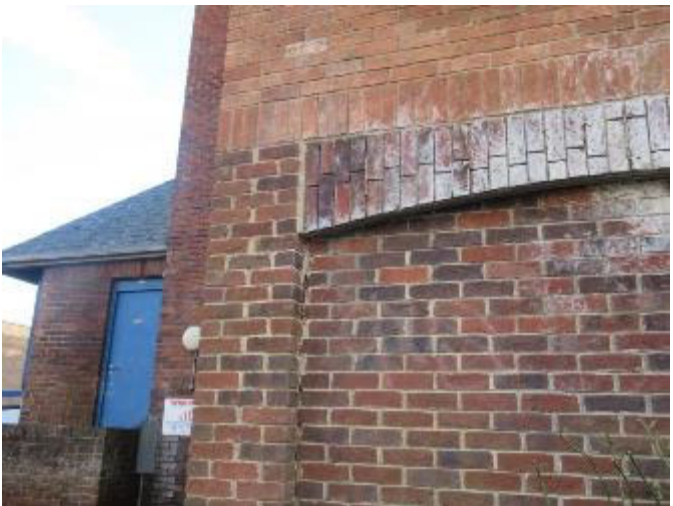
<p>3.</p>	<p>Western elevation typically in fair order, isolated areas of deterioration to external brickwork and mortar erosion to brick slips to concrete frame covering.</p>

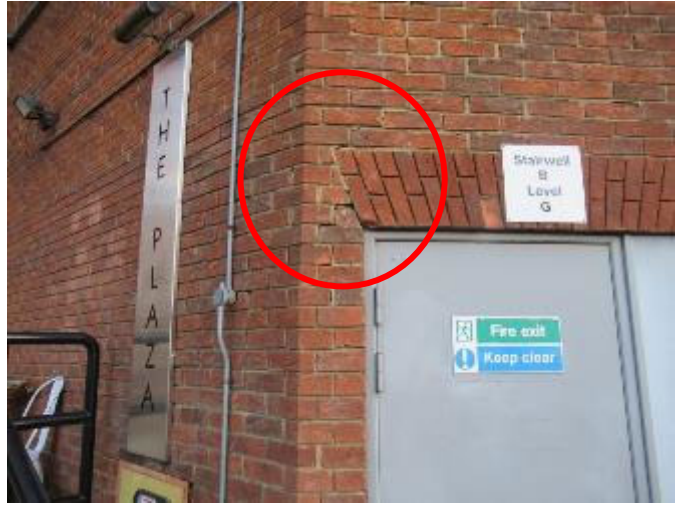
<p>5.</p>	<p>A view of cracking to Gauged brickwork to the southern elevation.</p>

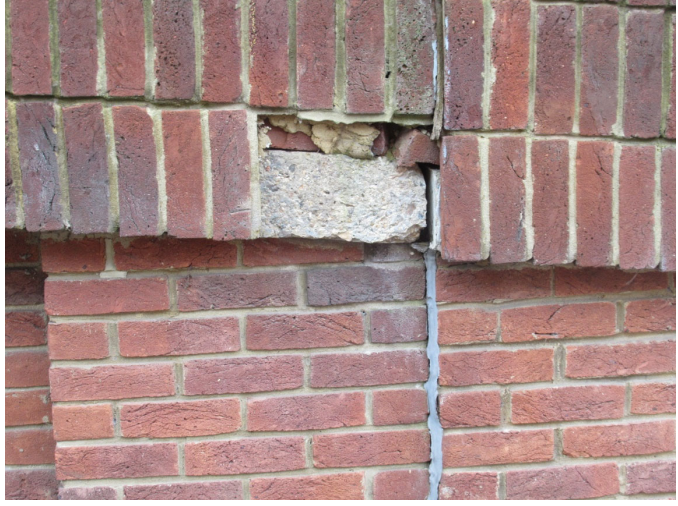
<p>6.</p>	<p>Isolated area of missing brick slips to the lower level of the car park ramp (north facing).</p>

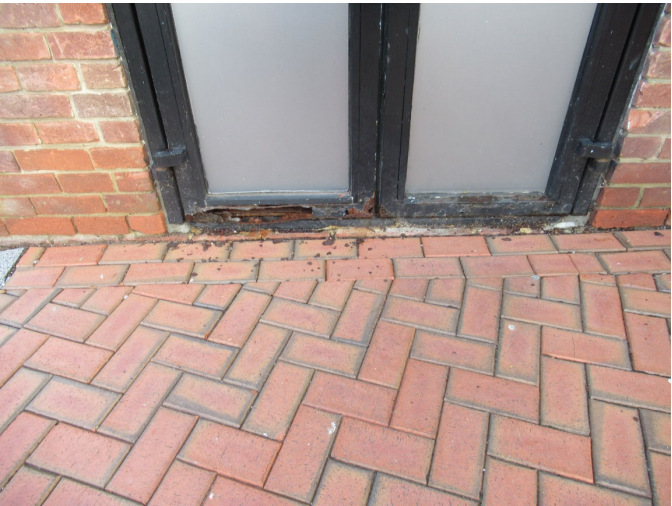
- The lower sections of the doors serving unit 2 from the adjacent patio area are heavily corroded, and the doors require extensive repair or replacement in the short to medium term.

<p>9.</p>	<p>Example of corrosion to base of metal doors, door to unit 2 shown.</p>

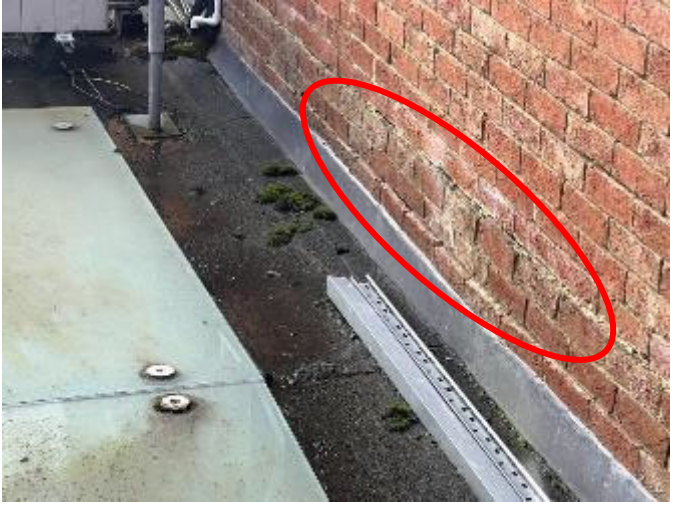
14.	A view of displaced bricks to the east elevation glazed roof.

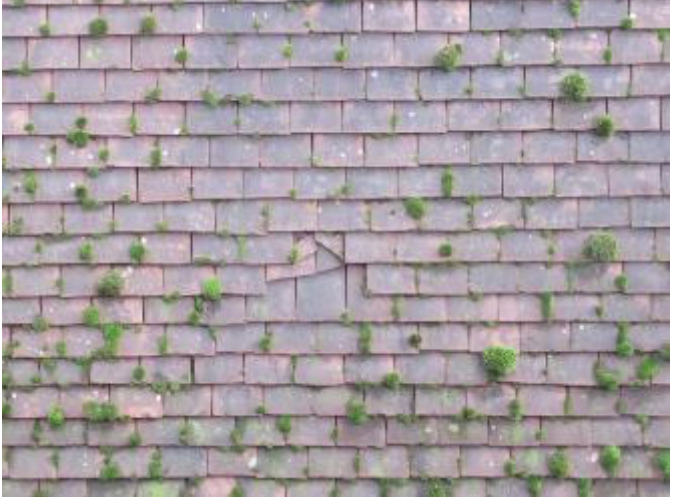
- Isolated areas of cracked and displaced tiles and slates were noted to the pitched roofs. Repairs should be planned for the medium to long term.
- The glazed roof to the canopy around unit 3 and the external lift lobby has been removed.

15.	A view of cracked tiles and heavy moss growth to the east elevation roof.

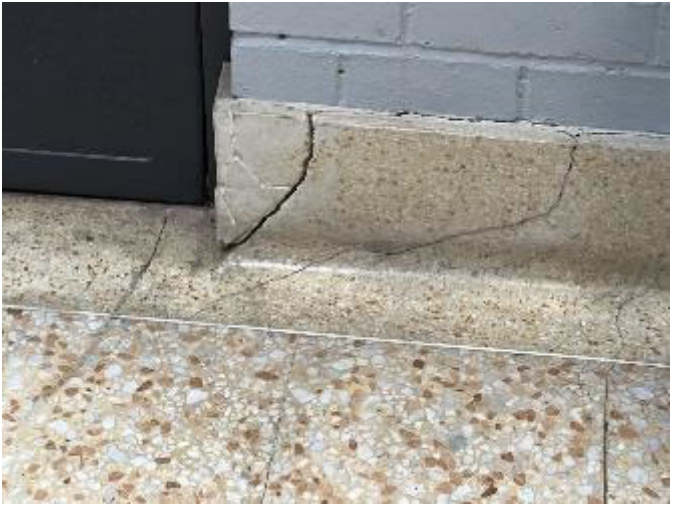
22.	View of cracking to the terrazzo skirting in the communal area to the residential section of the Plaza.

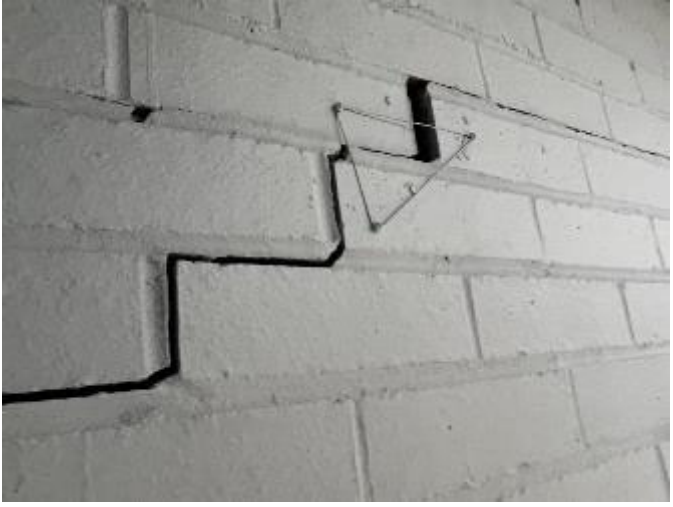
23.	Isolated areas of cracking to brickwork in communal corridor to the residential block; note, historic tell tales to the cracking.

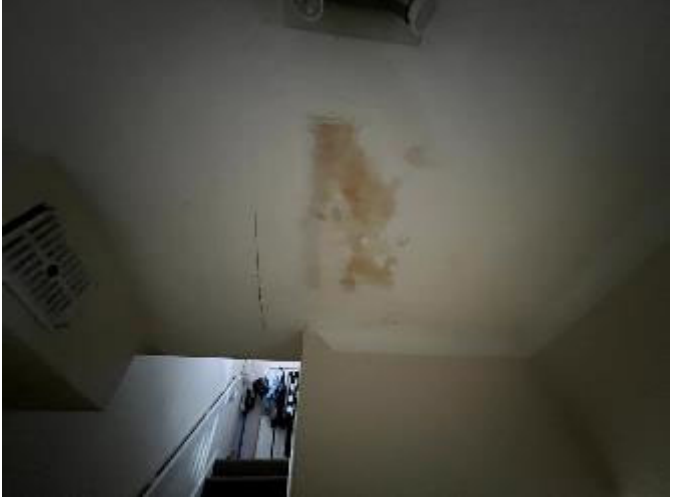
24.	Isolated areas of water/damp ingress to the ceilings of the residential units below the single ply mansard roof.

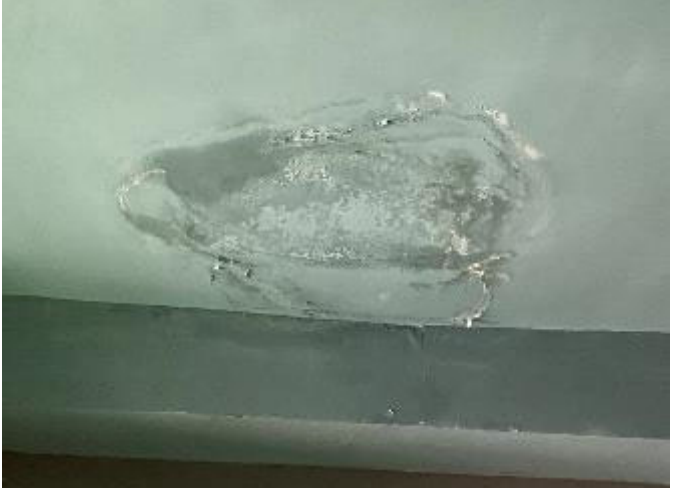
A photograph of a bar or pub interior. The space is filled with wooden tables and chairs, blue upholstered seating, and a bar counter in the background. The lighting is warm and ambient.
27.	Water/damp ingress to isolated ceiling areas of unit 2.

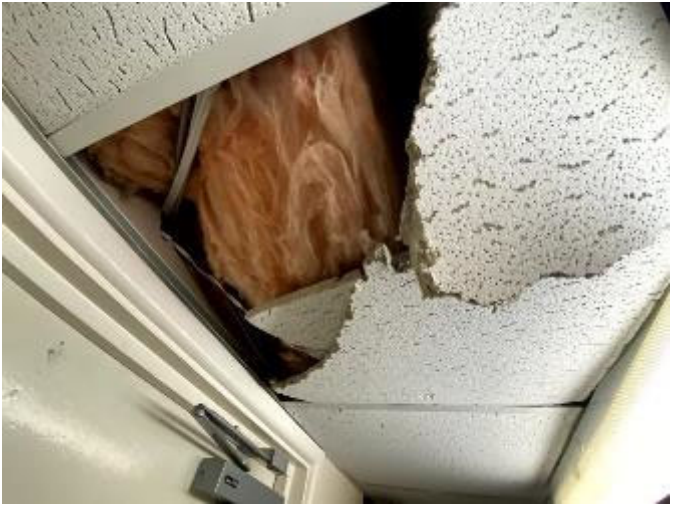
<p>28.</p>	<p>Example of multiple damaged suspended ceiling tiles to the back of house of unit 2.</p>

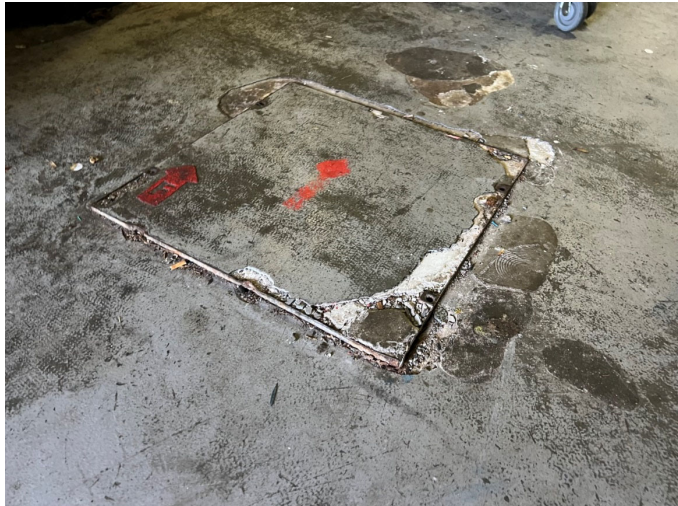
31.	Wear to the floor finish of the back of house/service corridor behind unit 3 and 4; damage to the inspection chamber surround.

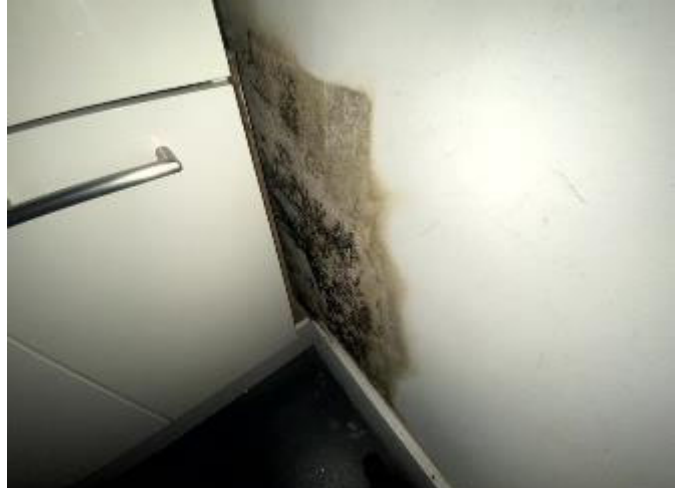
33.	Isolated areas of water ingress to back of house areas to Nuffield health.
