# Inspection Result Certificate

Brand/ Model (Year)	Nissan / XTrail (2005)
Mileage	121,308 km
Engine Type / Size	QR20 (DE) / 2000 cc
Transmission / Type of WD	AT / 4WD
Fuel	Petrol

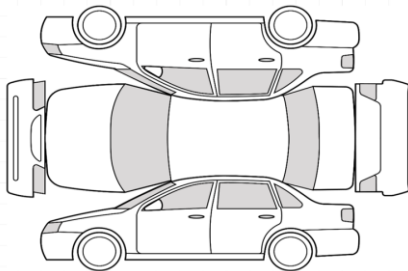
B: Blistering  
 C: Crack  
 D: Dent  
 P: Paint Peeling  
 R: Rust  
 S: Scratch

## Exterior 3.0 ★★★★★

Scratches on driver's side rear door  
 Repainted

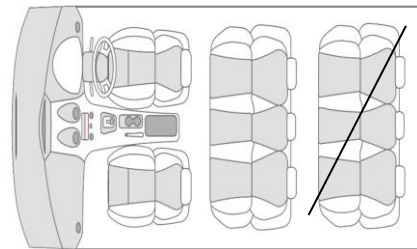
A: Stain  
 B: Sunburn  
 C: Crack  
 G: Gap  
 H: Hole  
 S: Scratch  
 T: Torn

## Interior 3.8 ★★★★★

Scratch on driver's seat
