Direct To Auction Form

B&B Stock Number	A3980492
Category	Other
Year	N/A
Make	Buckeye
Model	N/A
Fleet ID	E21
Serial Number / VIN	N/A
Serial Number Plate / VIN Sticker

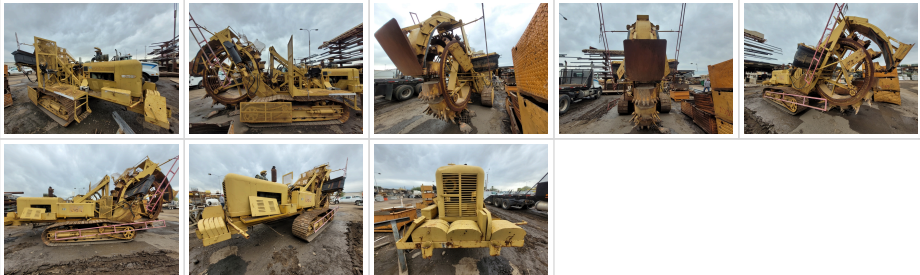
Exterior Walkaround Photos

<p>Multiple pieces of square steel tubing are placed throughout the machines exterior.</p>
Exterior Comments	The machines exterior has normal wear and tear when considering its age. Overall, it's in descent shape with no major damage seen on the exterior panels.
