# Firmware Release Notes

# **AMS-2616P**

## Release Firmware Version 4.1.3 - Recommended Update

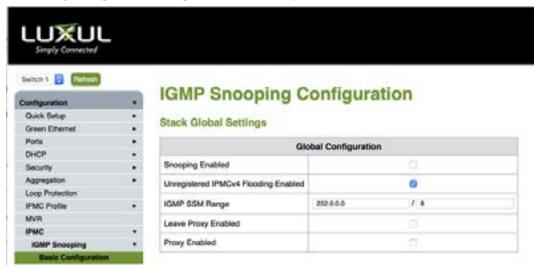
Changes IGMP settings that were set with factory default for firmware version 4.1.2 that would cause discovery of devices to fail for systems like Savant, Control4, Luxul controllers, etc.

The final configuration should resemble the image (Figure 1) below.

After completing the upgrade to 4.1.3, there are 2 options for the settings to be applied:

- In the web UI navigate to Configuration > IPMC > IGMP Snooping > Basic
  Configuration. Uncheck Snooping Enabled and check Unregistered IPMCv4 Flooding
- Factory default your switch and the configuration will be automatically applied.
