AMS-4424P

Release Firmware Version 4.2.3 - Recommended Update

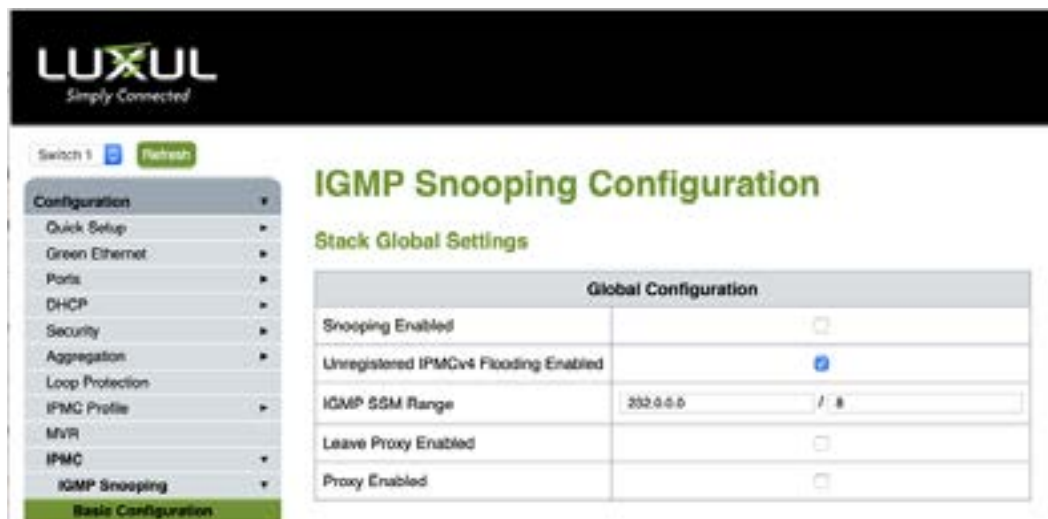
Figure 1:

- Changes IGMP settings that were set with factory default for firmware version 4.2.0 that would cause discovery of devices to fail for systems like Savant, Control4, Luxul controllers, etc. Reverting IGMP settings to as they were in the 4.1.3 release.

The final configuration should resemble the image (Figure 1) below.

After completing the upgrade to 4.2.1, there are 2 options for the settings to be applied:

- In the web UI navigate to Configuration > IPMC > IGMP Snooping > Basic Configuration. Uncheck Snooping Enabled and check Unregistered IPMCv4 Flooding
- Factory default your switch and the configuration will be automatically applied.

Note: If you restore a 4.2.0 config after factory defaulting, you will need to manually configure the settings as described in option 1 above.

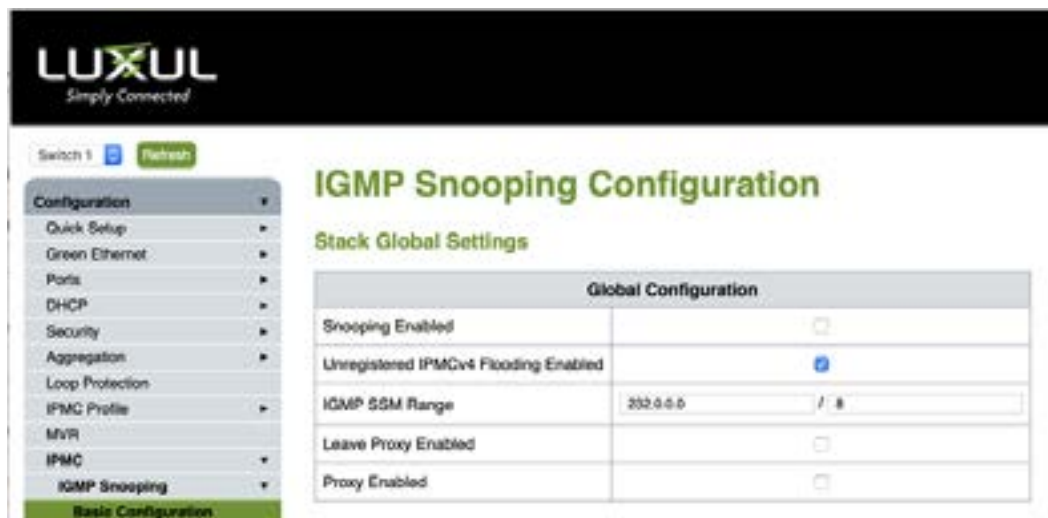
- Changes IGMP settings that were set with factory default for firmware version 4.1.2 that would cause discovery of devices to fail for systems like Savant, Control4, Luxul controllers, etc.

The final configuration should resemble the image (Figure 1) below.

After completing the upgrade to 4.1.3, there are 2 options for the settings to be applied:

- In the web UI navigate to Configuration > IPMC > IGMP Snooping > Basic Configuration. Uncheck Snooping Enabled and check Unregistered IPMCv4 Flooding
- Factory default your switch and the configuration will be automatically applied.

Note: *If you restore a 4.1.2 config after factory defaulting, you will need to manually configure the settings as described in option 1 above.*
