# FIRMWARE V2.0 TROUBLESHOOTING GUIDE

©2025 Legrand AV Inc. 250379 Rev A 6/25 C2G, Chief, Da-Lite, Luxul, Middle Atlantic, Vaddio and Wiremold registered trademarks of Legrand AV Inc. All other brand names or marks are used for identification purposes and are trademarks of their respective owners. All patents are protected under existing designations. Other patents pending.

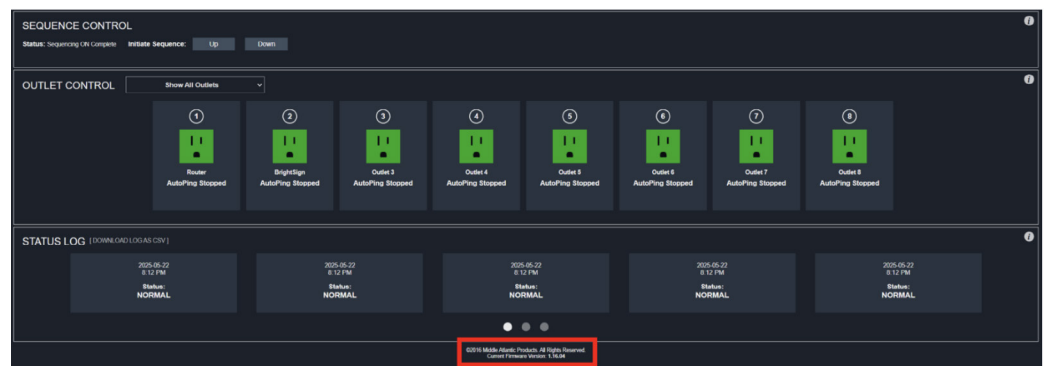
The firmware version can be found at the bottom of the dashboard
