FIRMWARE V2.0 TROUBLESHOOTING GUIDE

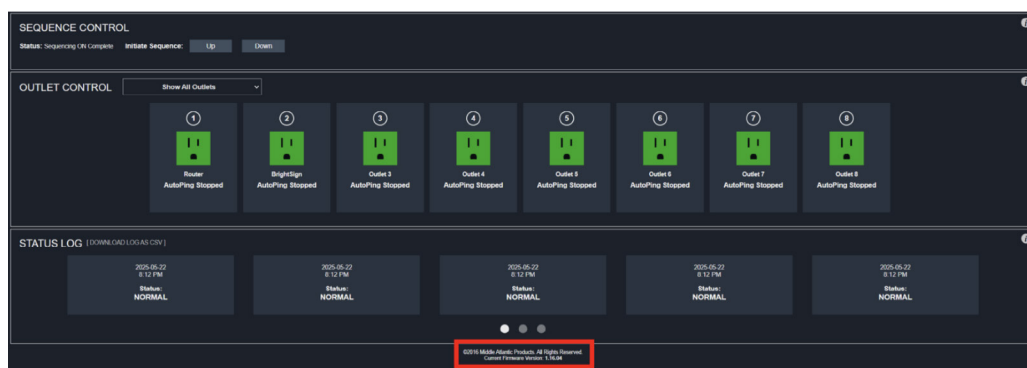
The firmware version can be found at the bottom of the dashboard
